Addendum Arboricultural Report

Subsidence Damage Investigation at:

23 Three Oaks Close
Ickenham
Uxbridge
UB10 8DU

CLIENT: Crawford & Company
CLIENT REF: SU2005239
MWA REF: SUB201123-7901Rev01
MWA CONSULTANT: Andy Clark
REPORT DATE: 21/04/2022

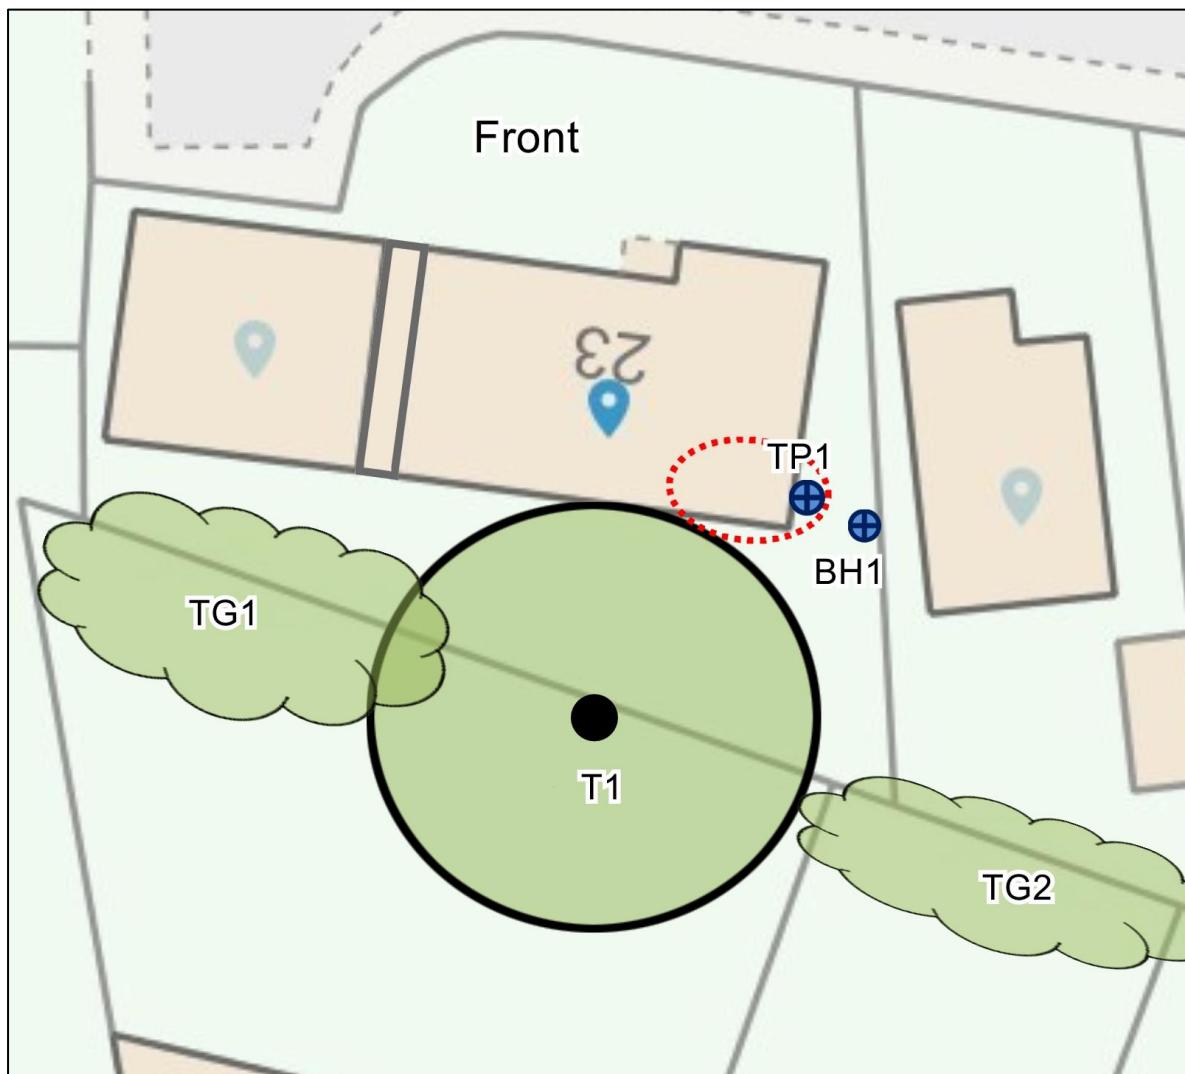
Site Plan

Approximate areas of damage

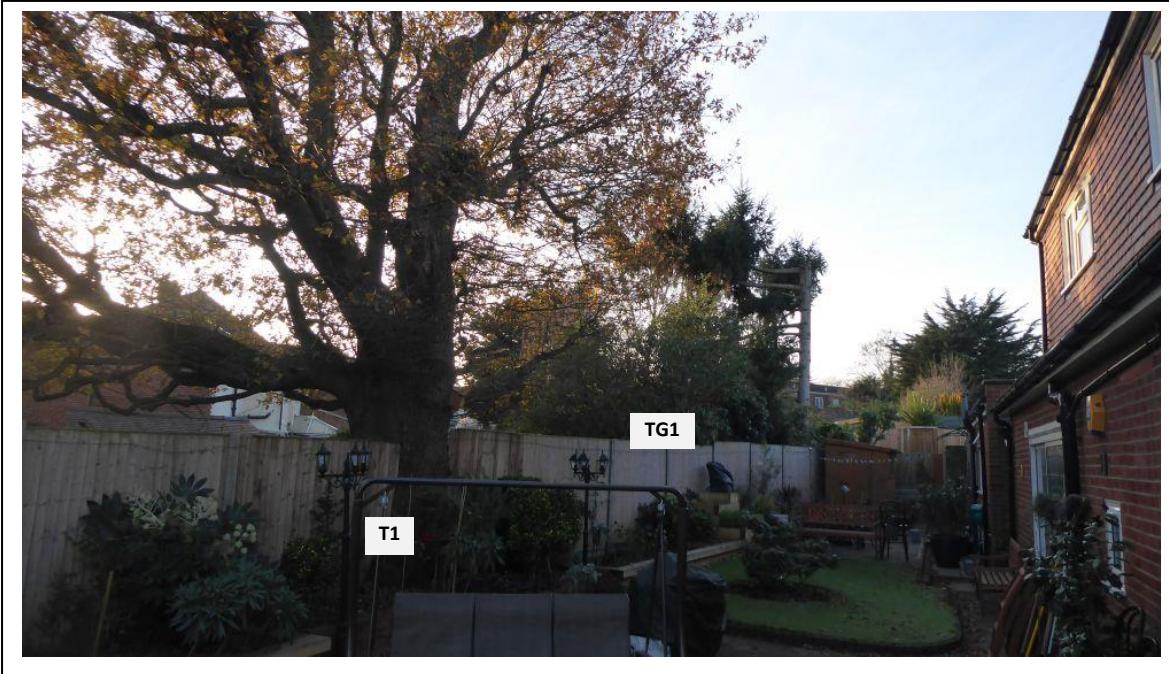
Roots were observed to a depth of 0.9m bgl in TP1 and to 2.0m bgl in the adjacent BH1, and recovered samples have been positively identified (using anatomical analysis) as *Quercus spp.*; the origin of which will be T1 Oak.

Based on the information currently available, engineering opinion and our own site assessment we conclude the damage appears consistent with shrinkage of the clay fraction due to the soil drying effects of vegetation.

View of T1 Oak and TG1 mixed spp. group

At this stage we recommend that T1 Oak is significantly reduced. This tree is of a significant age estimated to be in excess of 150 years old and predates surrounding properties by many decades. Removal is therefore considered to be disproportionate however if movement persists following reduction works, then removal may need to be considered.

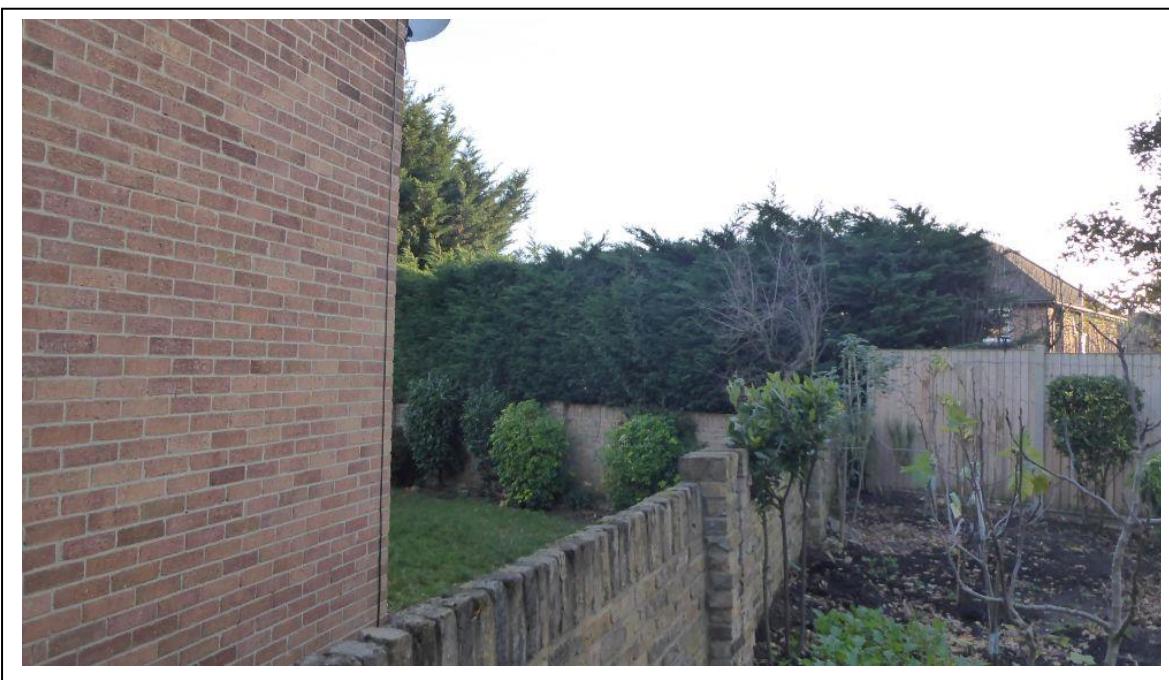
View of TG2 Cypress group

Other vegetation recorded presents a potential future risk to building stability and management is therefore recommended. Recommended tree works may however be subject to change upon receipt of additional information.
