## SD - Damage:

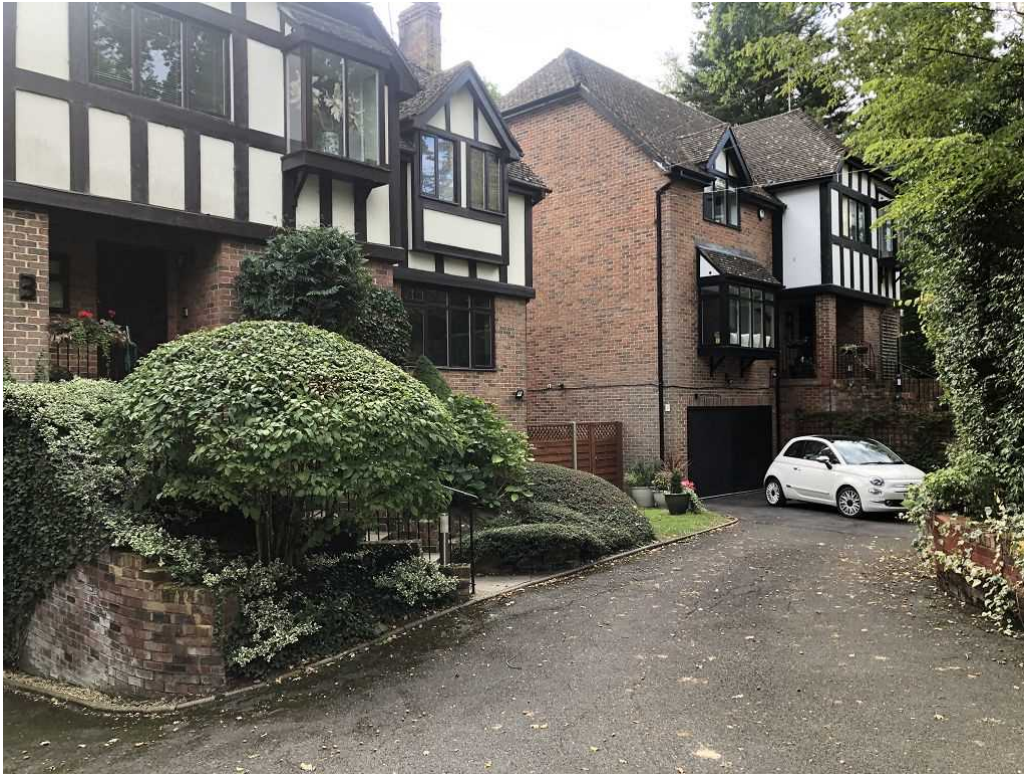
1

Risk address in the background at far end of a cul de sac

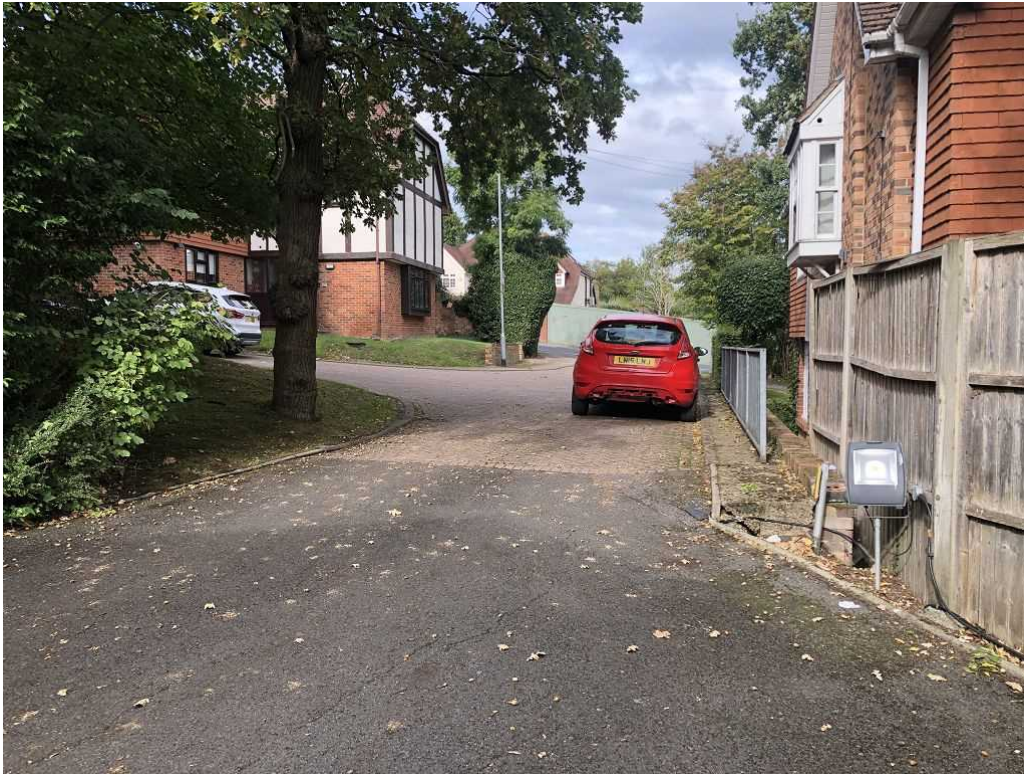
3

Cul de sac entrance from main road. Heavily sloping down

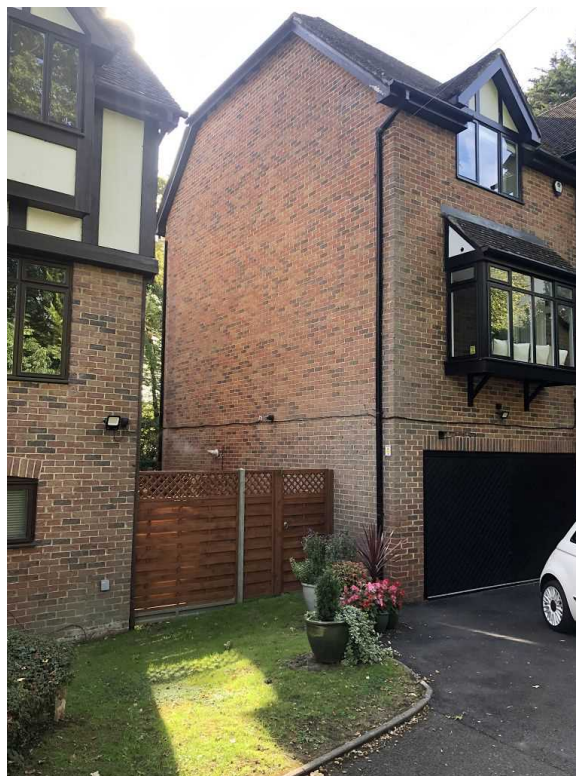
4

Front left corner - the heavy land slopes enables the front left corner to be 3 storey inc garage. The rest of house 2 storey. See floor plans

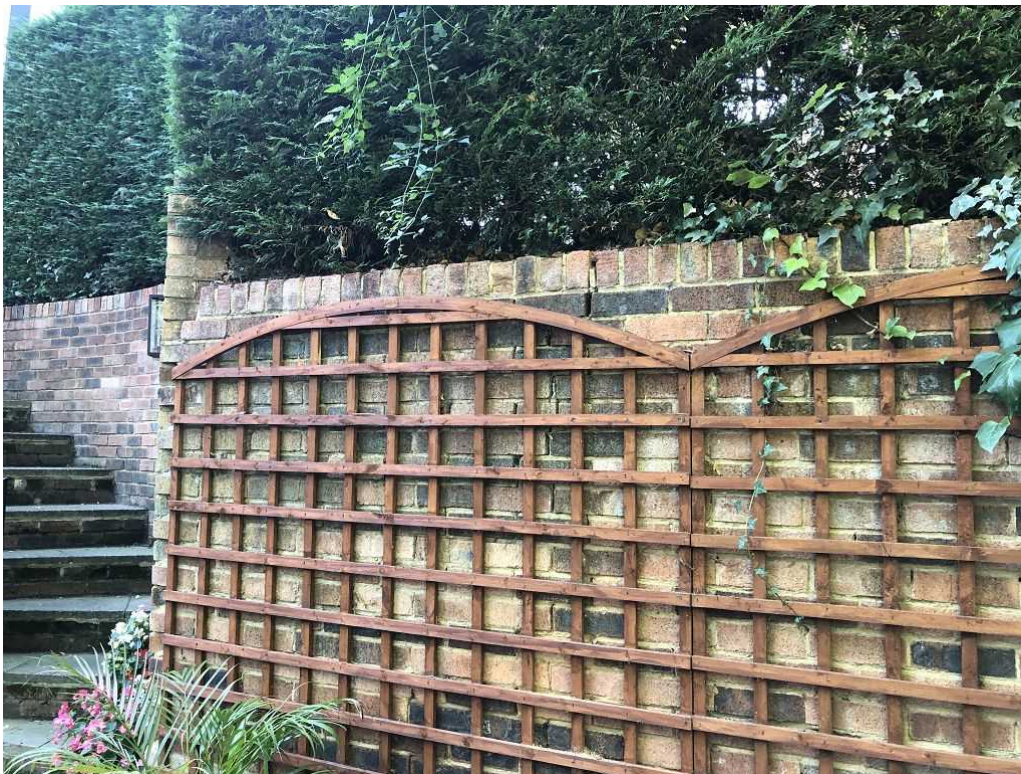
8

Crack seen in 9 inch brick garden retaining wall. Land level high behind the wall and conifer hedge

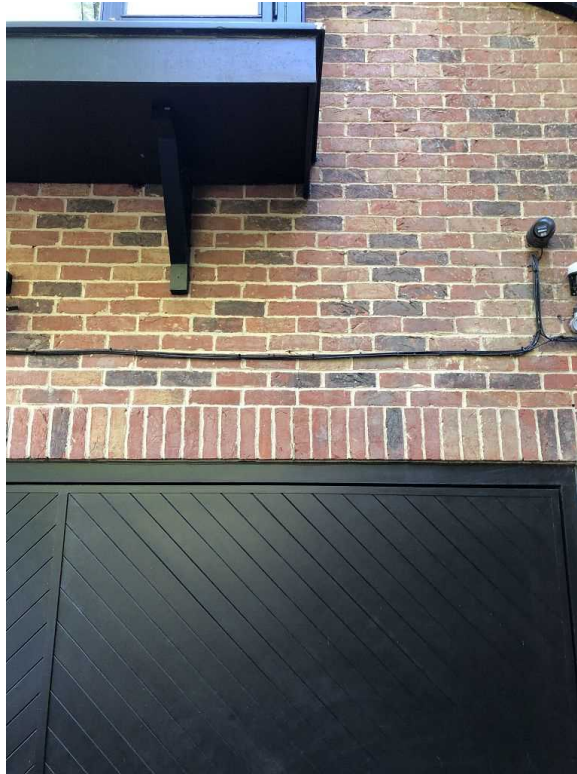
11

Not mentioned in the engineer report but a 1mm stepped crack line seen over the garage entrance

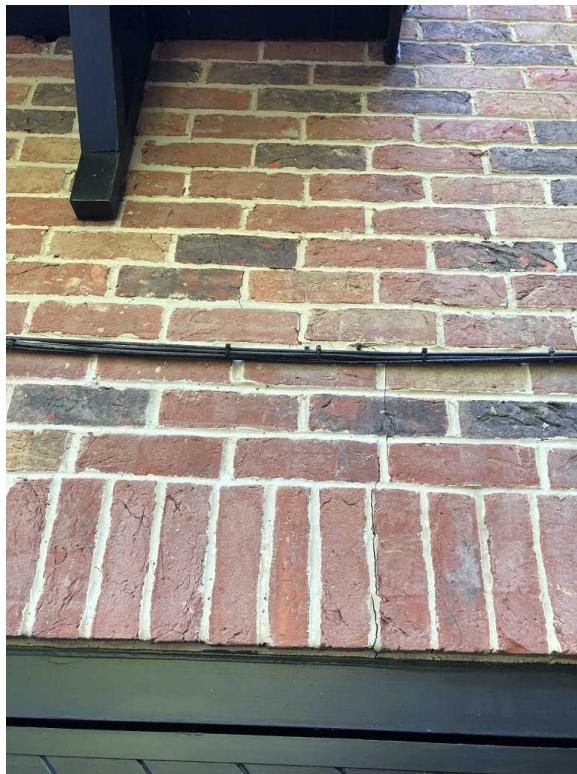
12

In upright course and 5 further brick courses. Nothing adverse internally or to the up and over door operation

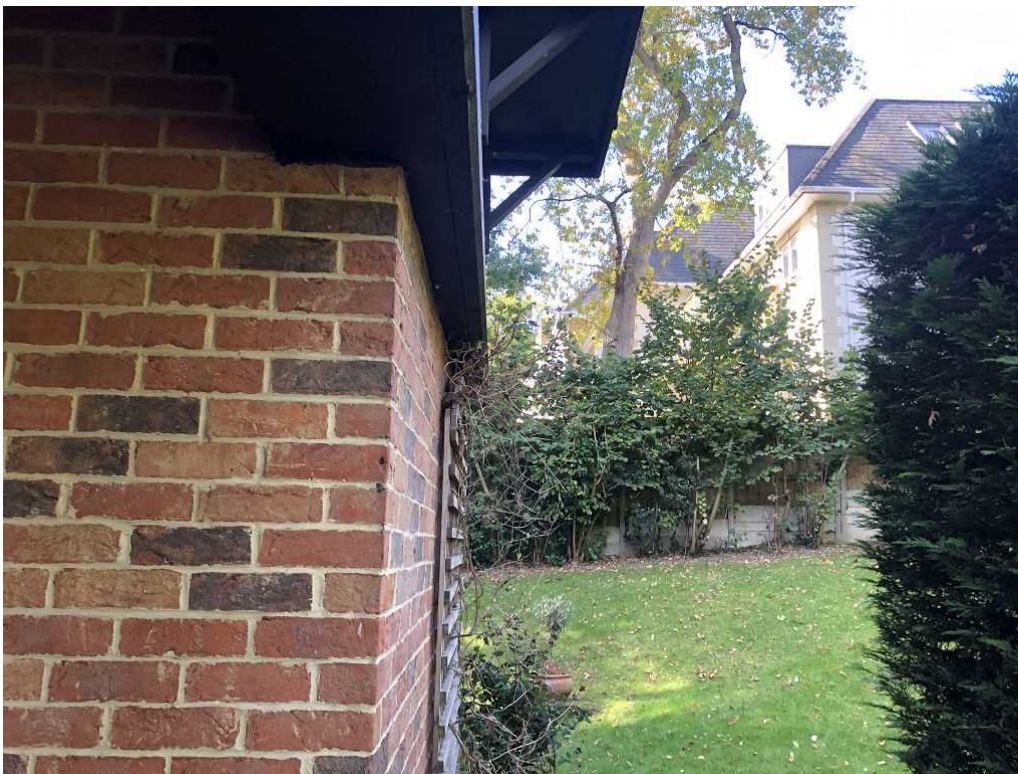
13

Front right corner and right side flank. Note insureds hedging and large trees on right side and rear

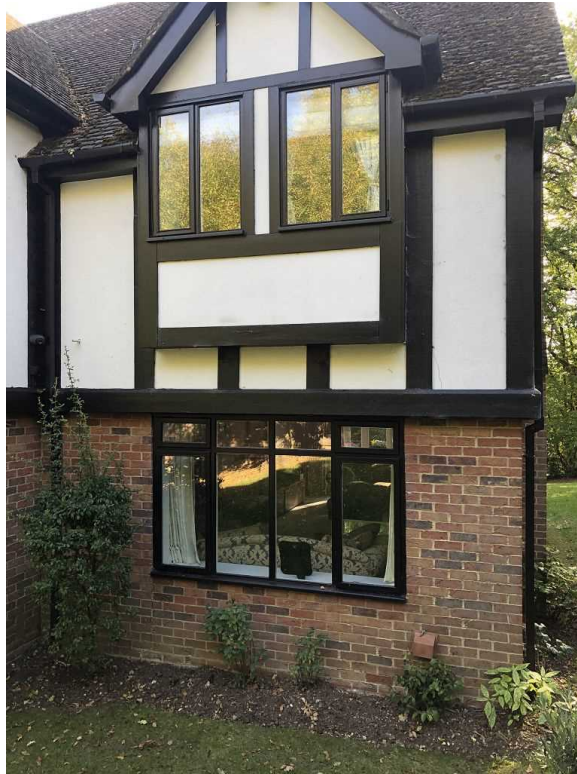
17

Back to the front right corner the insureds engineer report identifies the vertical crack left of lounge window and upper bedroom box window

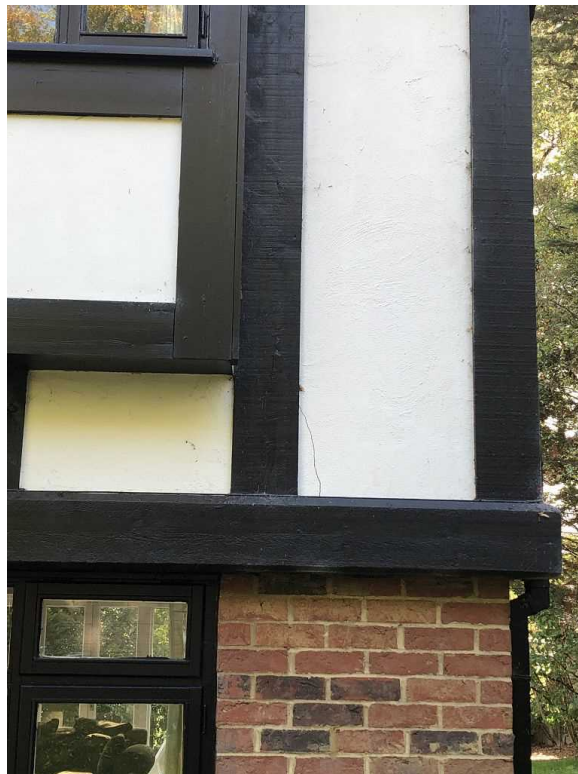
24

Smaller right side crack in render. There is internal cracking at these corner positions

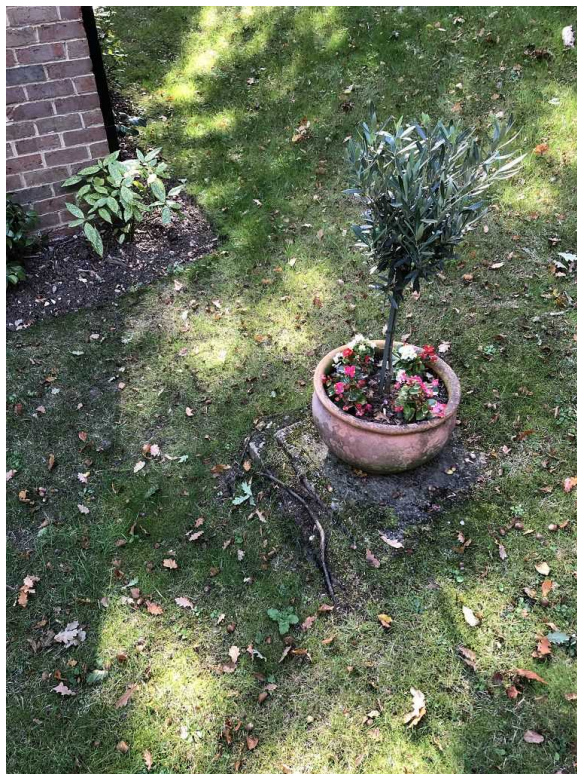
25

A manhole is close to the front right corner. See the tree roots around the manhole and generally coming up through the lawn in multiple places

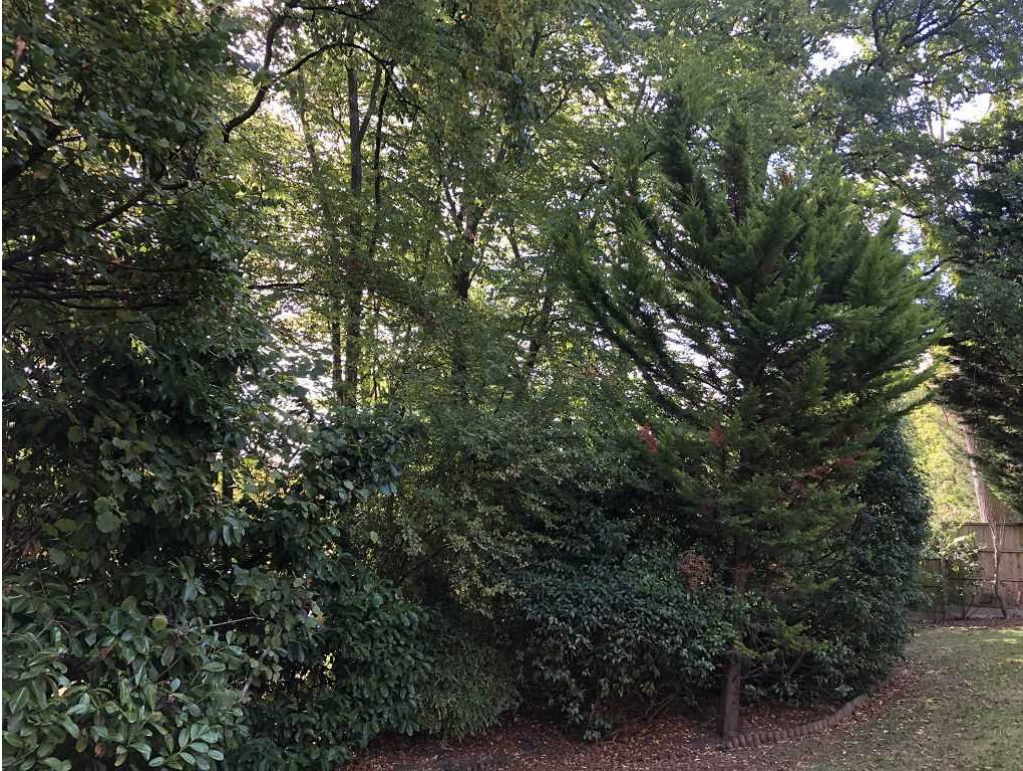
35

Several back boundary line trees between 11-19m away

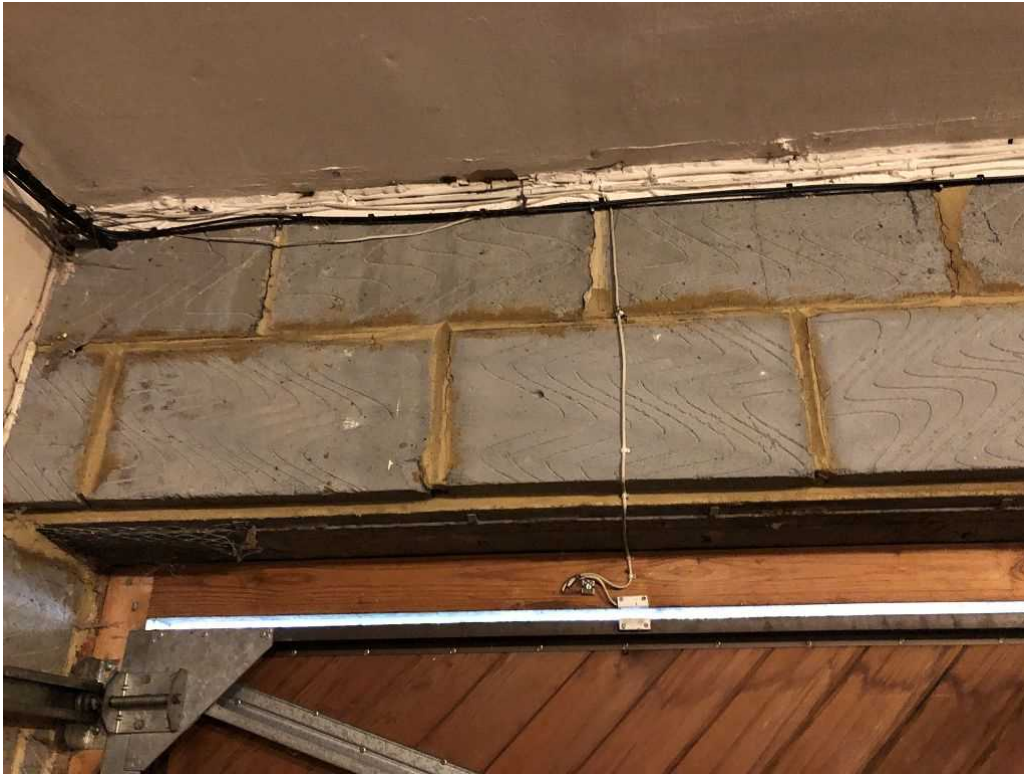
45

Inside of garage checked and no concerns

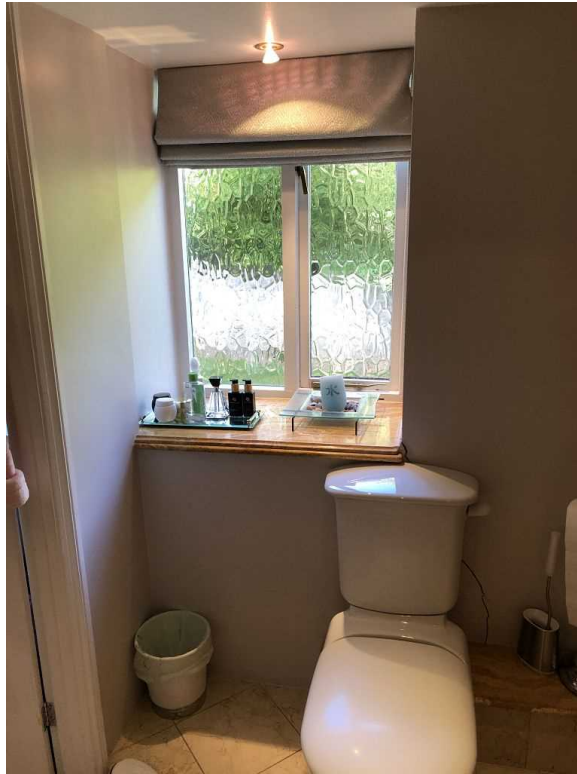
47

Front right first floor WC is above the lounge and the position of an engineer described crack

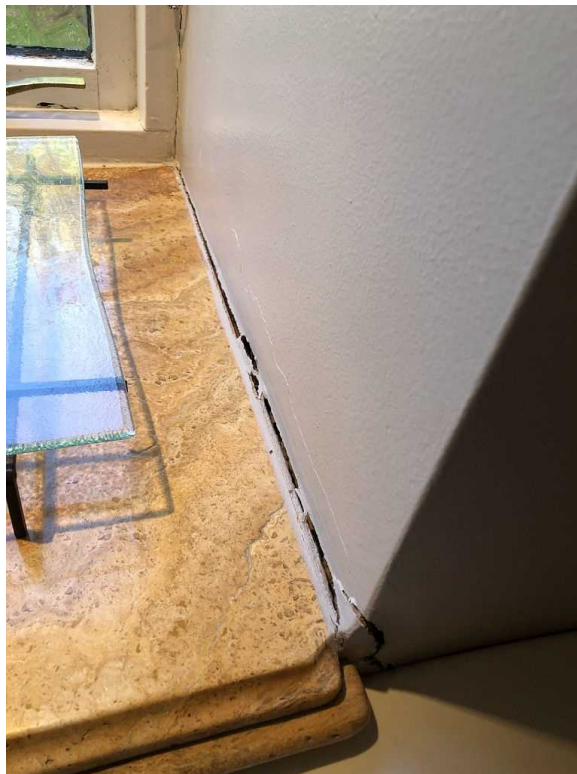
48

5mm cracking around bottom window corner and sill. Other side ok

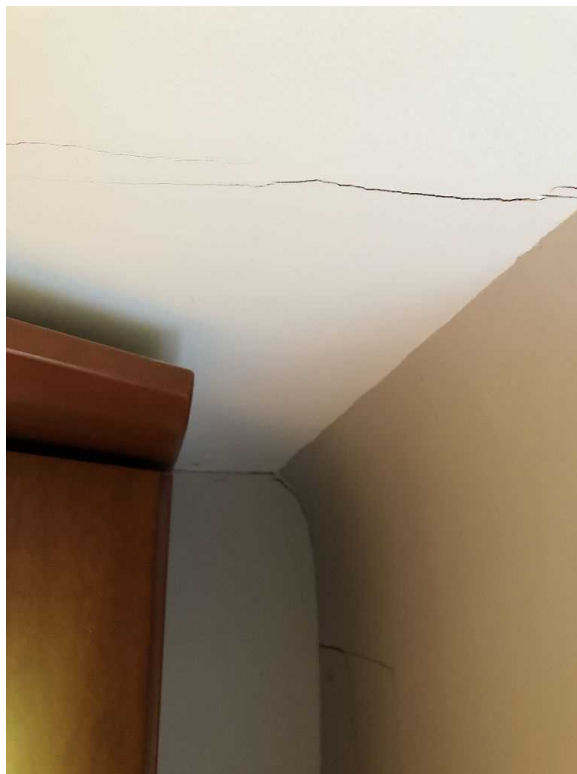
55

Various high level cracks to top of wall and ceiling at the far front right corner of the house ie over the lounge corner

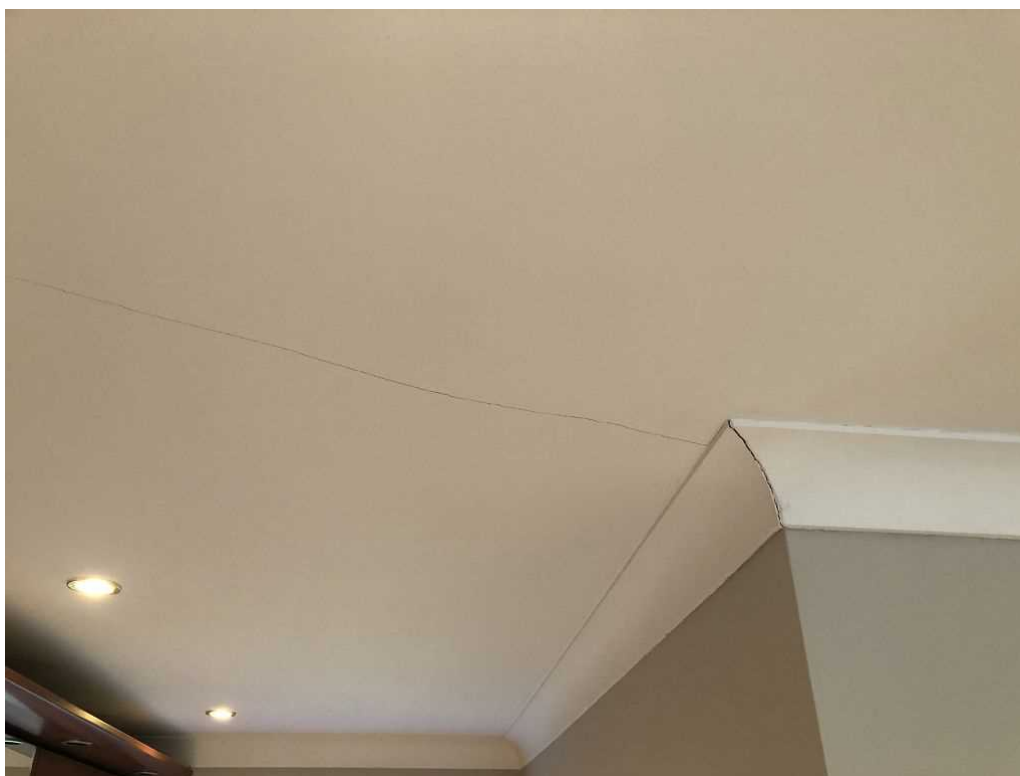
60

Further into the same room ceiling cracks reported as new

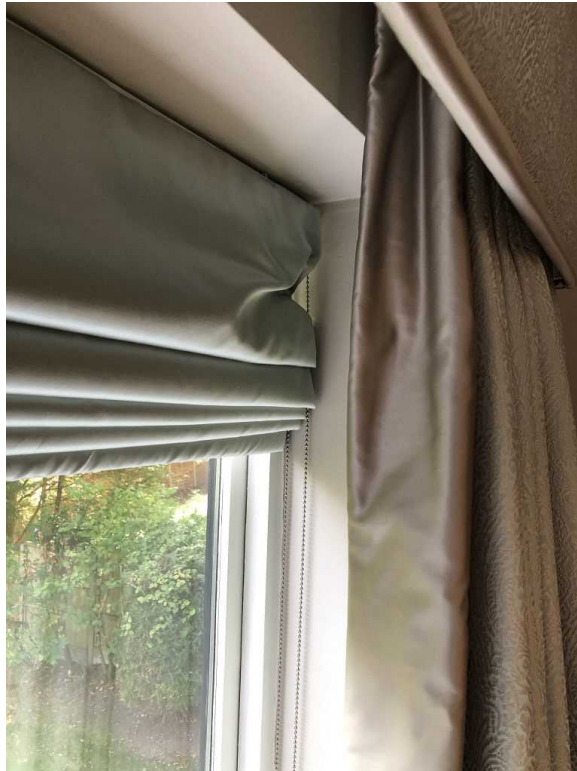
62

The back right corner is over the patio. Top right window corner cracking 1/2mm

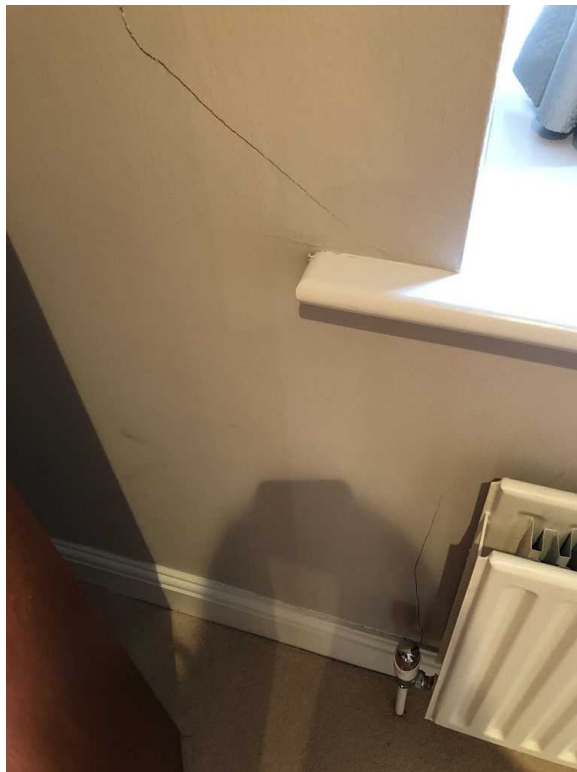
64

And smaller crack bottom left window corner

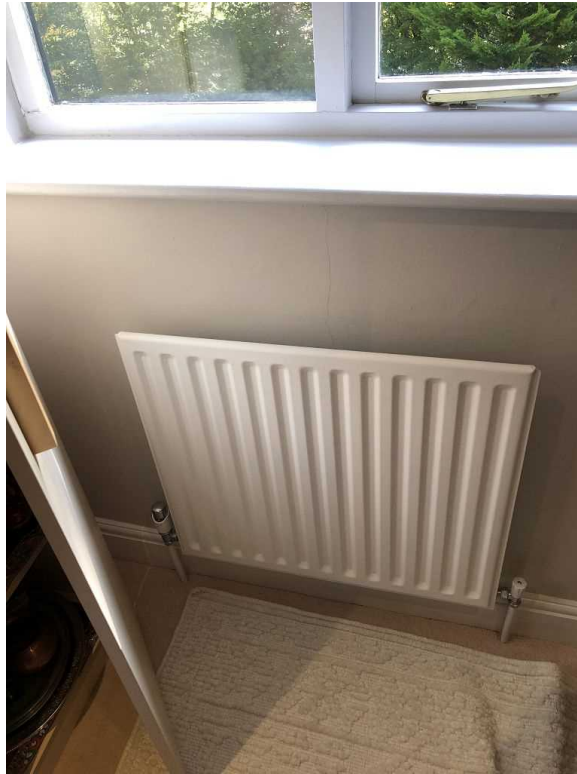
65

Rear elevation central small bedroom. Crack 1mm under sill and behind radiator

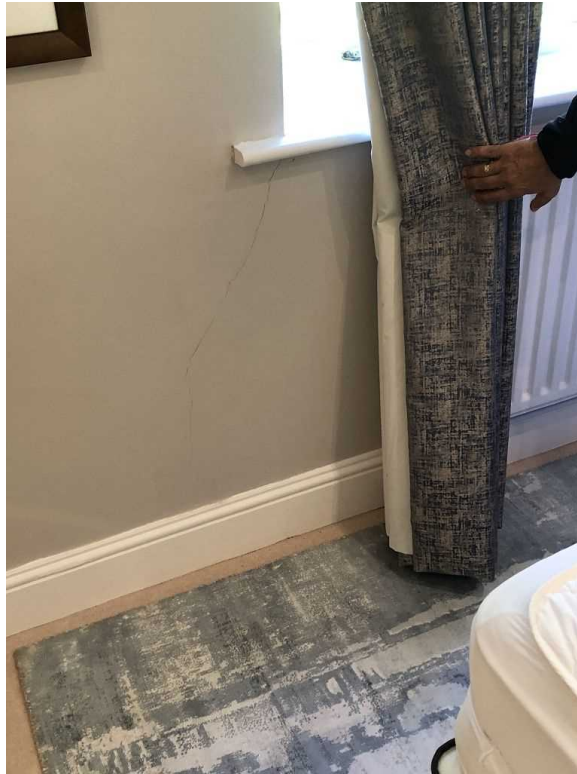
67

Front elevation second floor bedroom above garage. Bottom right corner crack 1mm jagged

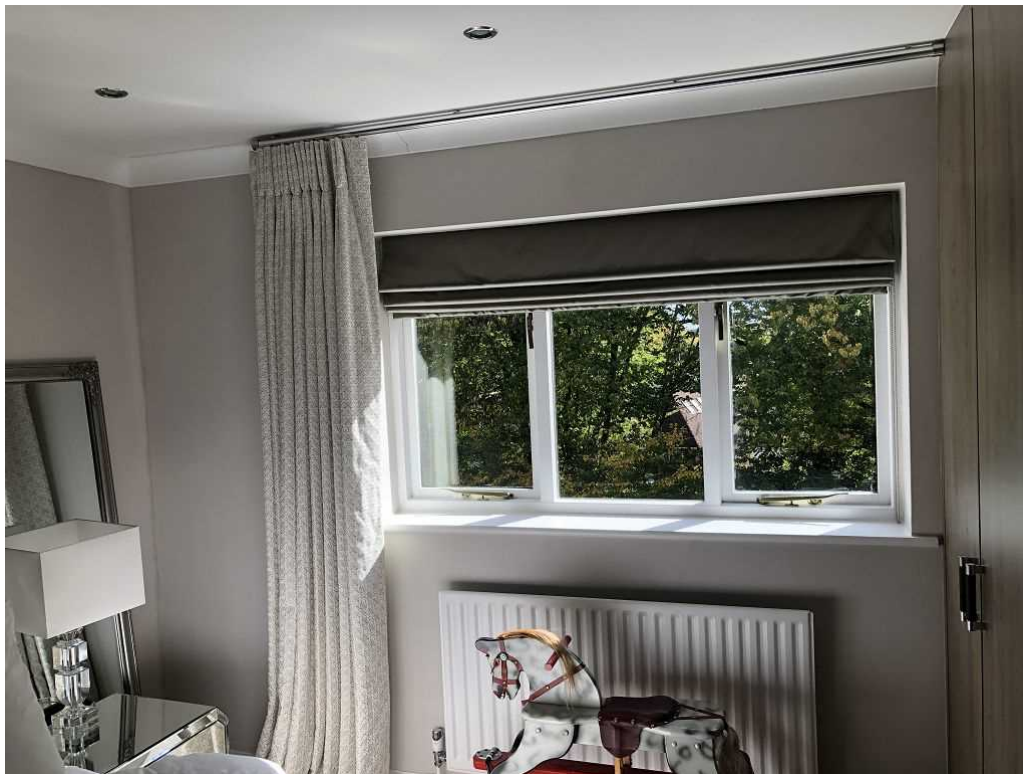
70

Back left corner bedroom - 1mm crack under sill

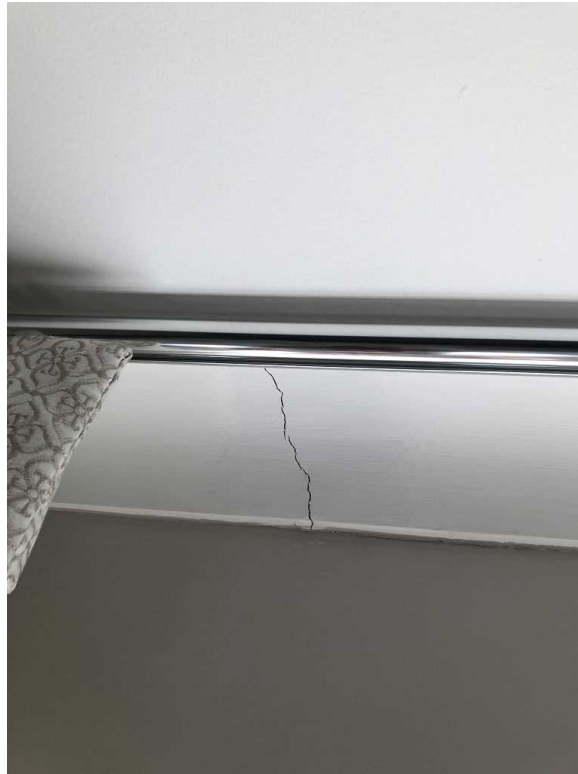
73

And slight ceiling crack

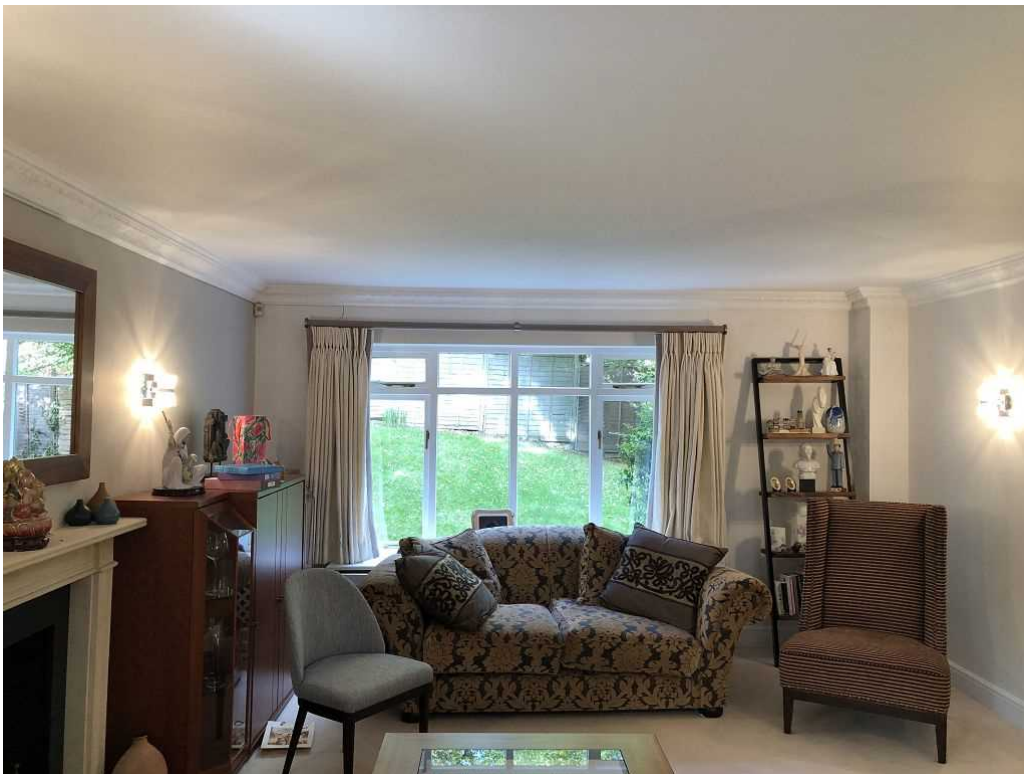
74

Ground floor right side through lounge. Cracks mainly around windows to front and back elevation

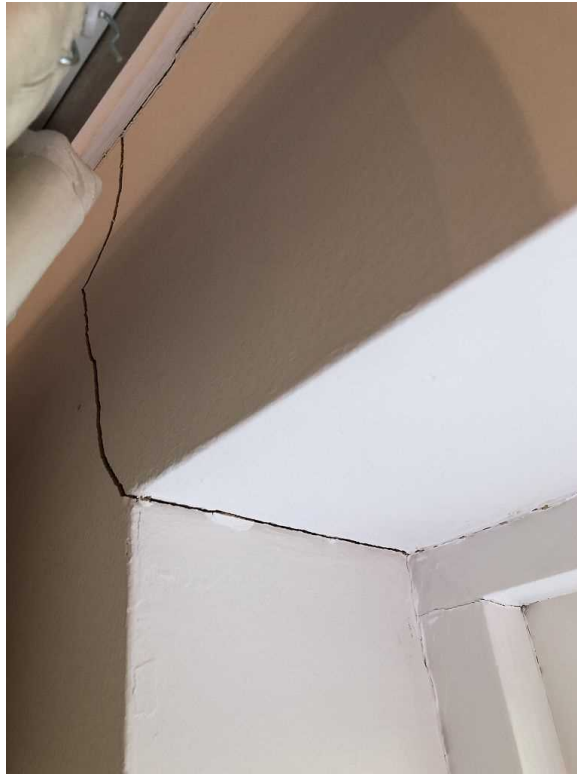
75

Front elevation window was where the engineer identified the vertical crack. Cracking to window corners

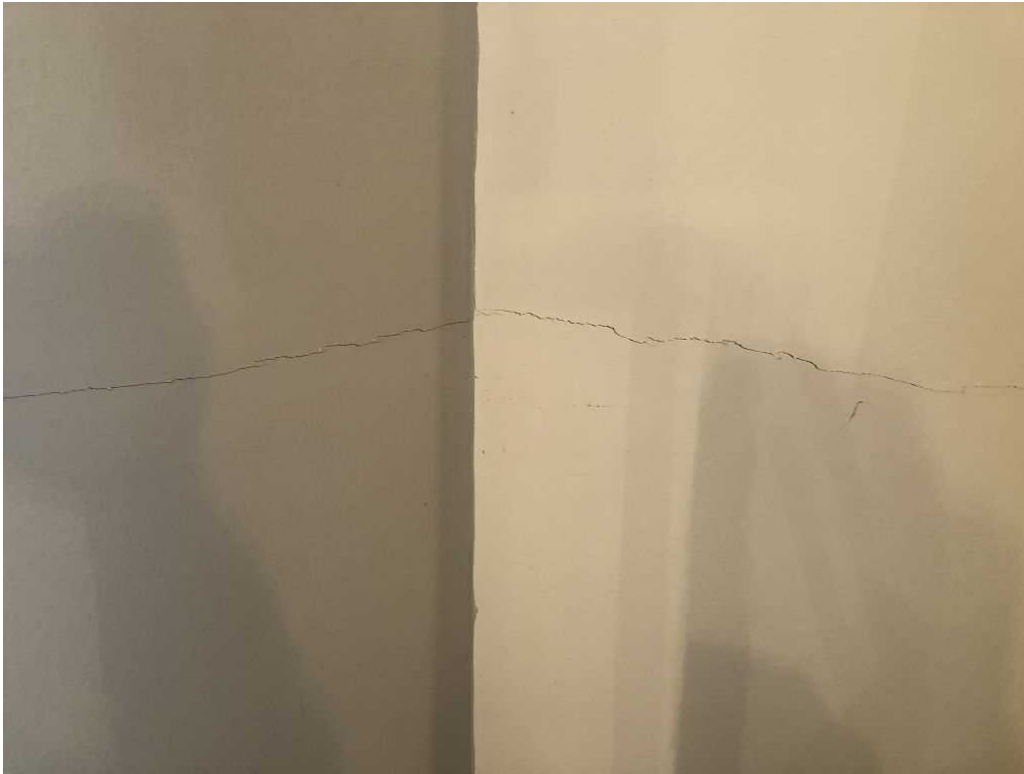
81

And crack lines in the wall front right corner

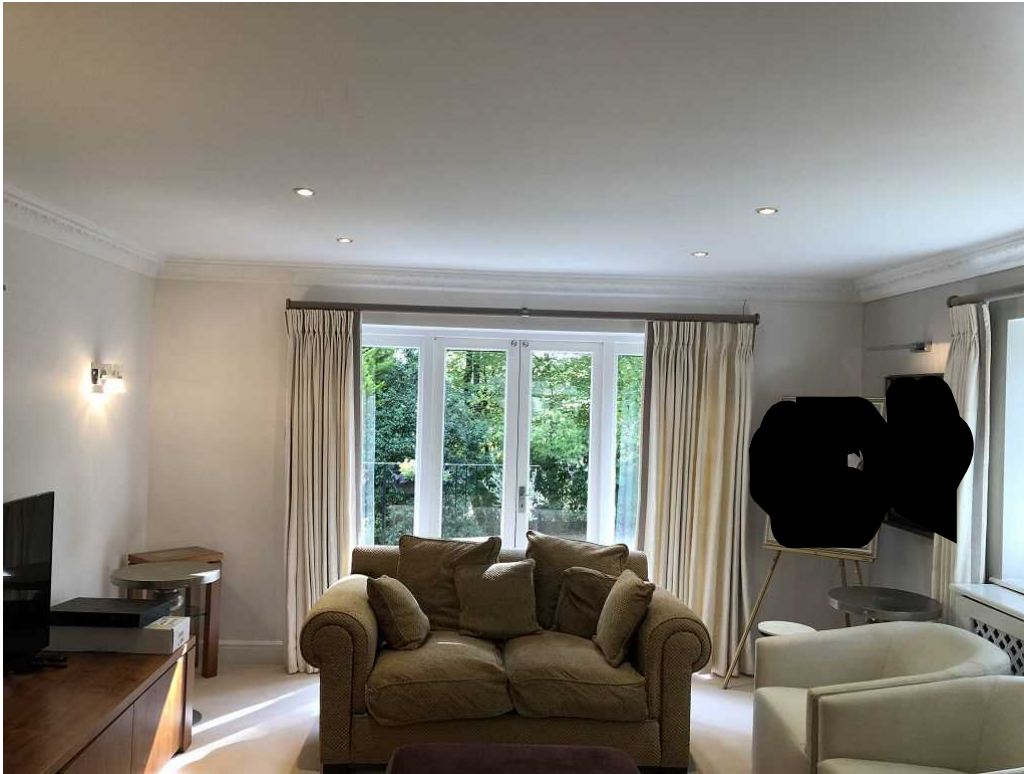
87

Back elevation bi-fold window corner cracks and cornice line gaps
