Arboricultural Subsidence Report

SUBSIDENCE INVESTIGATION AT:

**4 Teal Drive
Northwood
HA6 2PT**

Client:	Crawford and Company Adjusters UK
Reference No:	1875934
Enviro Trees UK Ref No:	TM2069
Report Date:	22/01/2026

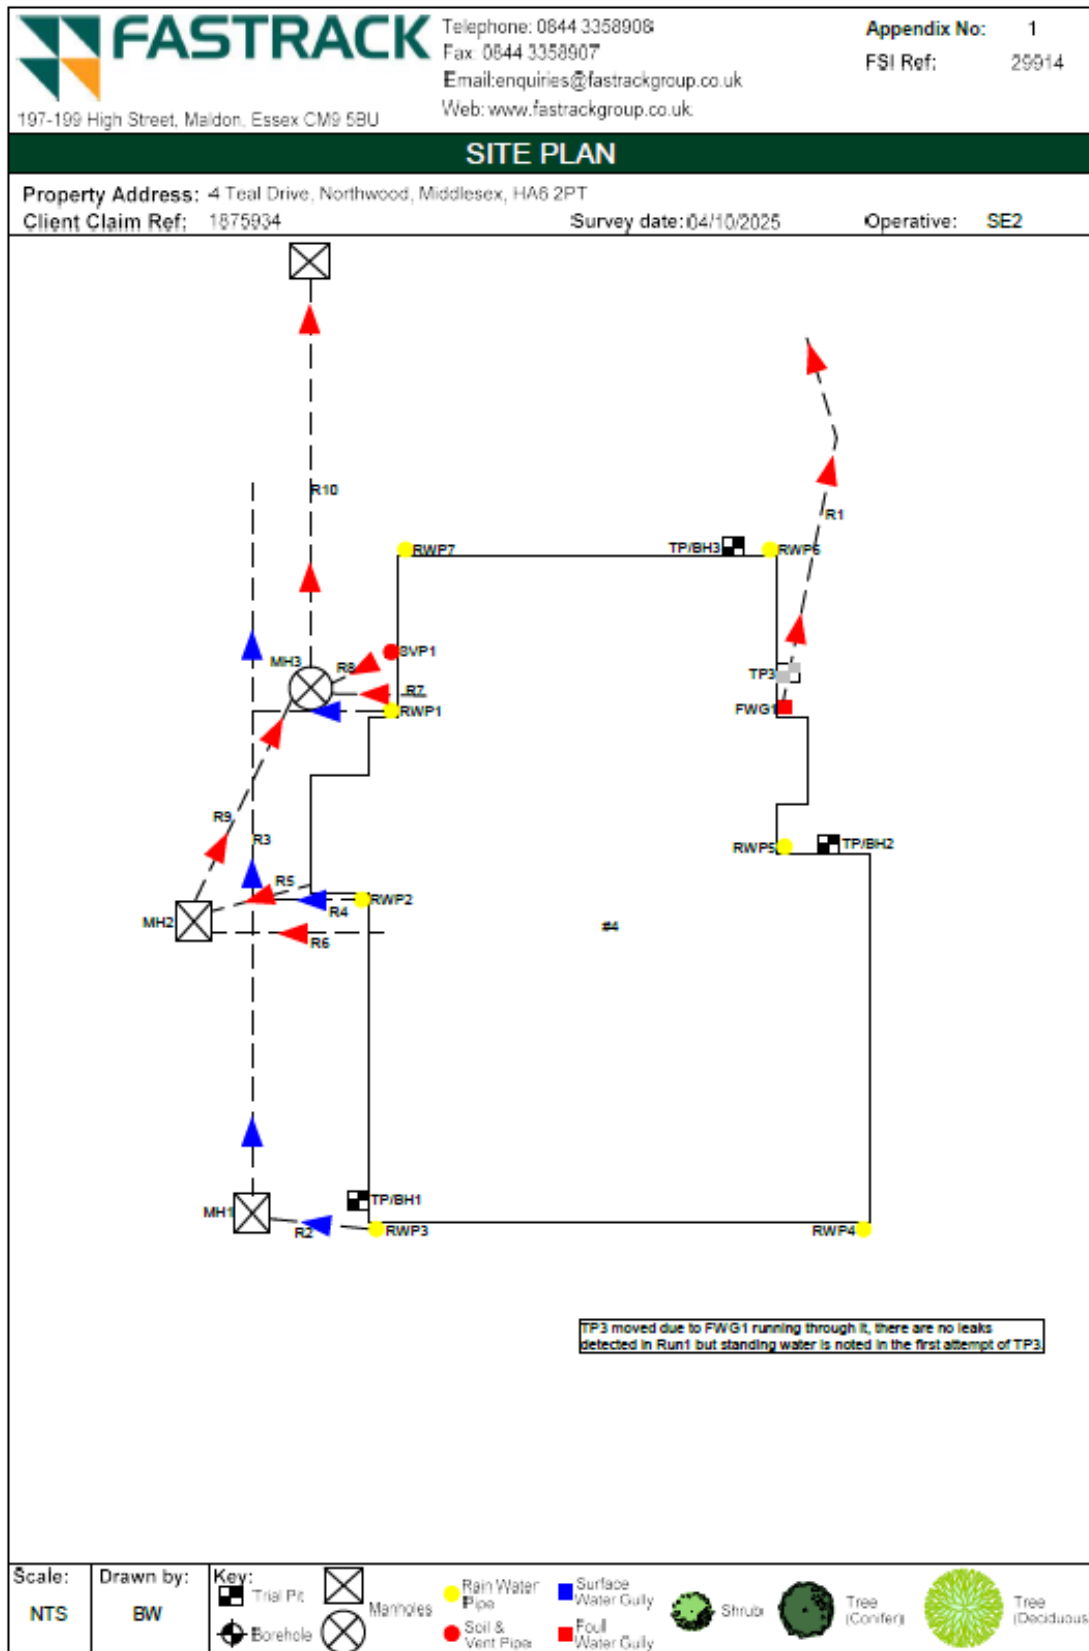
Site investigation plan showing location of boreholes

Site investigations were carried out by Fastrack on 04/10/2025 when trial pits were excavated to reveal the foundations and to determine subsoil conditions. The results are summarised in the plan and tables below.

TP/BH Number	Type	Depth at Underside (mm)
TP1	Concrete	1100
TP2	Concrete	1200
TP3	Concrete	1100

TP/BH Number	Roots observed to depth (mm)	Identification	Root Dia. (mm)	Starch
TP/BH1	1100	Quercus spp; oaks (both deciduous and evergreen)	8	Abundant

TP/BH Number	Description	Plasticity Index %	Volume Change Potential (NHBC)
BH1	Stiff grey / brown silty CLAY containing orange mottle	41	High
BH2	Firm grey / brown silty CLAY containing orange mottle	40 - 42	High
	Firm grey / brown silty CLAY containing orange mottle and gypsum		
BH3	Firm grey / brown silty CLAY containing orange mottle and sand pockets	42	High
	Firm grey / brown silty CLAY containing orange mottle and gypsum

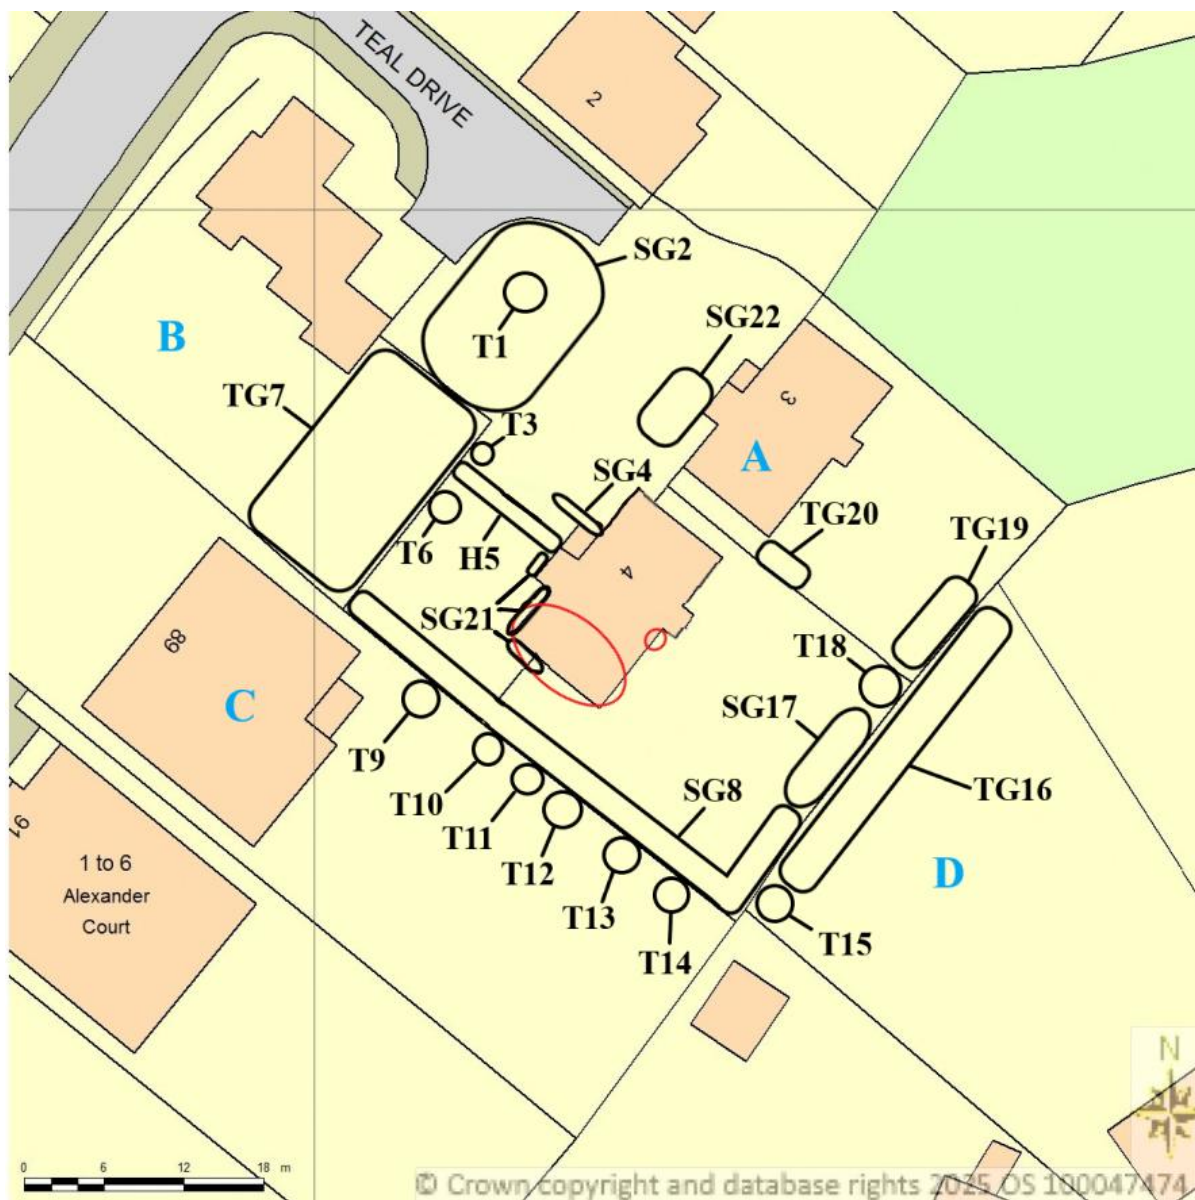
Tree plan showing area of damage with red circle and location of neighbours as detailed below.

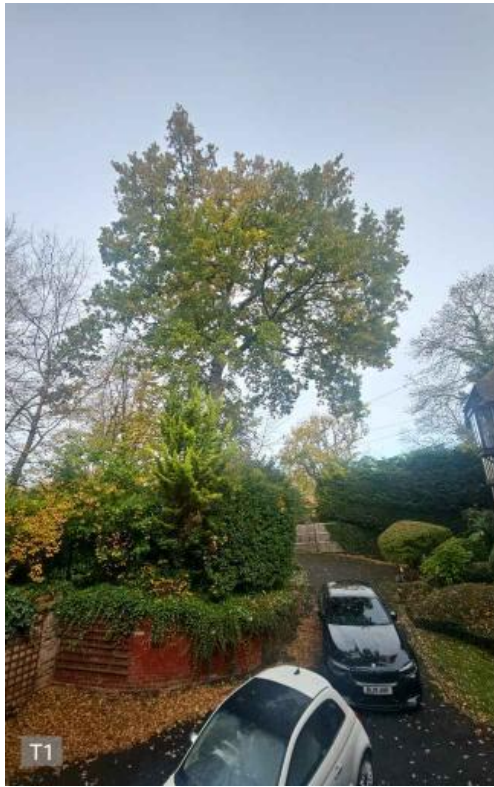
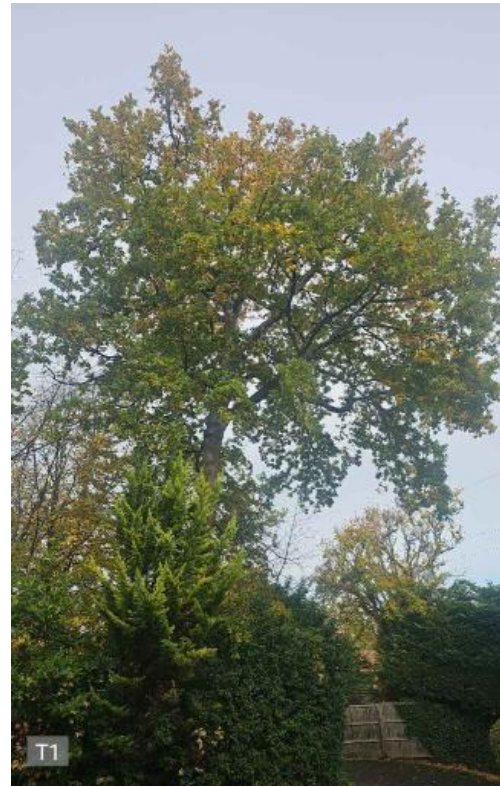
- Oak (T1) has a high-water demand and is toward the maximum distance for damage in the C&R study.
- Portugal laurel, Laurel, small cypress , Ivy (SG2) is unlikely to be of influence.

Ref.	Species & estimated age	Hight DBH (m)	Dist. to area of damage (m)	Vitality & previous works	Tree owner/ location	Recommendation	TPO CA
T1	Oak 100 Early-mature	15 (0.50)	22 #	Good Reduced	Neighbour (see plan)	Maintain at no greater than current size through periodic pruning.	TPO
T3	Hornbeam 30 Semi-mature	4.5 (0.12)	3.7 #	Poor	Insured	Maintain at no greater than current size through periodic pruning.	TPO
T6	Hornbeam 70 Early-mature	5.5 (0.35)	9.7 #	Good Pollarded	Insured	Maintain at no greater than current size through periodic pruning.	TPO
TG7	Hornbeam, Field maple, Ash 60 Early-mature	6 (0.30)	7.7 #	Good Reduced	Neighbour (see plan)	Maintain at no greater than current size through periodic pruning.	TPO
T11	Lawson cypress 50 Semi-mature	8 (0.24)	6 #	Good	Neighbour (see plan)	Maintain at no greater than current size through periodic pruning.	TPO
T12	Macrocarpa 140	18 (0.80)	7.4 #	Good	Neighbour (see plan)	Maintain at no greater than current size through periodic pruning.	TPO

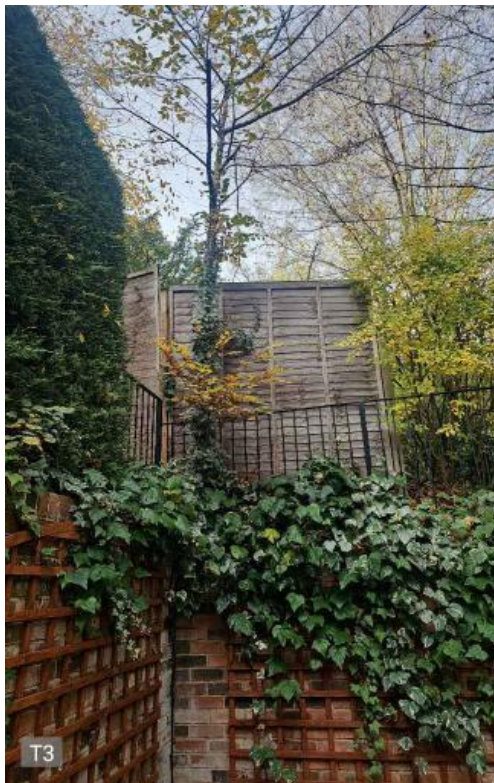
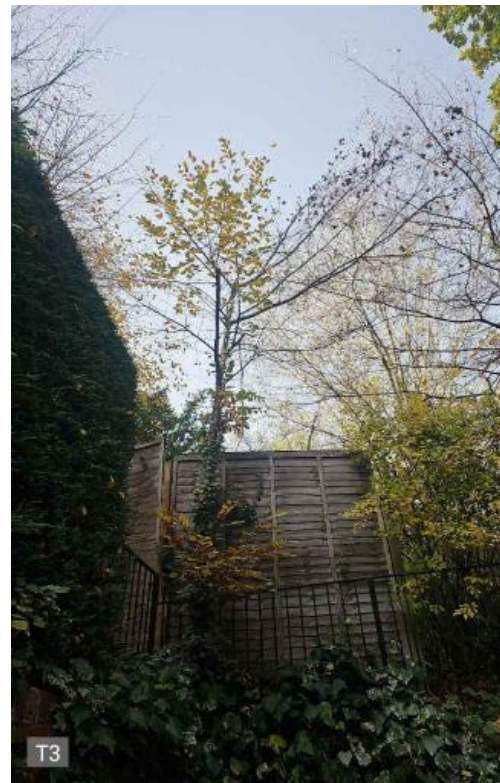
T3

- Hornbeam (T3) is toward the maximum distance for damage in the C&R study.
- Mixed shrubs, Rose (SG4) is unlikely to be of influence.
- Leylandii (H5) has a high-water demand and is toward the maximum distance for damage in the C&R study.

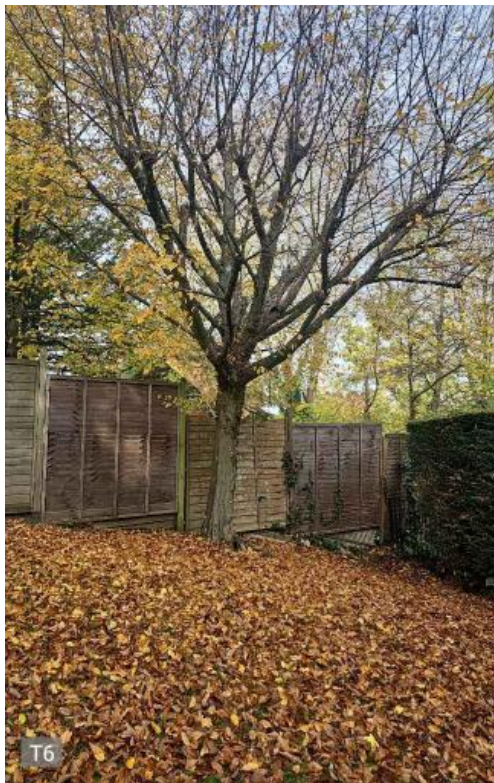
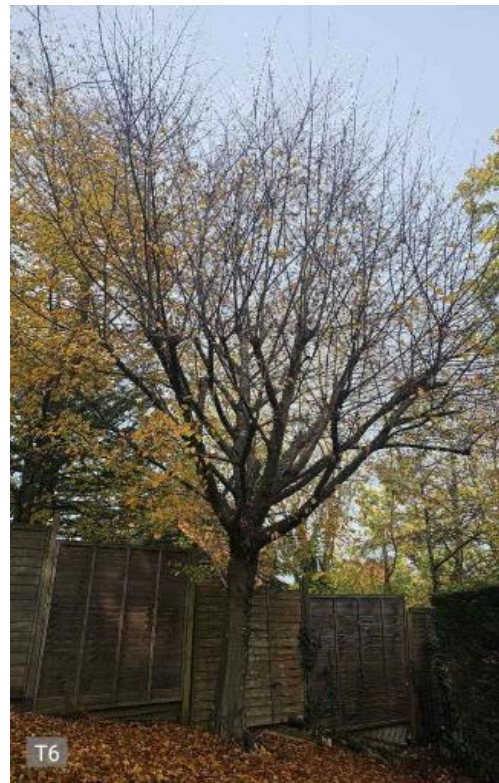
T6

- Hornbeam (T6) is toward the maximum distance for damage in the C&R study.
- Hornbeam, Field maple, Ash (TG7) is toward the maximum distance for damage in the C&R study.

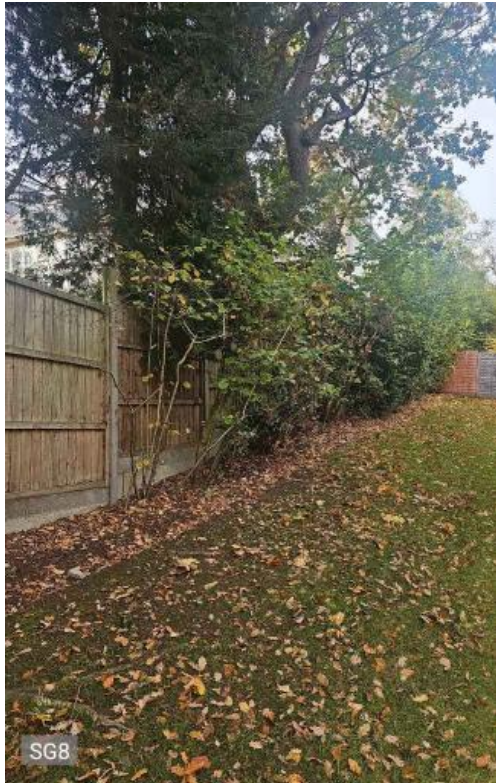
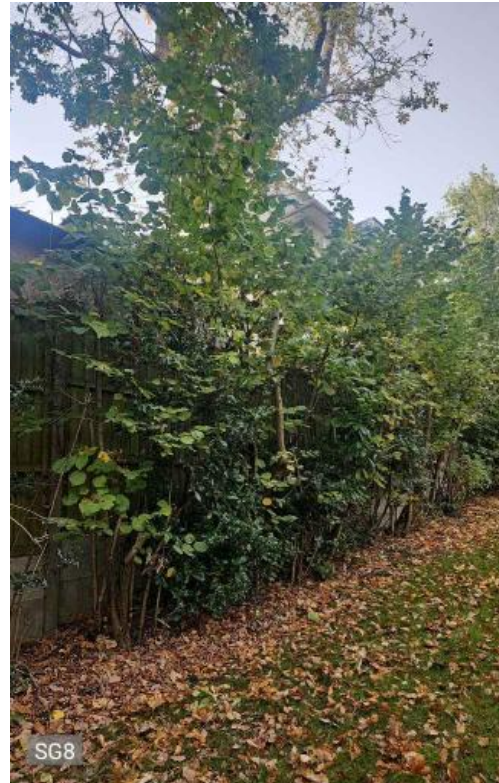
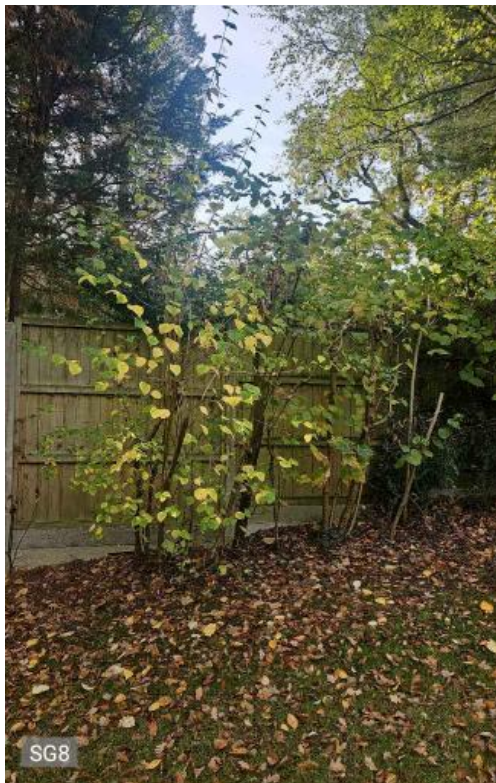
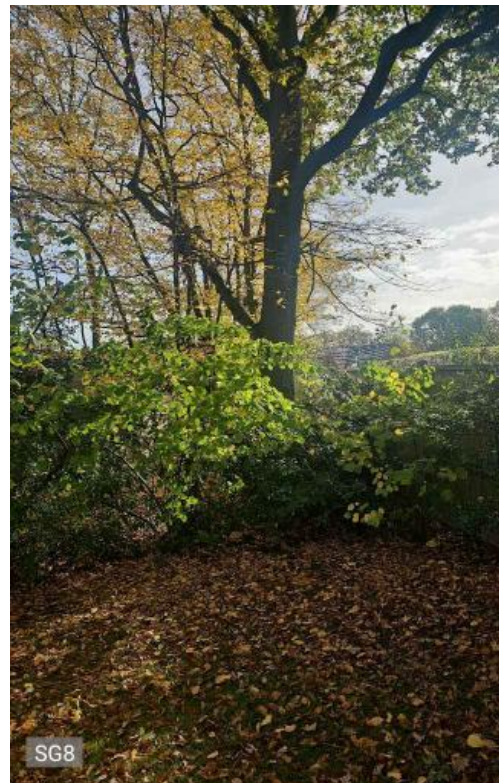
SG8

- Hazel, Holly, Mixed shrubs, Cotoneaster (SG8) is unlikely to be of influence.
- Oak (T9) has a high-water demand and is within the 50% distance for damage in the C&R study. Laboratory analysis of the roots found below foundation depth during the site investigation identified them as Quercus spp.

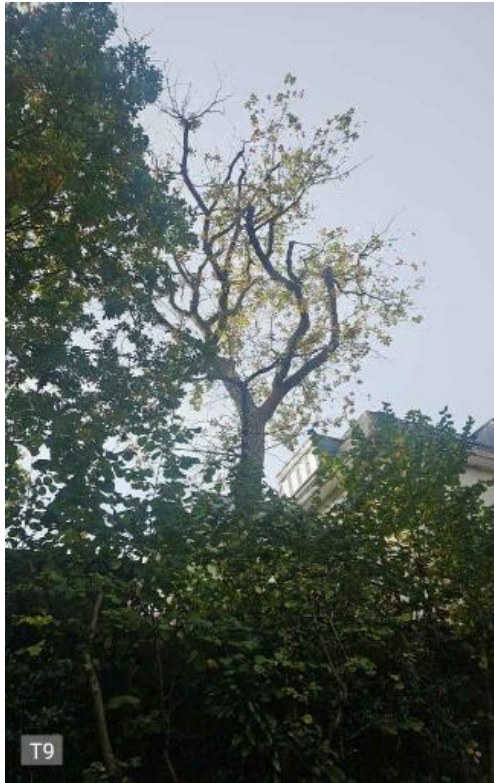
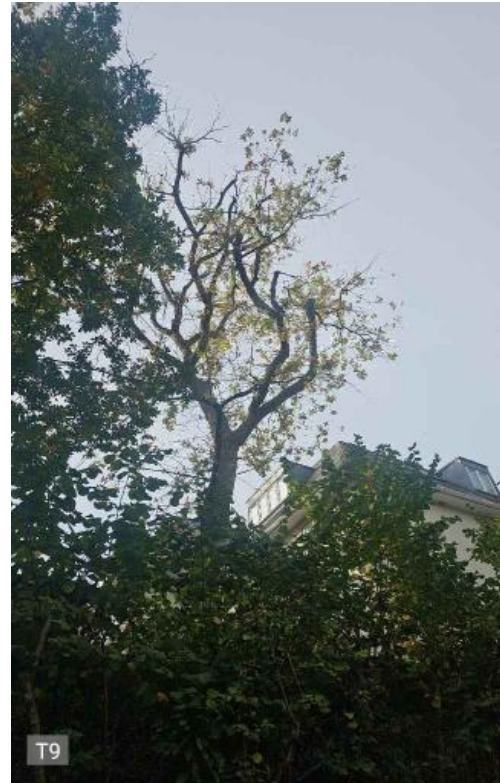
T9	Oak	12	2	50 # 1	100 Early-mature	8.5 #	Neighbour	Poor. Reduced High-water demand.	TPO
T10	Oak	14	2.5	60 # 1	120 Early-mature	6.7 #	Neighbour	Good. Reduced High-water demand.	TPO

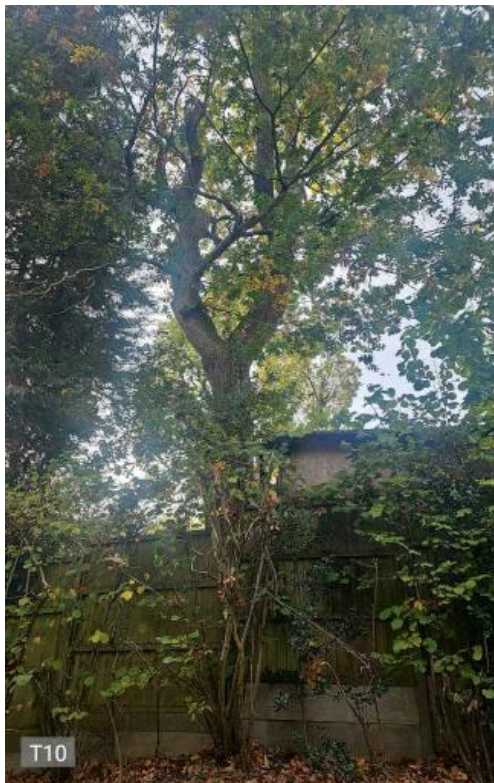
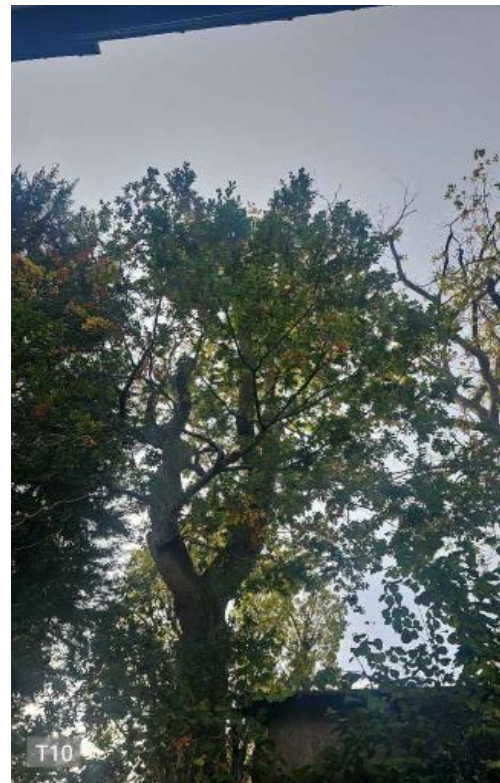
T10

- Oak (T10) has a high-water demand and is within the 50% distance for damage in the C&R study. Laboratory analysis of the roots found below foundation depth during the site investigation identified them as Quercus spp.

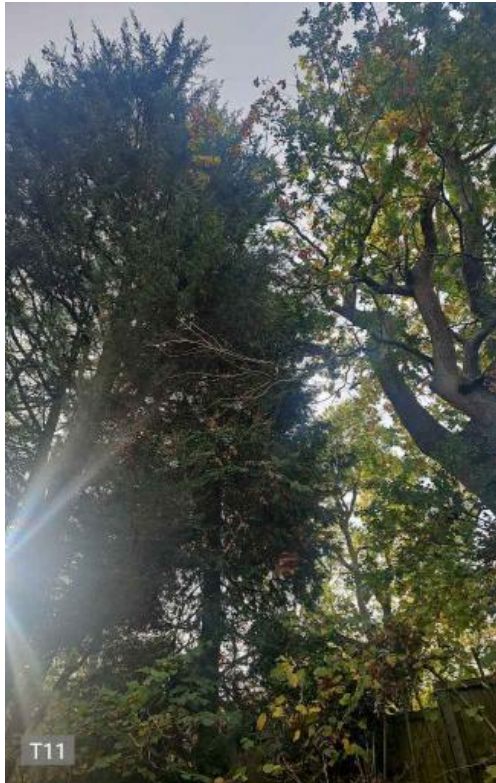
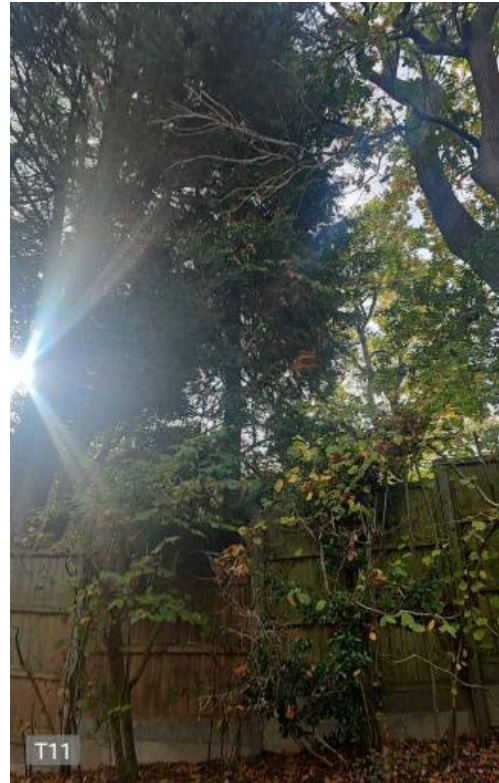
T11

- Lawson cypress (T11) has a high-water demand and is within the maximum distance for damage in the C&R study.
- Macrocarpa (T12) is within the zone of influence defined by NHBC.

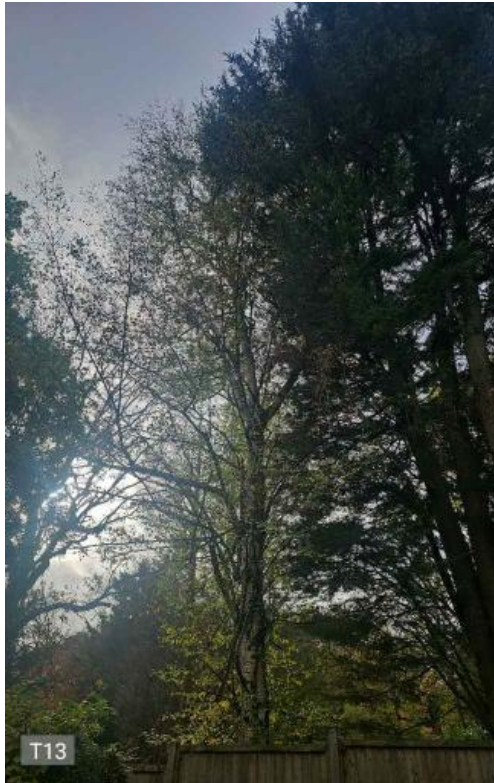
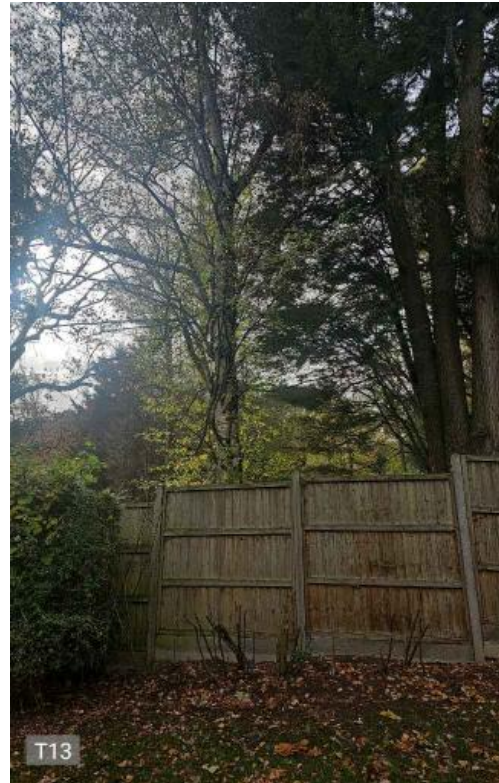
T13

- Birch (T13) is unlikely to be of influence.
- Leylandii (T14) has a high-water demand and is toward the maximum distance for damage in the C&R study.
- Oak (T15) has a high-water demand and is within the maximum distance for damage in the C&R study.

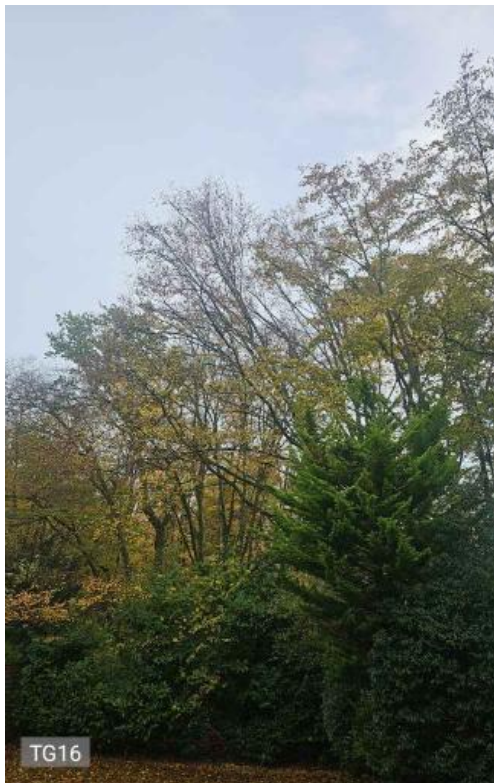
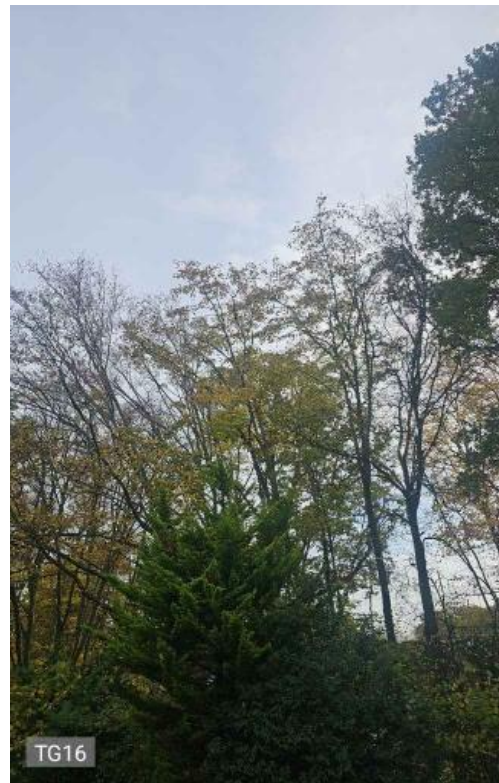
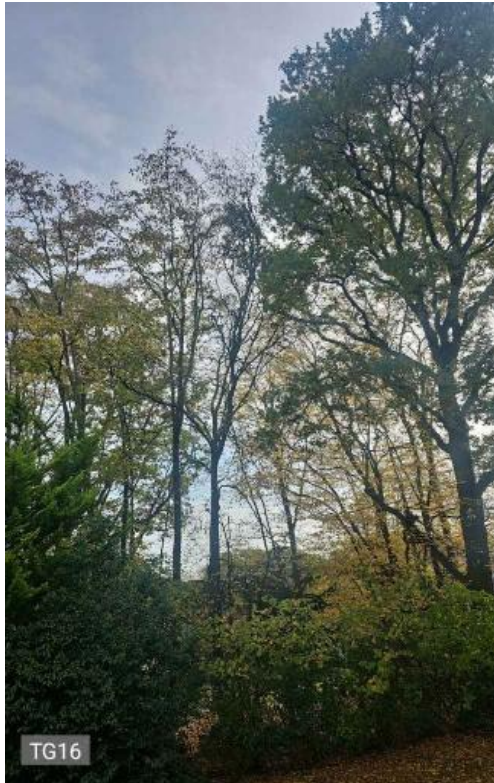
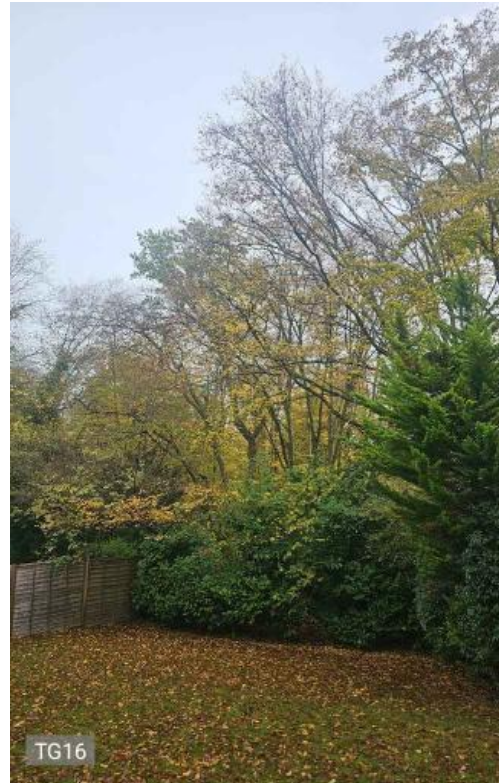
TG16

- Hornbeam, Oak (TG16) is unlikely to be of influence.
- Laurel, Portugal laurel, Small cypress, Hawthorn , Hazel (SG17) is unlikely to be of influence.

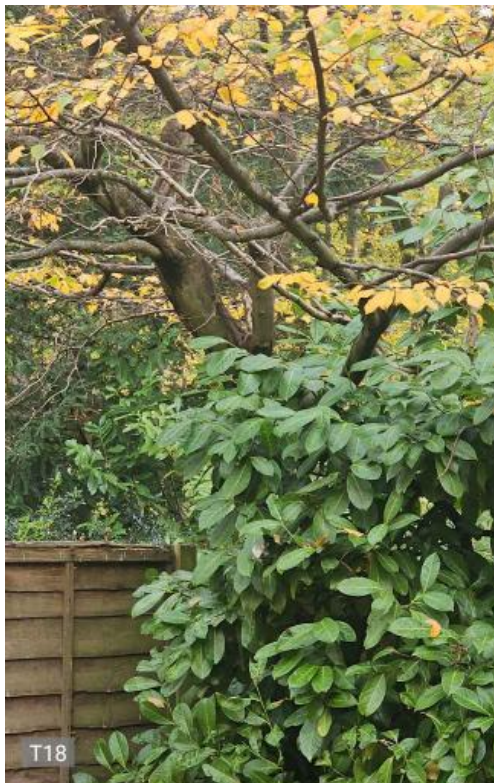
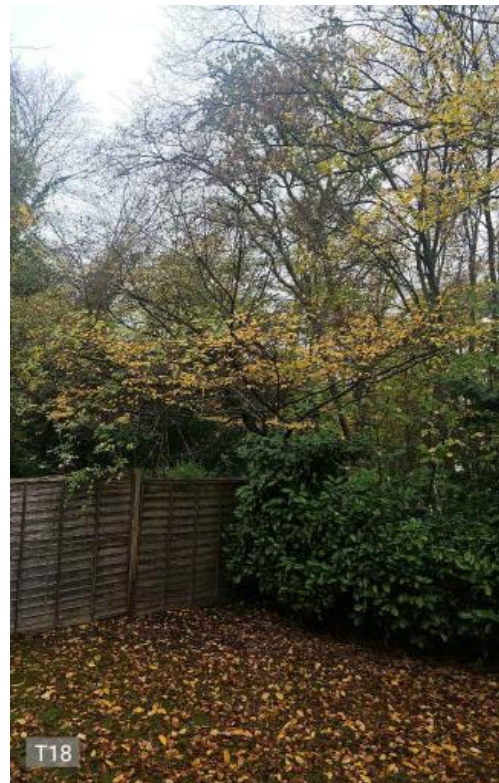
T18

- Hornbeam (T18) is unlikely to be of influence.
- Hawthorn, Cherry (TG19) has a high-water demand but is unlikely to be of influence.
- Cherry (TG20) is unlikely to be of influence.

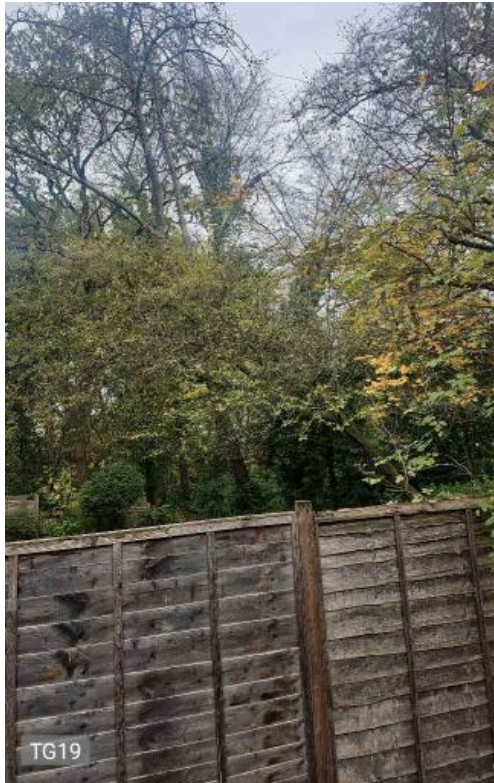
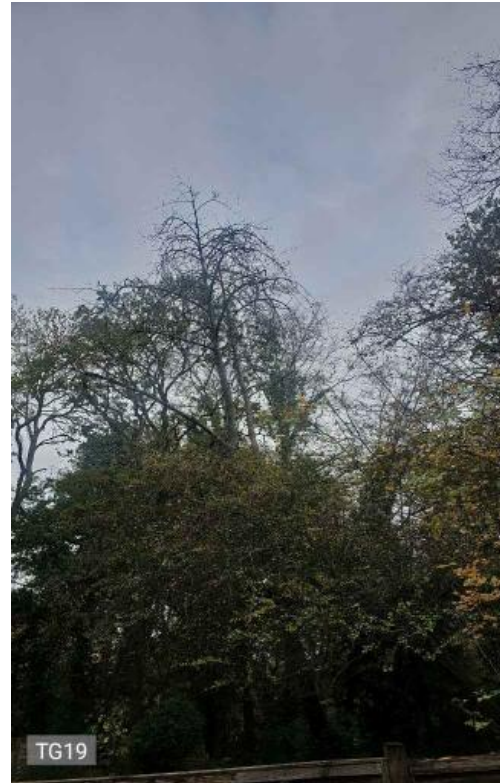
TG19	Hawthorn, Cherry	14	2	35 # 0	70 Mature	21.3 #	Neighbour	Good. High-water demand.	TPO
TG20	Cherry	4	1	22 # 0	30 Early-mature	12.36 #	Neighbour	Good. Reduced Moderate-water demand.	TPO

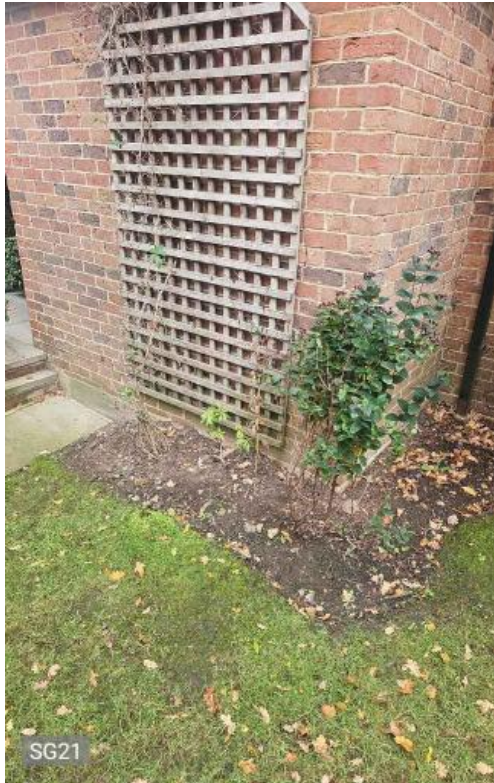
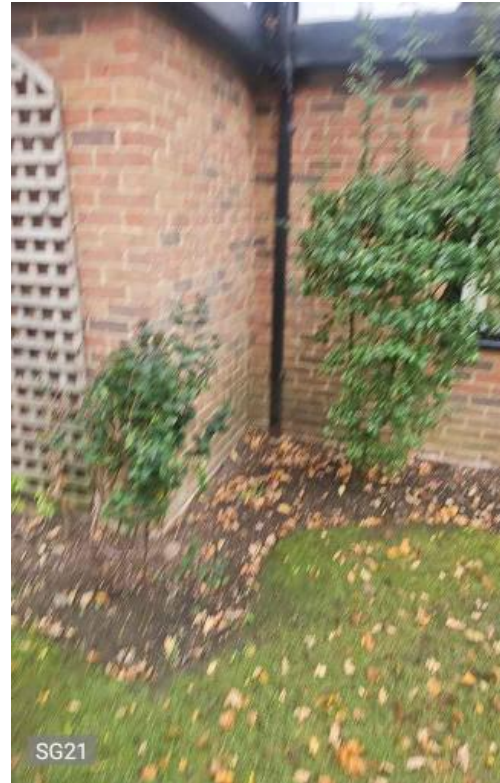
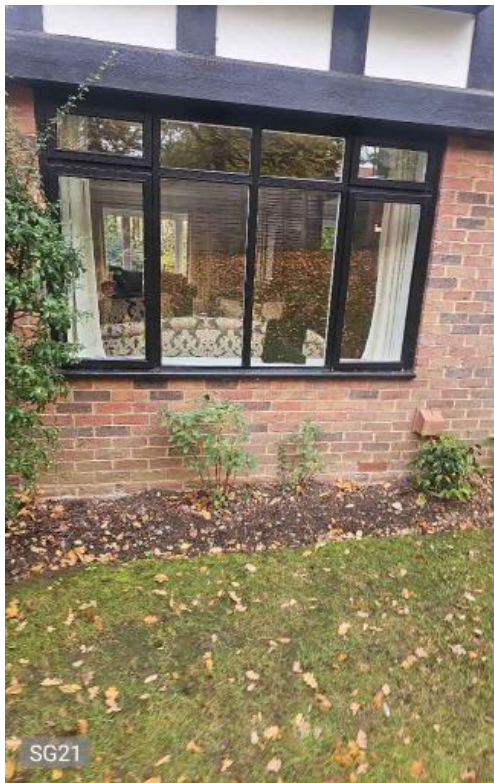
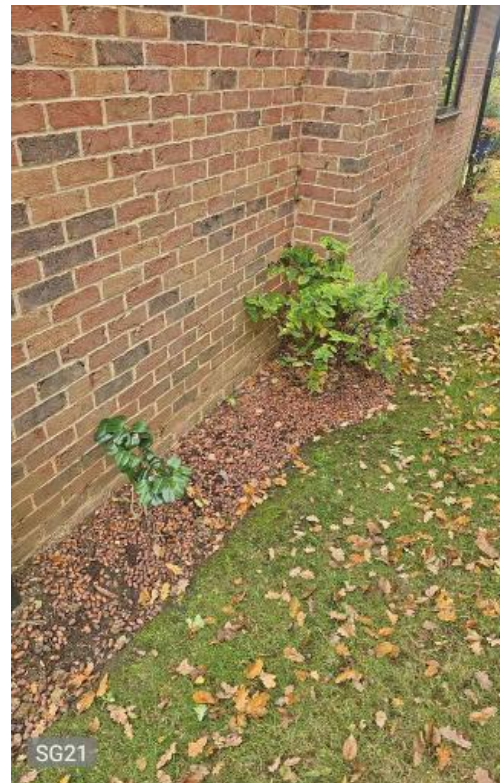
- Choisya, Pyracantha, Acuba, Camilia , Mixed shrubs (SG21) is within 50% of the radius of influence defined by NHBC.
- Cotoneaster, Hydrangea, Mixed shrubs (SG22) is unlikely to be of influence.

Ref.	Species & estimated age	Hight DBH (m)	Dist. to area of damage (m)	Vitality & previous works	Tree owner/ location	Recommendation	TPO CA
H5	Leylandii	2	4.5 #	Good Regular pruning	Insured	Remove stems within 5 metres of area of damage and maintain remainder at no greater than current size through regular pruning.	No
T9	Oak 100 Early-mature	12 (0.50)	8.5 #	Poor Reduced	Neighbour (see plan)	Remove close to ground level and treat stumps with herbicide to inhibit regrowth.	TPO
T10	Oak 120 Early-mature	14 (0.60)	6.7 #	Good Reduced	Neighbour (see plan)	Remove close to ground level and treat stumps with herbicide to inhibit regrowth.	TPO
SG21	Choisya, Pyracantha, Acuba, Camilia , Mixed shrubs	2	0.5 #	Good	Insured	Remove close to ground level and treat stumps with herbicide to inhibit regrowth.	No
