ADDENDUM TPO REPORT

SUBSIDENCE CLAIM

Crawford Reference: 1875934

4 Teal Drive, Northwood, Middlesex, HA6 2PT

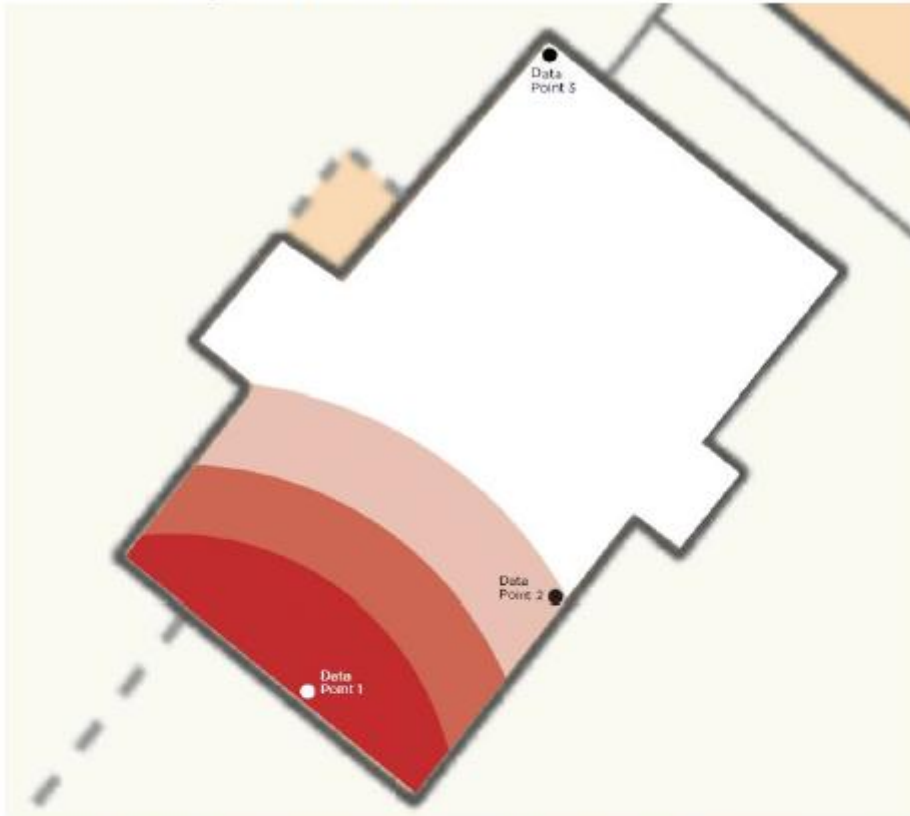
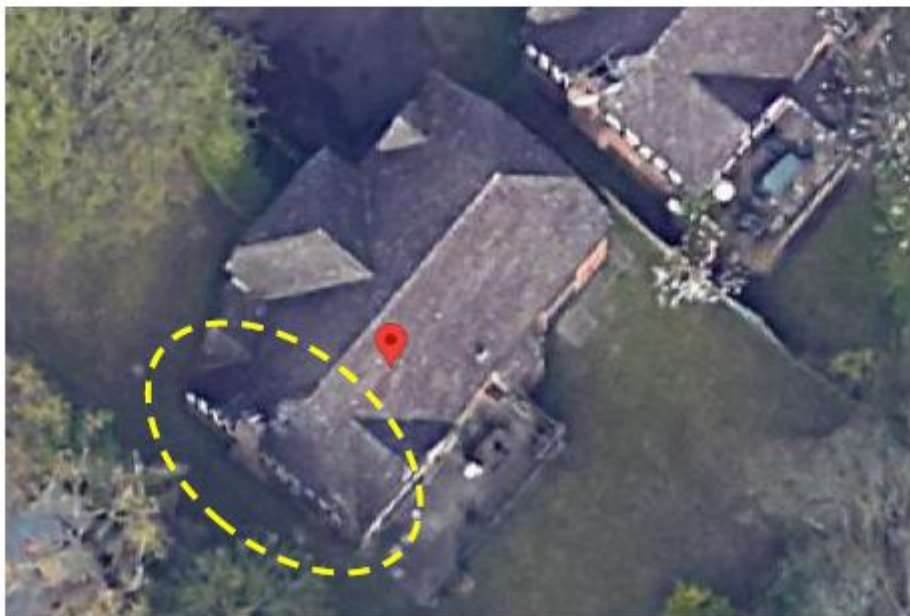
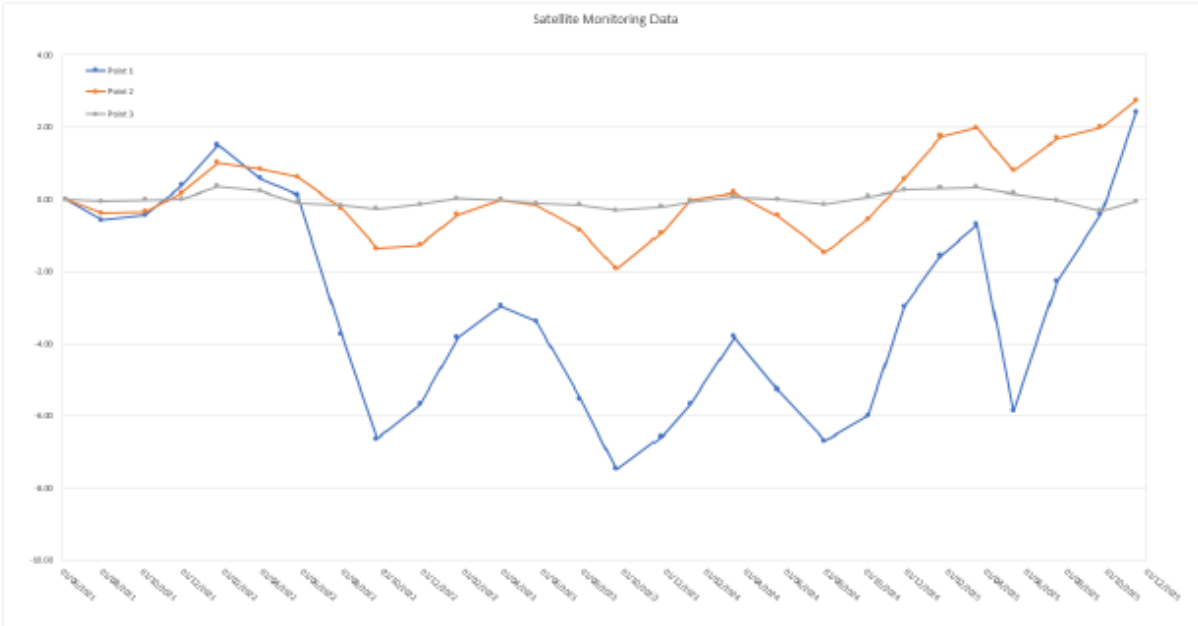
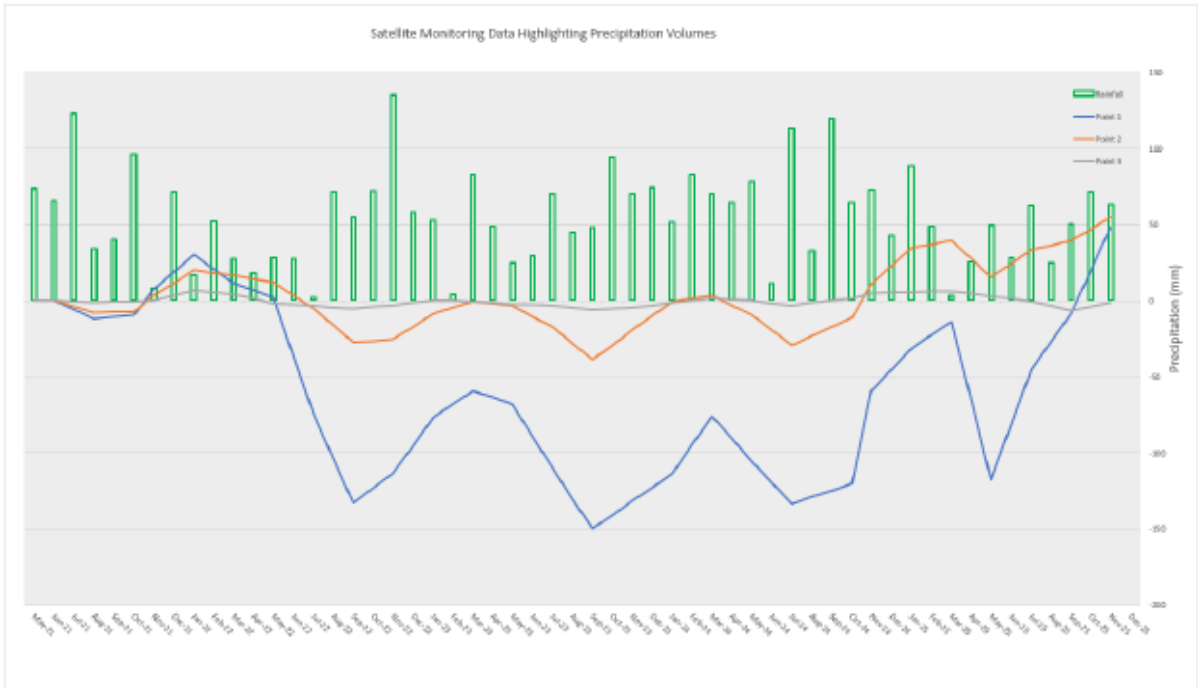
Figure (i) – Site plan denoting areas of varying movement
(Darker Red denoting increase in movement)

Satellite monitoring was undertaken between 07/06/2021- 16/11/2025 clearly shows evidence of cyclical seasonal movement consistent with root induced clay shrinkage, with downward movement during the summer and corresponding upward movement over the subsequent winter. The movement which is focused at points 1 and 2 and shows movement of up to 7.49mm, is located in the area of subsidence damage affecting the property. This is characteristic of the seasonal pattern of foundation movement where vegetation is involved. No other cause produces a similar pattern.

The pattern of movement is not uniform around the property so 'nominal clay shrinkage' can be discounted as a cause; nearby vegetation is seen to be the source of the ongoing localised movement to the front right, rear Patio and the left bend over the garage.

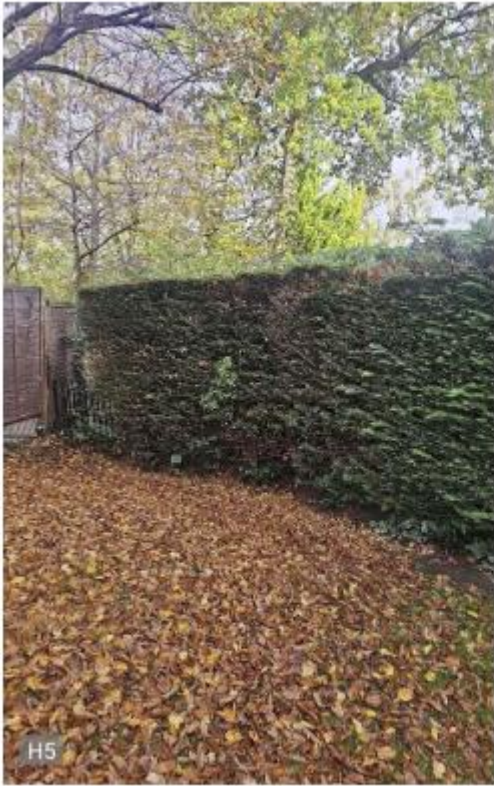
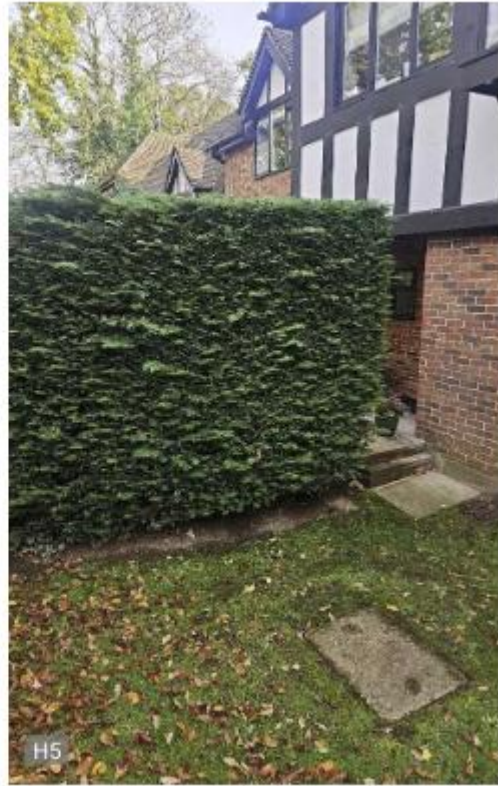
Ref.	Species & estimated age	Hight DBH (m)	Dist. to area of damage (m)	Vitality & previous works	Tree owner/ location	Recommendation	TP O CA
H5	Leylandii	2	4.5 #	Good Regular pruning	Insured	Remove stems within 5 metres of area of damage and maintain remainder at no greater than current size through regular pruning.	No
T9	Oak 100 Early-mature	12 (0.50)	8.5 #	Poor Reduced	Neighbour (see plan)	Remove close to ground level and treat stumps with herbicide to inhibit regrowth.	TPO
T10	Oak 120 Early-mature	14 (0.60)	6.7 #	Good Reduced	Neighbour (see plan)	Remove close to ground level and treat stumps with herbicide to inhibit regrowth.	TPO

The Arboricultural Consultants were appointed to provide their recommendations in relation to necessary tree management works to be undertaken in order to return long stability to the property. It is their opinion that the H5 Leylandii, T9 Oak, T10 Oak and SG21 Choisya are judged to be exerting the principal vegetative influence in respect of the current damage and are, by virtue of their size and proximity, having a significant influence on soil volumes below the insured property due to localised moisture abstraction.

Hedge H5 – Remove stems within 5 metres of area of damage and maintain remainder at no greater than current size through regular pruning.

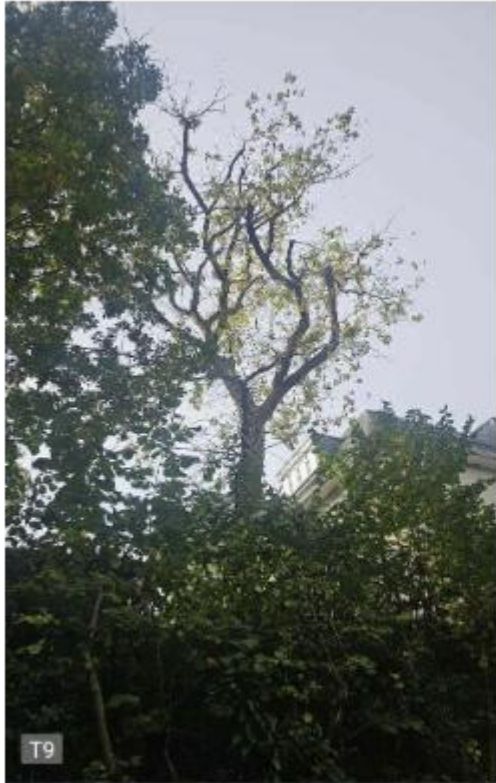
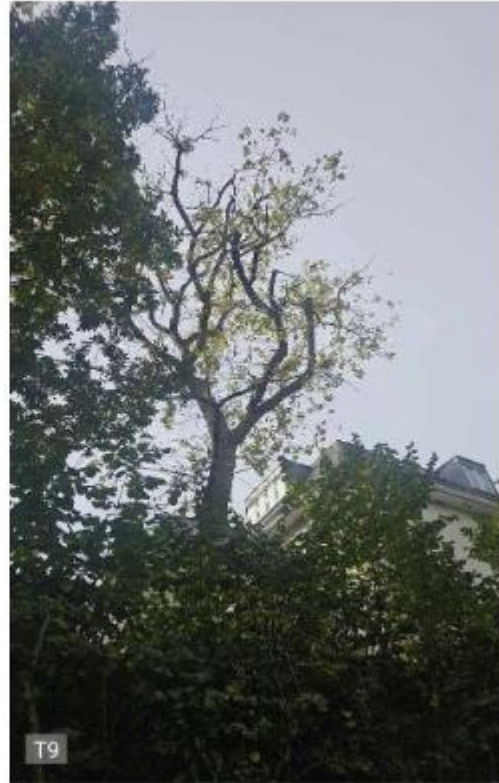
Roots retrieved from the beneath the foundations of the property in the area of subsidence damage were submitted to a botanist for identification, which confirmed the roots from Quercus spp. (oaks – both deciduous and evergreen).

Based on the above, the root identified will have emanated from T9 Oak and T10 Oak noted in the Arboricultural report.

Tree T9 – Remove close to ground level and treat stumps with herbicide to inhibit regrowth (subject to TPO consent being granted).

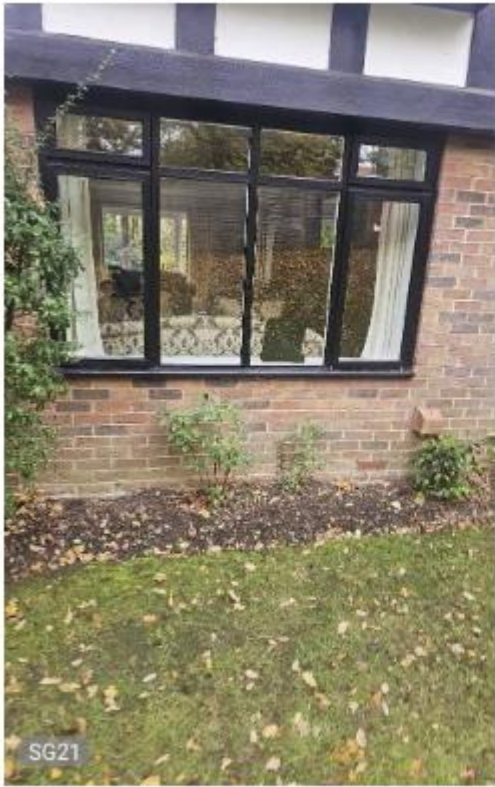
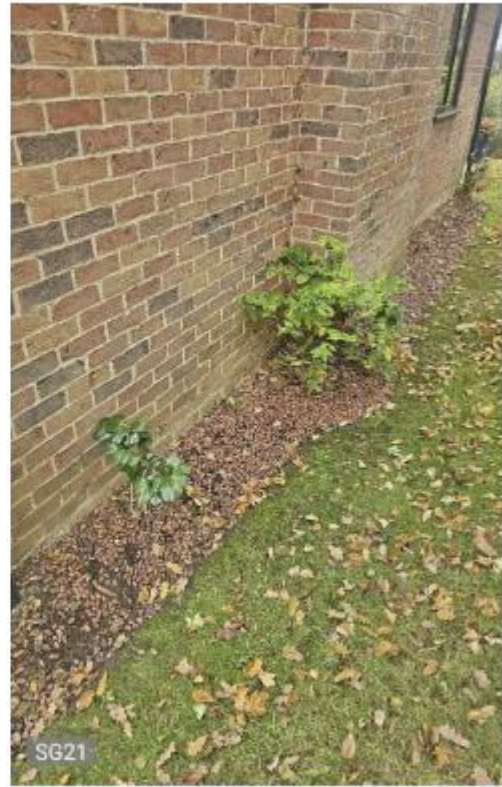
Ref.	Species & estimated age	Hight DBH (m)	Dist. to area of damage (m)	Vitality & previous works	Tree owner/ location	Recommendation	TP O CA
SG21	Choisya, Pyracantha, Acuba, Camilia , Mixed shrubs	2	0.5 #	Good	Insured	Remove close to ground level and treat stumps with herbicide to inhibit regrowth.	No

Shrub Group SG21 – Remove close to ground level and treat stumps with herbicide to inhibit regrowth.
