# Geotechnical Survey Report

FSI Ref: 29914  
Issue Date: October 2025

Risk Address: 4 Teal Drive  
Northwood  
Middlesex  
HA6 2PT

Company: Crawford  
Claim Ref: 1875934

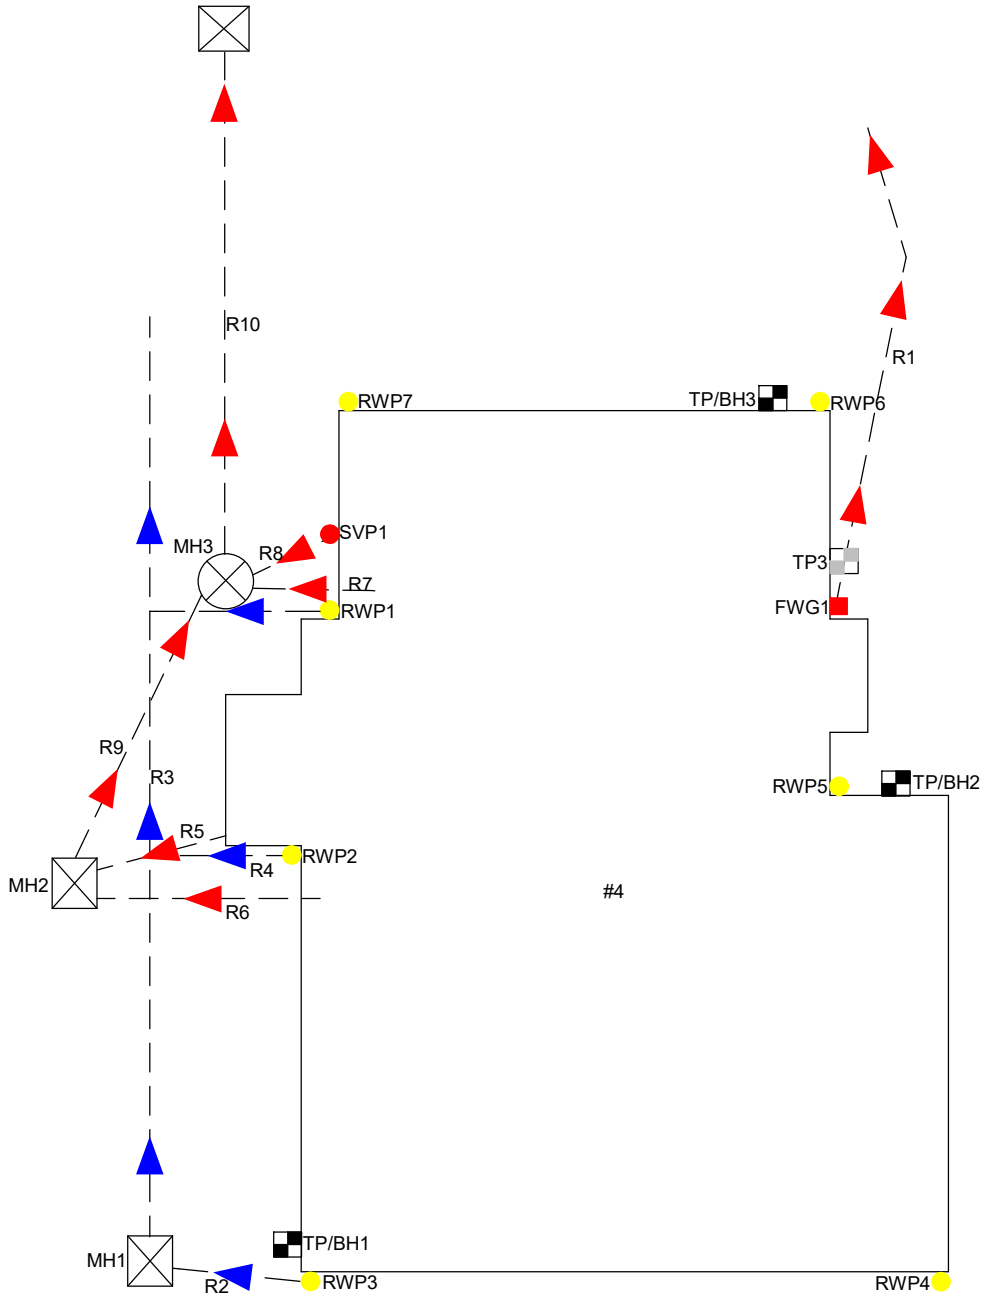
## SITE PLAN

TP3 moved due to FWG1 running through it, there are no leaks detected in Run1 but standing water is noted in the first attempt of TP3.

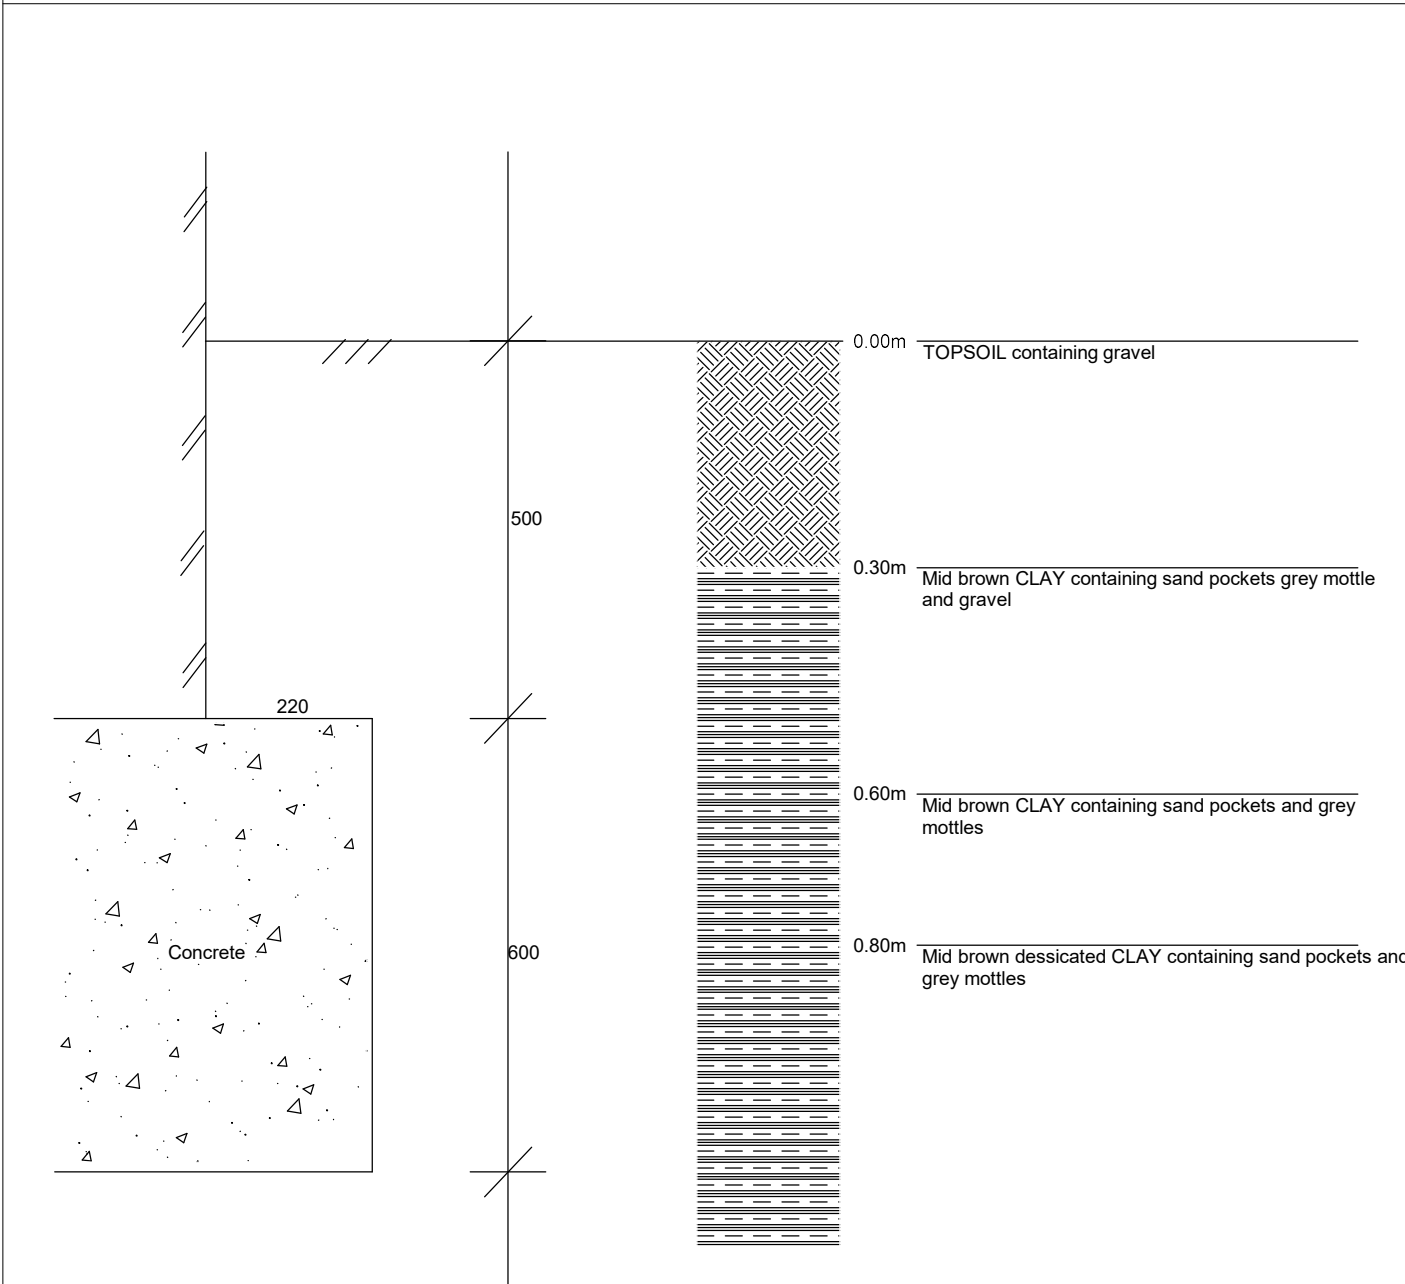
## TRIAL PIT 1

D1 @ F.L. (1.10m)

V = 140+kPa

Founding strata: Mid brown dessicated CLAY containing sand pockets and grey mottles

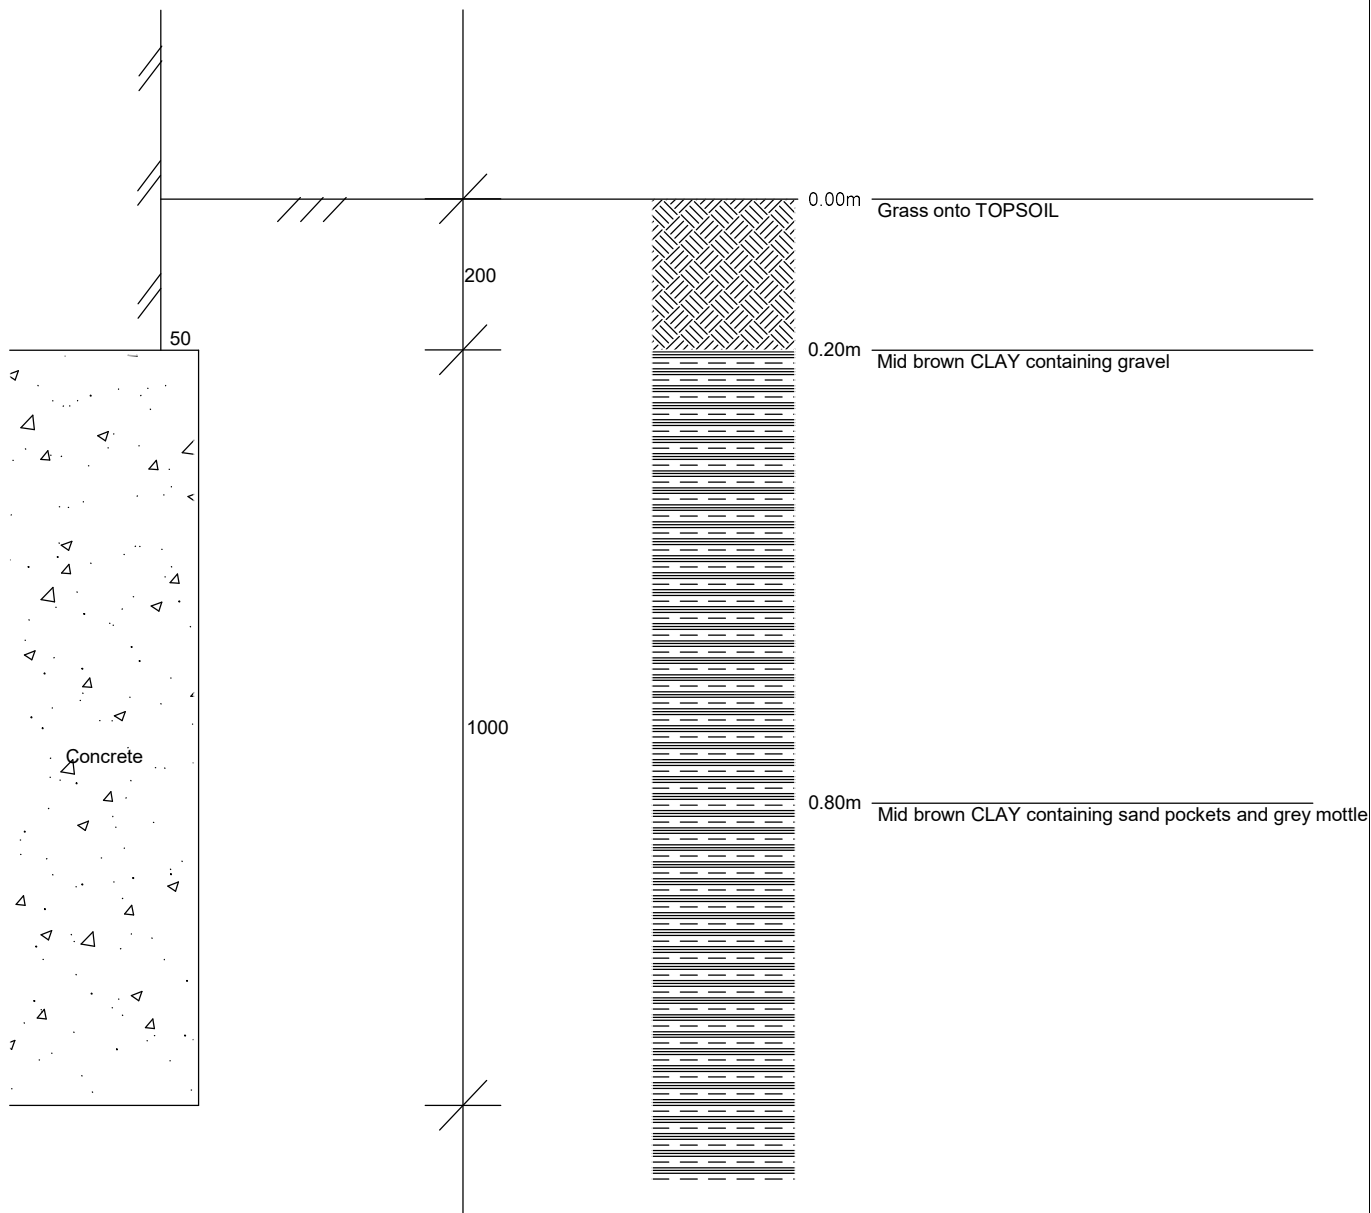
## TRIAL PIT 2

D1 @ F.L. (1.20m)  
 V = 98-100kPa  
 Founding strata: Mid brown CLAY containing sand pockets and grey mottle

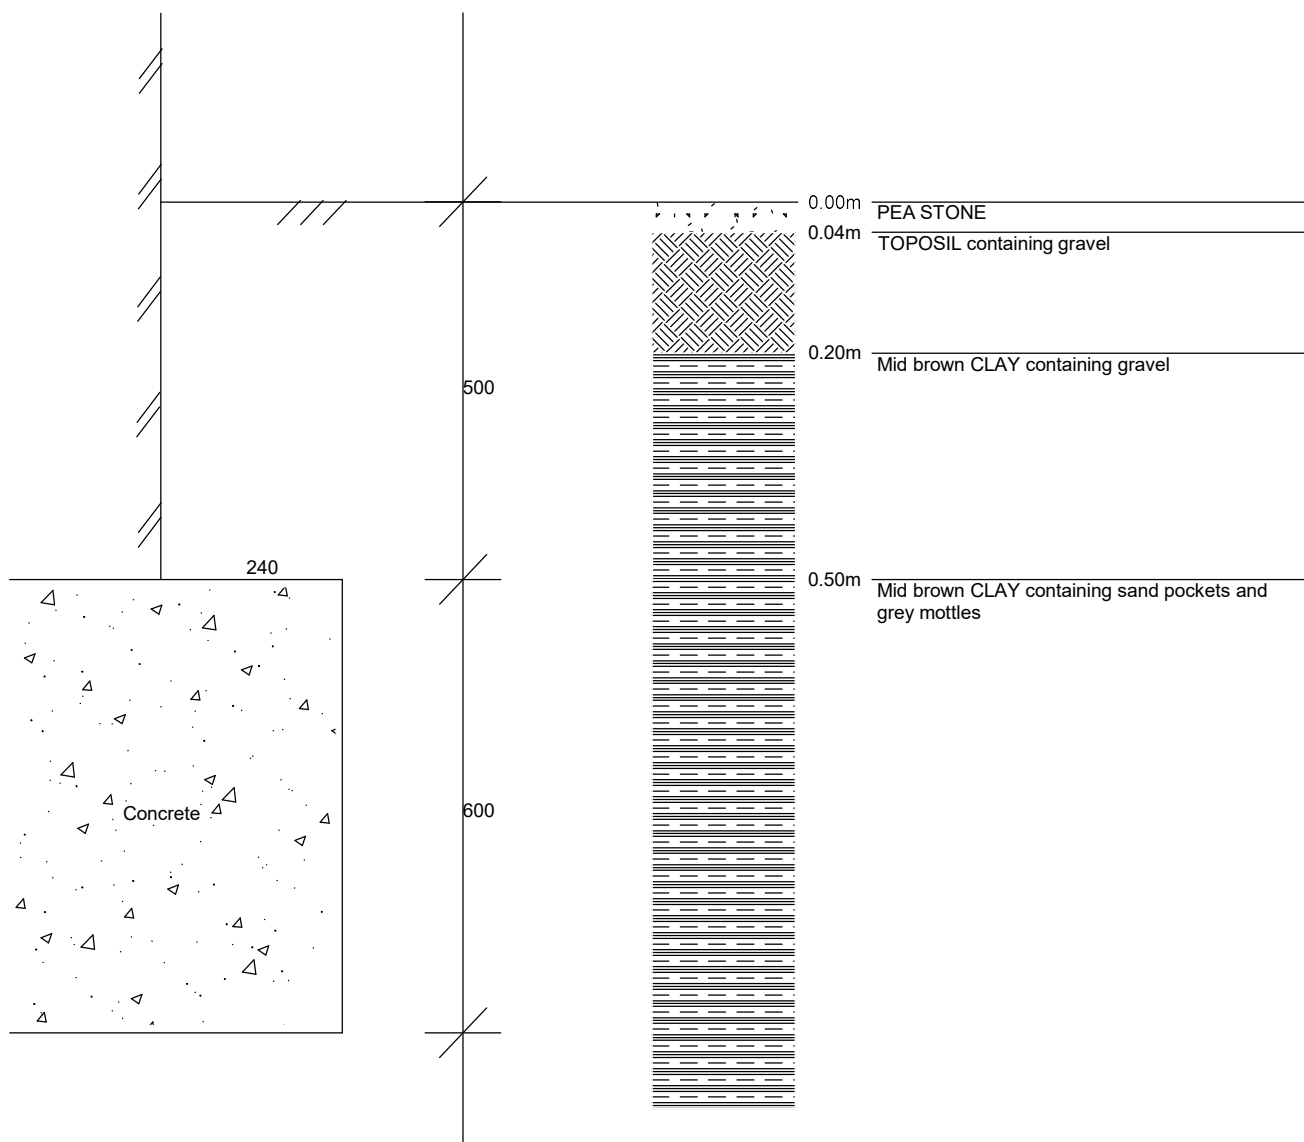
## TRIAL PIT 3

D1 @ F.L. (1.10m)  
 V = 100-104kPa  
 Founding strata: Mid brown CLAY containing sand pockets and grey mottles

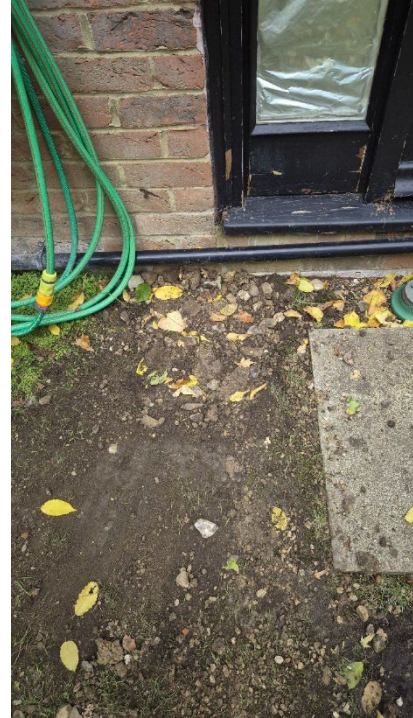
Photo 2 (Showing TP3 attempt closed)

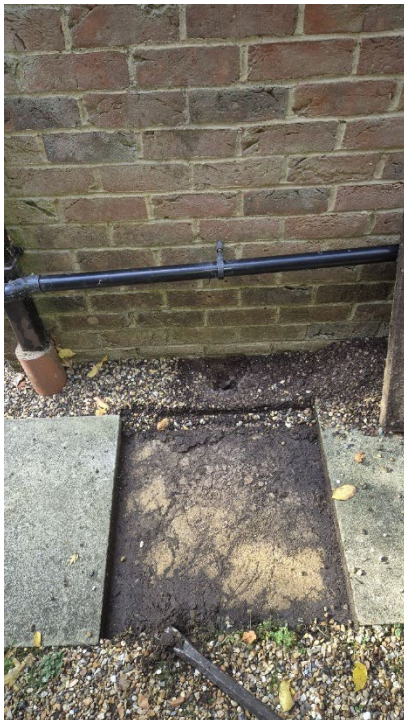
Photo 3 (Showing TP3 moved)

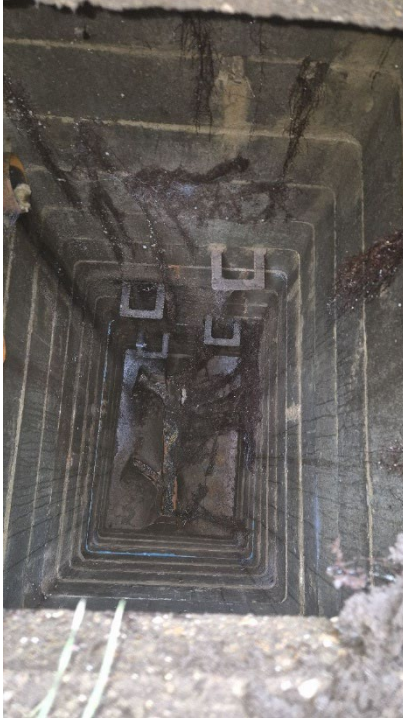
MH2 noted to contain roots. RWP4, RWP5, RWP6 & RWP7 require break-ins to survey. The operative performed the mains test on the water outlet at the rear of the property, they were unable to locate the policy holders water meter this resulted in a pass.

Photo 5 (Showing MH2)

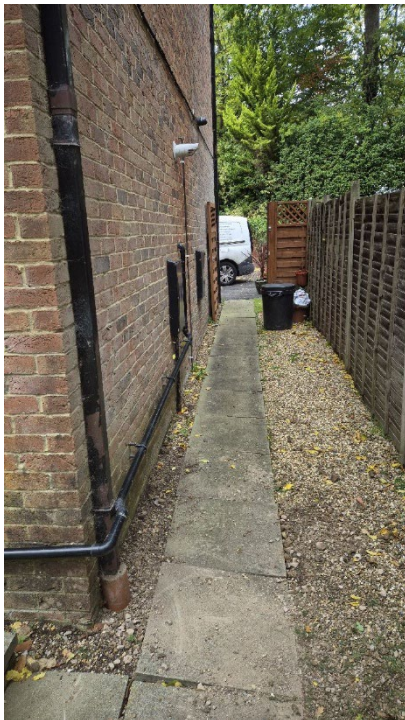
Photo 11 (Showing RWP 6 & RWP7)

1. Run 7 Re-survey to confirm if the run is dis-used – Run taps/ flush WC/s
2. RWP1 Break-in & survey
3. RWP4 Break-in & survey
4. RWP5 Break-in & survey
5. RWP6 Break-in & survey
6. RWP7 Break-in & survey

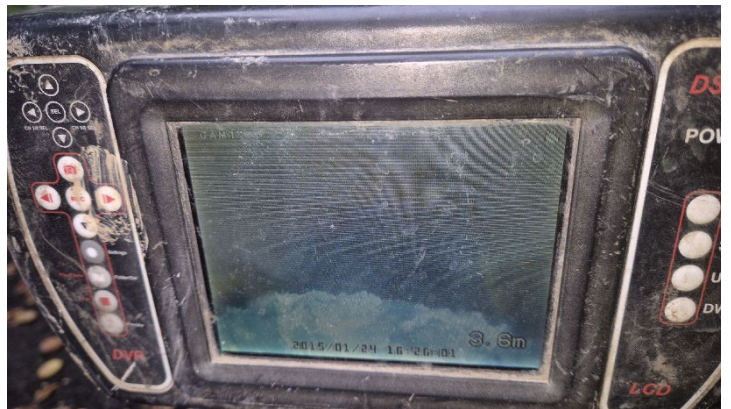
Photo 12 (Showing obstruction in Run7 at 3.6m)

Run	Grade	Recommended action
1-6	A	None required
7	B	Excavate & replace
8-10	A	None required
