PROPOSED  
SITE PLAN

| Place :<br><b>HAYES</b> | Road :<br><b>1-3 UXBRIDGE ROAD</b> | Date :<br><b>12/11/2012</b> | Section number :<br><b>6</b> | PLR suffix :<br><b>X</b> |

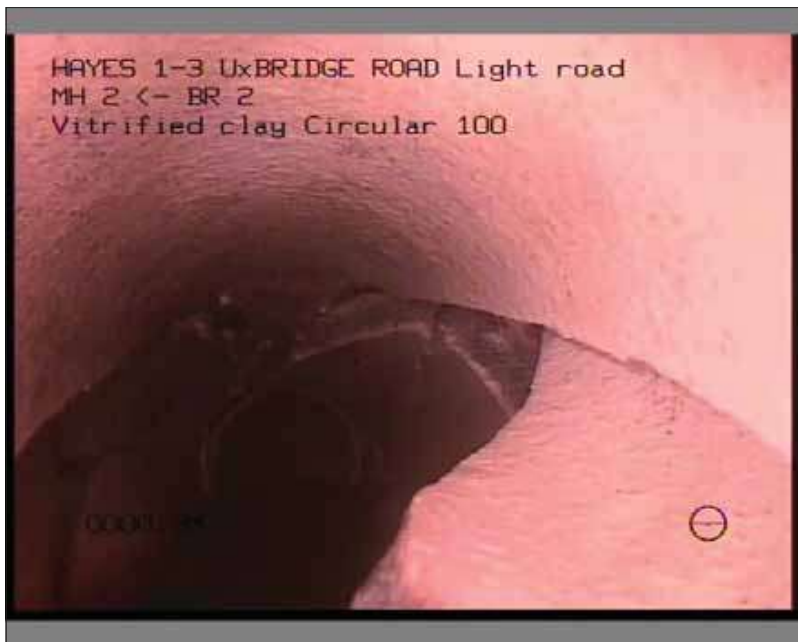
Photo: 6\_7\_60\_A.JPG  
0.9m, Broken sewer, from 12 to 12 o'clock

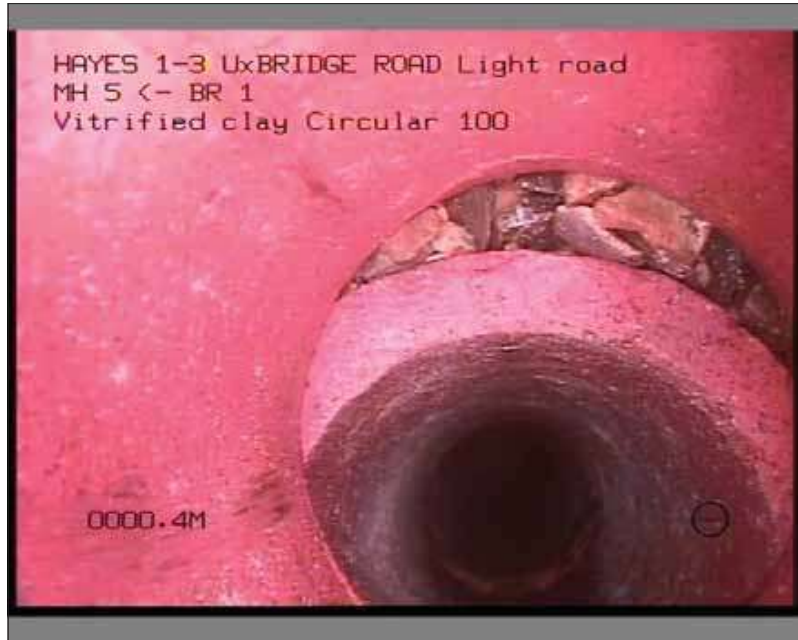
Photo: 16\_17\_131\_A.JPG  
0.4m, Joint displaced, large (over 1.5 times the pipe wall tickness)

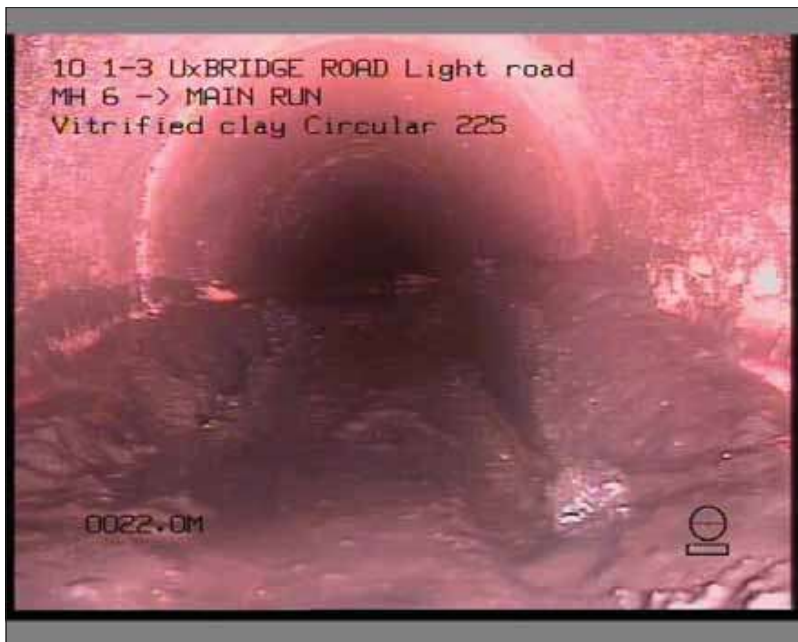
Photo: 19\_20\_160\_A.JPG  
21.4m, Debris silt, 30% cross-sectional area loss, Start

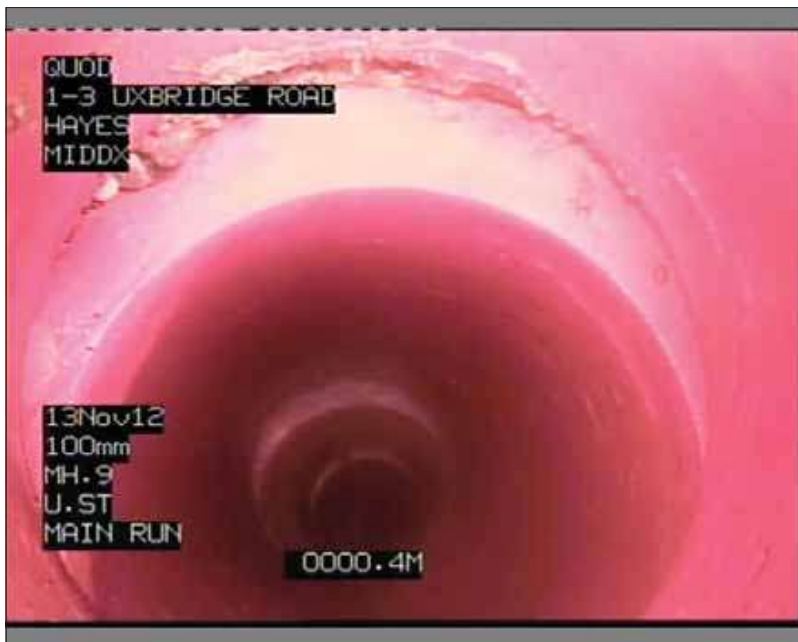
Photo: 28\_29\_227\_A.JPG  
0.4m, Joint displaced, large (over 1.5 times the pipe wall tickness)

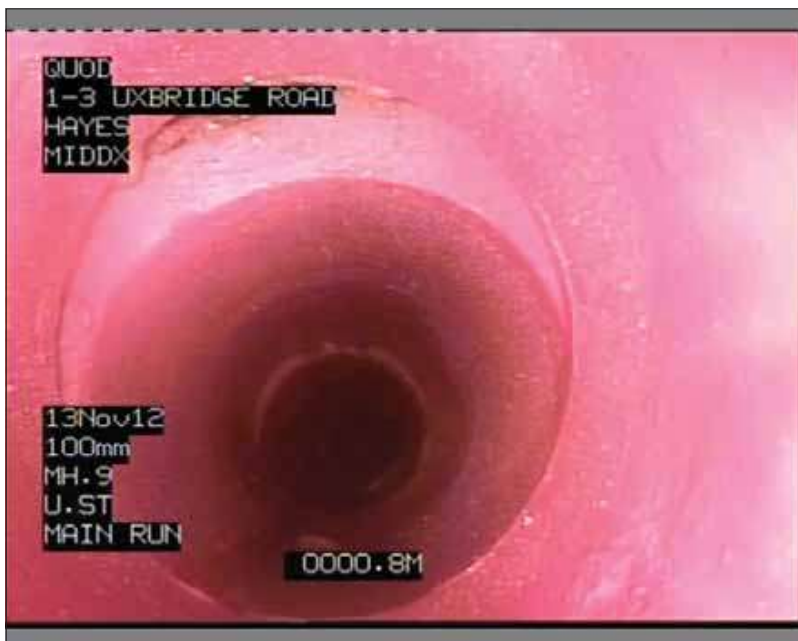
Photo: 28\_29\_228\_A.JPG  
0.8m, Joint displaced, large (over 1.5 times the pipe wall tickness)

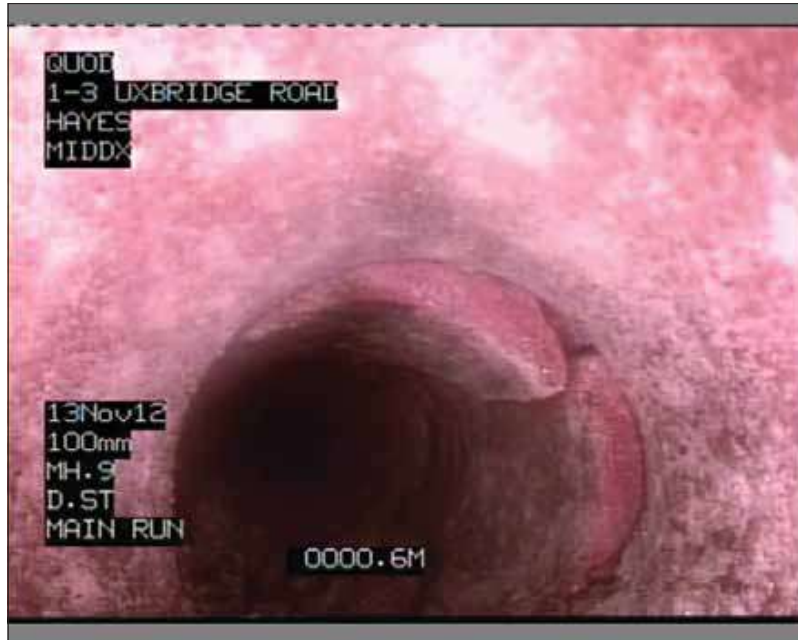
Photo: 29\_30\_238\_A.JPG  
0.6m, Fracture, longitudinal at joint, at 2 o'clock

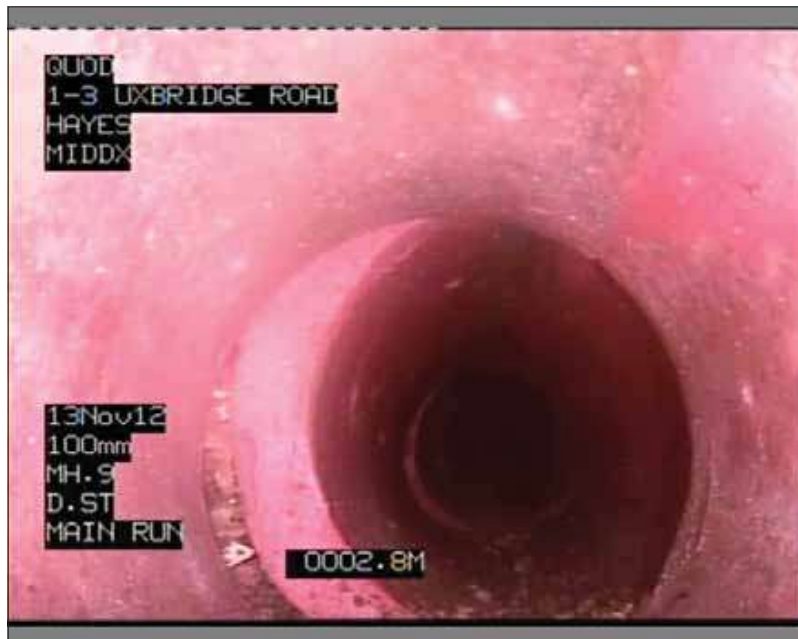
Photo: 29\_30\_244\_A.JPG  
2.8m, Joint displaced, large (over 1.5 times the pipe wall thickness)

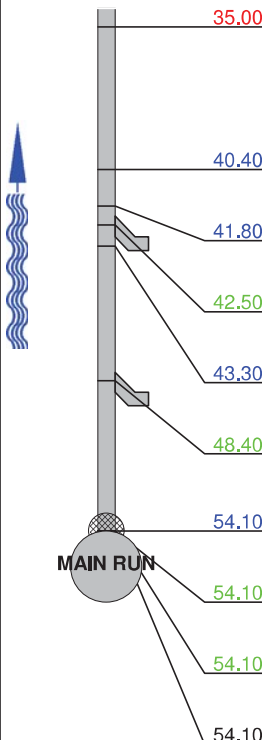
| 1:270 | Position | Code | Observation | Grade |
|---|---|---|---|---|
| | 35.00 | CLJ | Crack, longitudinal at joint, at 1 o'clock | (Struct) 2 |

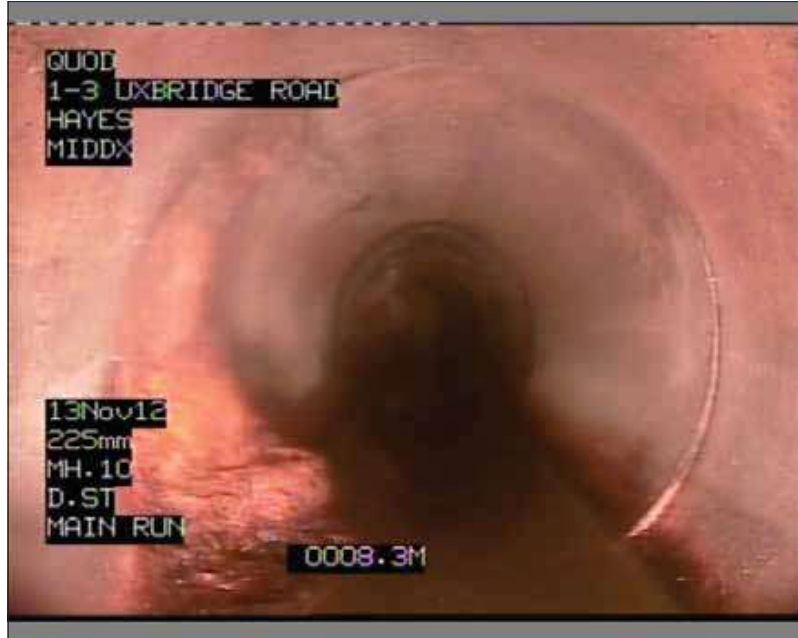
Photo: 32\_33\_291\_A.JPG  
8.3m, Encrustation, light at joint, from 7 to 11 o'clock

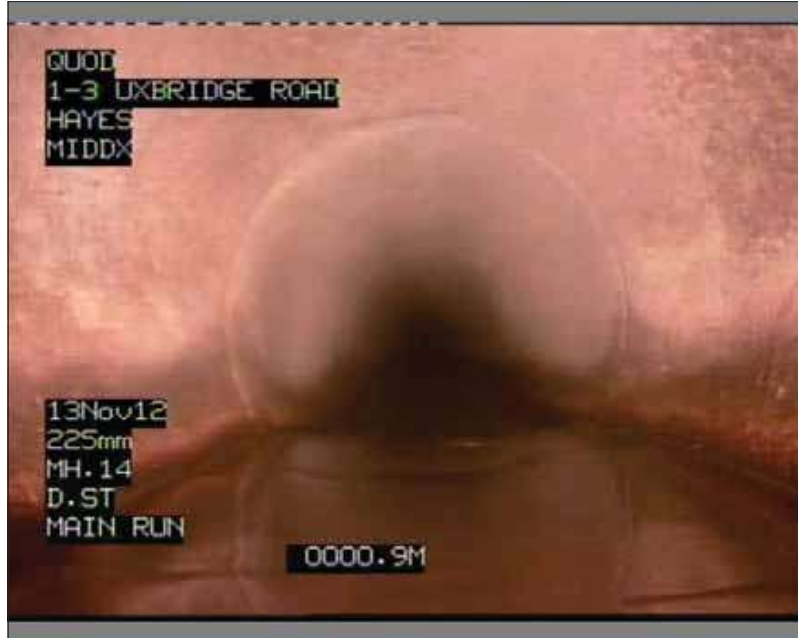
Photo: 34\_35\_308\_A.JPG  
0.9m, Encrustation, light, from 5 to 7 o'clock

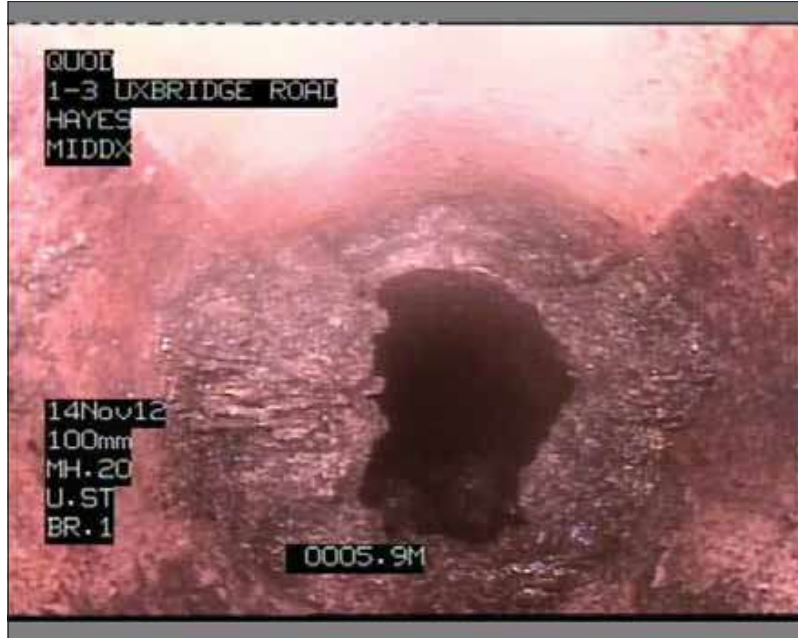
Photo: 44\_45\_407\_A.JPG  
5.9m, Survey abandoned Remarks: DUE TO EHJ

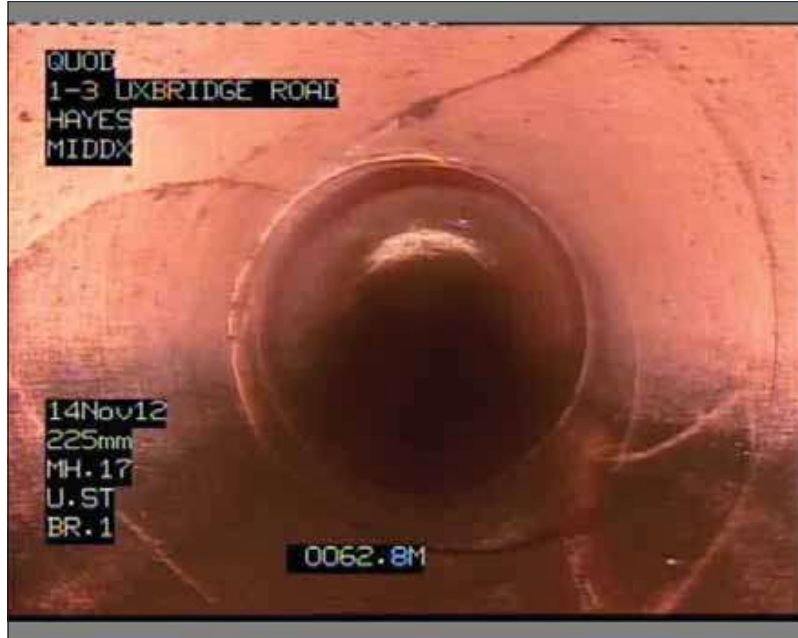
Photo: 51\_52\_467\_A.JPG  
62.8m, Fracture, multiple at joint, from 12 to 12 o'clock

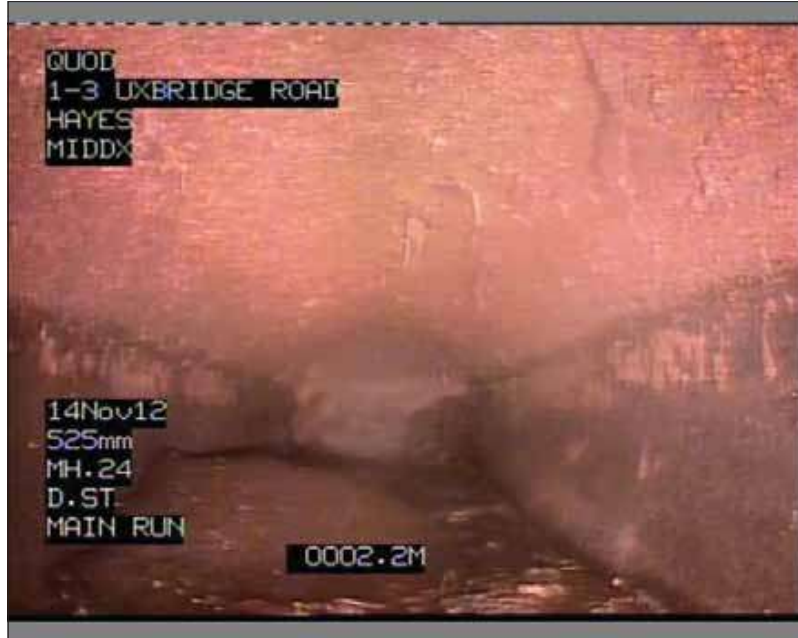
Photo: 53\_54\_481\_A.JPG  
2.2m, Debris, 20% cross-sectional area loss

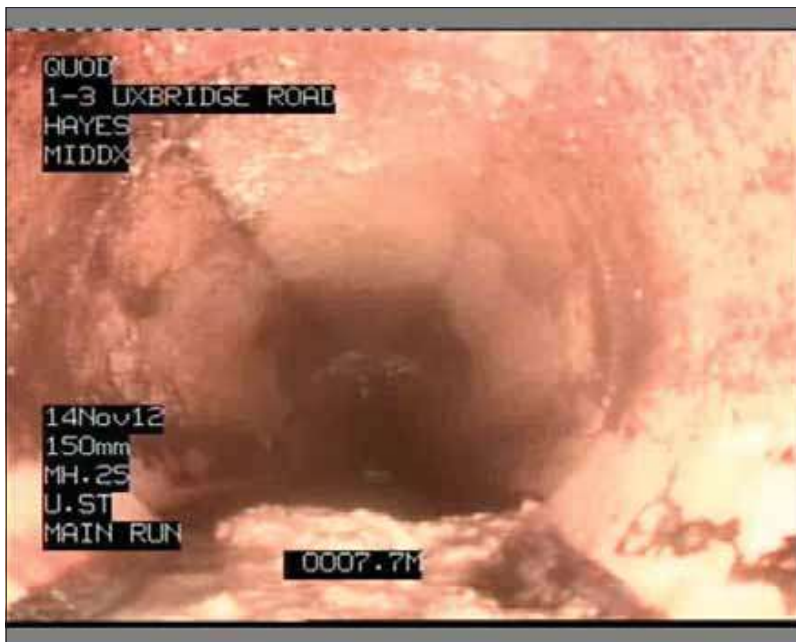
Photo: 55\_56\_498\_A.JPG  
7.7m, Encrustation, light at joint, from 5 to 7 o'clock

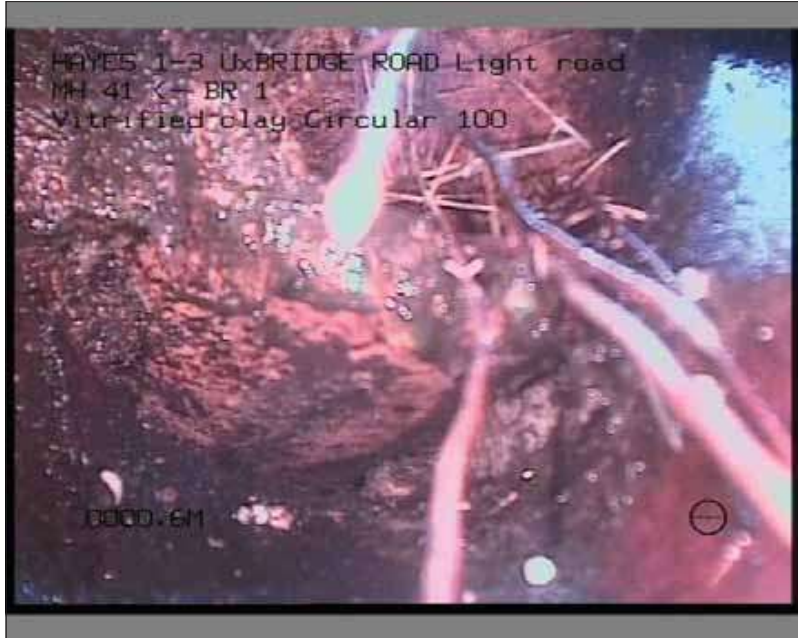
Photo: 68\_69\_624\_A.JPG  
0.6m, Roots, mass, 95% cross-sectional area loss

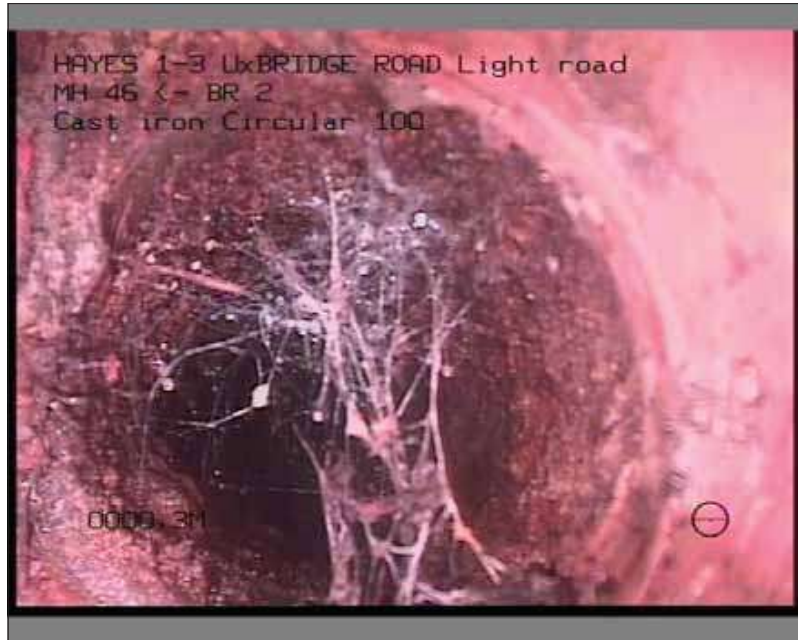
Photo: 94\_95\_790\_A.JPG  
0.4m, Encrustation, medium, from 12 to 12 o'clock, 20%  
cross-sectional area loss
