Cover System Verification Report

**HYDE PARK HAYES BUILDING 3,
MILLINGTON ROAD,
HAYES,
UB3 4AZ**

Report No: 24-05-13

May 2024

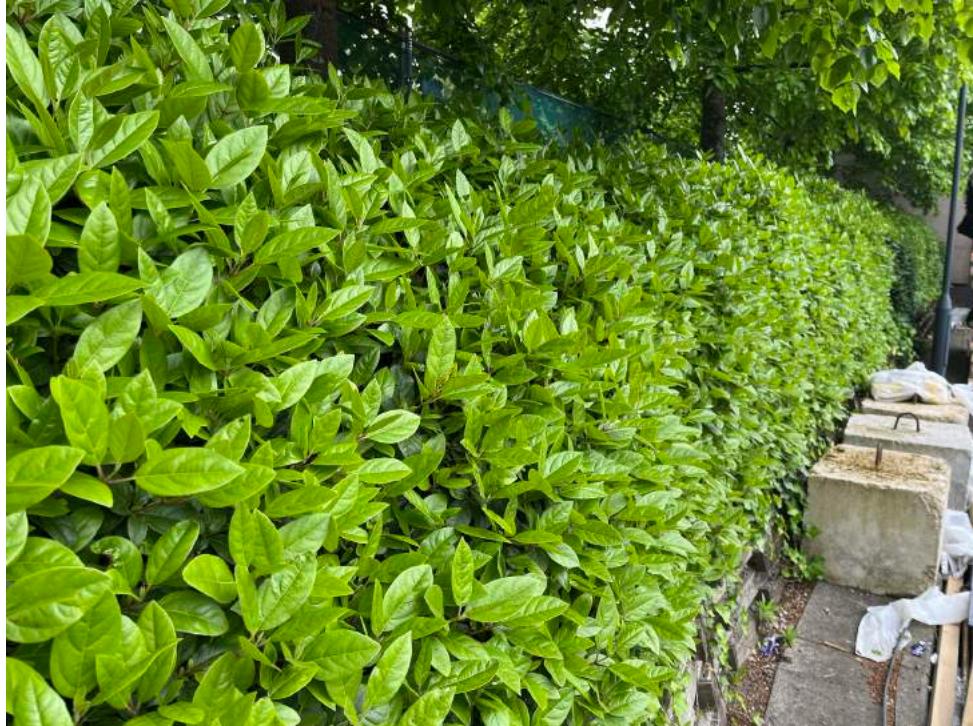
Photo 1 - Existing Hedging
not disturbed

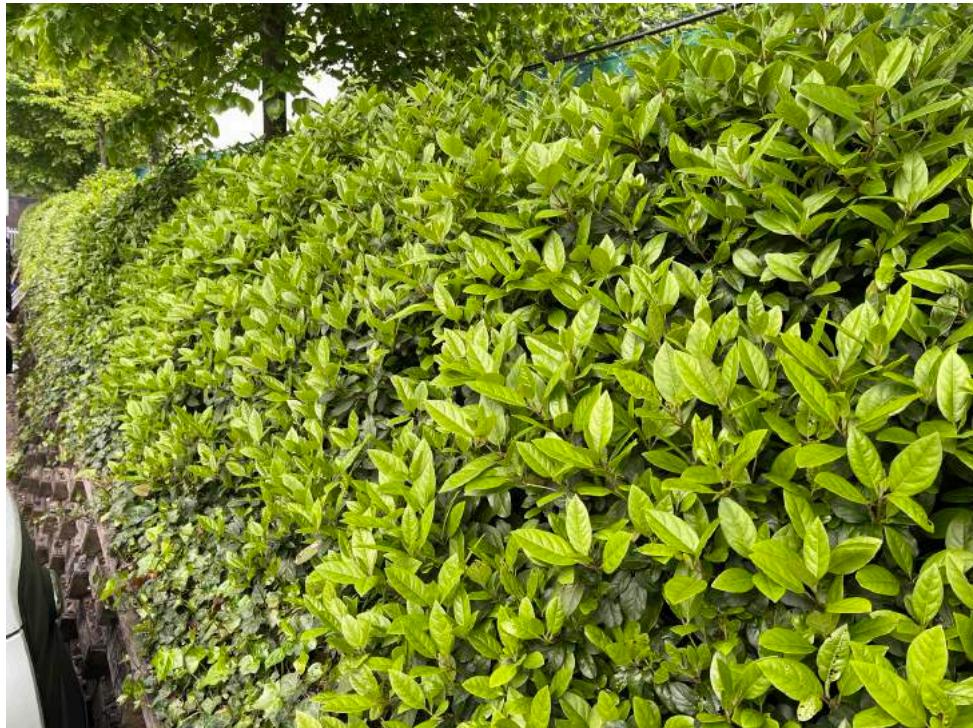
Photo 3 - Existing Hedging
not disturbed

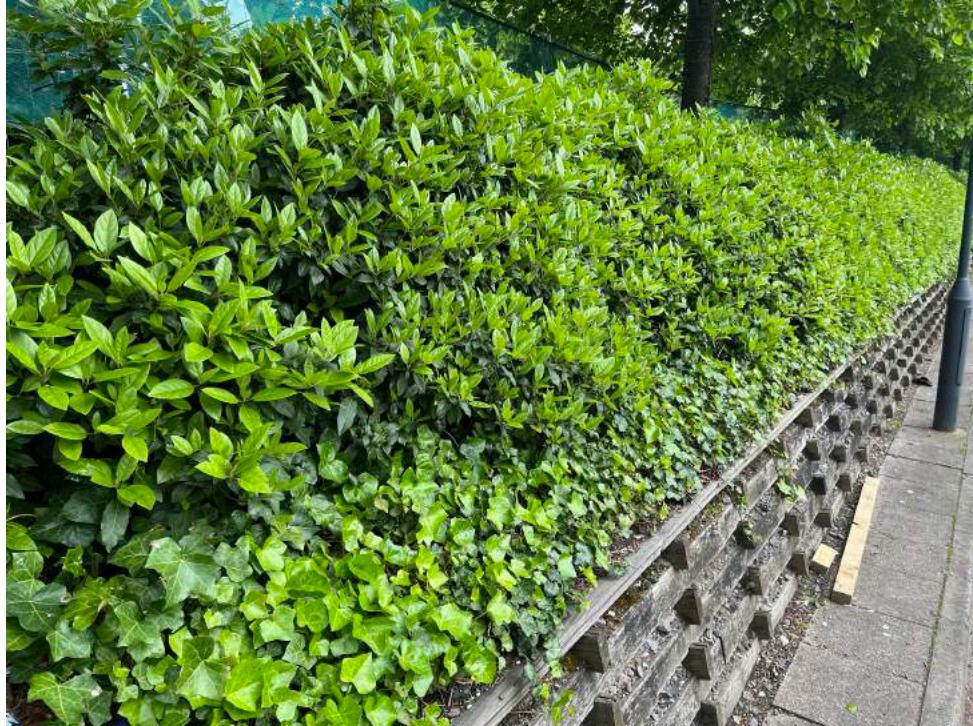
Photo 2 - Existing Hedging
not disturbed.

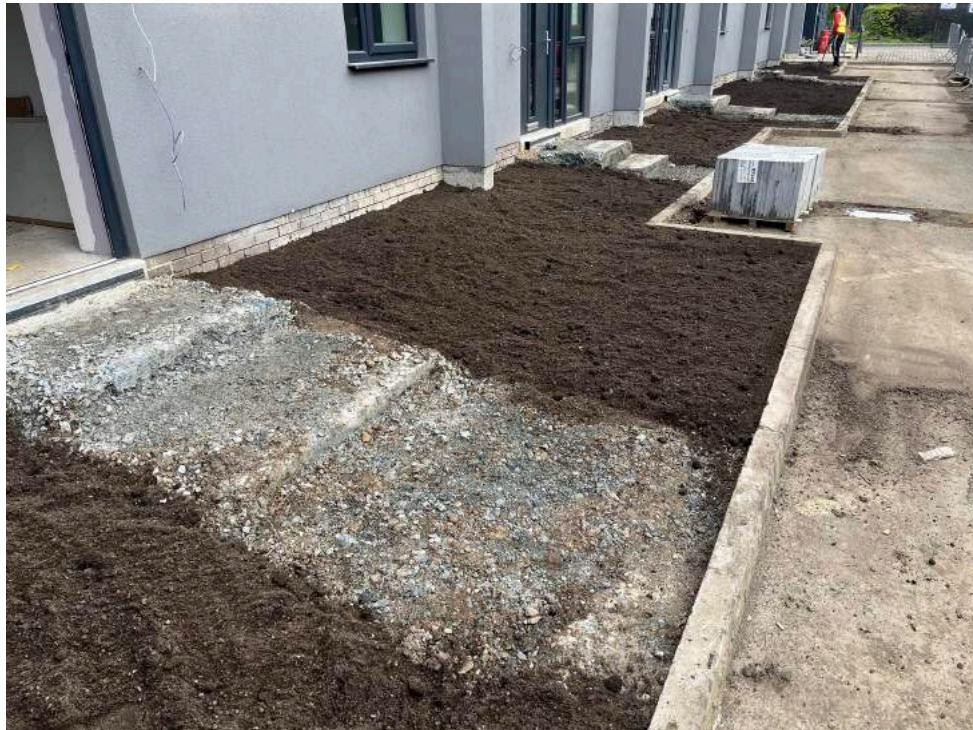
Photo 4 - View of topsoil
install across SE Elev.

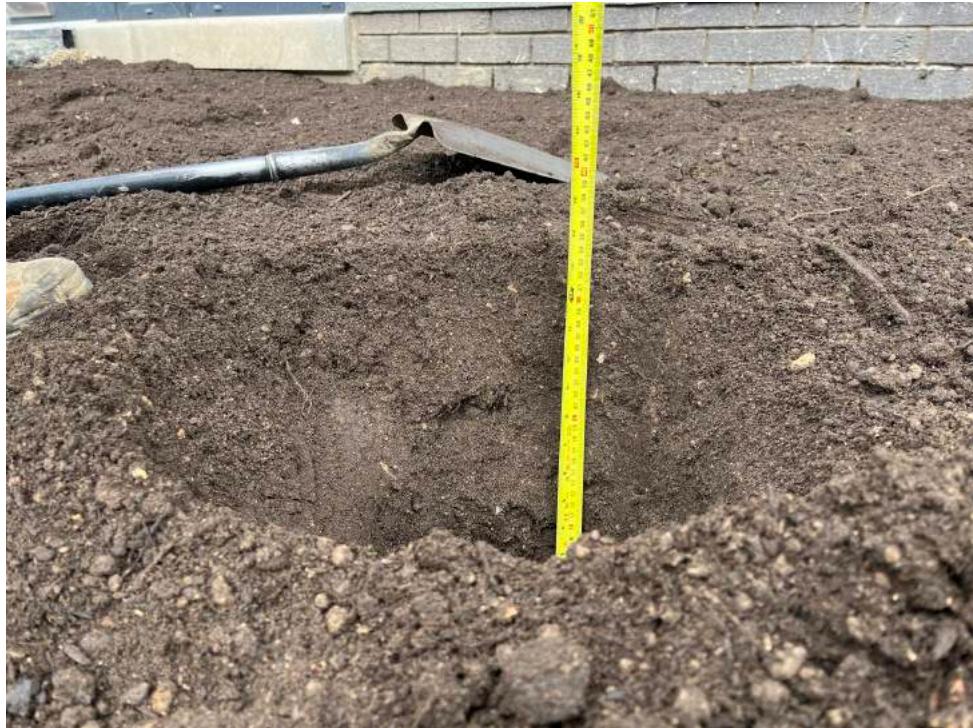
The provided information satisfies the physical thickness requirement for the cover system that the topsoil needed to be at least 150mm thick and the cover has to be either >300mm or onto natural material.

Photo 5 - Measuring Tape
showing minimum depth
of 300mm

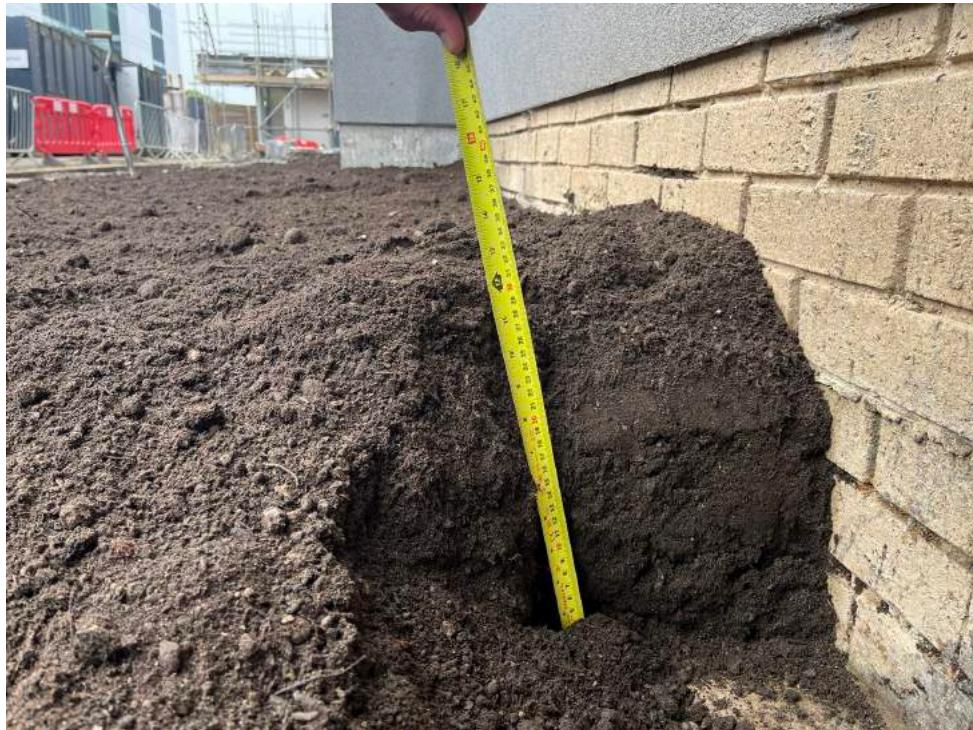
Photo 6 - Measuring Tape
showing 300mm minimum
depth of new topsoil

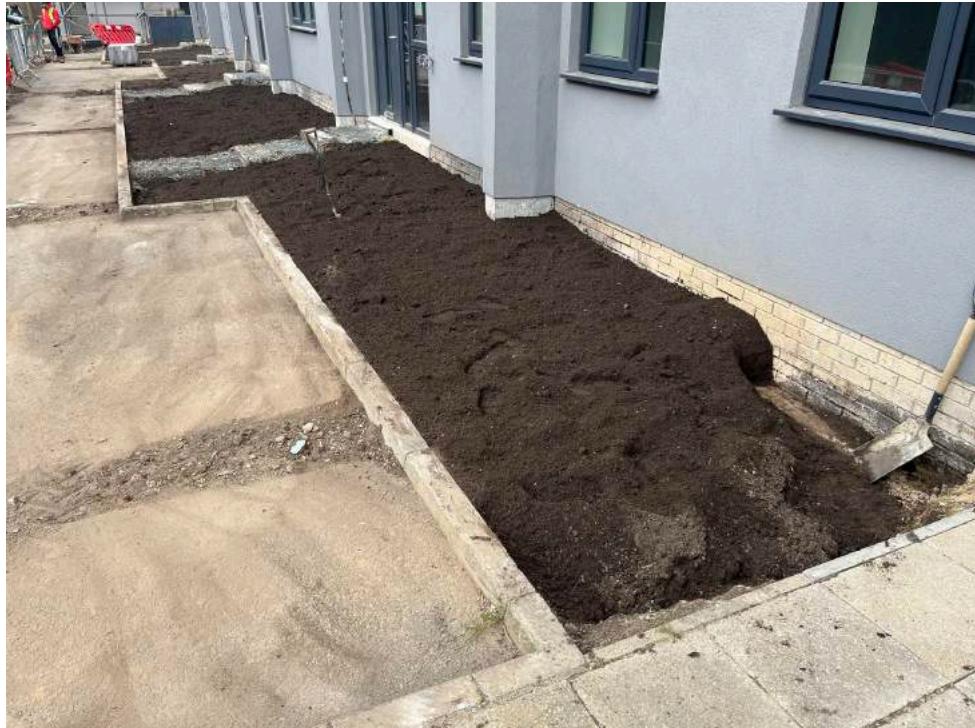
Photo 7 - View across front
of SE Elev.

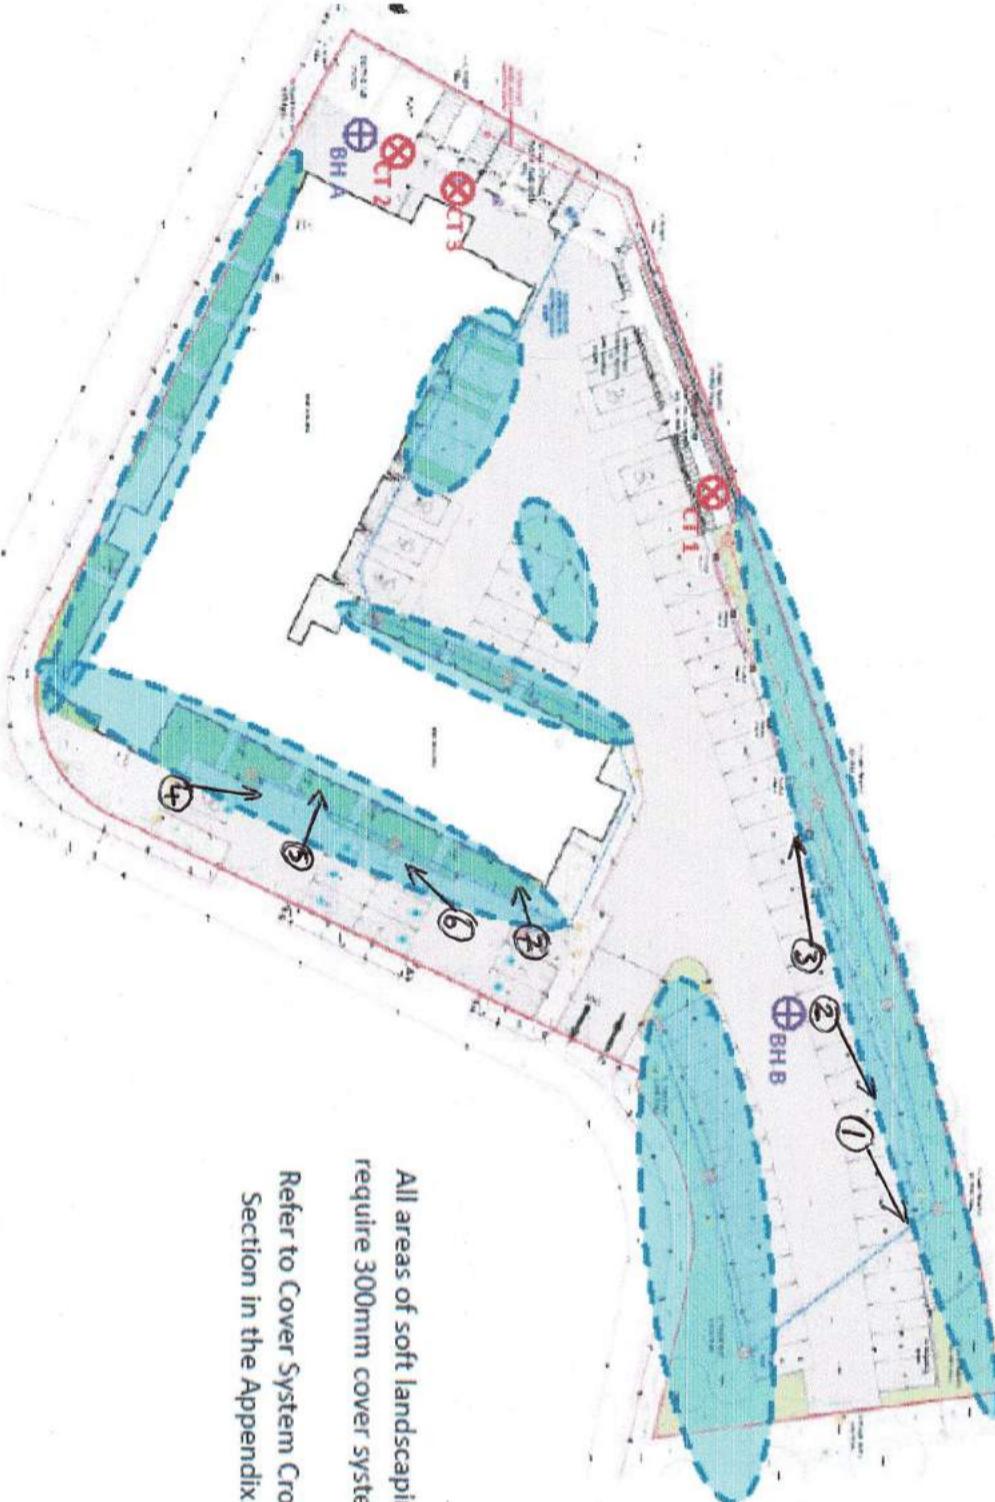
BY Continuous Tube Borehole	Cover System Plan - Proposed	SITE:- Hyde Park Hayes Building 3, Millington Road, Hayes, UB3 4AZ	Drawn SB
Existing Boreholes			
Approximate area where Cover System is required.			
All areas of Soft Landscaping. Not required under hardstanding or structures.
