Report

C1008600

MSCC5_COMMERICAL

Hillingdon Court Park Pavillion Parkway, Uxbridge, Greater London, UB10 9JX, United Kingdom

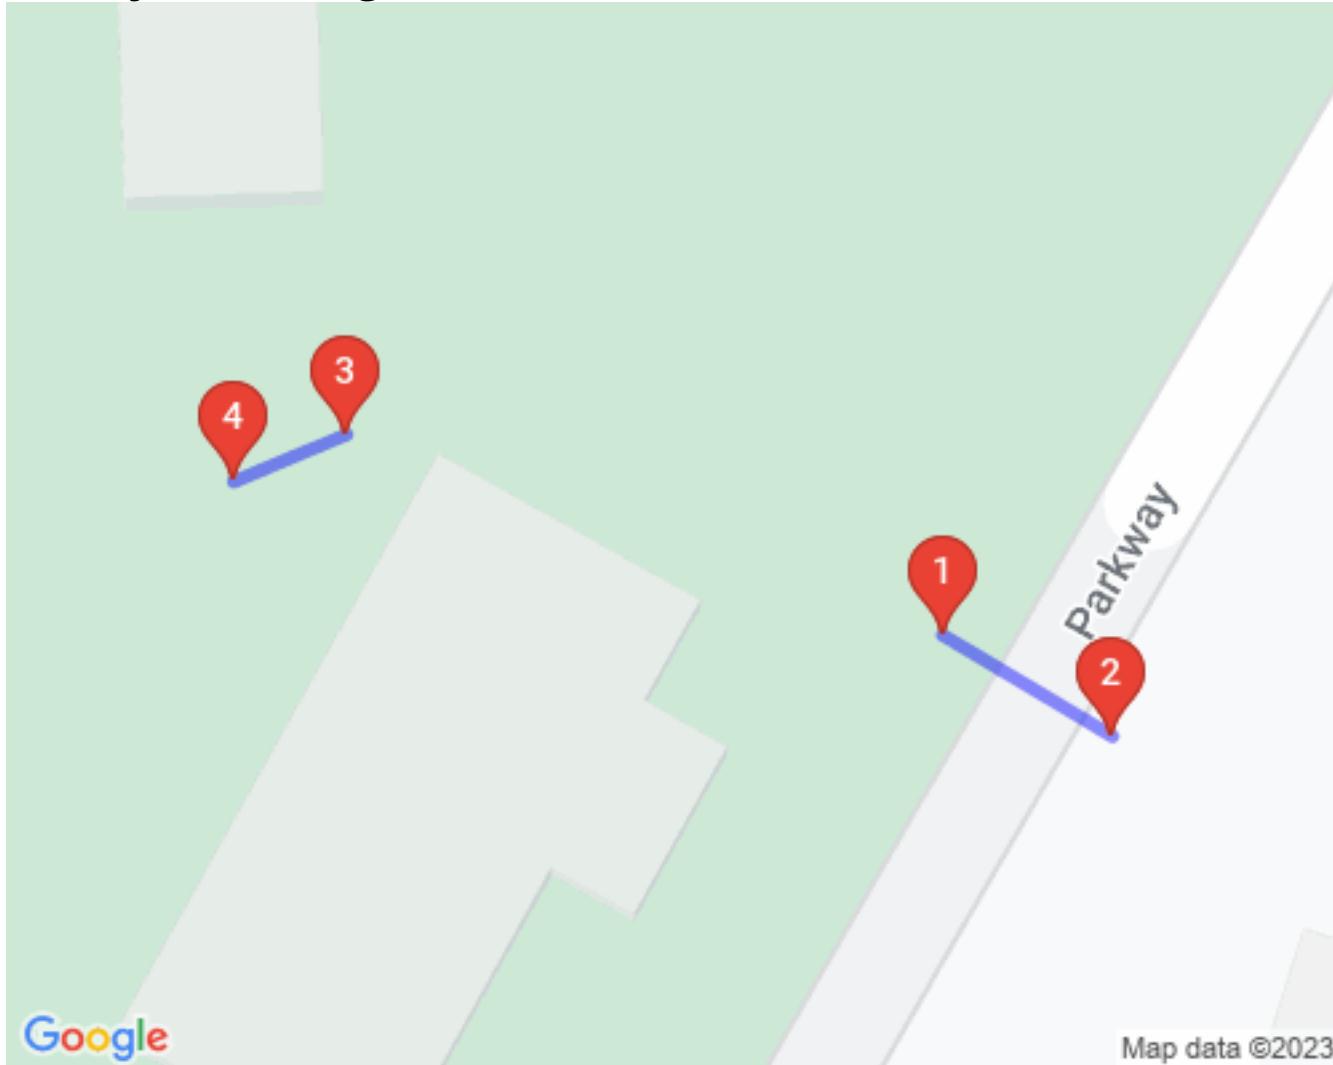
Project drawing

- ① MH-1
- ② Sewer
- ③ CP-1
- ④ OF-1

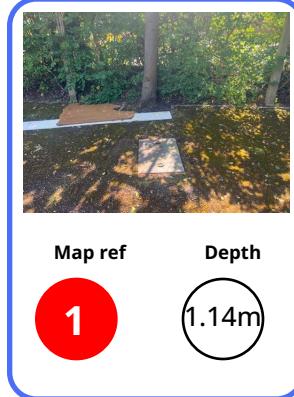
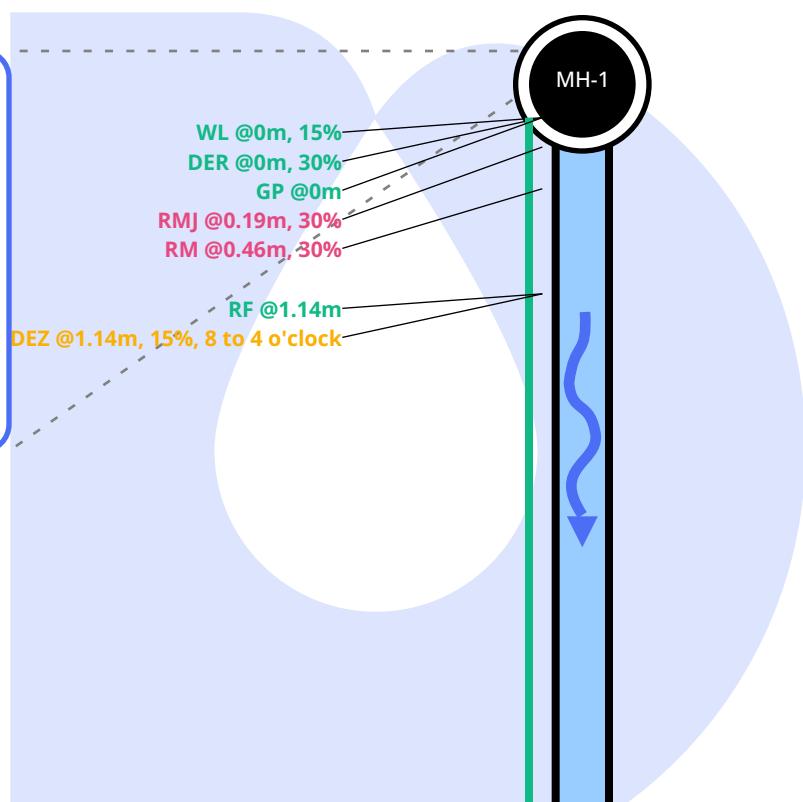
Manhole

Section 1 - At a glance

Length
6.04m

Diameter
0.1m

Use
Foul

Material
Vitrified Clay

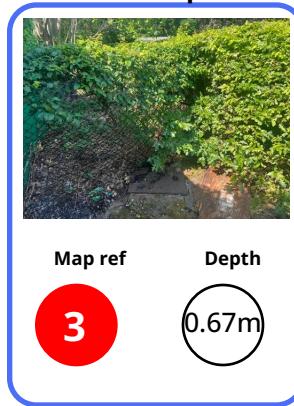
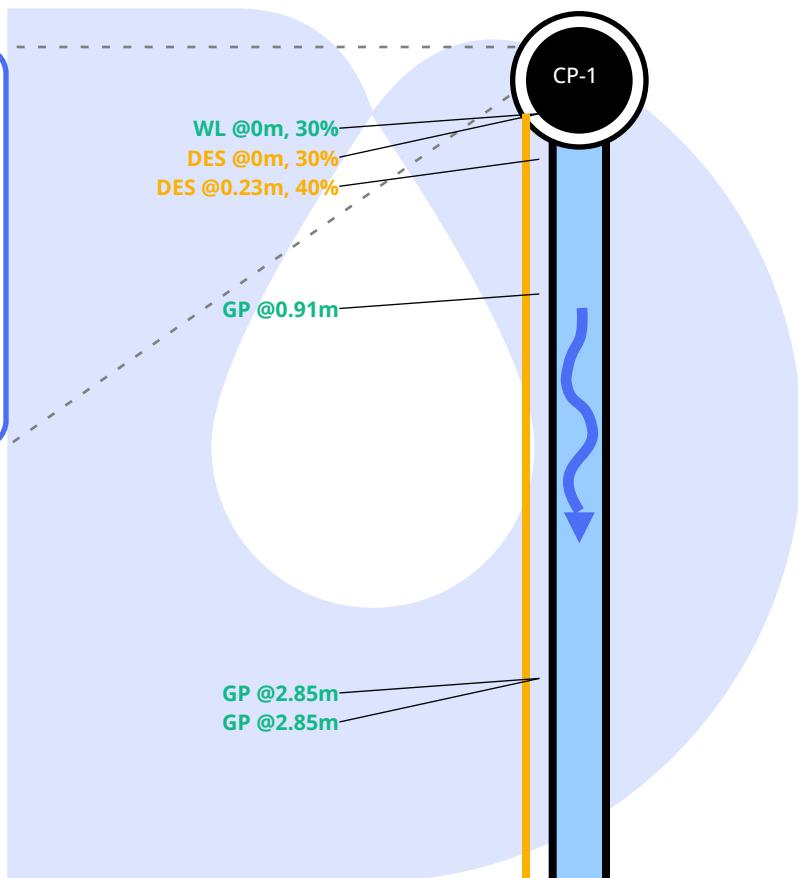
Catchpit

Section 2 - At a glance

Length
4.71m

Diameter
0.3m

Use
Surface Water

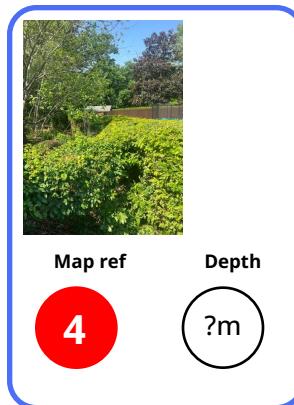
Outfall

DES @4.71m, 30%
GP @4.71m
SA @4.71m
