GROUND INVESTIGATION REPORT

233-236 Nestles Avenue
Hayes & Harlington
London
UB3 4SH

Client: Buccleuch Property

June 2019

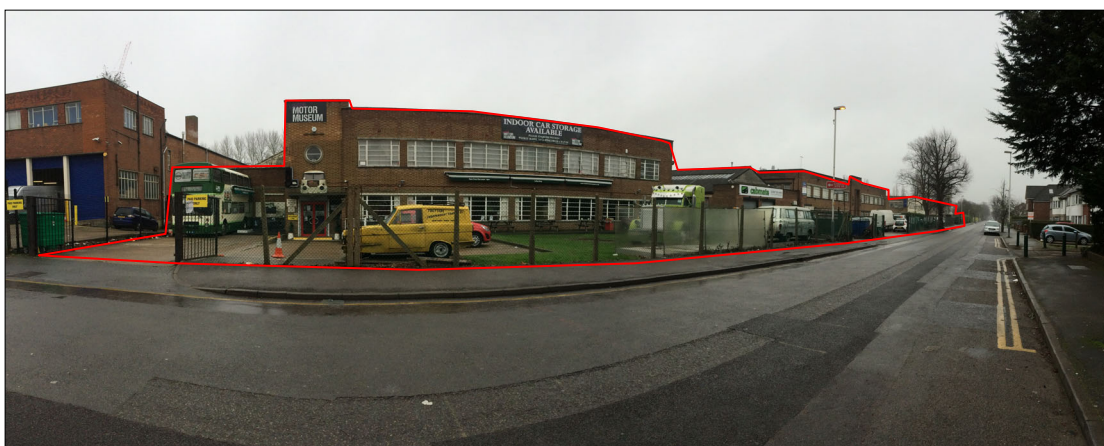
Panoramic view of the southern elevation of the site along Nestles Avenue, including the London Motor Museum occupying the western portion of the site. To the east of this is the extension to No 233 Claremont House and then the main building, which occupies the southern portion of the site. There is soft landscaping and hardstanding to the front of both buildings.

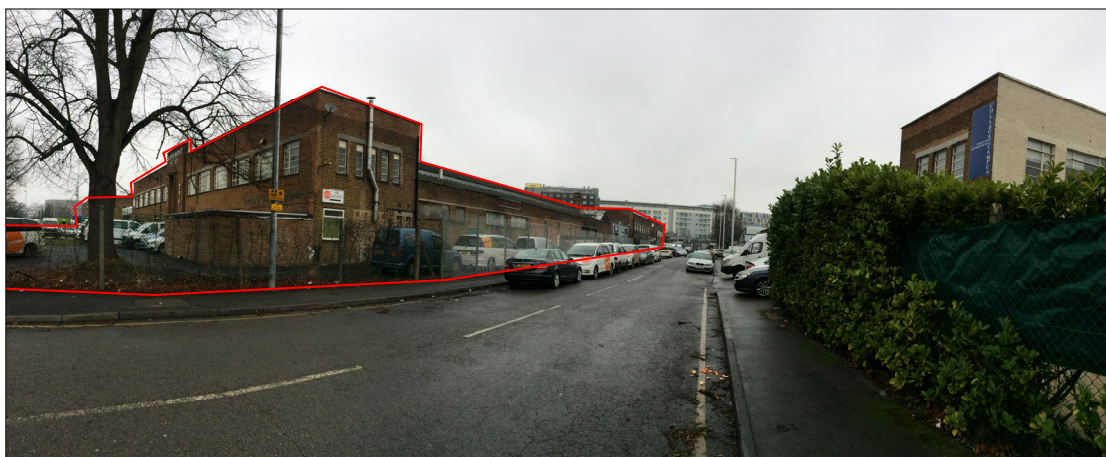
Panoramic view of the eastern elevation of the site along Viveash Close, including No 236 Claremont House on the corner.

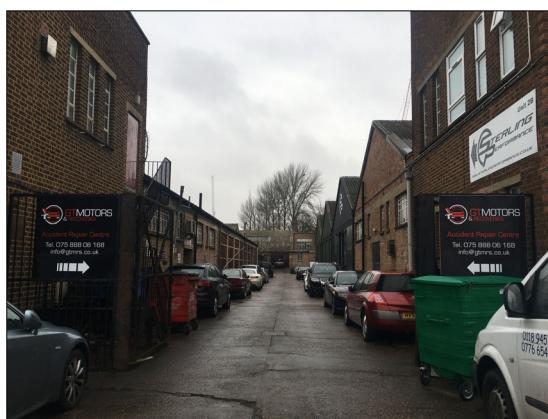
Asbestos cement warning labels are present along the buildings in the alleyway between the two buildings fronting Viveash Close. It is likely that other asbestos containing materials are present throughout the structures and an asbestos survey will be required for the site.

Looking roughly west at the alleyway between the two buildings fronting Viveash Close, which are occupied by numerous garage businesses and workshops
