ZC 47R-47A Reinstatement Information Note

Skip Lane

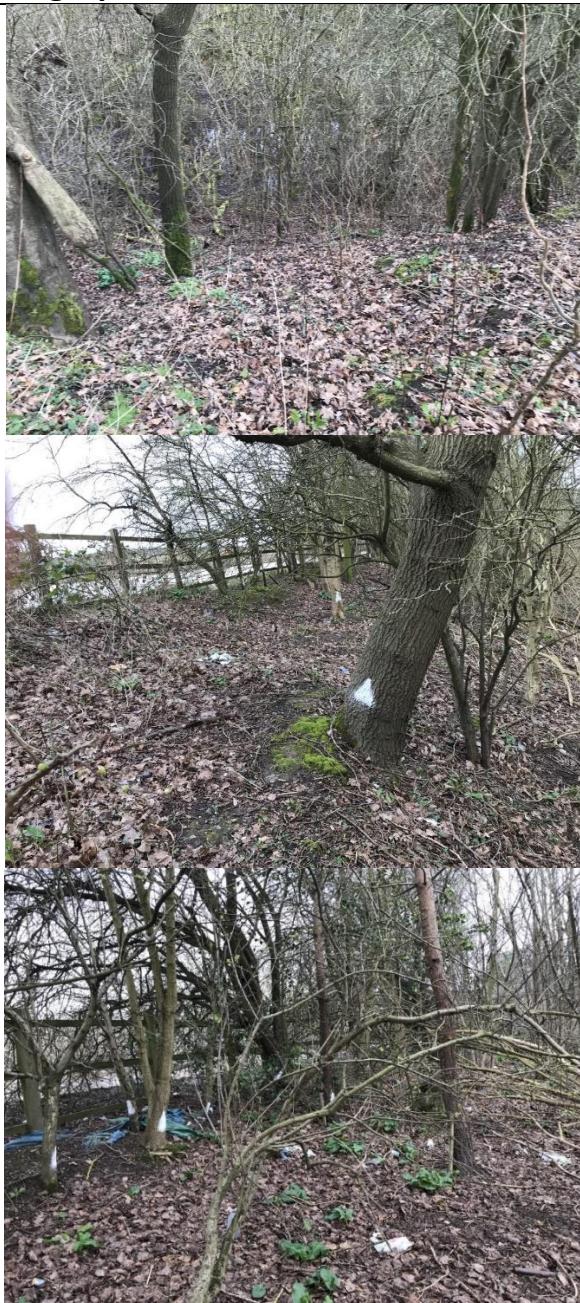
Before works

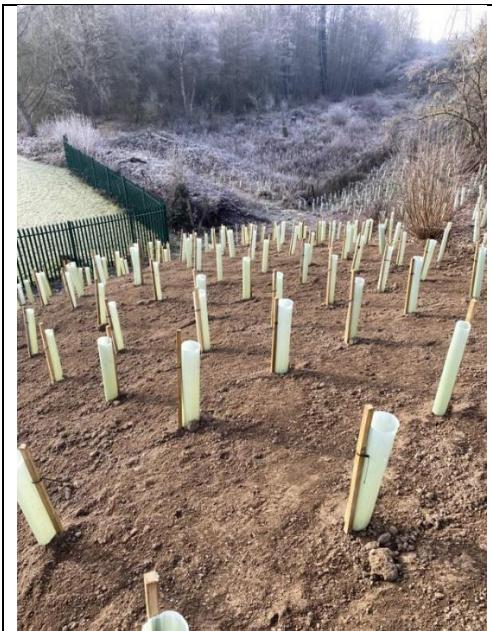
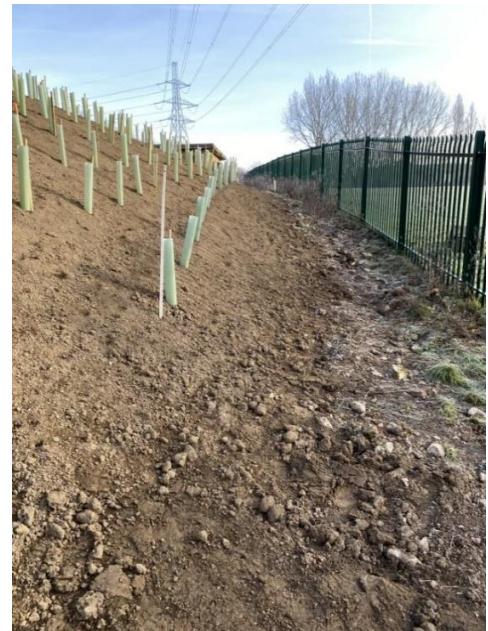
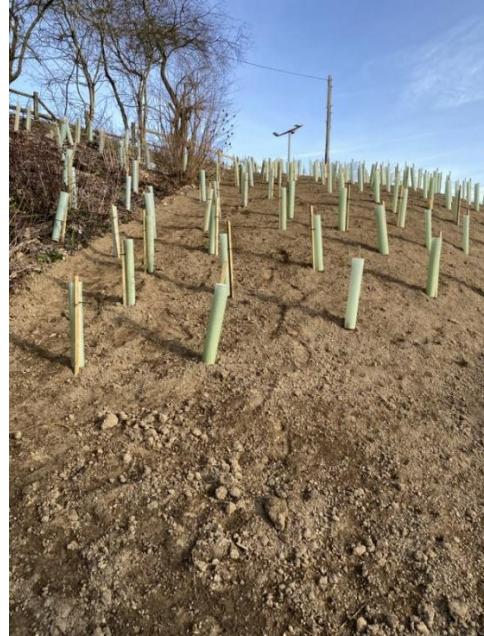
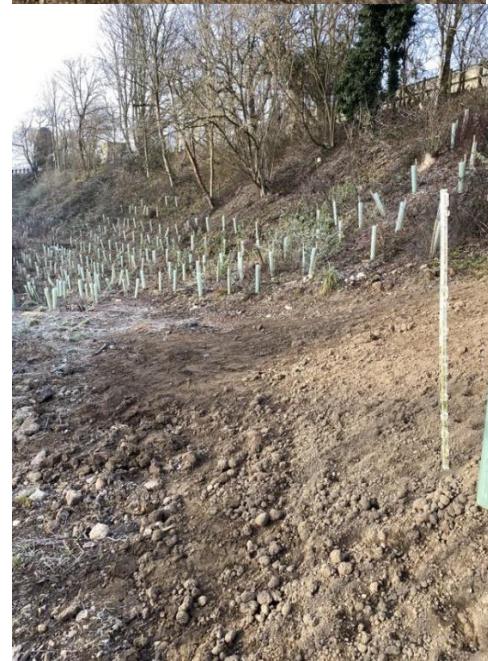
After works

Reinstatement of trees and shrubs on embankment for screening/visual amenity/slope stabilisation has been conducted on Skip Lane, a focus on low growing shrub species beneath conductor span has been implanted to reduce the need of future maintenance and reduce any effect to wildlife in the area. We have also planted Guelder rose in localised areas of damper ground conditions such as at the toe of the slope as Guelder rose is more tolerant to damper growing conditions.

The post and rail fence along skip lane was replaced with a similar fence and the fence that borders golf course at bottom of slope was replaced with a green powder coated palisade fence.

The turf on the golf course was reinstated.
