**Demolition Works at**

**501-504 Stone Close,  
West Drayton  
UB7 8JU**

Unit 501  
Stone Close  
Horton Road  
West Drayton  
UB7 8JU

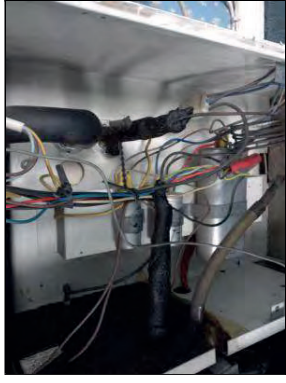
| | 11 Apr 2017 | Roy Pearce | Refurbishment & Demolition survey | 1st Floor | No Asbestos Detected (0) |
| Surveyor comments | NON Asbestos bitumen insulation to heater units | | | | |

| Recommended action | No further action required | | | | |

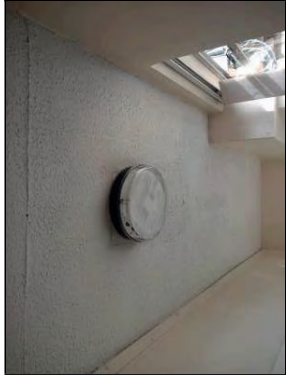
| | 11 Apr 2017 | Roy Pearce | Refurbishment & Demolition survey | 1st Floor | Chrysotile (1) |
| Surveyor comments | The textured coating (Artex) to the ceilings contains asbestos fibres | | | | |

| Recommended action | B - Remove | | | | |

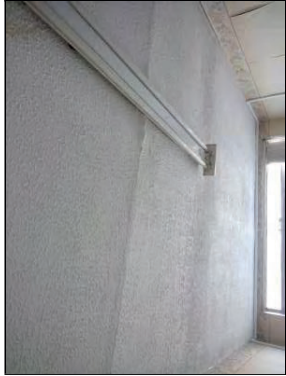
| | Unit 501, Stone Close, West Drayton, UB7 8JU | | Kitchen 104 | | Textured Coating to ceilings | | 12m <sup>2</sup> | | | |
| Surveyor comments | The textured coating (Artex) to the ceilings contains asbestos fibres | | | | | | | | | |

| Recommended action | B - Remove | | | | | | | | | |

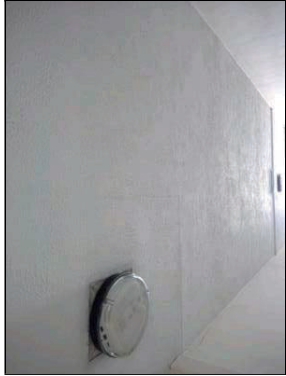
| | 11 Apr 2017 | Roy Pearce | Refurbishment & Demolition survey | 1st Floor | Chrysotile (1) |
| Surveyor comments | The textured coating (Artex) to the ceilings contains asbestos fibres | | | | |

| Recommended action | B - Remove | | | | |

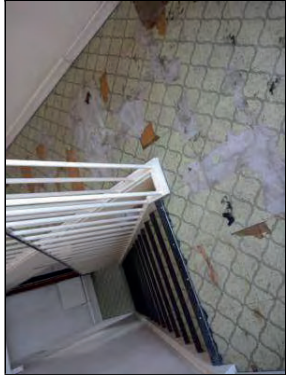
| | Unit 501, Stone Close, West Drayton, UB7 8JU | | Stairwell and Landing 105 | | Green Floor Tiles to floor | | 14m <sup>2</sup> | | | |
| Surveyor comments | The green floor tiles contain asbestos fibres | | | | | | | | | |

| Recommended action | B - Remove | | | | | | | | | |

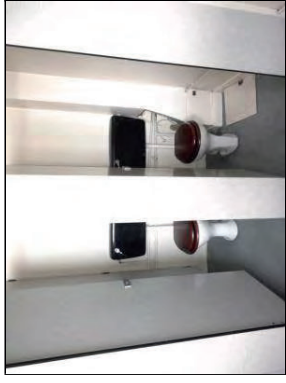
| | 11 Apr 2017 | Roy Pearce | Refurbishment & Demolition survey | 1st Floor | Amosite (2) |
| Surveyor comments | X 3 Asbestos toilet cisterns | | | | |

| Recommended action | B - Remove | | | | |

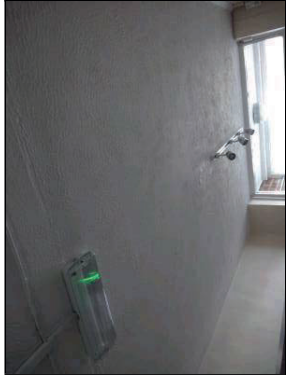
| | 11 Apr 2017 | Roy Pearce | Refurbishment & Demolition survey | Ground Floor | Chrysotile (1) |
| Surveyor comments | The textured coating (Artex) to the ceilings contains asbestos fibres | | | | |

| Recommended action | B - Remove | | | | |

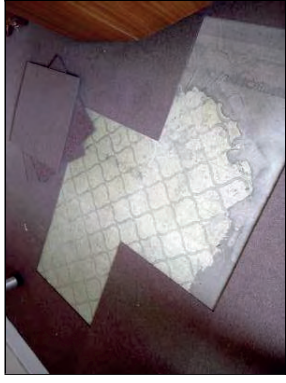
| | Unit 501, Stone Close, West Drayton, UB7 8JU | | Reception Lobby G02 | | Green Floor Tiles to floor | | 10m² | | | |
| Surveyor comments | The green floor tiles contain asbestos fibres | | | | | | | | | |

| Recommended action | B - Remove | | | | | | | | | |

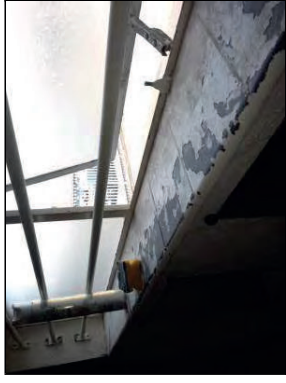
| | 11 Apr 2017 | Roy Pearce | Refurbishment & Demolition survey | Ground Floor | No Asbestos Detected (0) |
| Surveyor comments | NON Asbestos Black cills (painted white) | | | | |

| Recommended action | No further action required | | | | |

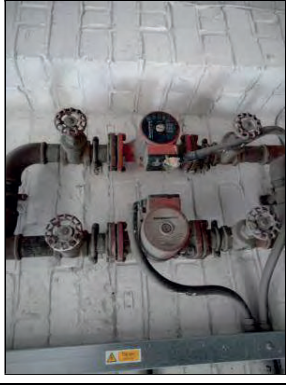
| | 11 Apr 2017 | Roy Pearce | Refurbishment & Demolition survey | Ground Floor | Chrysotile (1) |
| Surveyor comments | Asbestos Gaskets - assume all flanged pipe work to site have asbestos gaskets unless good reason is given to believe otherwise | | | | |

| Recommended action | B - Remove | | | | |

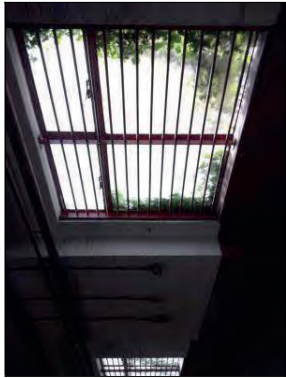
| | 11 Apr 2017 | Roy Pearce | Refurbishment & Demolition survey | Ground Floor | No Asbestos Detected (0) |
| Surveyor comments | NON Asbestos putty seals to warehouse windows | | | | |

| Recommended action | No further action required | | | | |

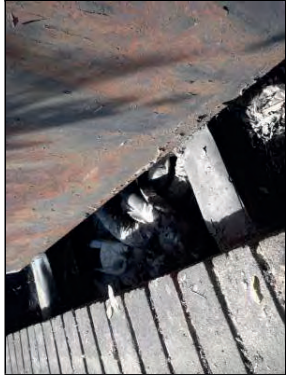
| | 11 Apr 2017 | Roy Pearce | Refurbishment & Demolition survey | External | No Asbestos Detected (0) |
| Surveyor comments | NON Asbestos bitumen felt under tank | | | | |

| Recommended action | No further action required | | | | |
