Our Ref.: 20227/LR\_Rev1.01

**Re: Crown Trading Centre, Clayton Road, Hayes UB3 1DU**

We are writing regarding the stability of canal wall at the above site.

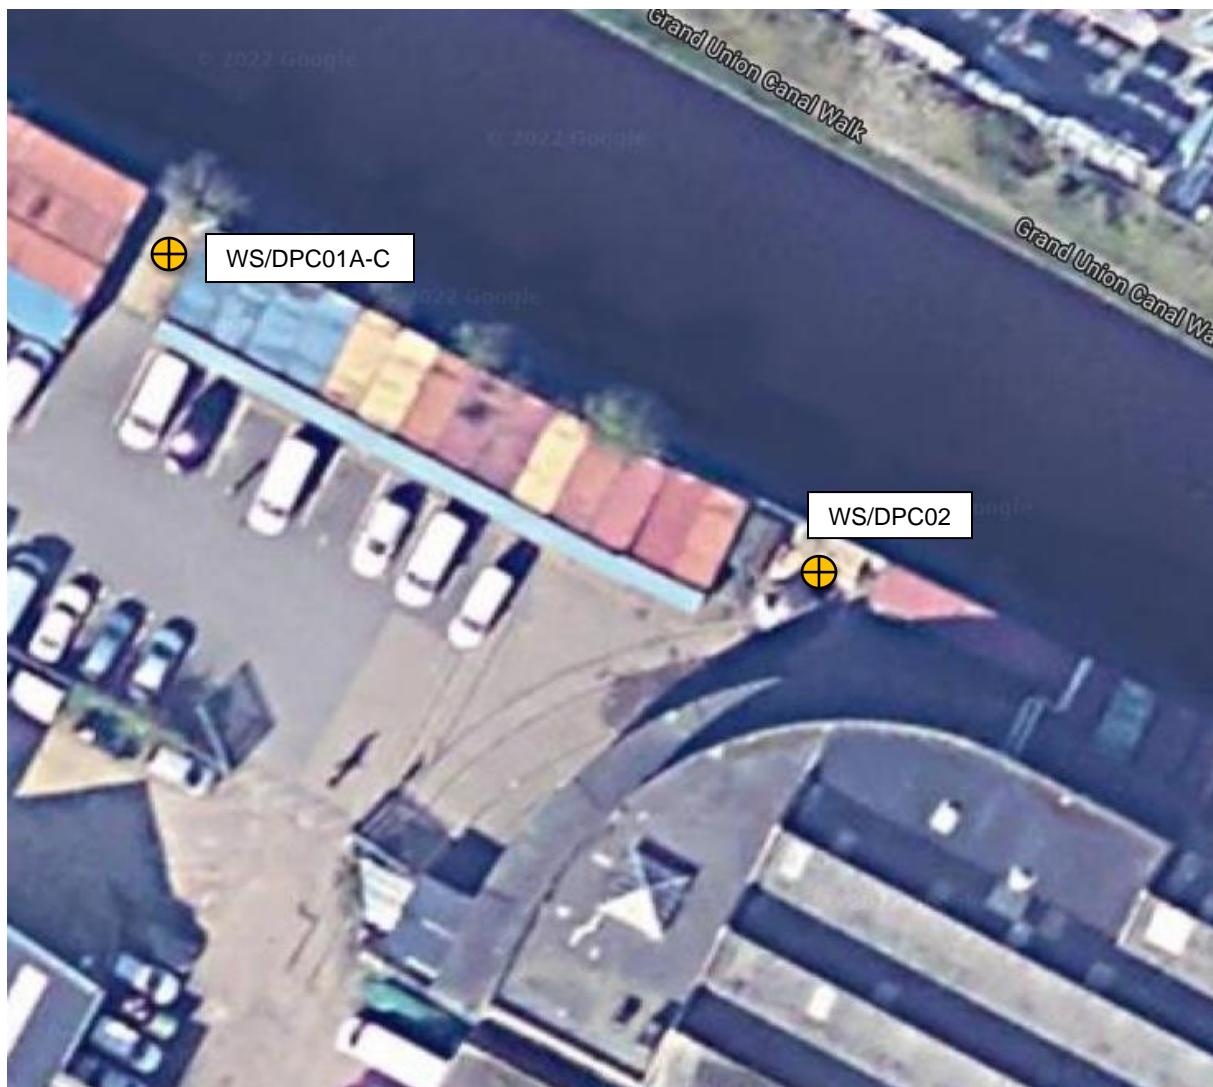
Figure 2. Trial Hole Location Plan

The investigation concerning the canal wall, undertaken by Soils Limited on 20<sup>th</sup> May 2022, with reporting, comprised 2No. windowless sampler boreholes (WS01 and WS02) and 2No. dynamic probes (DPC01 and DPC02), driven prior and adjacent to the corresponding windowless sampler boreholes, and a survey with Ground Penetration Radar (GPR). This was to be undertaken to provide details on the eventual presence of cable ties retaining the walls. A trial hole location plan is included as Figure 2.

The selection of test locations for both drilling and surveying was limited by the presence of storage sea-containers located very close to the edge of the canal wall. The site investigation, however, was carried out within two areas respectively representative of the brick wall and reinforced concrete wall sections.

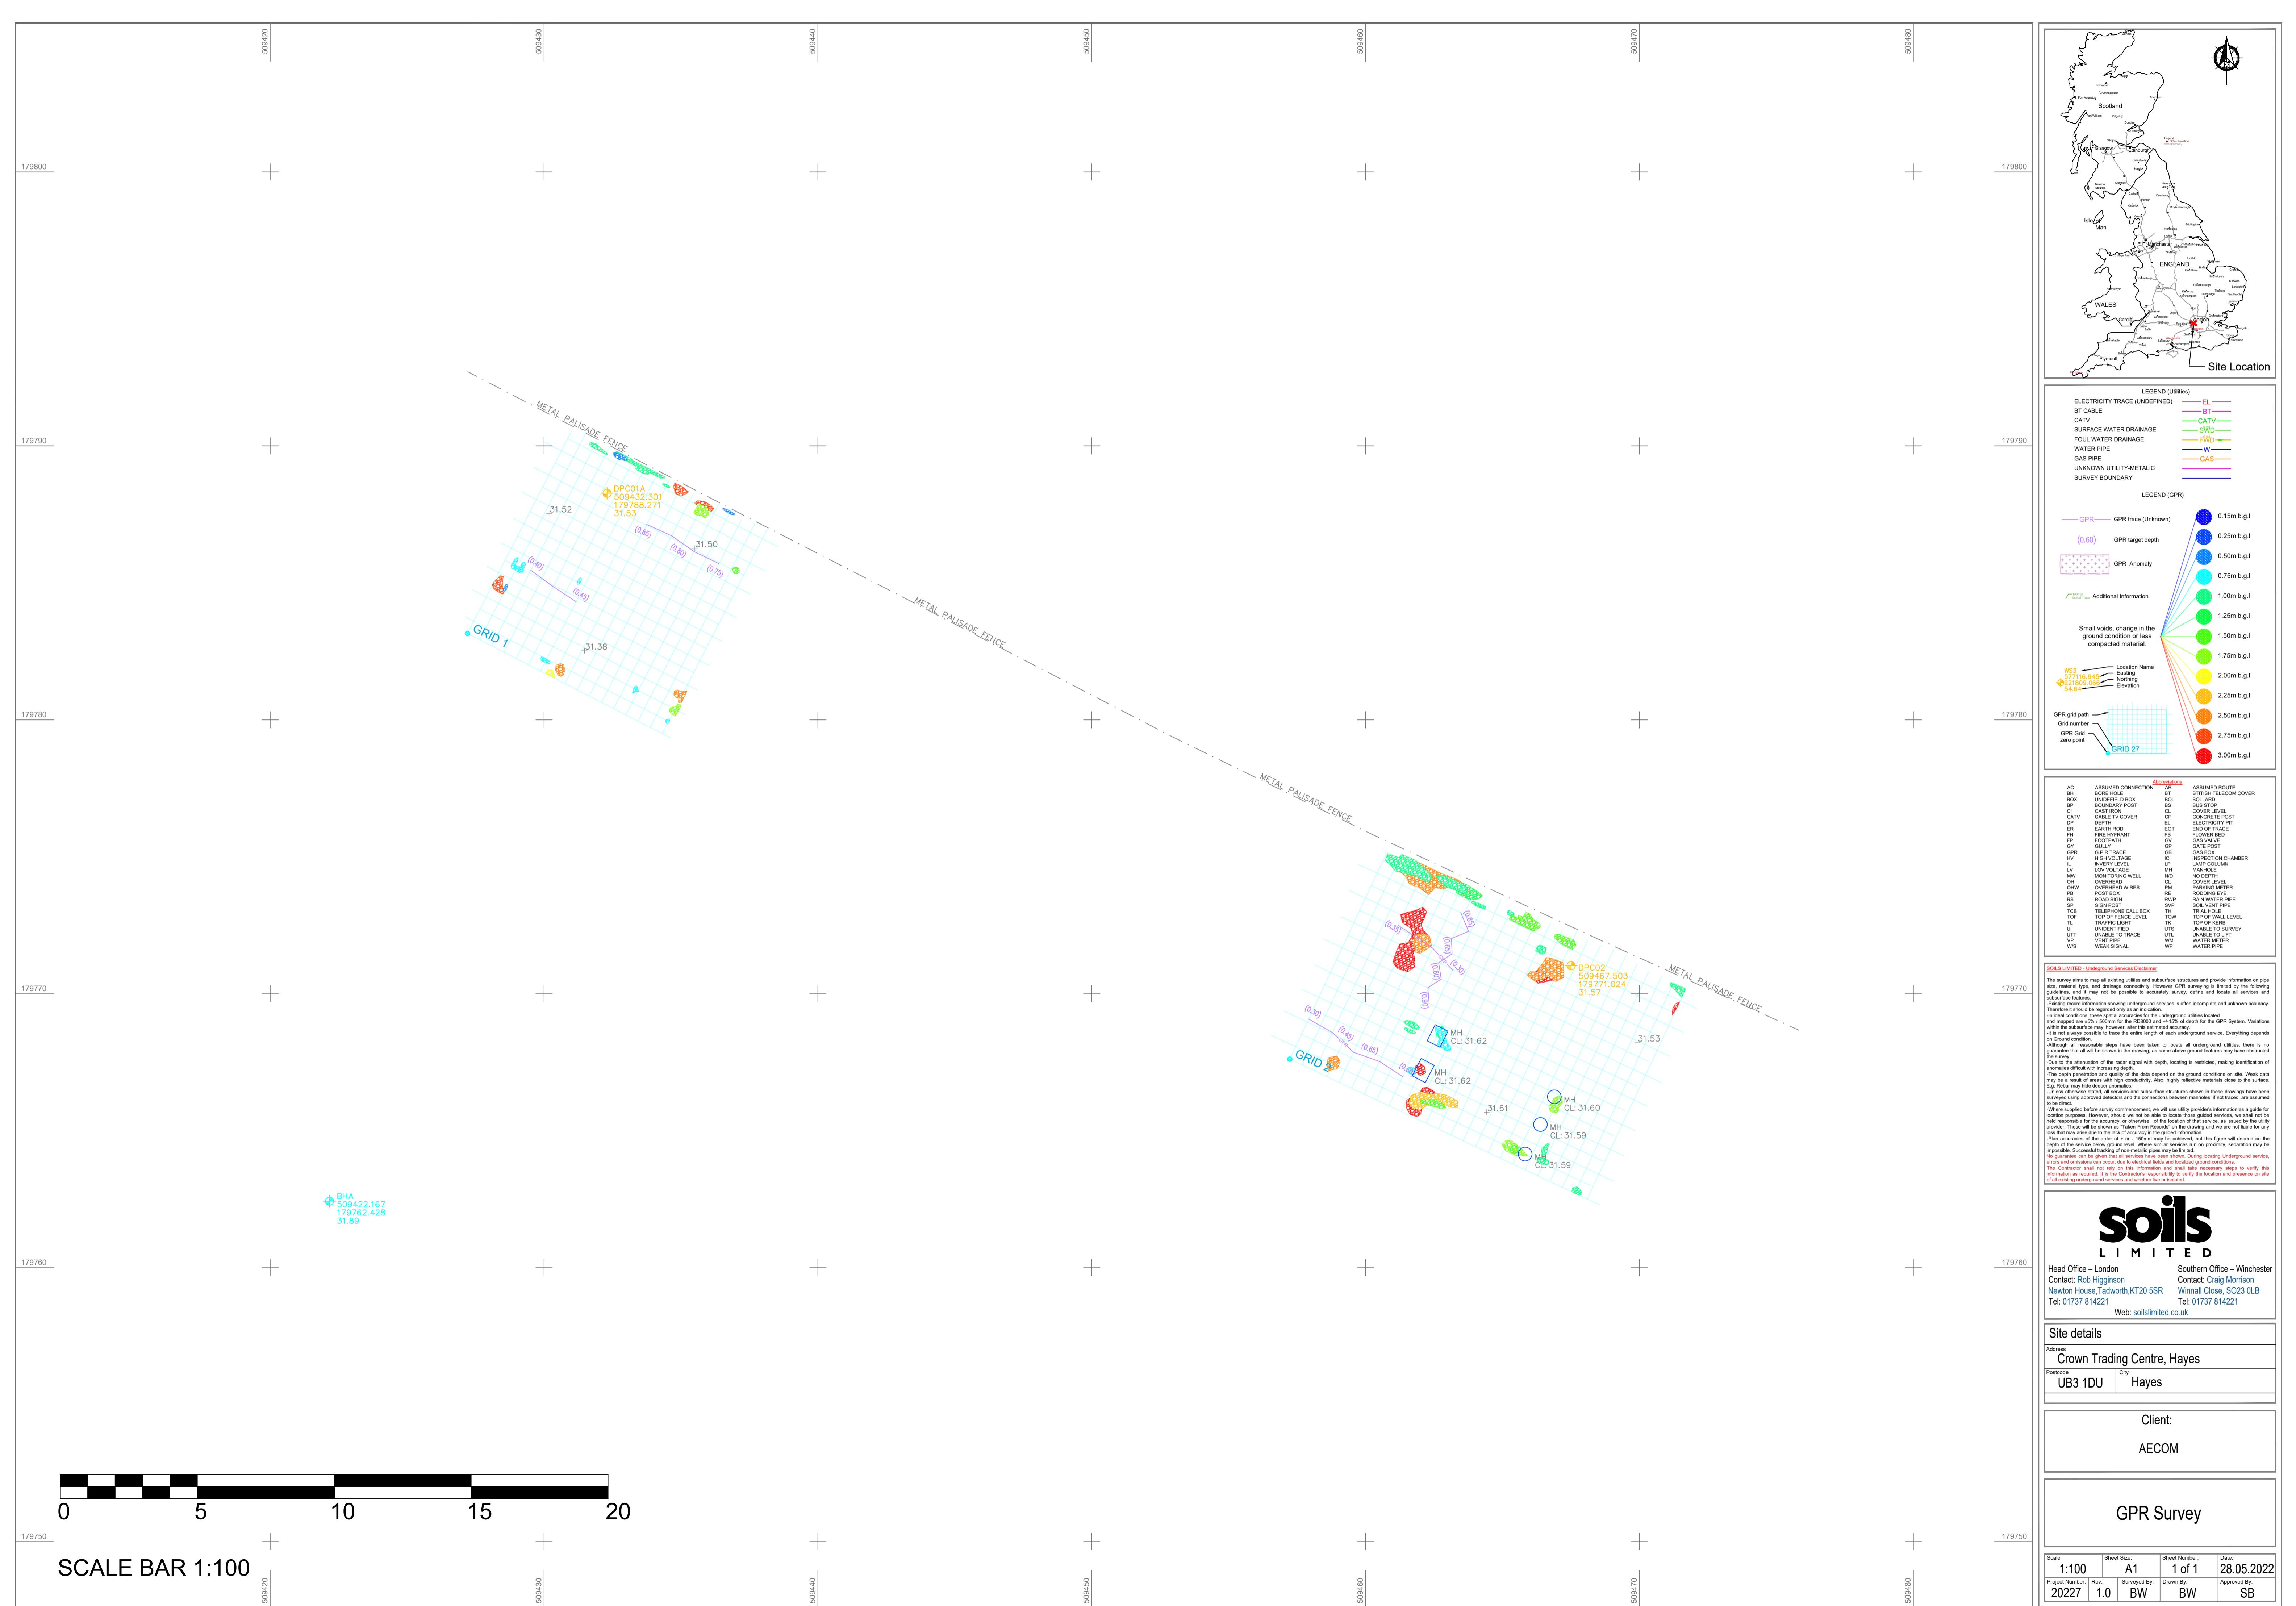
## **Appendix B. GPR Survey**

The GPR survey did not detect any obvious linear objects behind the wall that could be representative of the presence of tiebacks. Although undetected metallic objects could be present deeper in the ground, beyond the depth investigated by the GPR, tiebacks are usually applied near the top of the wall to improve their effectiveness. The presence of cable ties at the back of the canal wall can therefore be considered unlikely at least within the two investigated areas.

The GPR Survey, however, identified areas characterised by changes in soil conditions, representing voids/soft soils/less compacted materials, at depths ranging between 0.15m and 3.00m bgl.
