**CANAL WALL INSPECTION GRAND UNION CANAL
HAYES - LONDON BOROUGH OF HILLINGDON**

ABOVE AND BELOW WATER INSPECTION OF
109M SECTION OF CANAL WASHWALL – GRAND
UNION CANAL HAYES. MIDDLESEX.

JUNE 2021

DIVERS SUMMARY/ REPORT
CANAL WASHWALL – HAYES
GRAND UNION CANAL

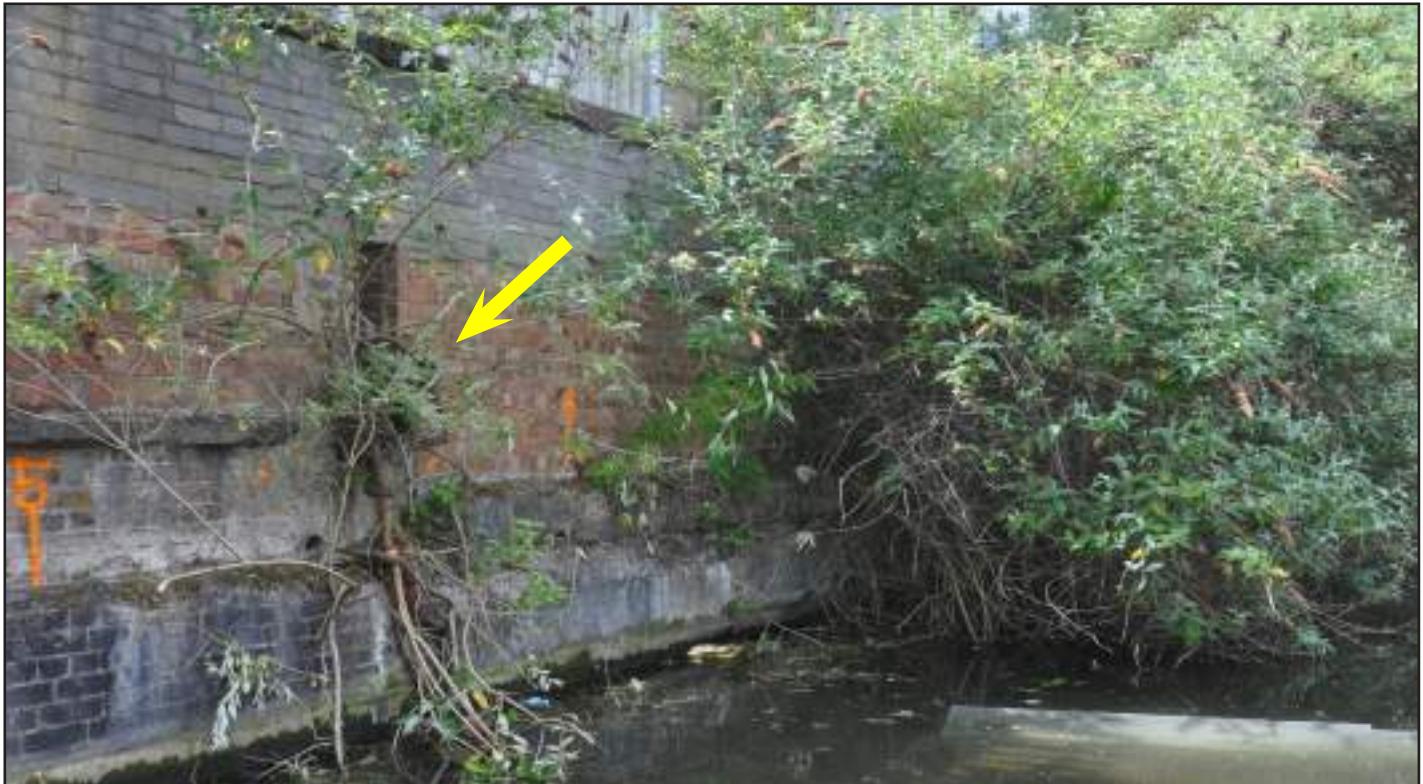
Fig.1

0m chainage - Large bush access difficult very soft mud on canal bed. 6.5 courses of blue brick from W/L up concrete coping insitu 330mm thick from 0m back and forward to chainage 3m. Arrow Indicates location of Steel Ring in Wall.

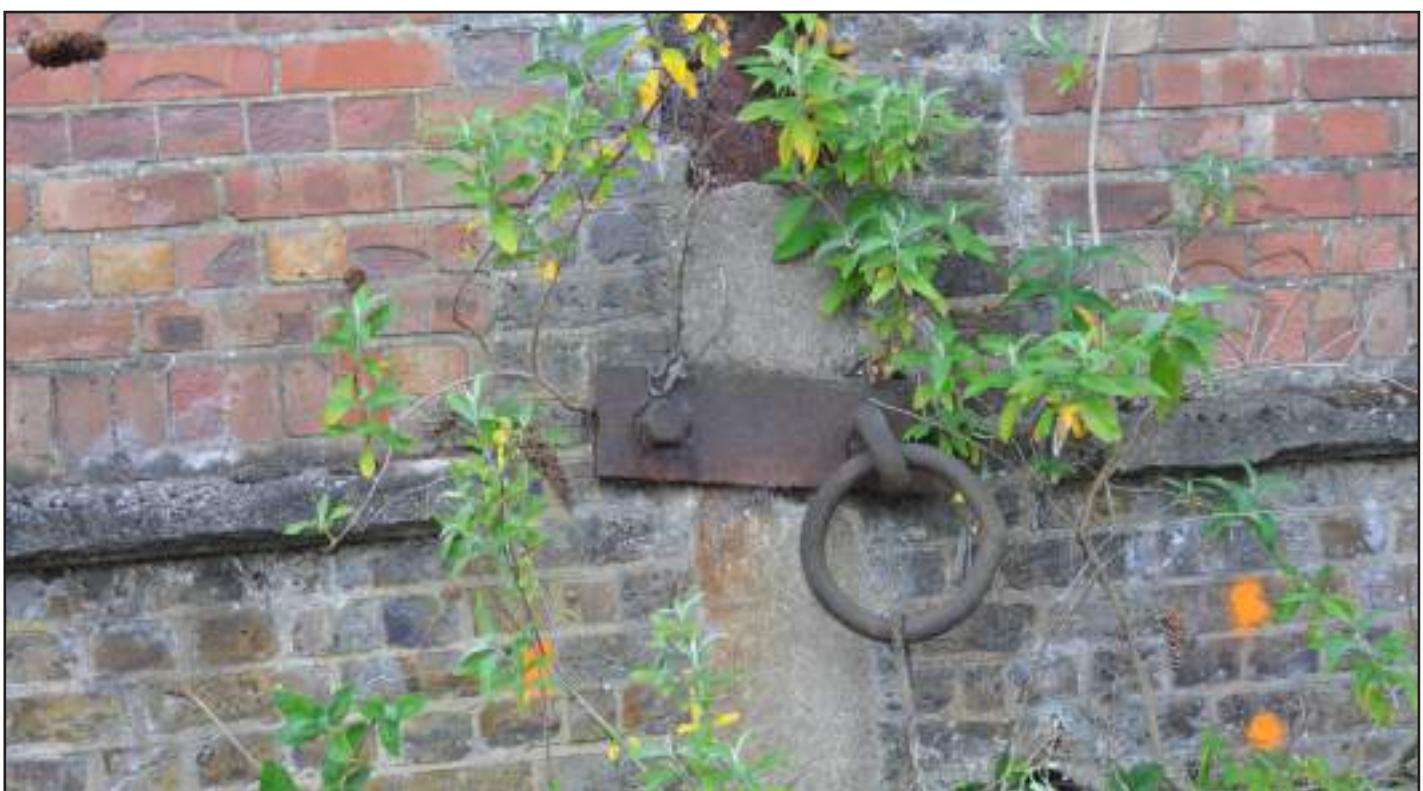
Fig.2

3.5m chainage -Mooring ring and steel member with round rivet heads (x8) purpose / function unknown (possible wall retaining column) vegetation growing from wall and steel compartment (Requires De-Veg). (Arrow Indicates Ring location in Fig.1)

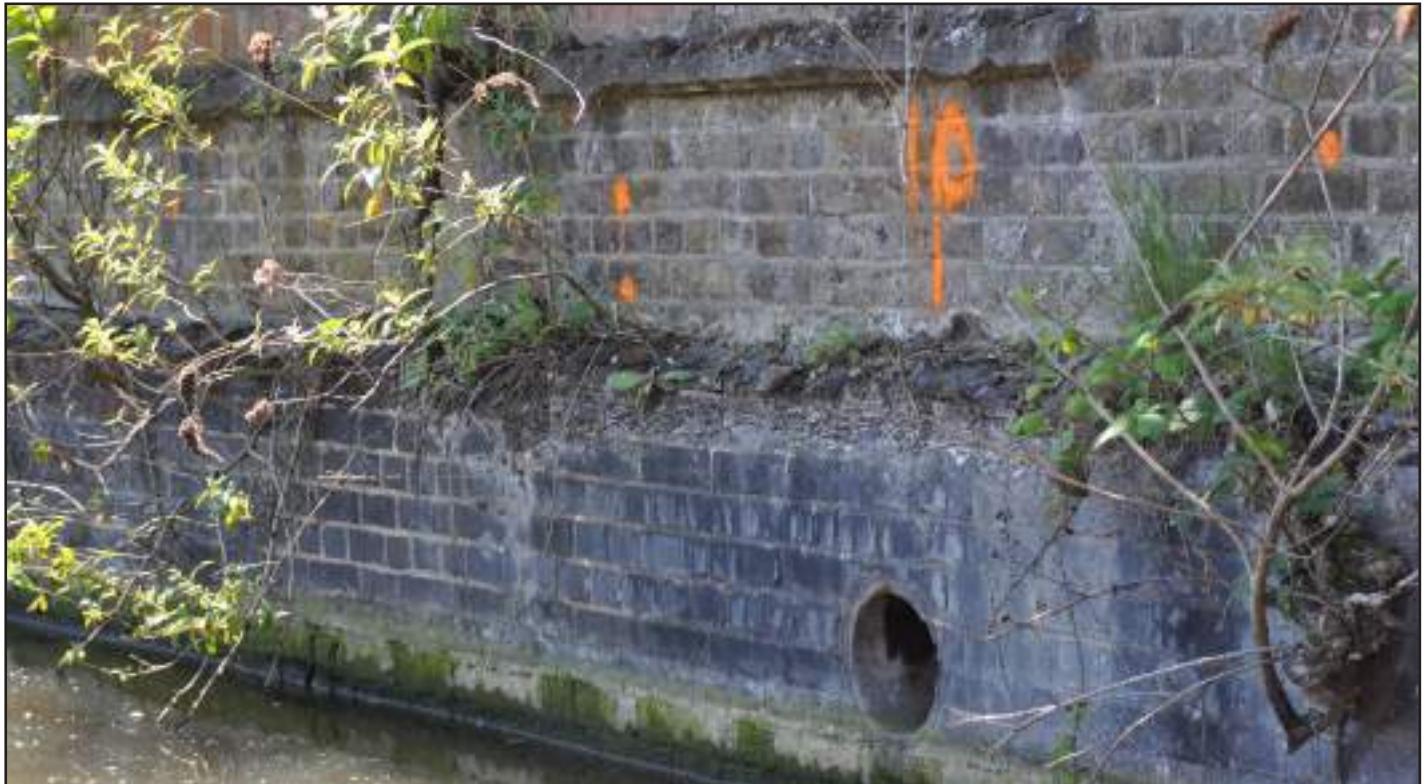
Fig.3

9m chainage - Small tree growing from between brickwork 9m to 11.3m. Redundant window sill. Drain at 10m chainage.

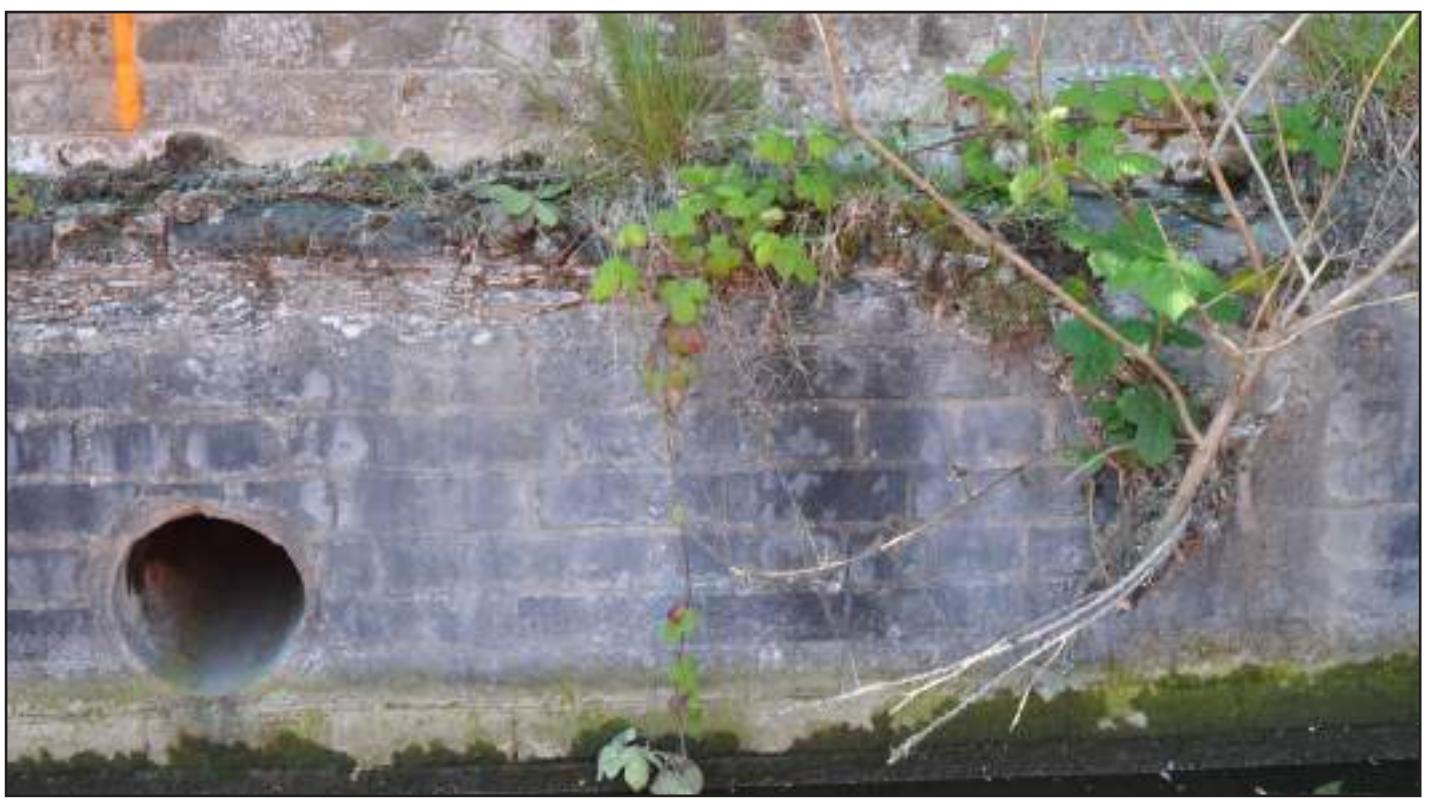
Fig.4

10m chainage - Discharge drain 200mm diameter appears clear - 2 courses above W/L.

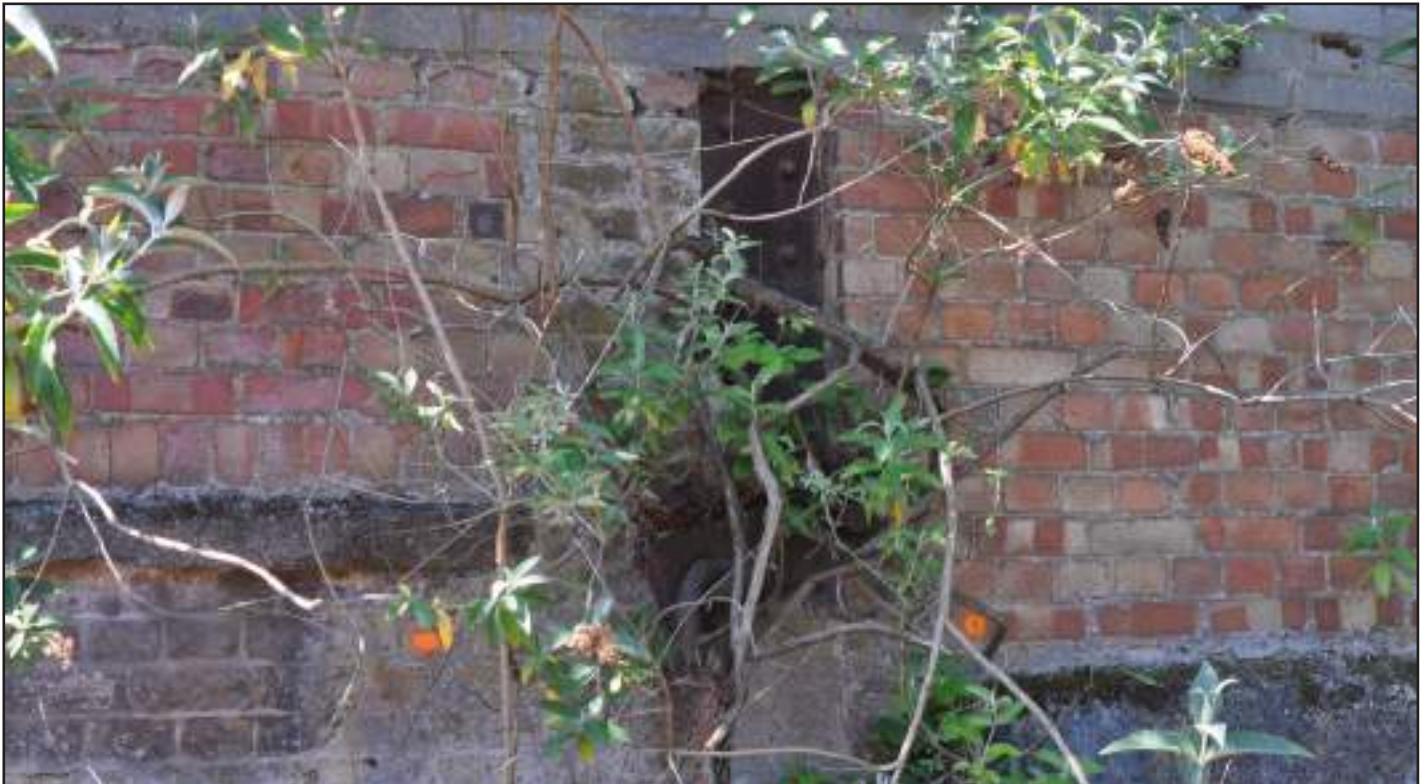
Fig.5

11.6m chainage - Discharge drain appears clear 200mm diameter. Site of steel member suspect mooring points for barges 1.3m above W/L spalled concrete infill cover.

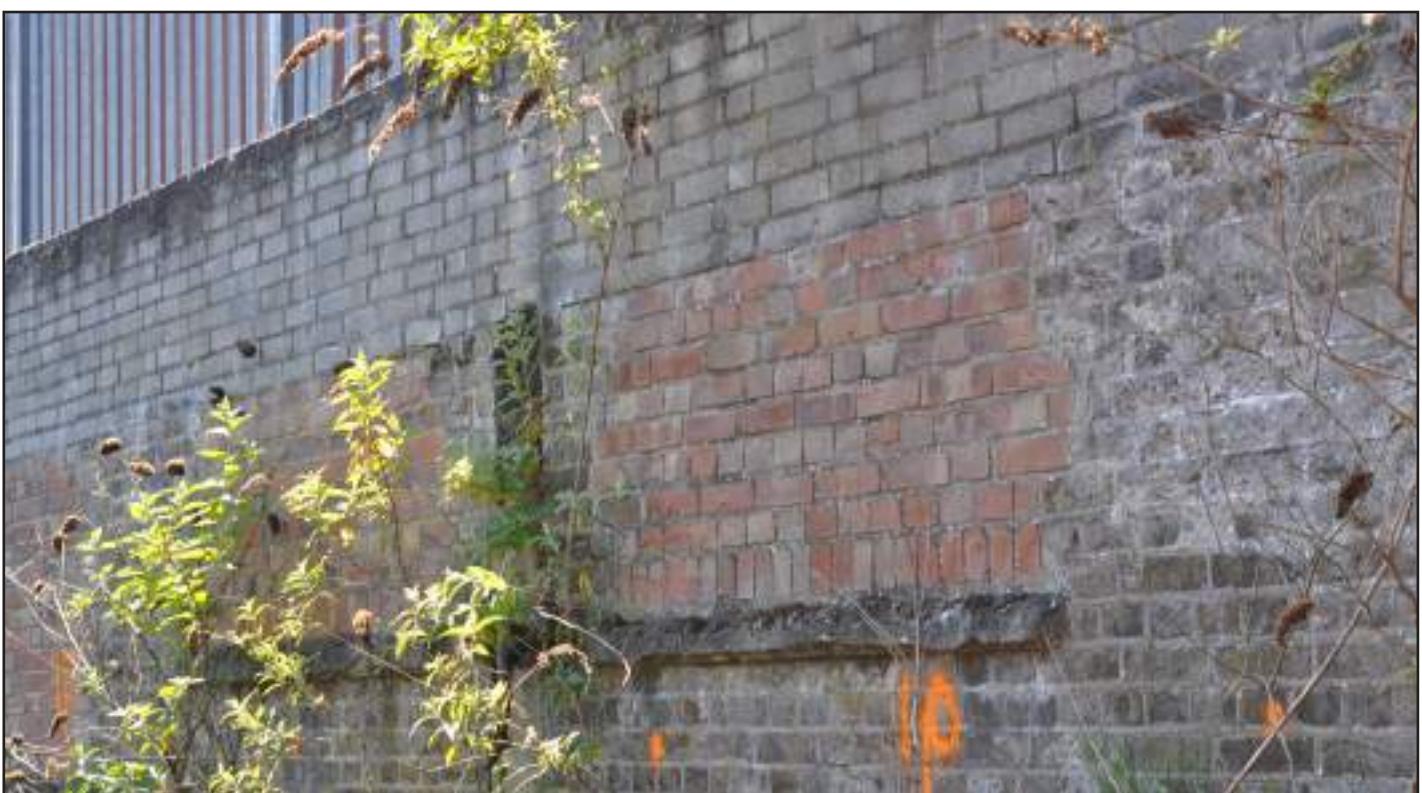
Fig.6

11.7m chainage - Eroded brickwork adjacent to steel. 12m from W/L to bed defective missing pointing 250mm x 650mm soft mud 12m to 13.8m redundant cill brickedup window location. 14.8 to 16.75 concrete cill ledge redundant window bricked up (vegetation needs removing) - Blue bricks present note original wharfage.

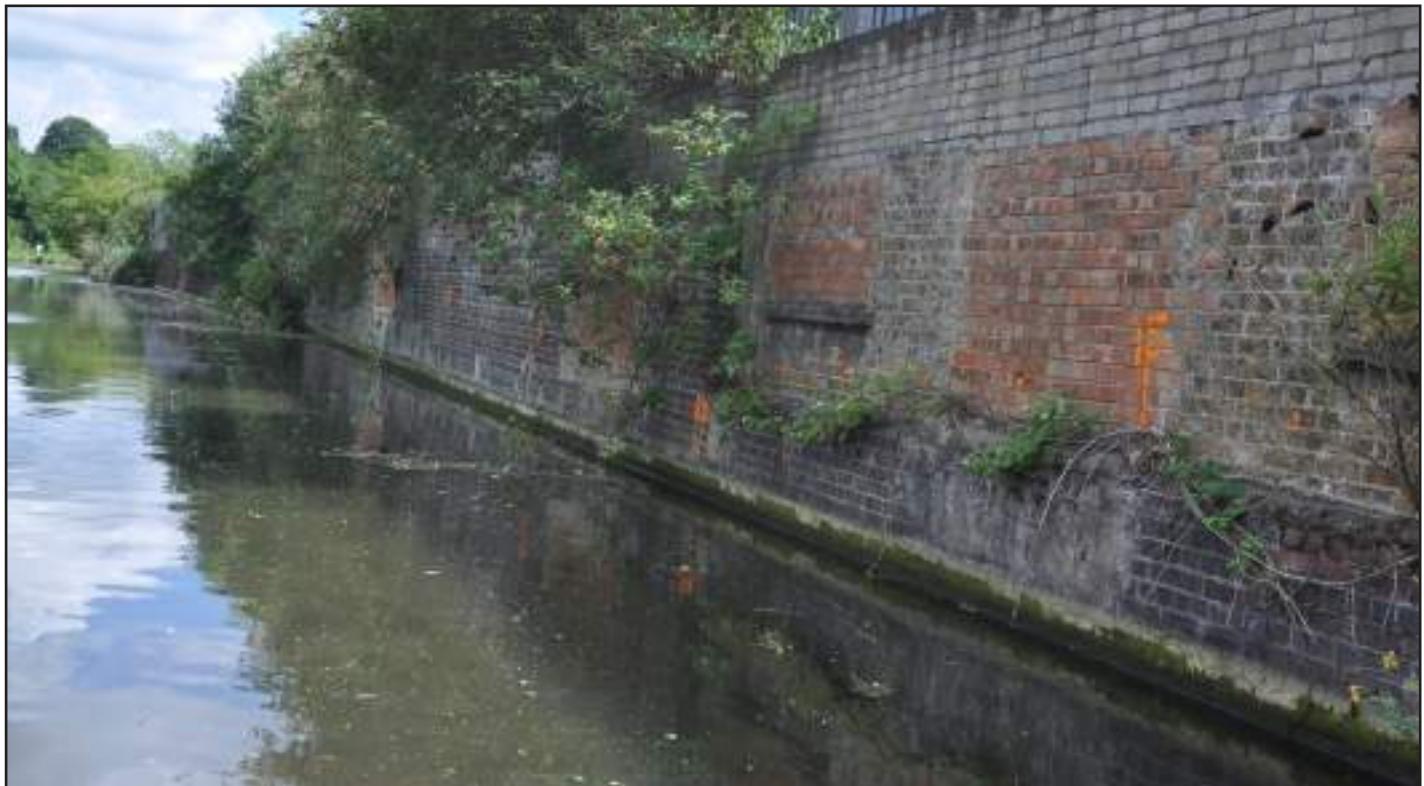
Fig.7
17.7m to 19.5 chainage - Redundant cill bricked up window red bricks

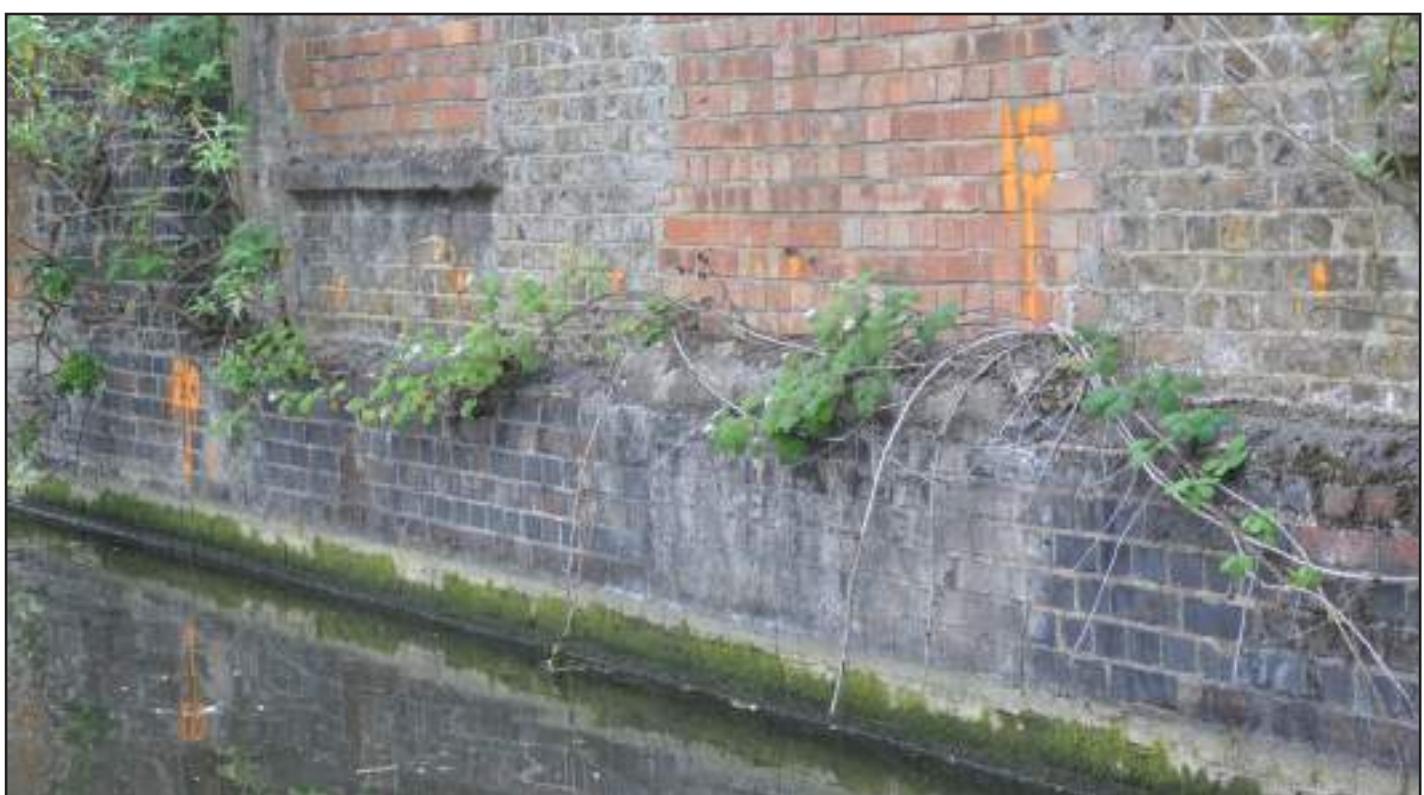
Fig.8
19.6m chainage - Tree growing from brickwork needs removal.

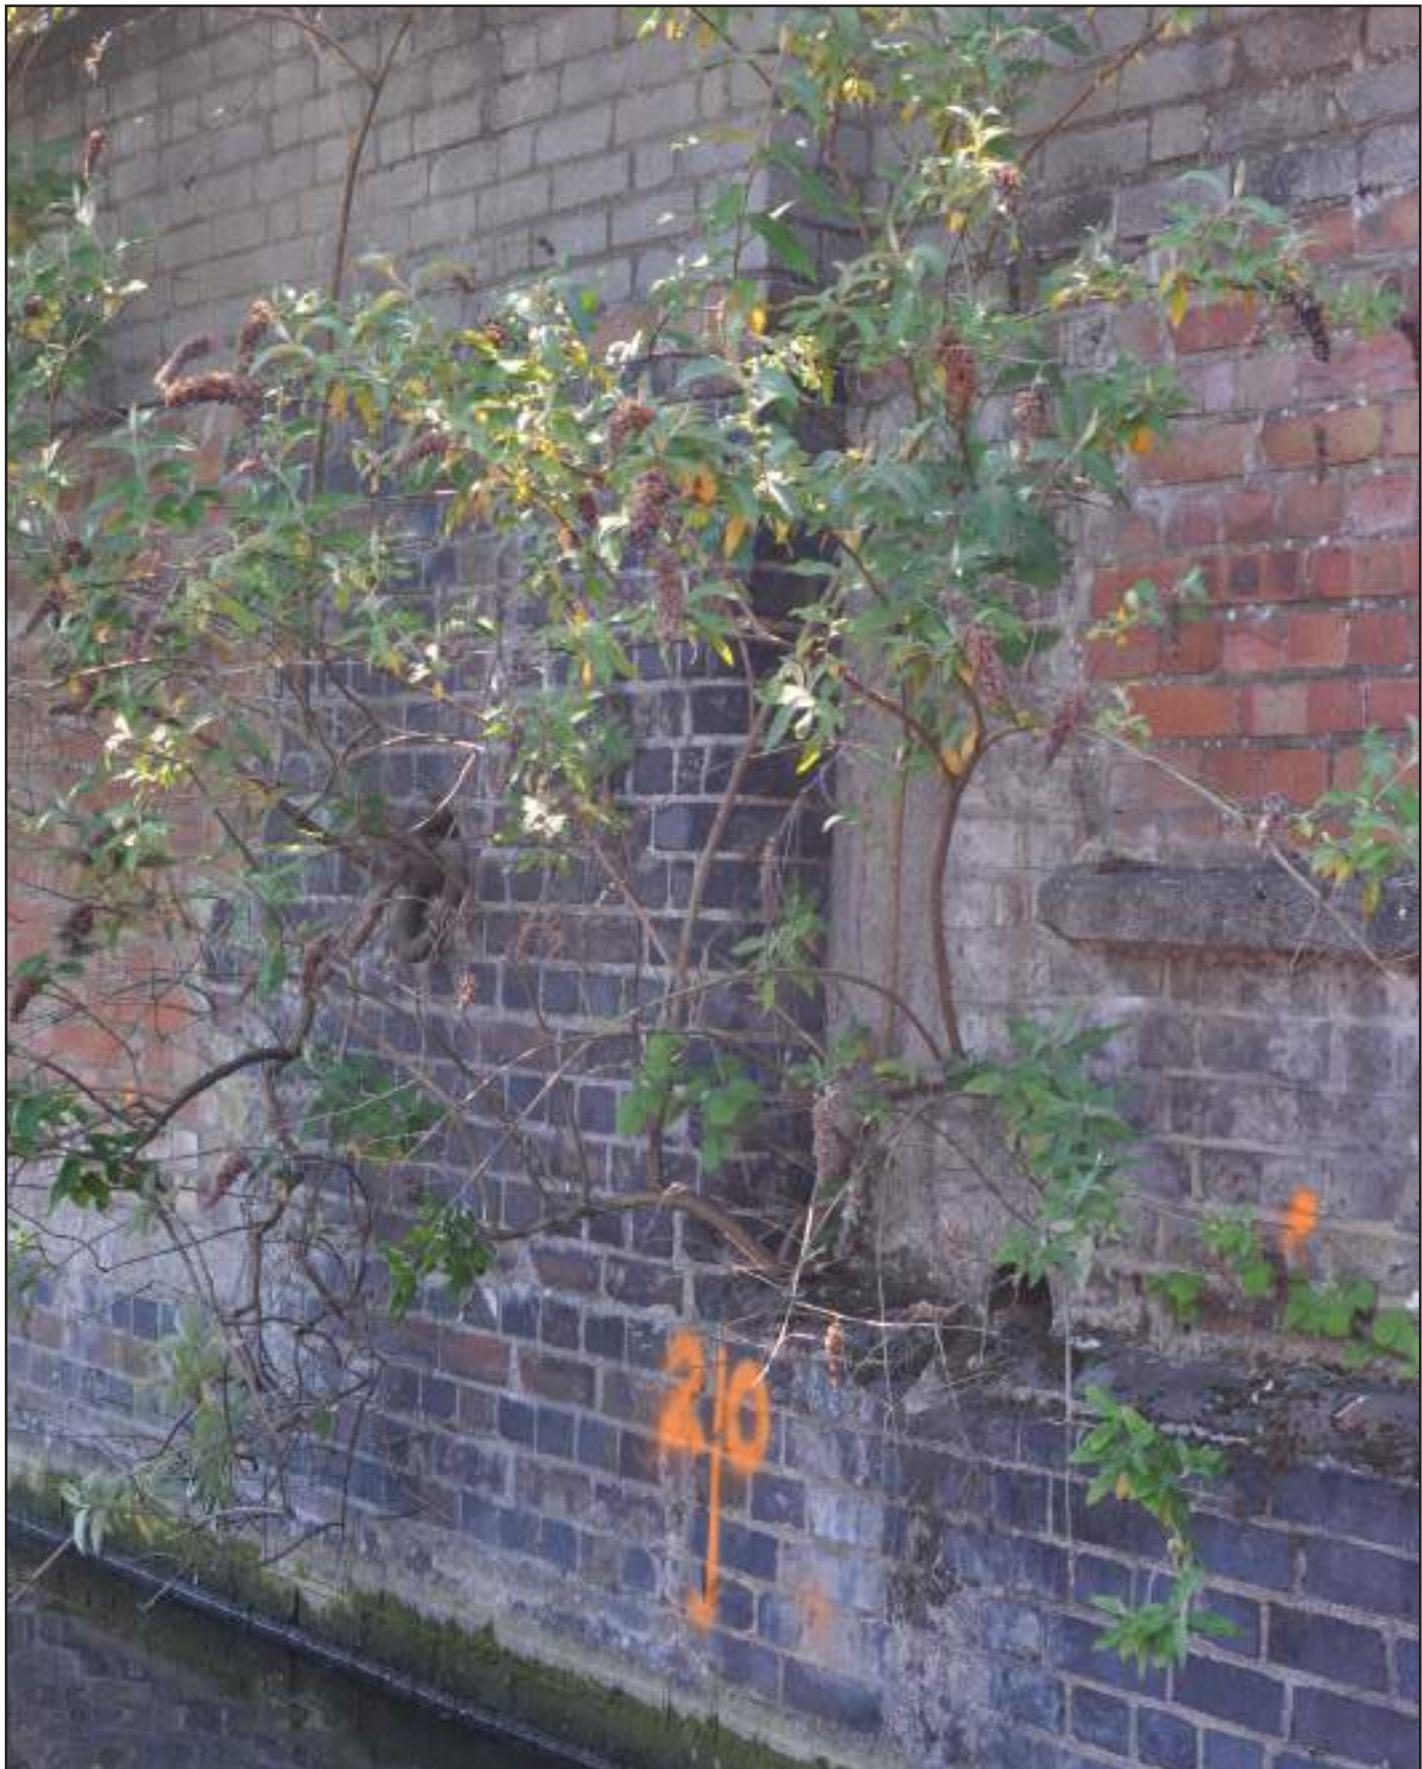
Fig.9

20m chainage - Wall alignment changes by 180mm out towards canal - blue brick

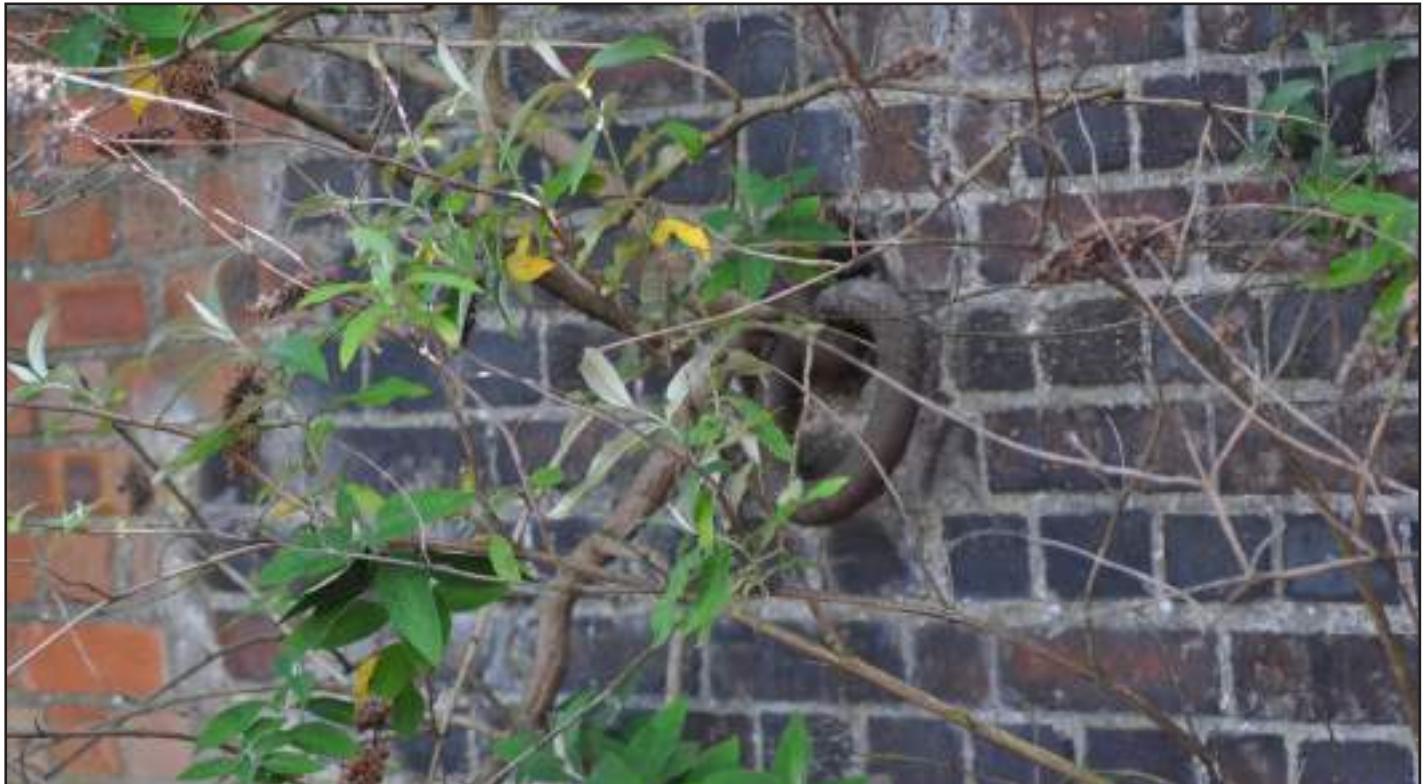
Fig.10

21m chainage - Mooring ring location tree growing out - Requires Removal
Defective mortar joint at W/L 21m to 22m Top 10 courses of brickwork pushing out at the top and leaning in towards canal suspected cause tree pushing root formation. Also defective joints at W/L 450mm.

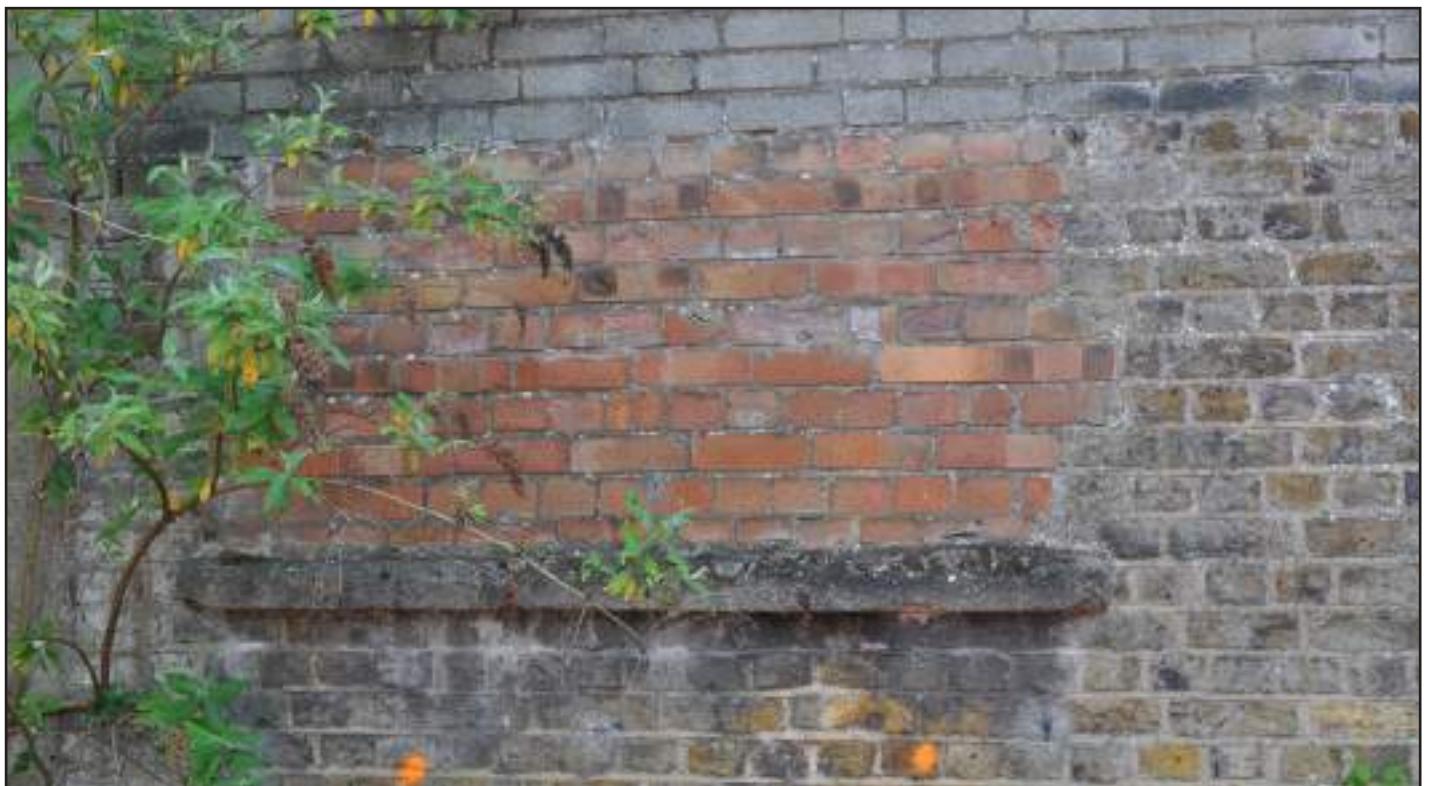
Fig.11

19m to 24m chainage - Redundant cill 6 courses above W/L bricked up window

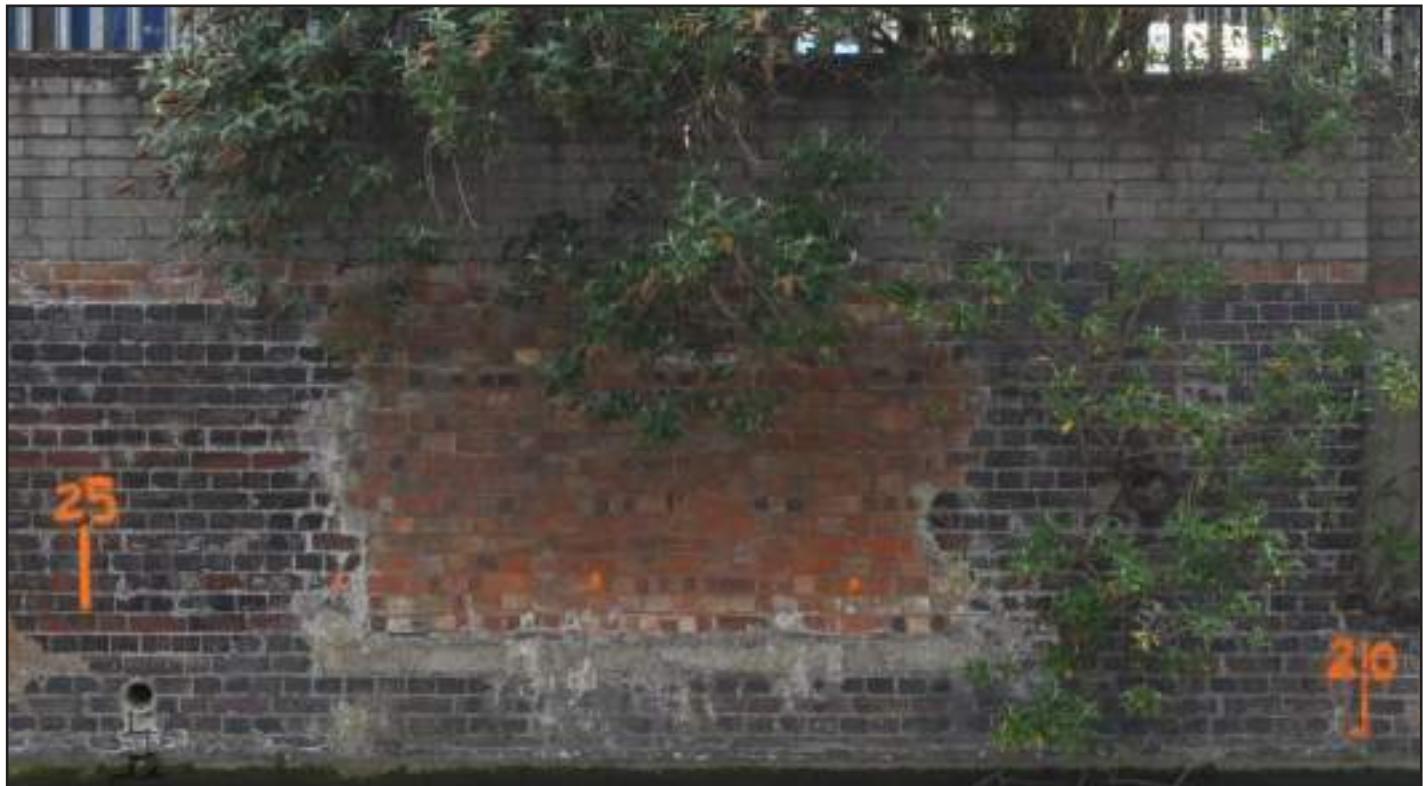
Fig.12

22.5m to 22.65 chainage - Defective joints with erosion of brickwork 100mm high x 100mm long x 2 courses down from W/L

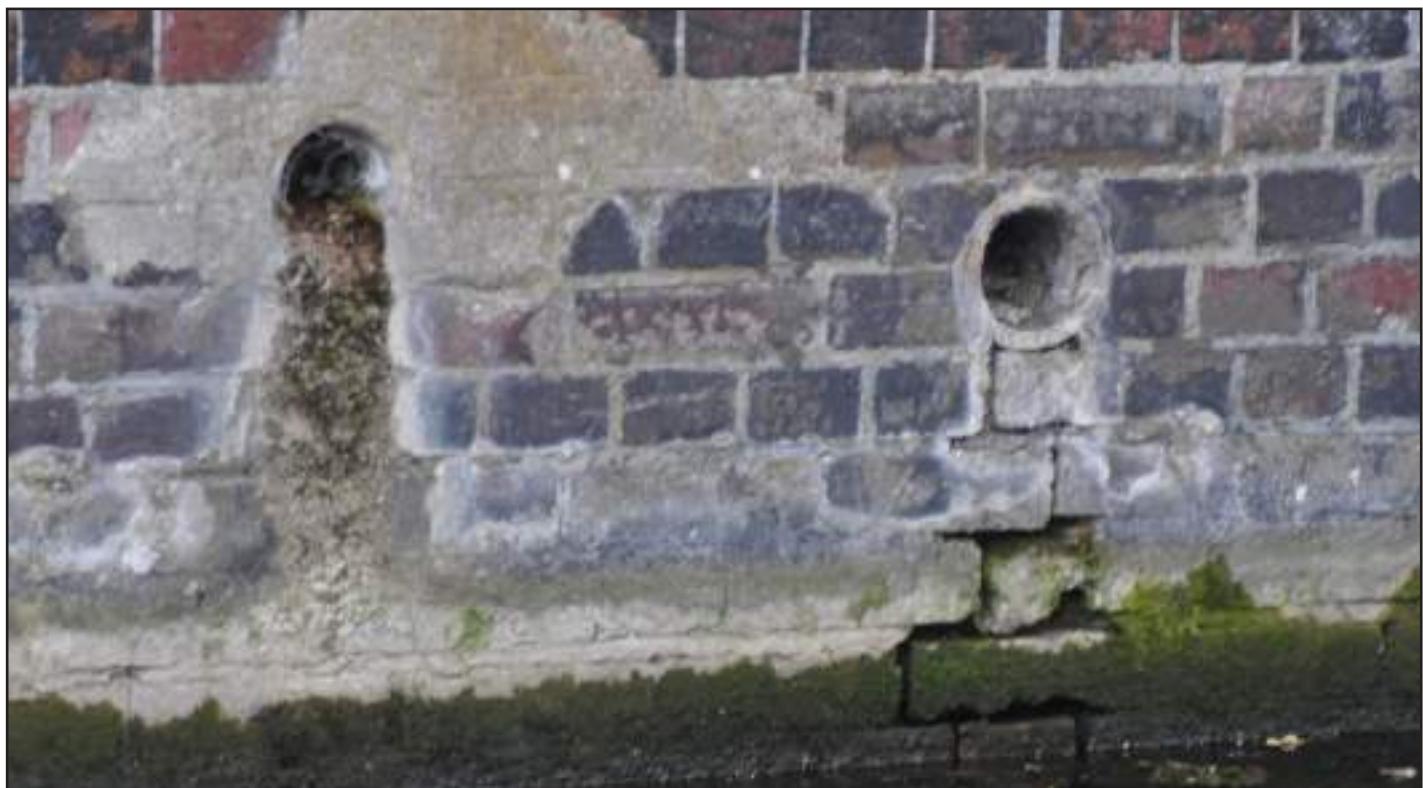
Fig.13

The condition of the underwater sections of wall along the full 109m survey limits is generally satisfactory apart from some defective mortar joints (as detailed, see figs 13,16,17 & 24) in sections 0m to 50m and some displaced expansion material in the associated construction joints (see fig 35) in the concrete wharf section 50m to 109m. Some minor erosion is present also but not serious (see fig 39). Defective joints would benefit from underwater and "Splash-zone" re-pointing to prevent further deterioration.

24.9m chainage - Defective mortar joints from x 2 courses below W/L to x 4 courses above W/L at site of 150mm and 100mm diameter drain discharge pipe blocked at 450mm.

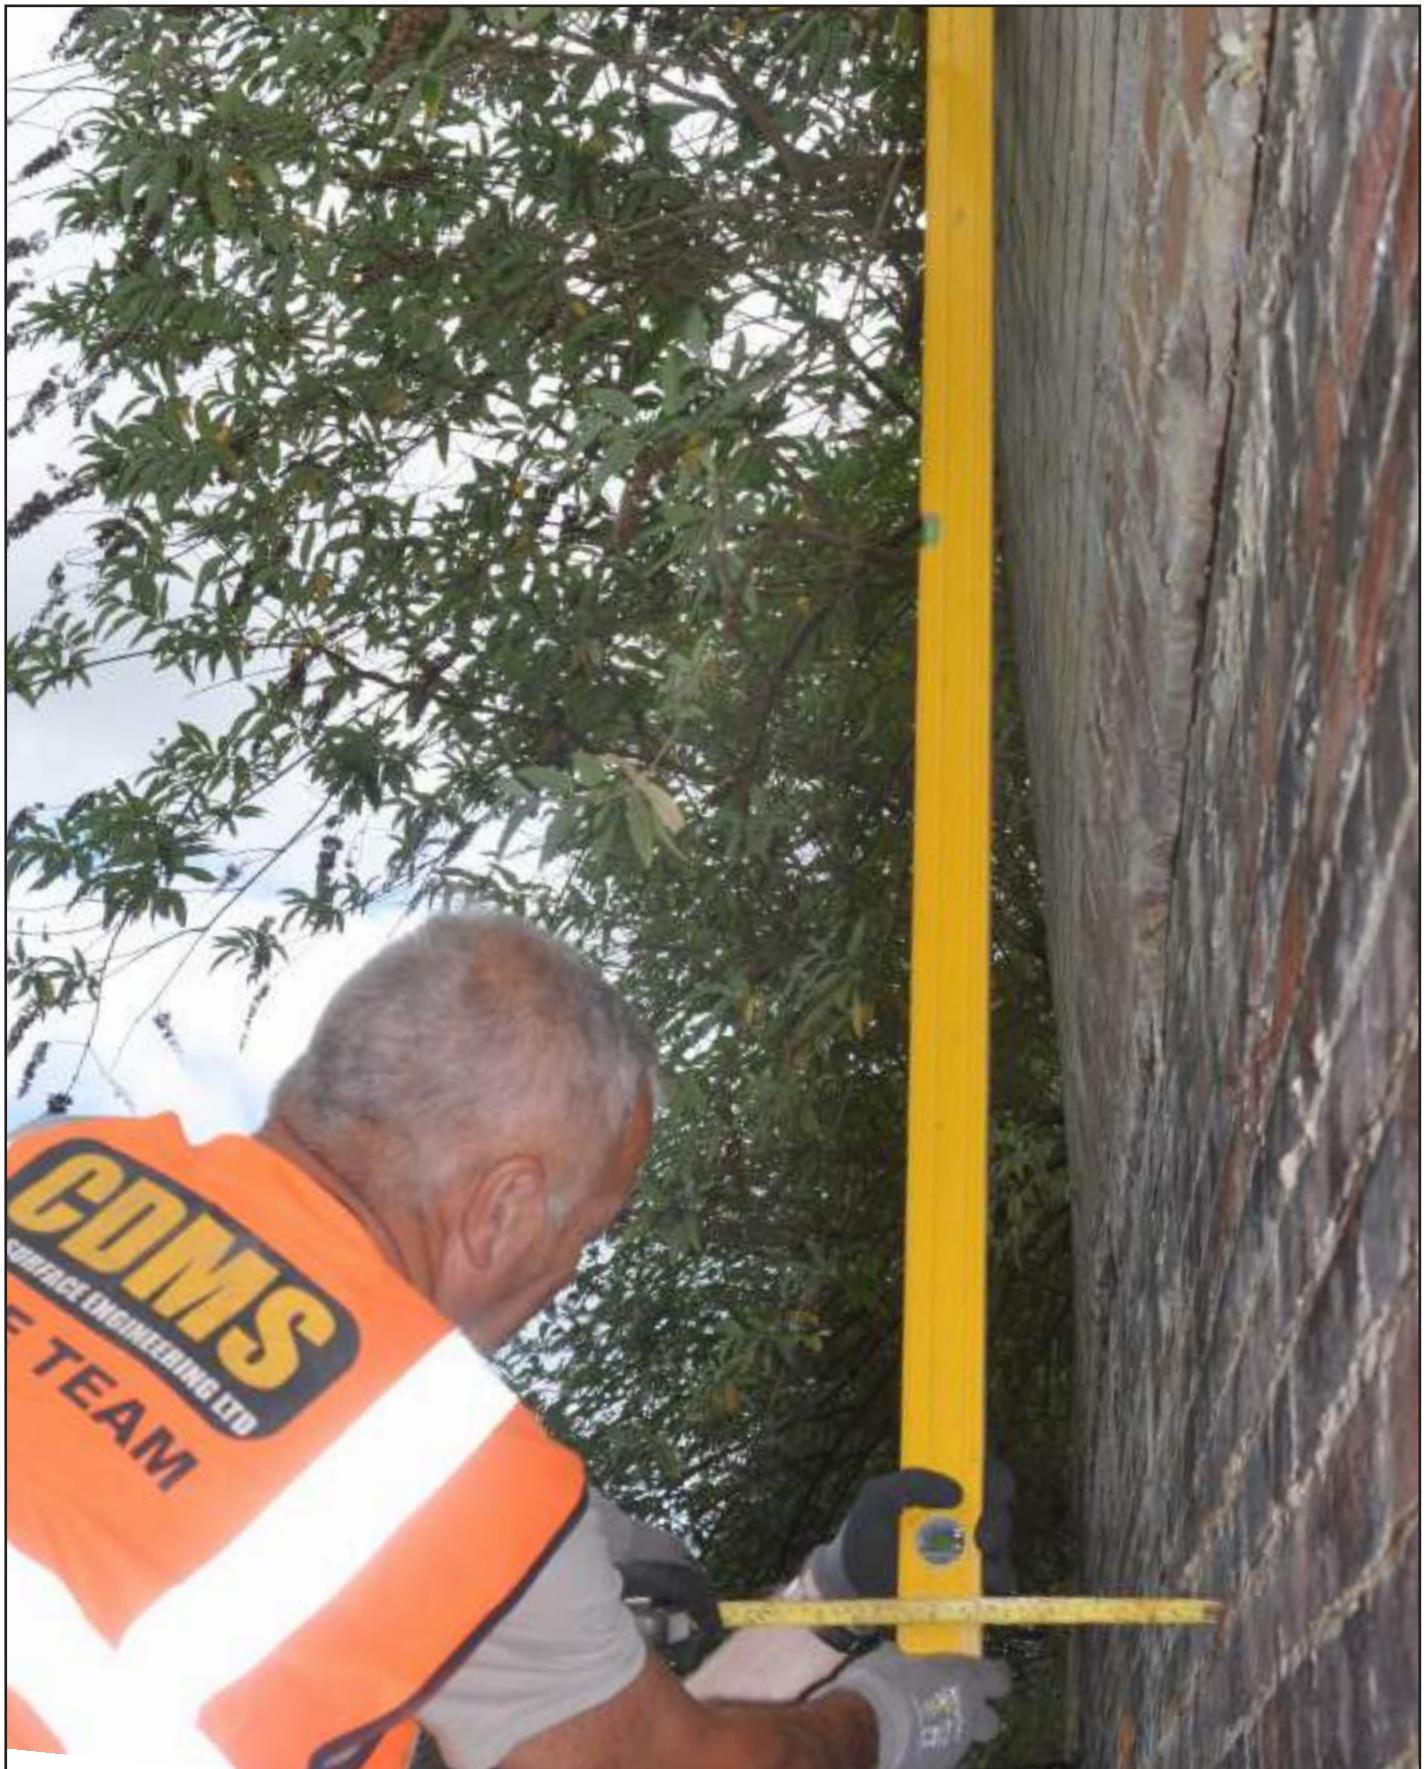
The general description of the wall construction falls into two distinctive area sections, i.e. 0m to 50m – This section in brief comprises of the remnants of the now demolished Warehouse frontage who's windows and door openings have been bricked up with mostly red brick. In order to level the wall to ground level grey bricks have been added in a number of locations, these are commonly displaced, missing or out of alignment. The top 21no. courses of grey brick between Chainage 26m to 30m are bulging out of alignment and the perpendicular by 170mm and has a 20mm wide overhang lip which has been created by established vegetation pushing the wall out towards the Canal. **This section is highly likely to collapse in the near future.** (See information sheets for detail, Figs 14,15&18)

From the information gathered by the team, commonly from 0m to 50m the wall is in poor condition and largely comprises of a “miss-match” of infill bricks in numerous locations with no real level of skill or quality evident. The upper wall sections (mostly in grey brick) have become loose and appreciable structural cracking is present. **At Chainage 26 to 30m the wall is close to collapse into the Canal due to vegetation root formations pushing the wall out of the perpendicular. (See fig 14).**

Fig.14
25.7m chainage 2 x capping / coping stones in position
x 21 courses from underside to W/L dangerous misalignment to 30m chainage.

- 1). Securing the dangerous sections of wall from Chainage 26m to 30m as collapse into the water course is highly likely (Creating masonry and debris clear-up difficulties afterwards).
- 2). Remove all vegetation (where accessibly possible) and kill off the roots.
- 3). Repair/ pressure point defective joints where applicable below water and in the Splash zone from which all remaining defective areas will be easier to access and repair as all these then would be in the upper sections of wall.

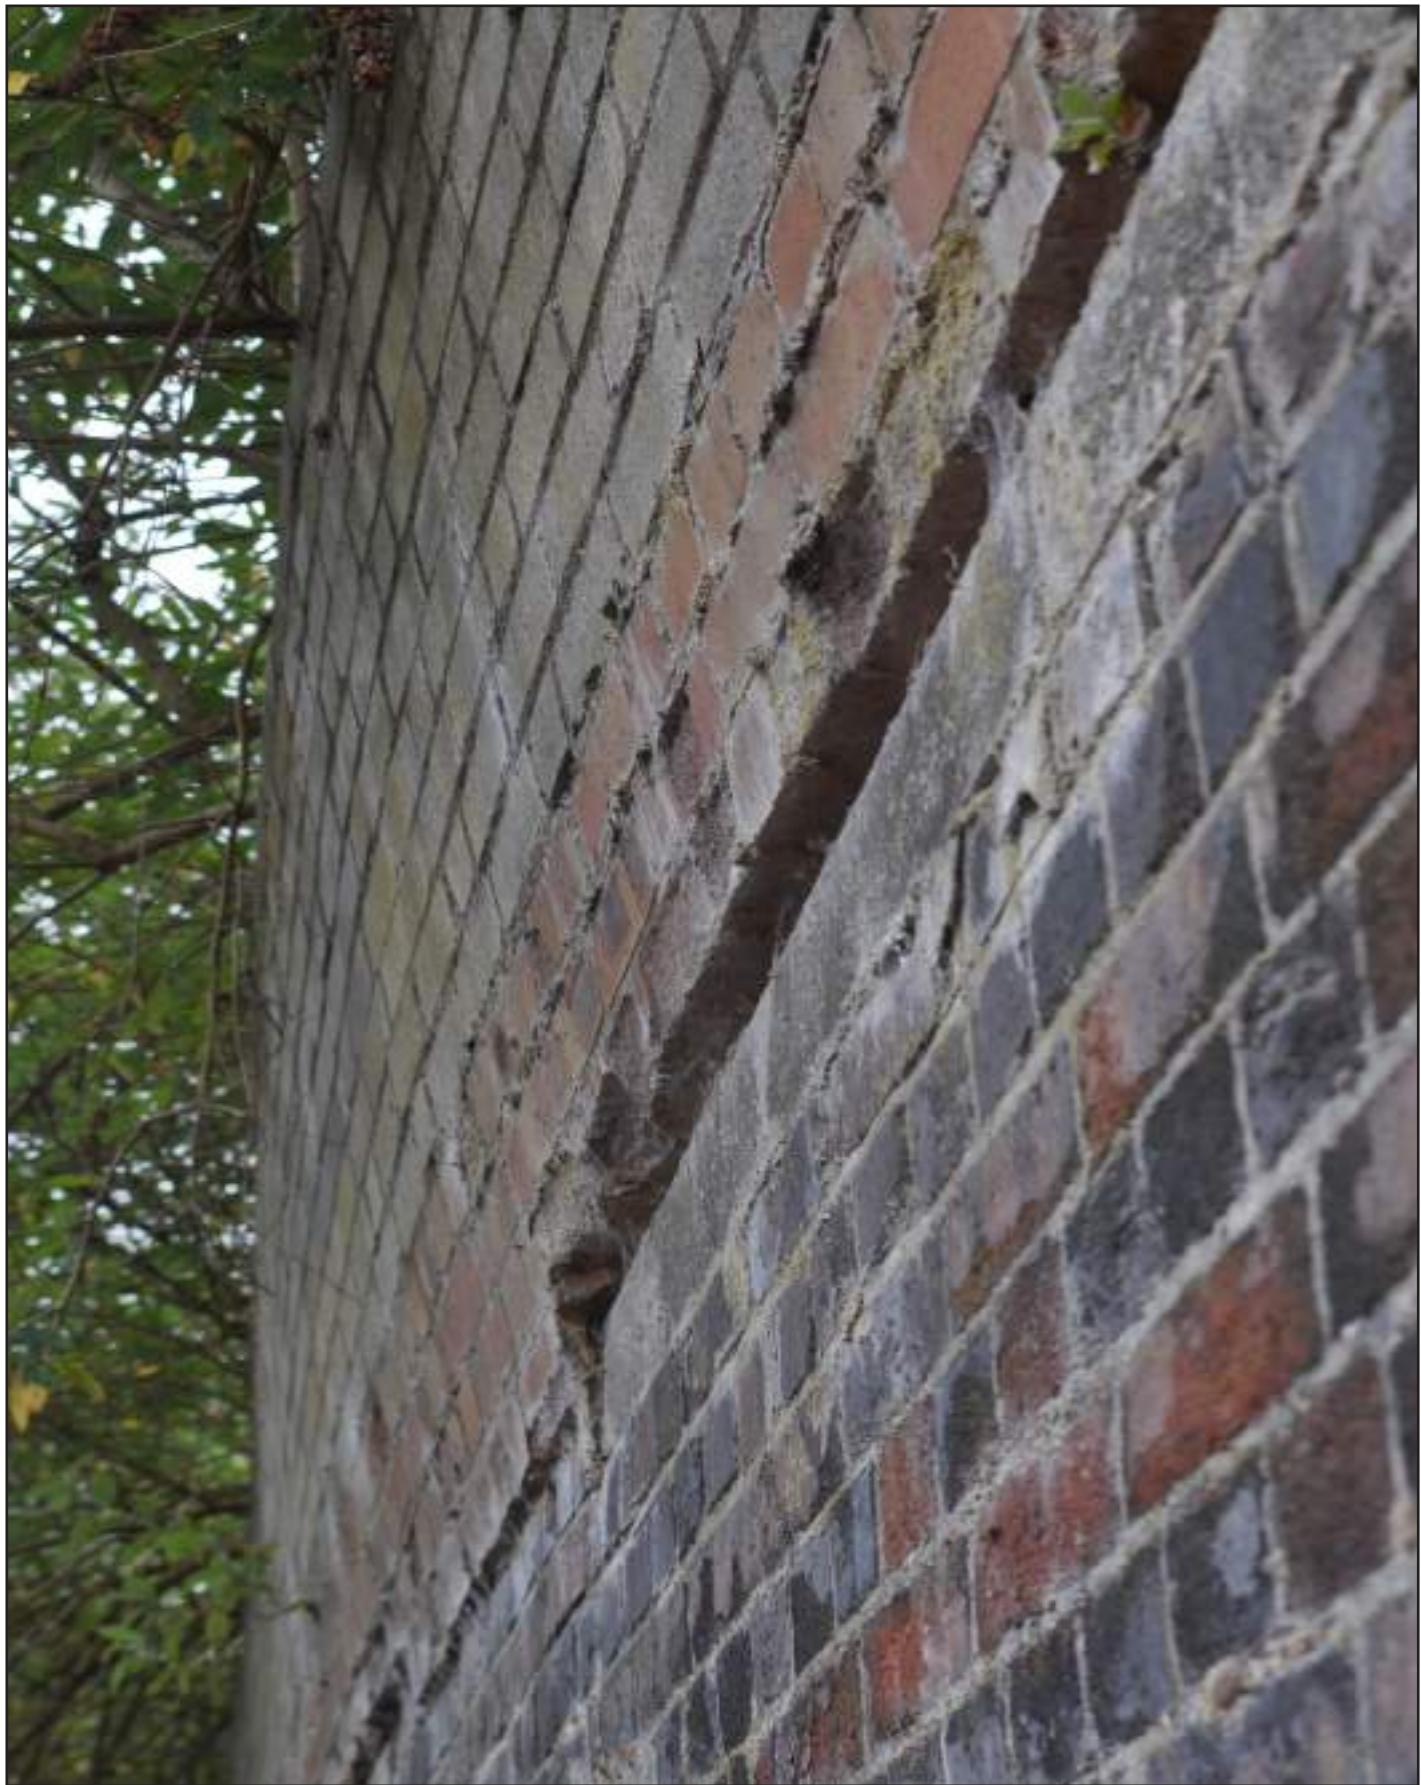
Fig.15
25.7m - chainage Dangerous misalignment to 30m chainage.
