**CANAL WALL INSPECTION GRAND UNION CANAL
HAYES - LONDON BOROUGH OF HILLINGDON**

ABOVE AND BELOW WATER INSPECTION OF
109M SECTION OF CANAL WASHWALL – GRAND
UNION CANAL HAYES. MIDDLESEX.

JUNE 2021

DIVERS SUMMARY/ REPORT
CANAL WASHWALL – HAYES
GRAND UNION CANAL

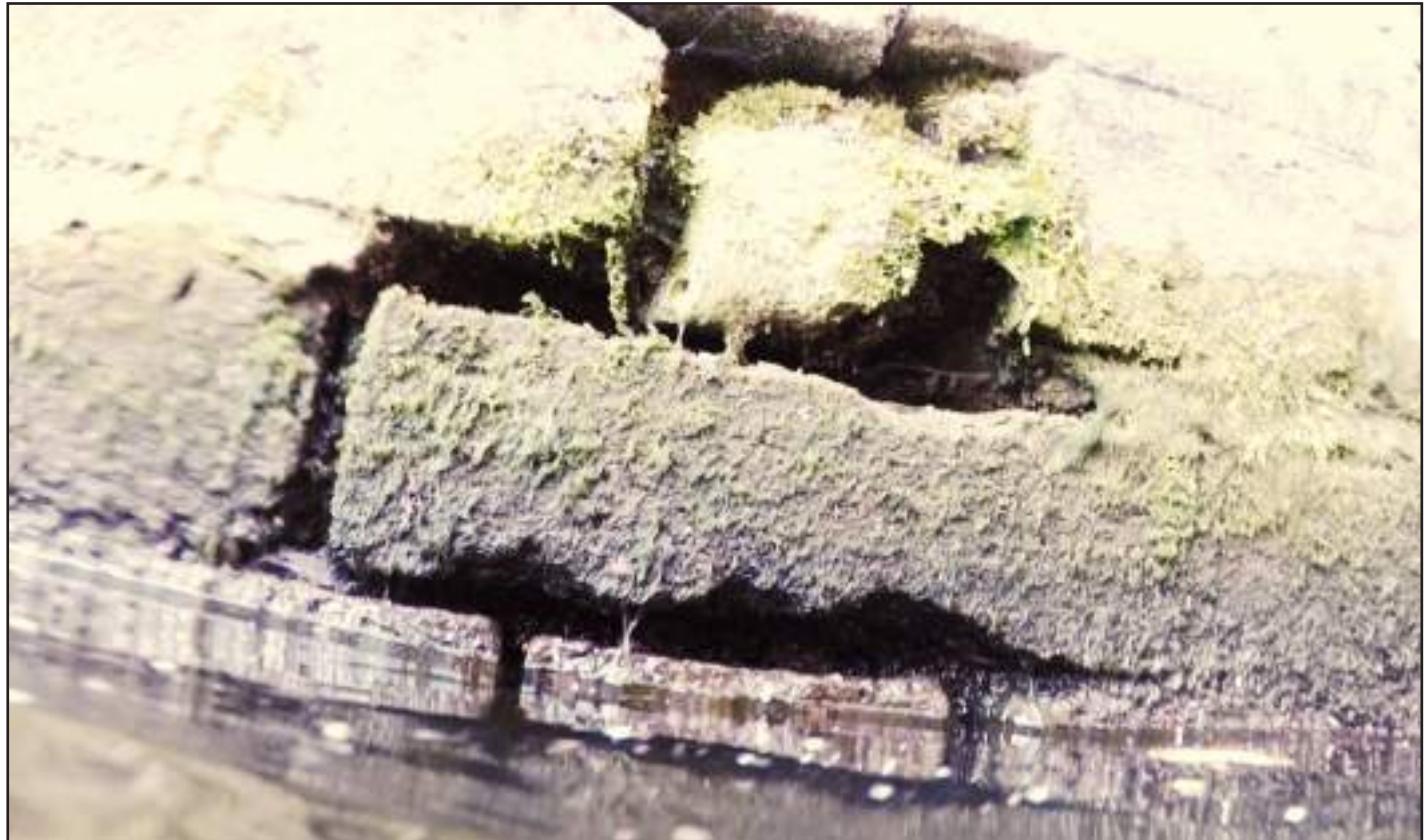
Fig.16

The condition of the underwater sections of wall along the full 109m survey limits is generally satisfactory apart from some defective mortar joints (as detailed, see figs 13,16,17 & 24) in sections 0m to 50m and some displaced expansion material in the associated construction joints (see fig 35) in the concrete wharf section 50m to 109m. Some minor erosion is present also but not serious (see fig 39). Defective joints would benefit from underwater and "Splash-zone" re-pointing to prevent further deterioration.

26m chainage - Missing Mortar and wide joints in bricks 2 courses above W/L & Splash zone

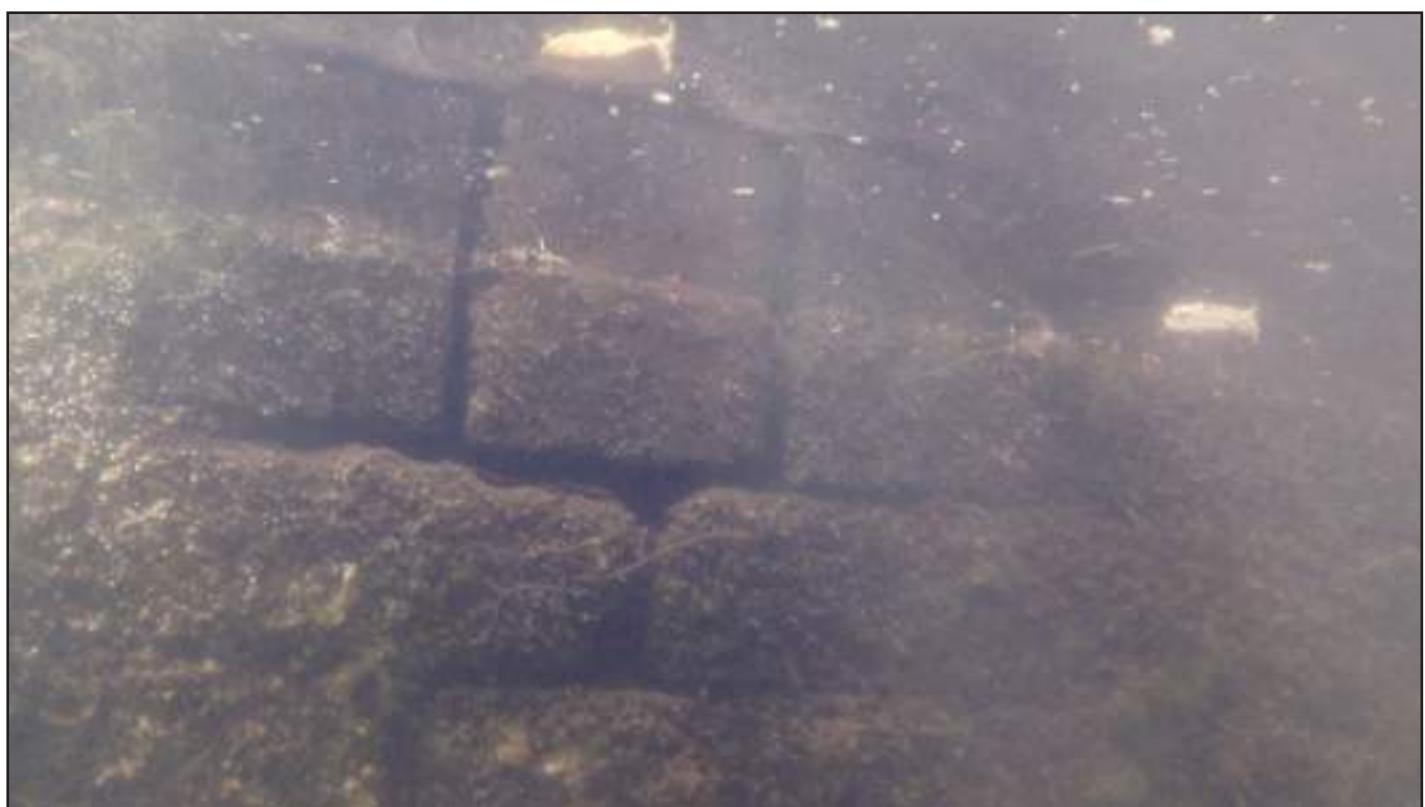
Fig.17

26m chainage - Missing Mortar and wide joints in bricks 2 courses below W/L

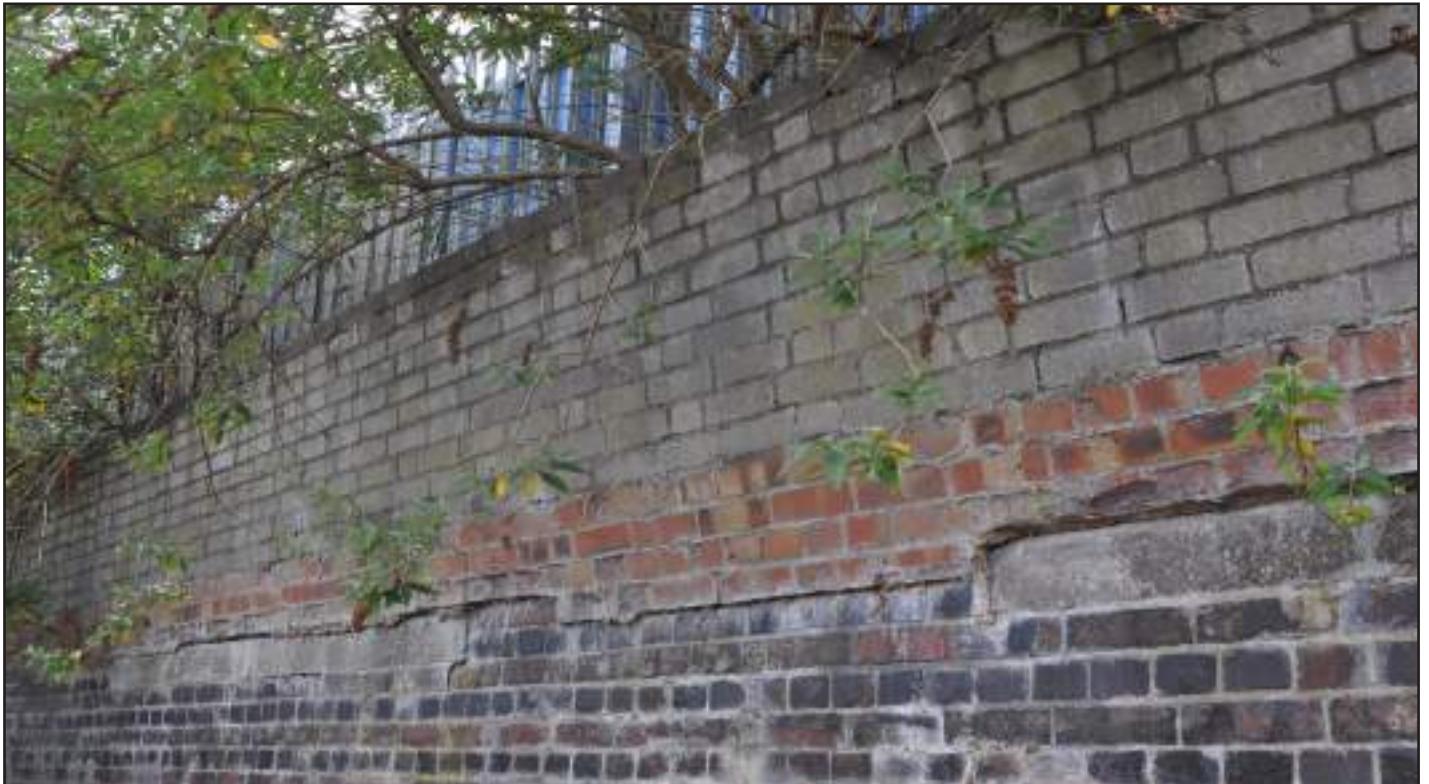
Fig.18

The general description of the wall construction falls into two distinctive area sections, i.e. 0m to 50m – This section in brief comprises of the remnants of the now demolished Warehouse frontage who's windows and door openings have been bricked up with mostly red brick. In order to level the wall to ground level grey bricks have been added in a number of locations, these are commonly displaced, missing or out of alignment. The top 21no. courses of grey brick between Chainage 26m to 30m are bulging out of alignment and the perpendicular by 170mm and has a 20mm wide overhang lip which has been created by established vegetation pushing the wall out towards the Canal. **This section is highly likely to collapse in the near future.** (See information sheets for detail, Figs 14,15&18)

26m chainage - Some petrification and discolouration in blue bricks 13 to 21 courses above W/L
Dangerous misalignment to 30m chainage

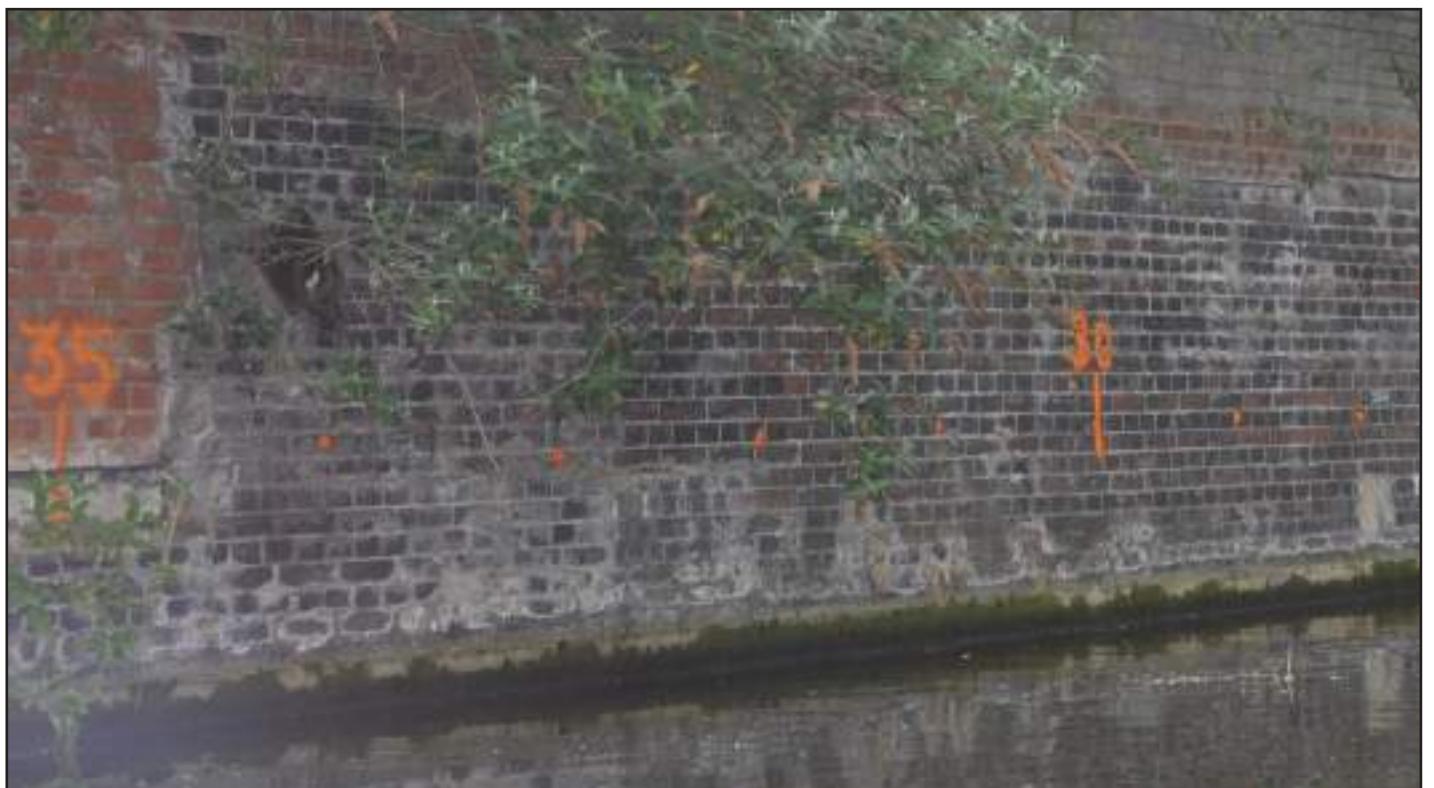
Fig.19

30m to 32.8m chainage - 2 x coping stones in position x 21 courses above W/L (Blue Bricks).

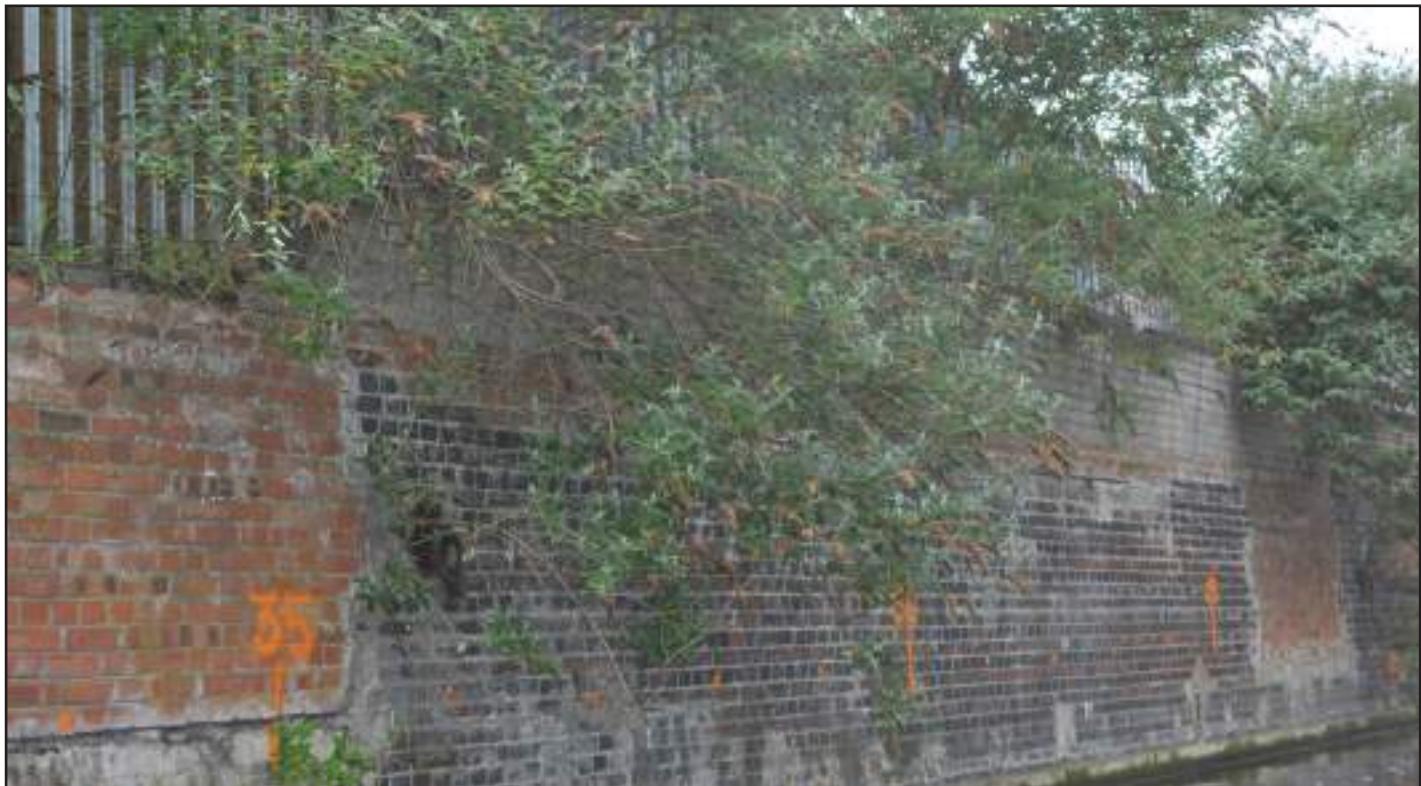
Fig.20

34m chainage - Mooring ring (Eye Bolt) 17 courses of bricks above W/L - Tree present at backplate.
33m - 34m chainage - 9 -10 courses of grey bricks missing from top of wall . Wall steps down.

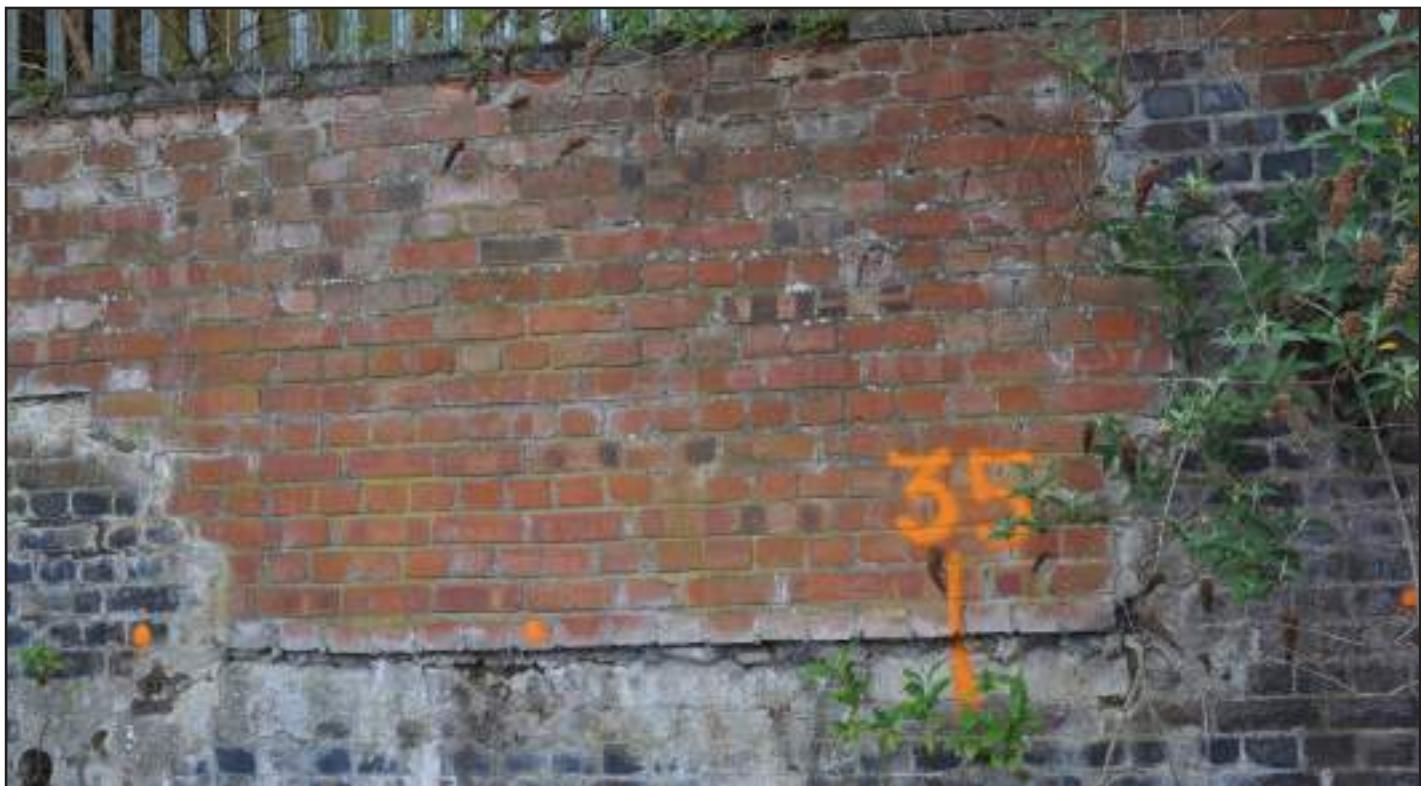
Fig.21

34.7m chainage - Site of bricked up redundant window and redundant cill
(Concrete) patched up into adjoining blue brick section to 39m.

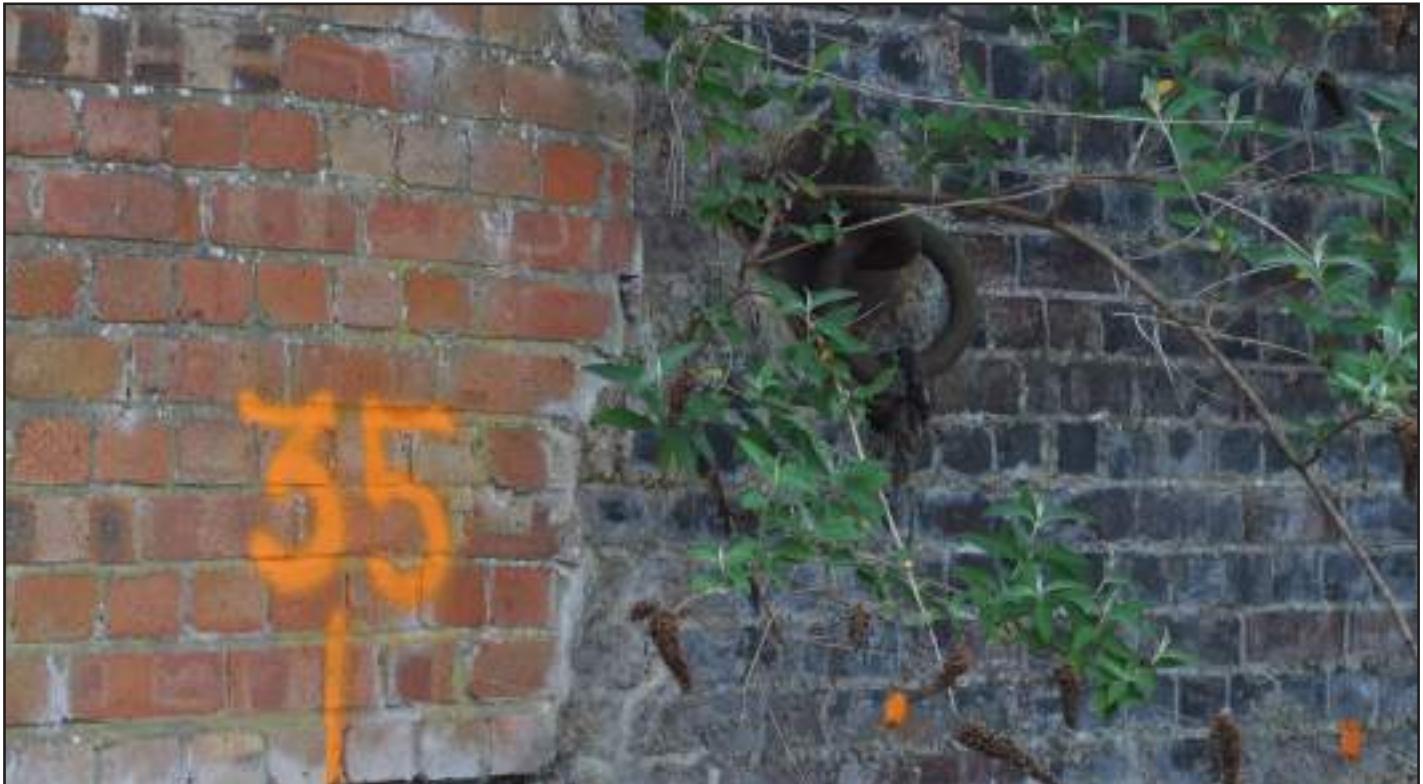
Fig.22

35.2m chainage - Misalignment of brickwork protruding 20mm recessed back x 3 courses.
Bricks on canal bed adjacent and to foot of wall to 36.9m.

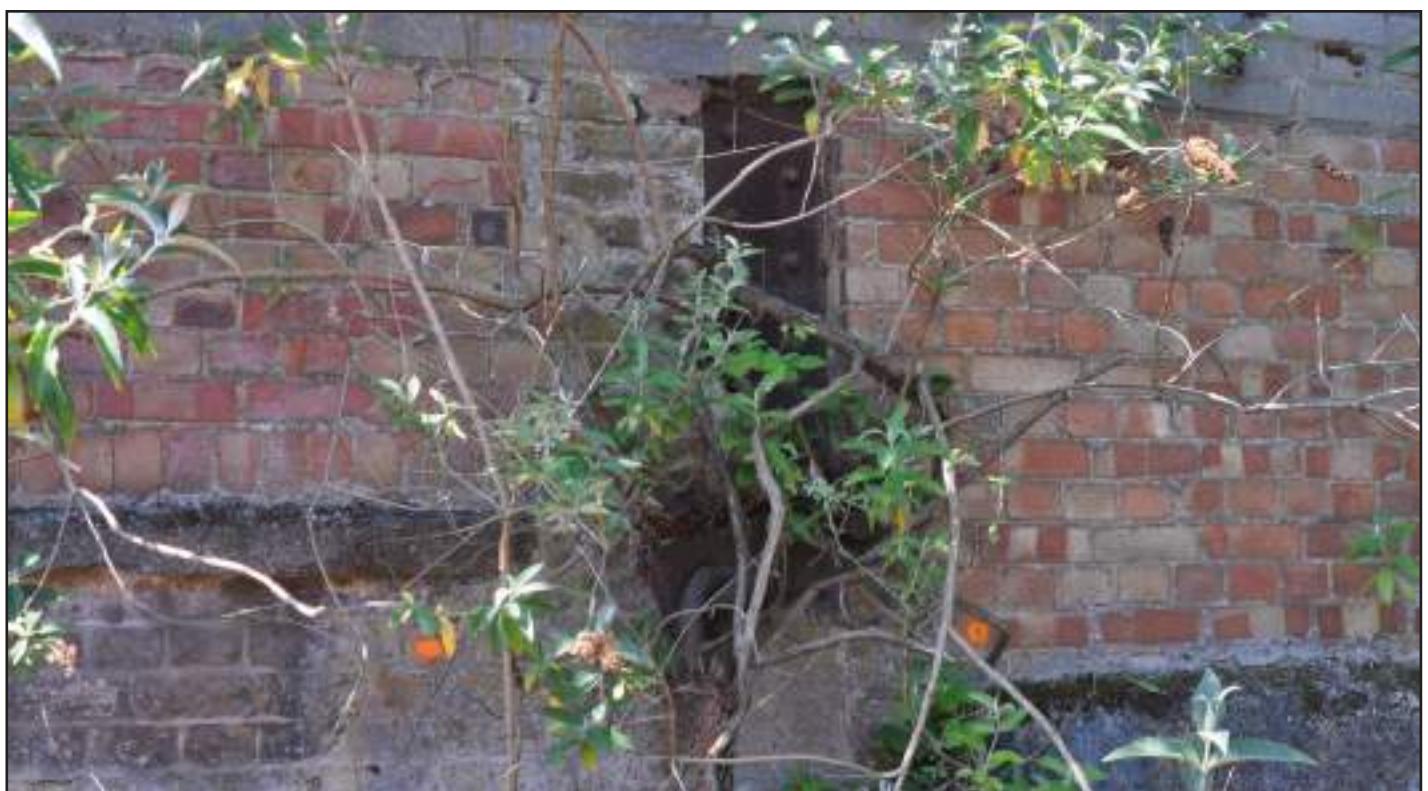
Fig.23

Tree roots at W/L x 2 courses below and x 2 courses above W/L x 2 bricks wide.
37m to 38m chainage - Irregular alignment - erosion damage face of bricks.

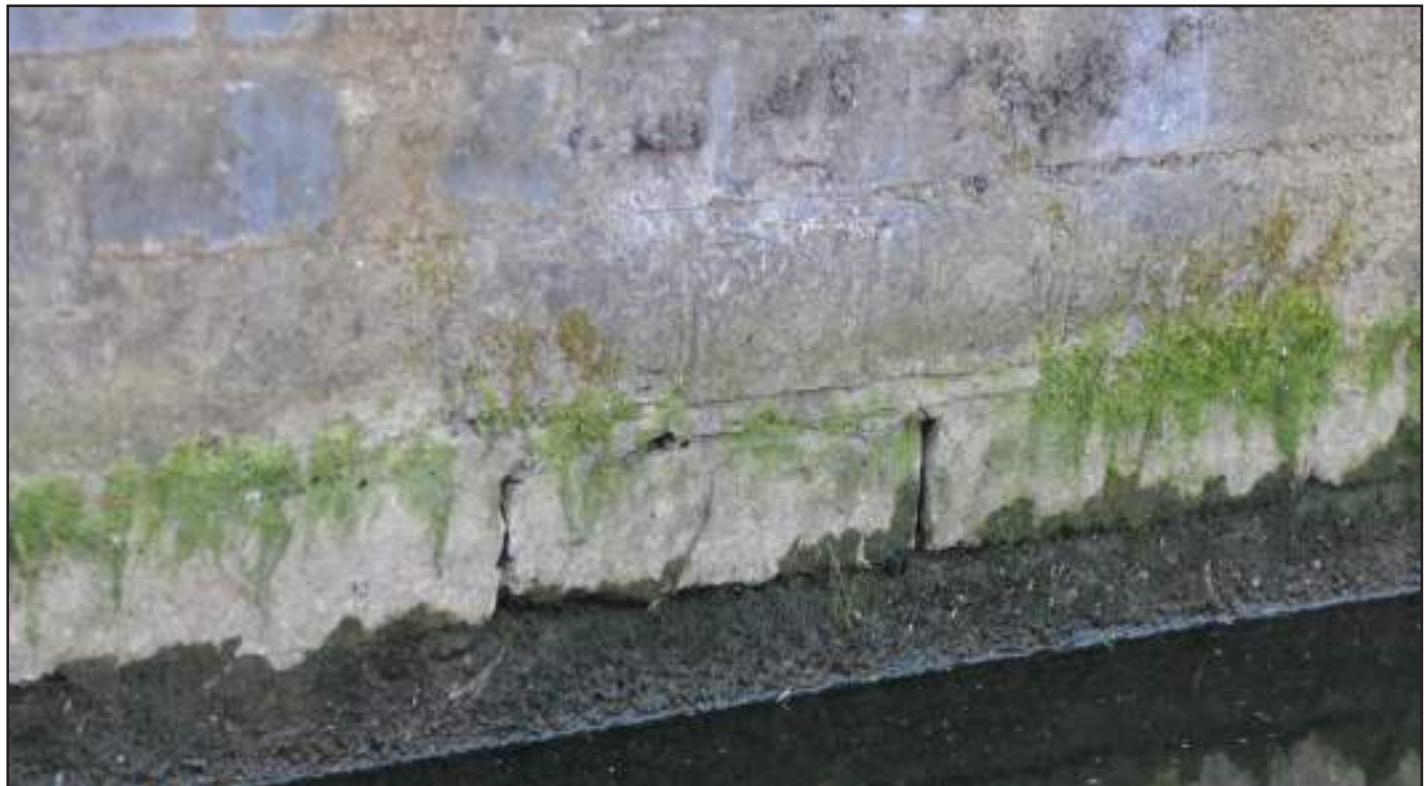
Fig.24
40m chainage - Missing Mortar x 2 bricks at W/L & Splash zone.

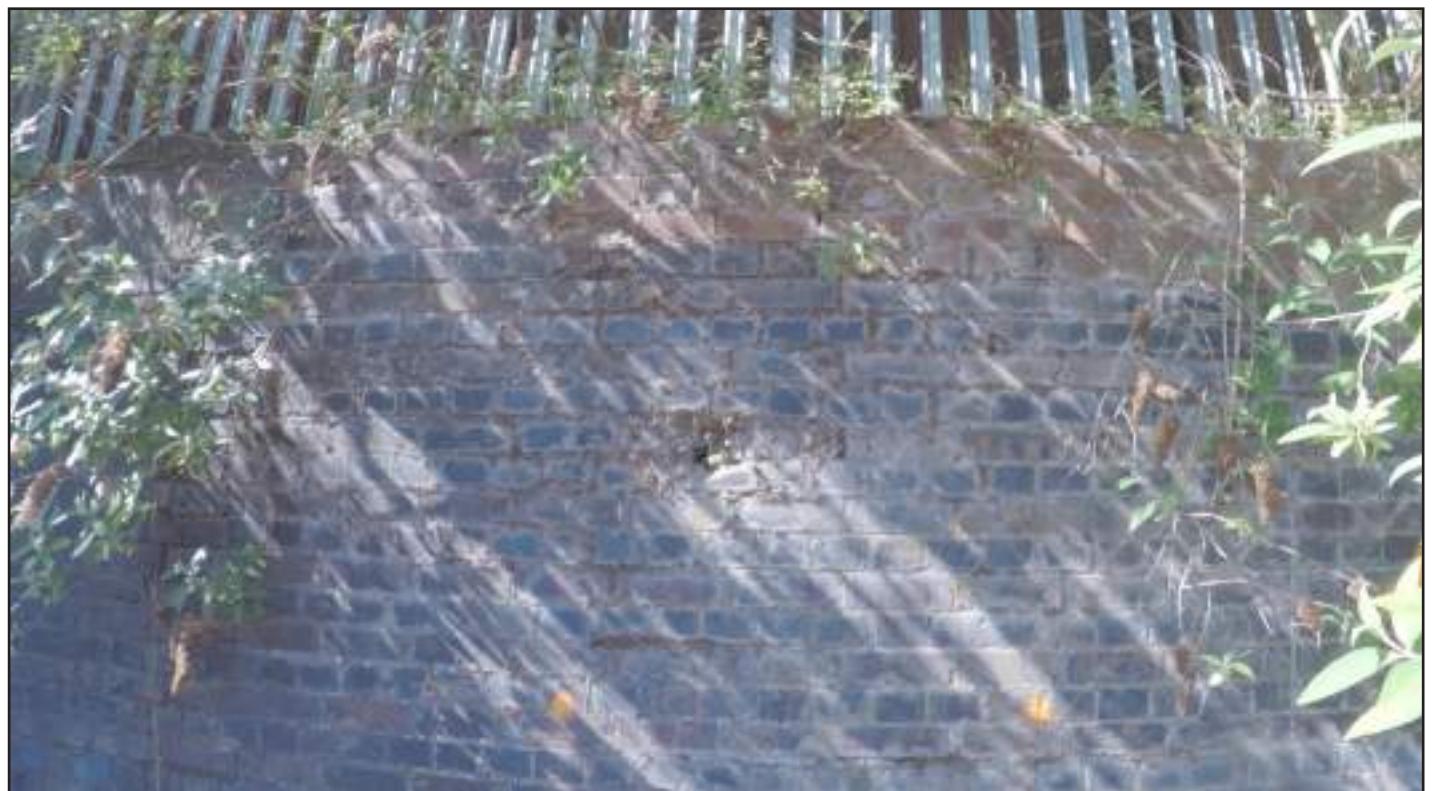
Fig.25
41.6m chainage - Hole drilled into brickwork (possible mooring area) No Ring 0.4m only spalled face 100mm x150mm

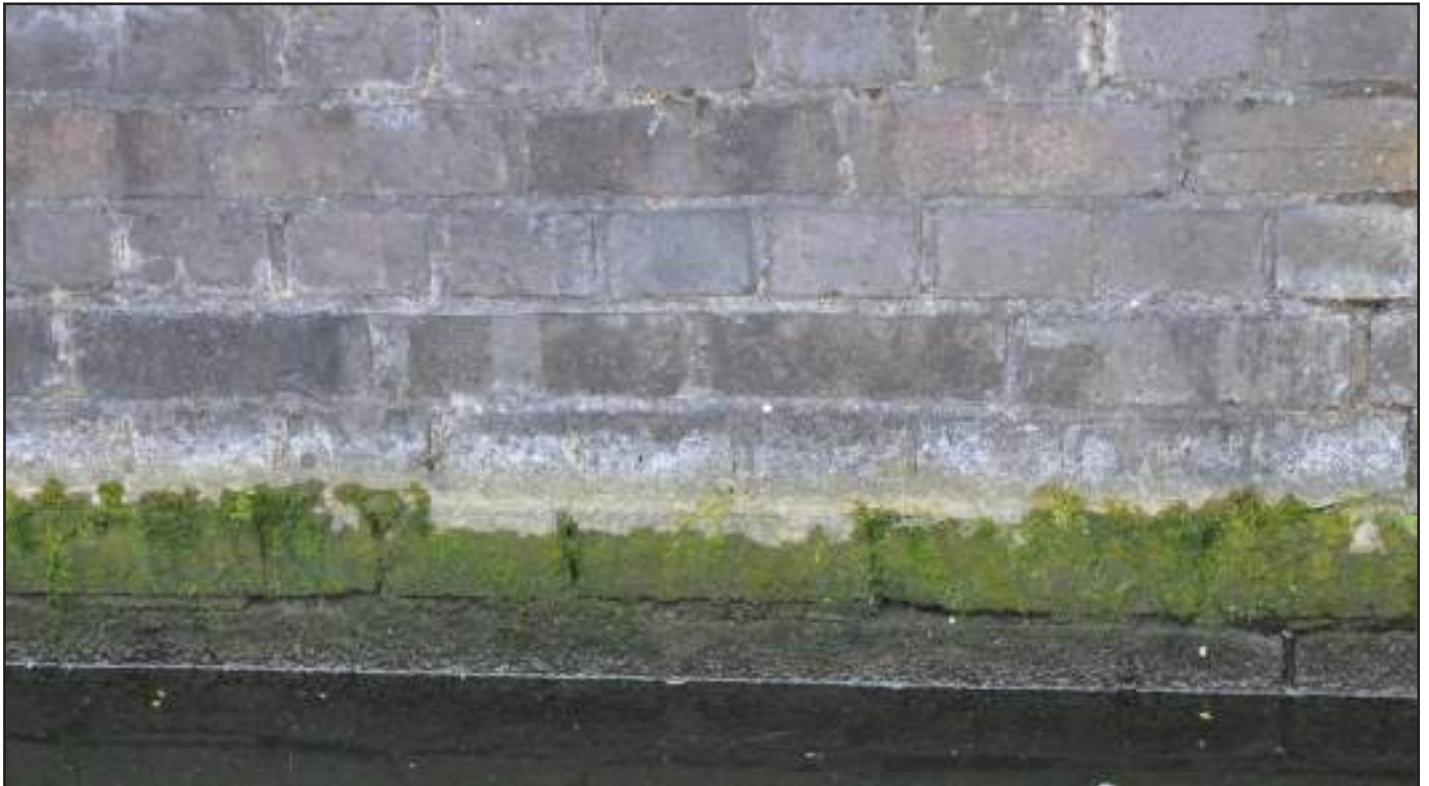
Fig.26

42.1m chainage - Trees to 46m. Missing mortar at W/L and above x 2 courses below W/L x 3 courses.

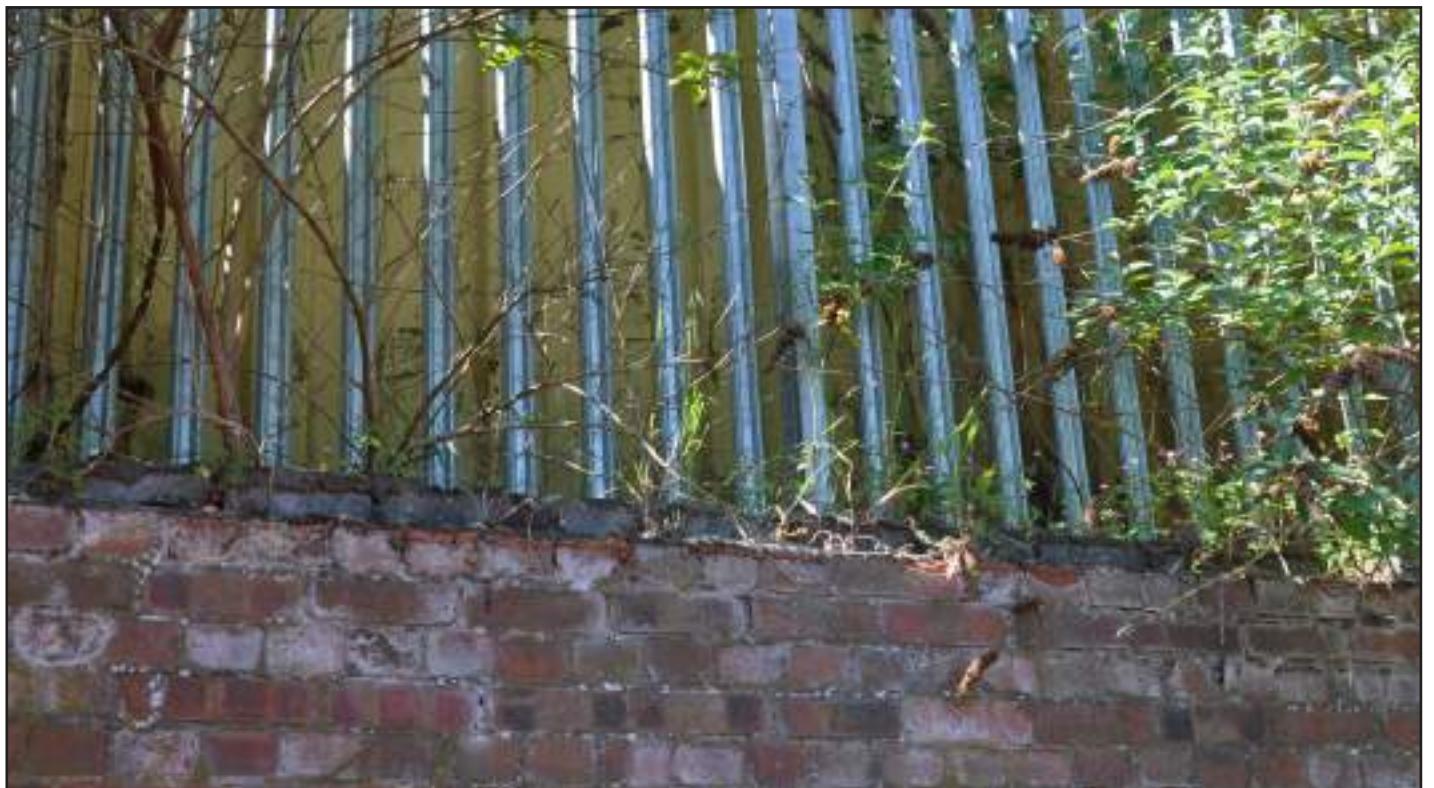
Fig.27

40m to 49.5m chainage - Trees ontop of wall irregular brickwork (spalled).

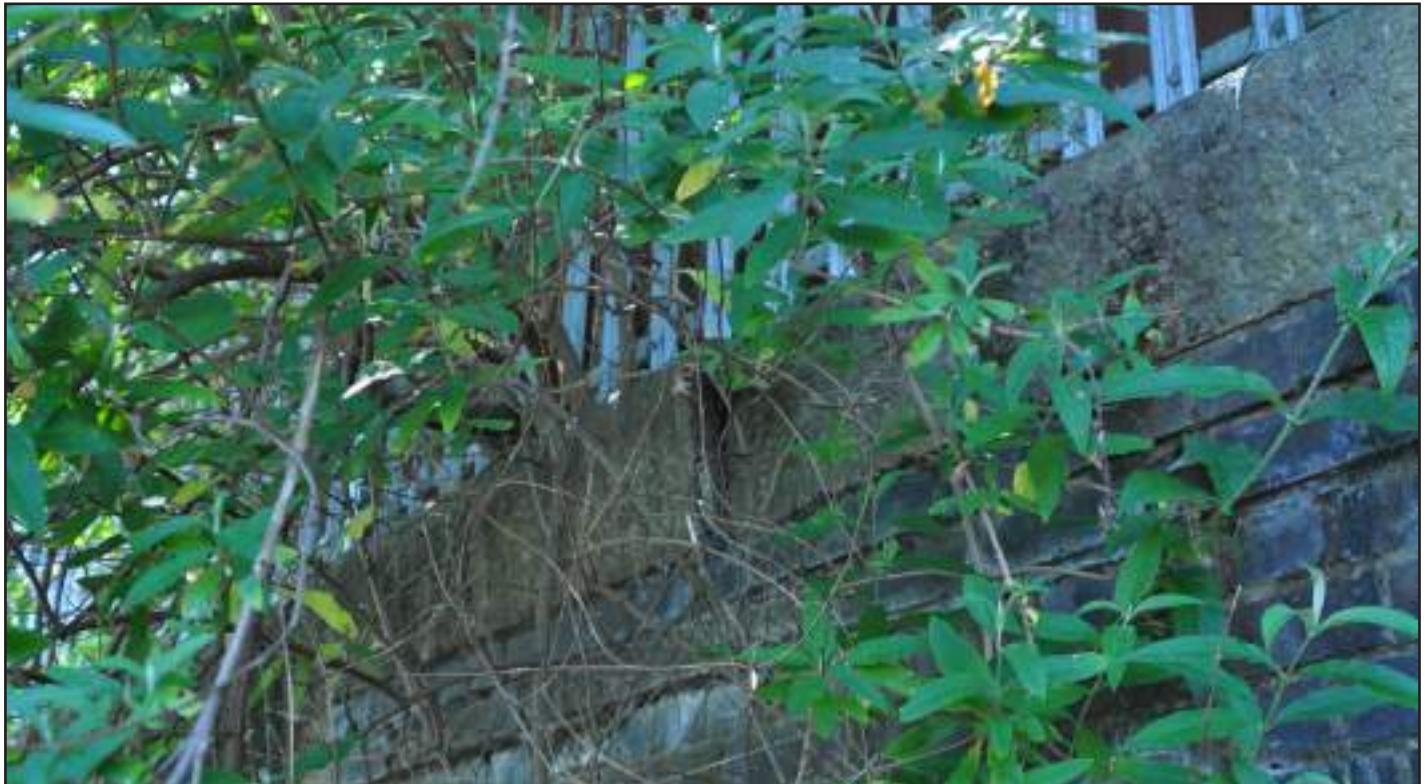
Fig.28

48m to 43m chainage - trees pushing wall out of alignment. Perpendicular section of wall
- end coping at interface of (Change of construction - to Concrete).

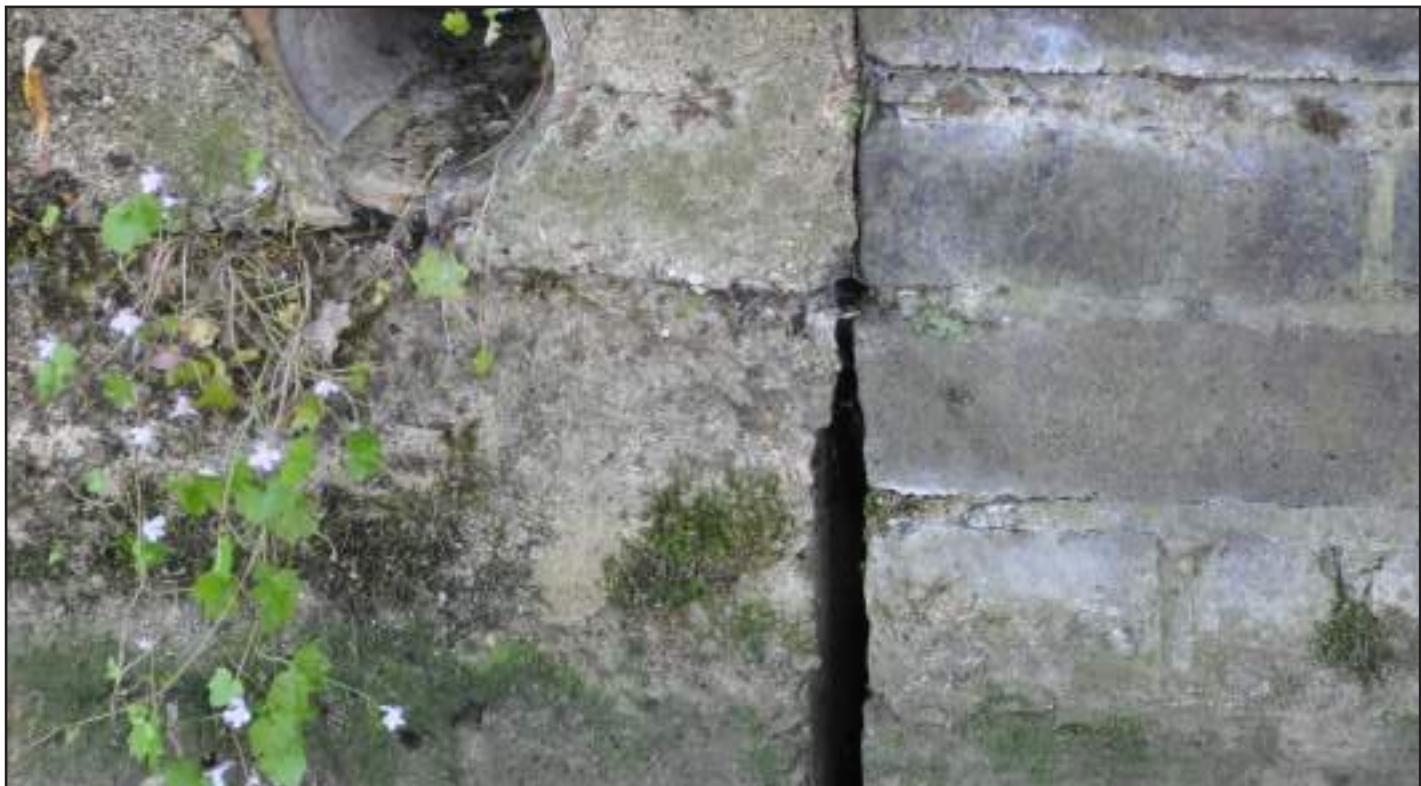
Fig.29

49.5m chainage - Change of construction materials from brickwork (Blue Brick) to shuttered concrete -
Definative vertical joint. No expansion material in place.

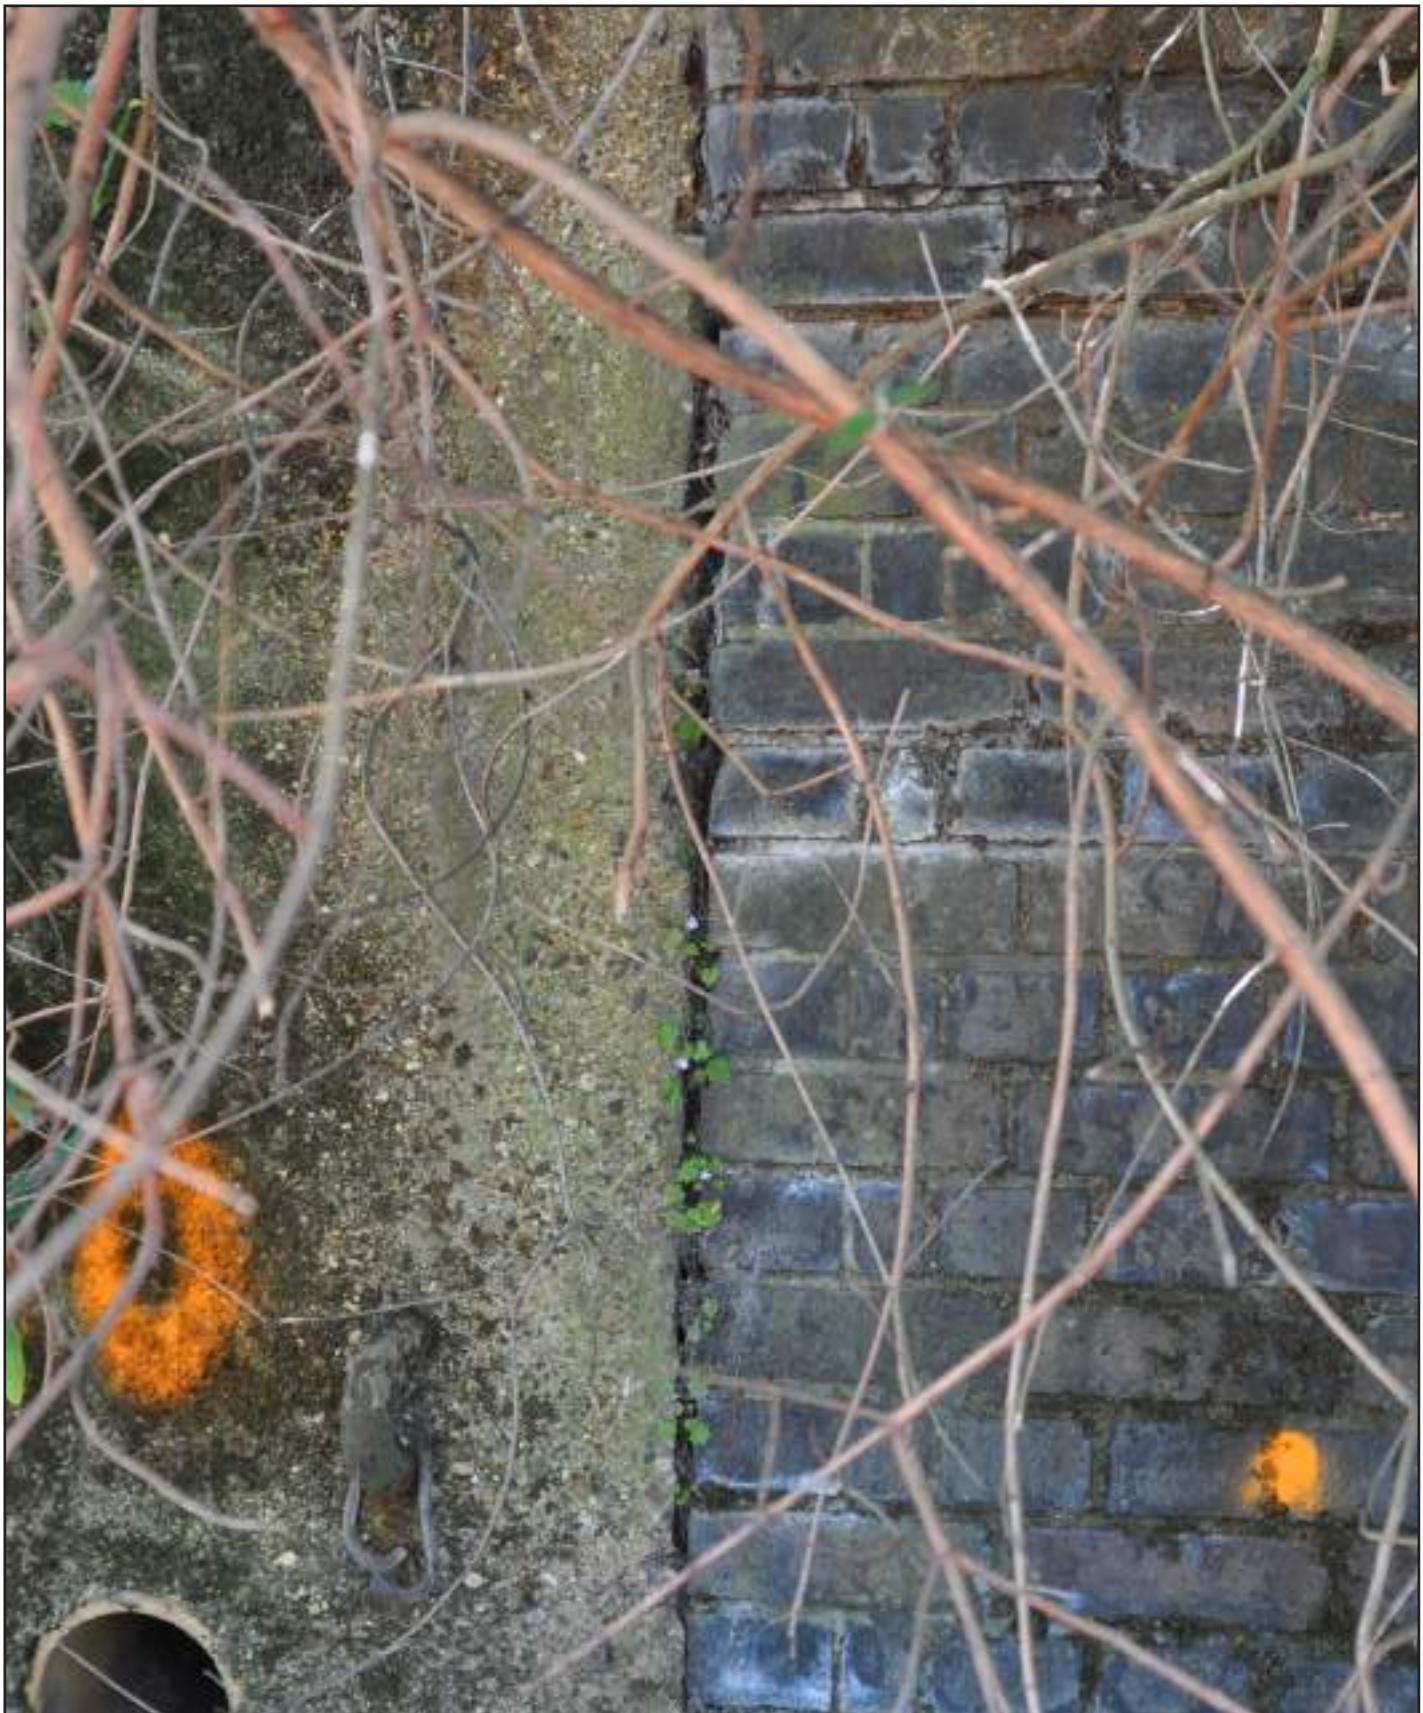
Fig.30
49.7m chainage - Grab Chain ring in position "U" Bolt 1m above W/L.
Wide gap between construction materials 32mm to bed level.

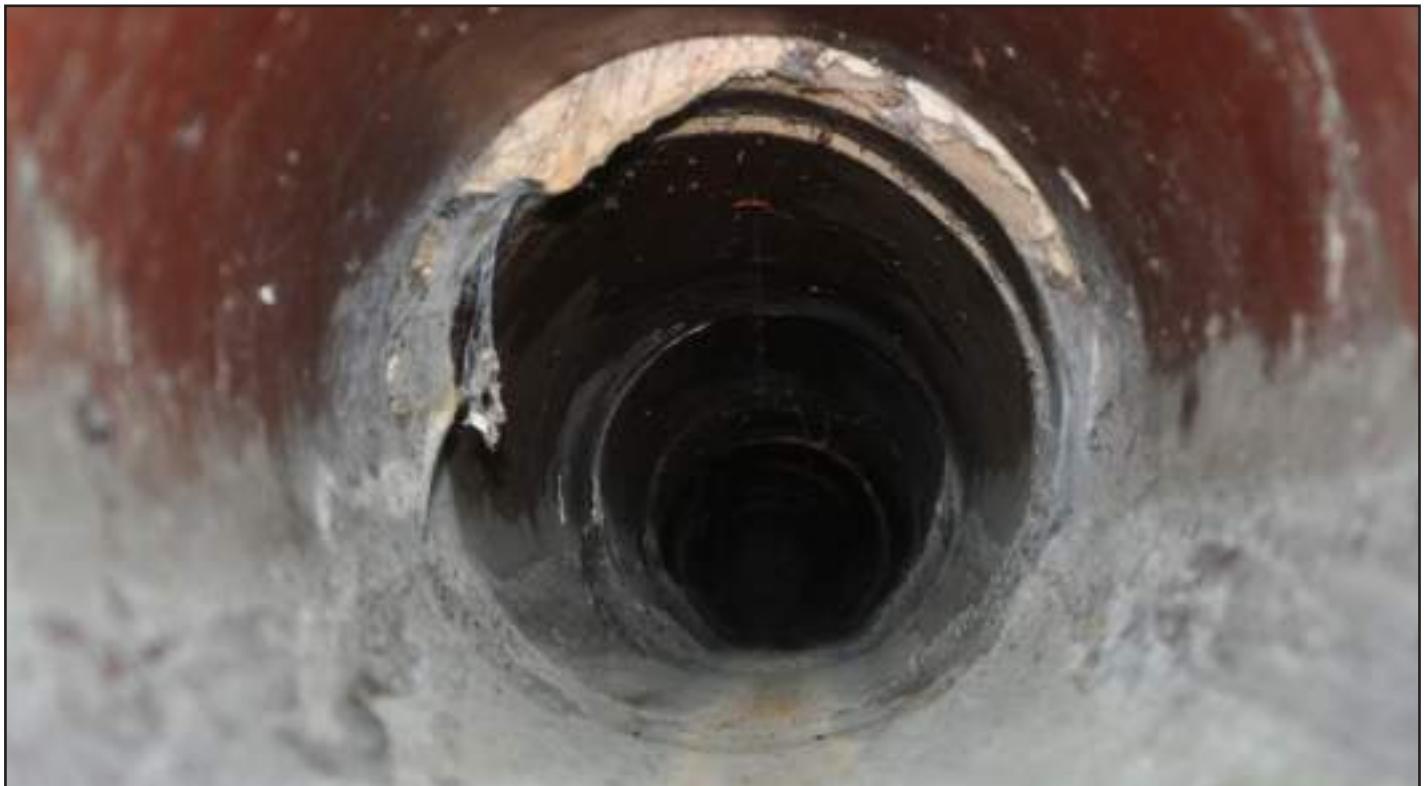
Fig.31
49.8m chainage - 150mm Drain through wall 550mm above W/L.

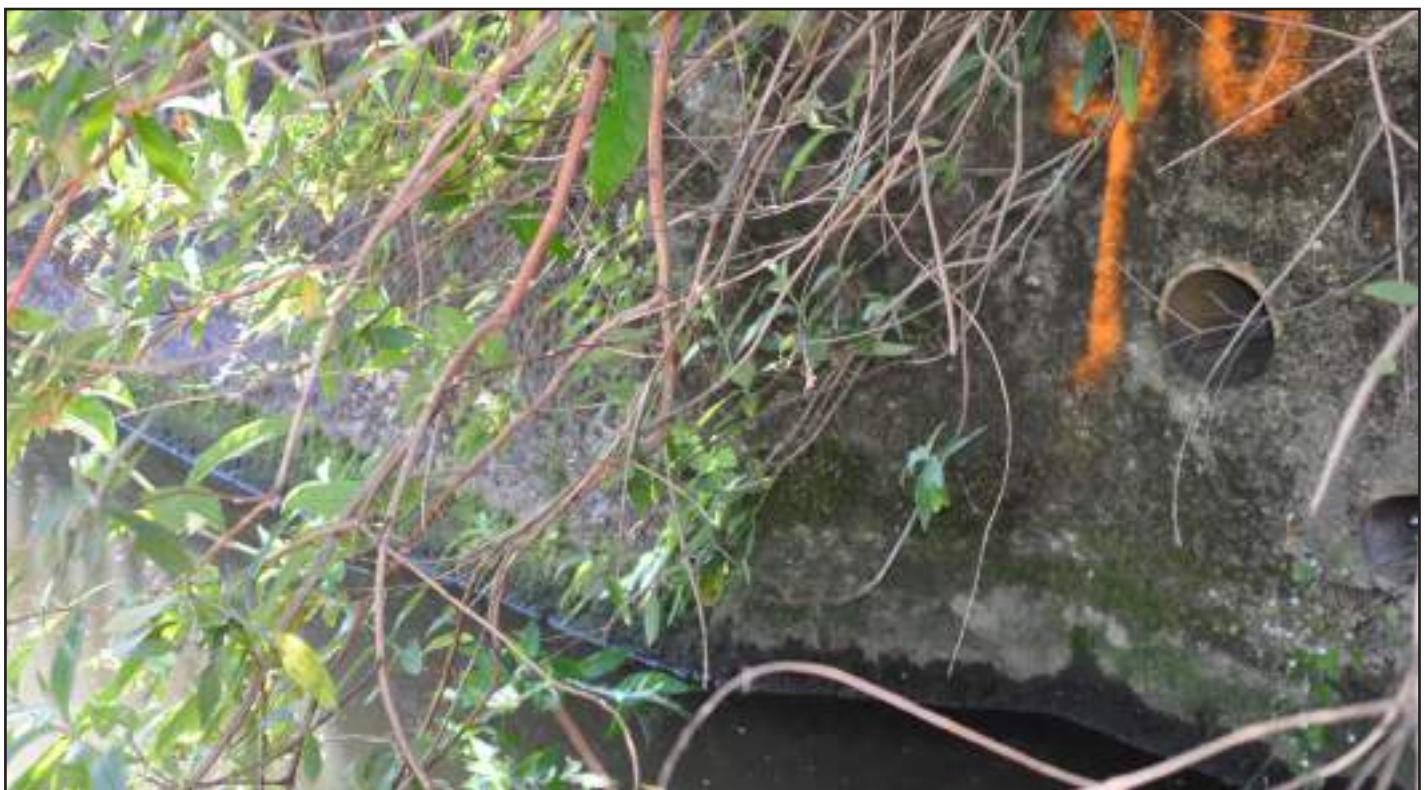
Fig.32
50m chainage - Alignment of wall frontage kicks out 320mm towards canal.
Toe protruding 25mm from 50.5m onwards.

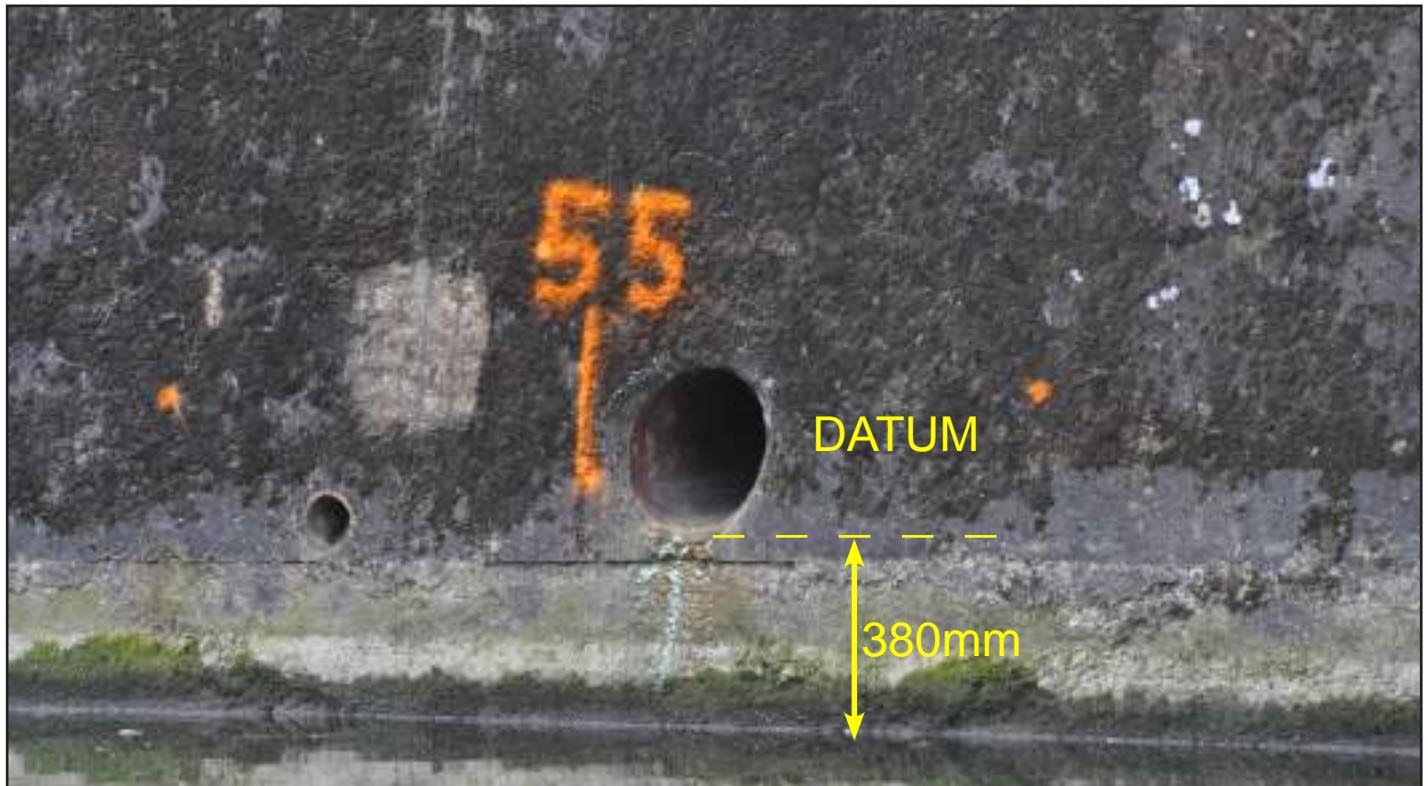
Fig.33

54.8m chainage - 300mm diameter Salt Glazed Drain. (Datum Point 380mm invert to W/L) at time of survey.
55m to 57.2m chainage - Boulder stones debris in water course at toe of wall (Wall Sat).
