**CANAL WALL INSPECTION GRAND UNION CANAL
HAYES - LONDON BOROUGH OF HILLINGDON**

ABOVE AND BELOW WATER INSPECTION OF
109M SECTION OF CANAL WASHWALL – GRAND
UNION CANAL HAYES. MIDDLESEX.

JUNE 2021

DIVERS SUMMARY/ REPORT
CANAL WASHWALL – HAYES
GRAND UNION CANAL

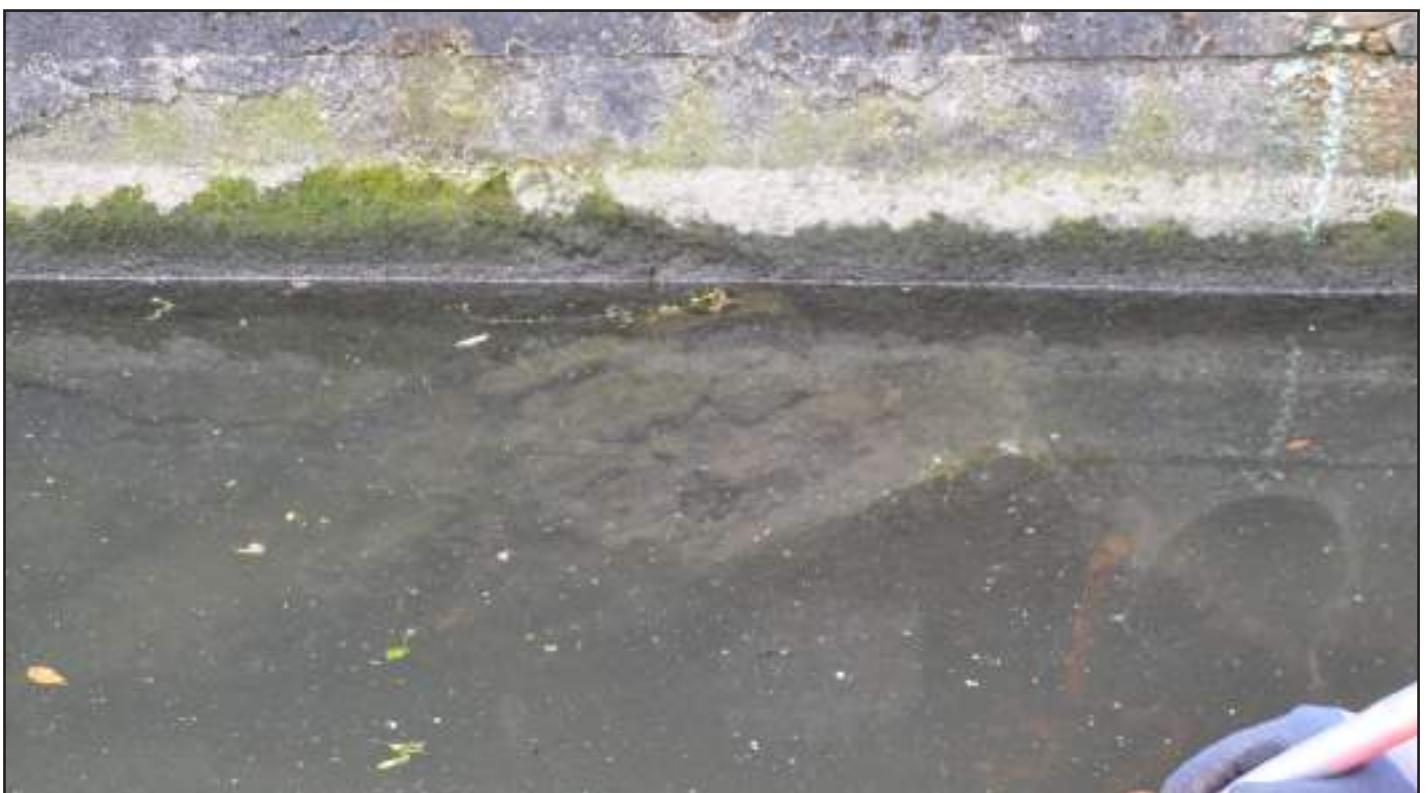
Fig.34

There is debris in certain locations e.g. Chainage 55m -. i.e. rocks, bricks some tree branches – see fig 34).

55m to 57.2m chainage - Boulder stones debris in water course at toe of wall (Wall Sat).

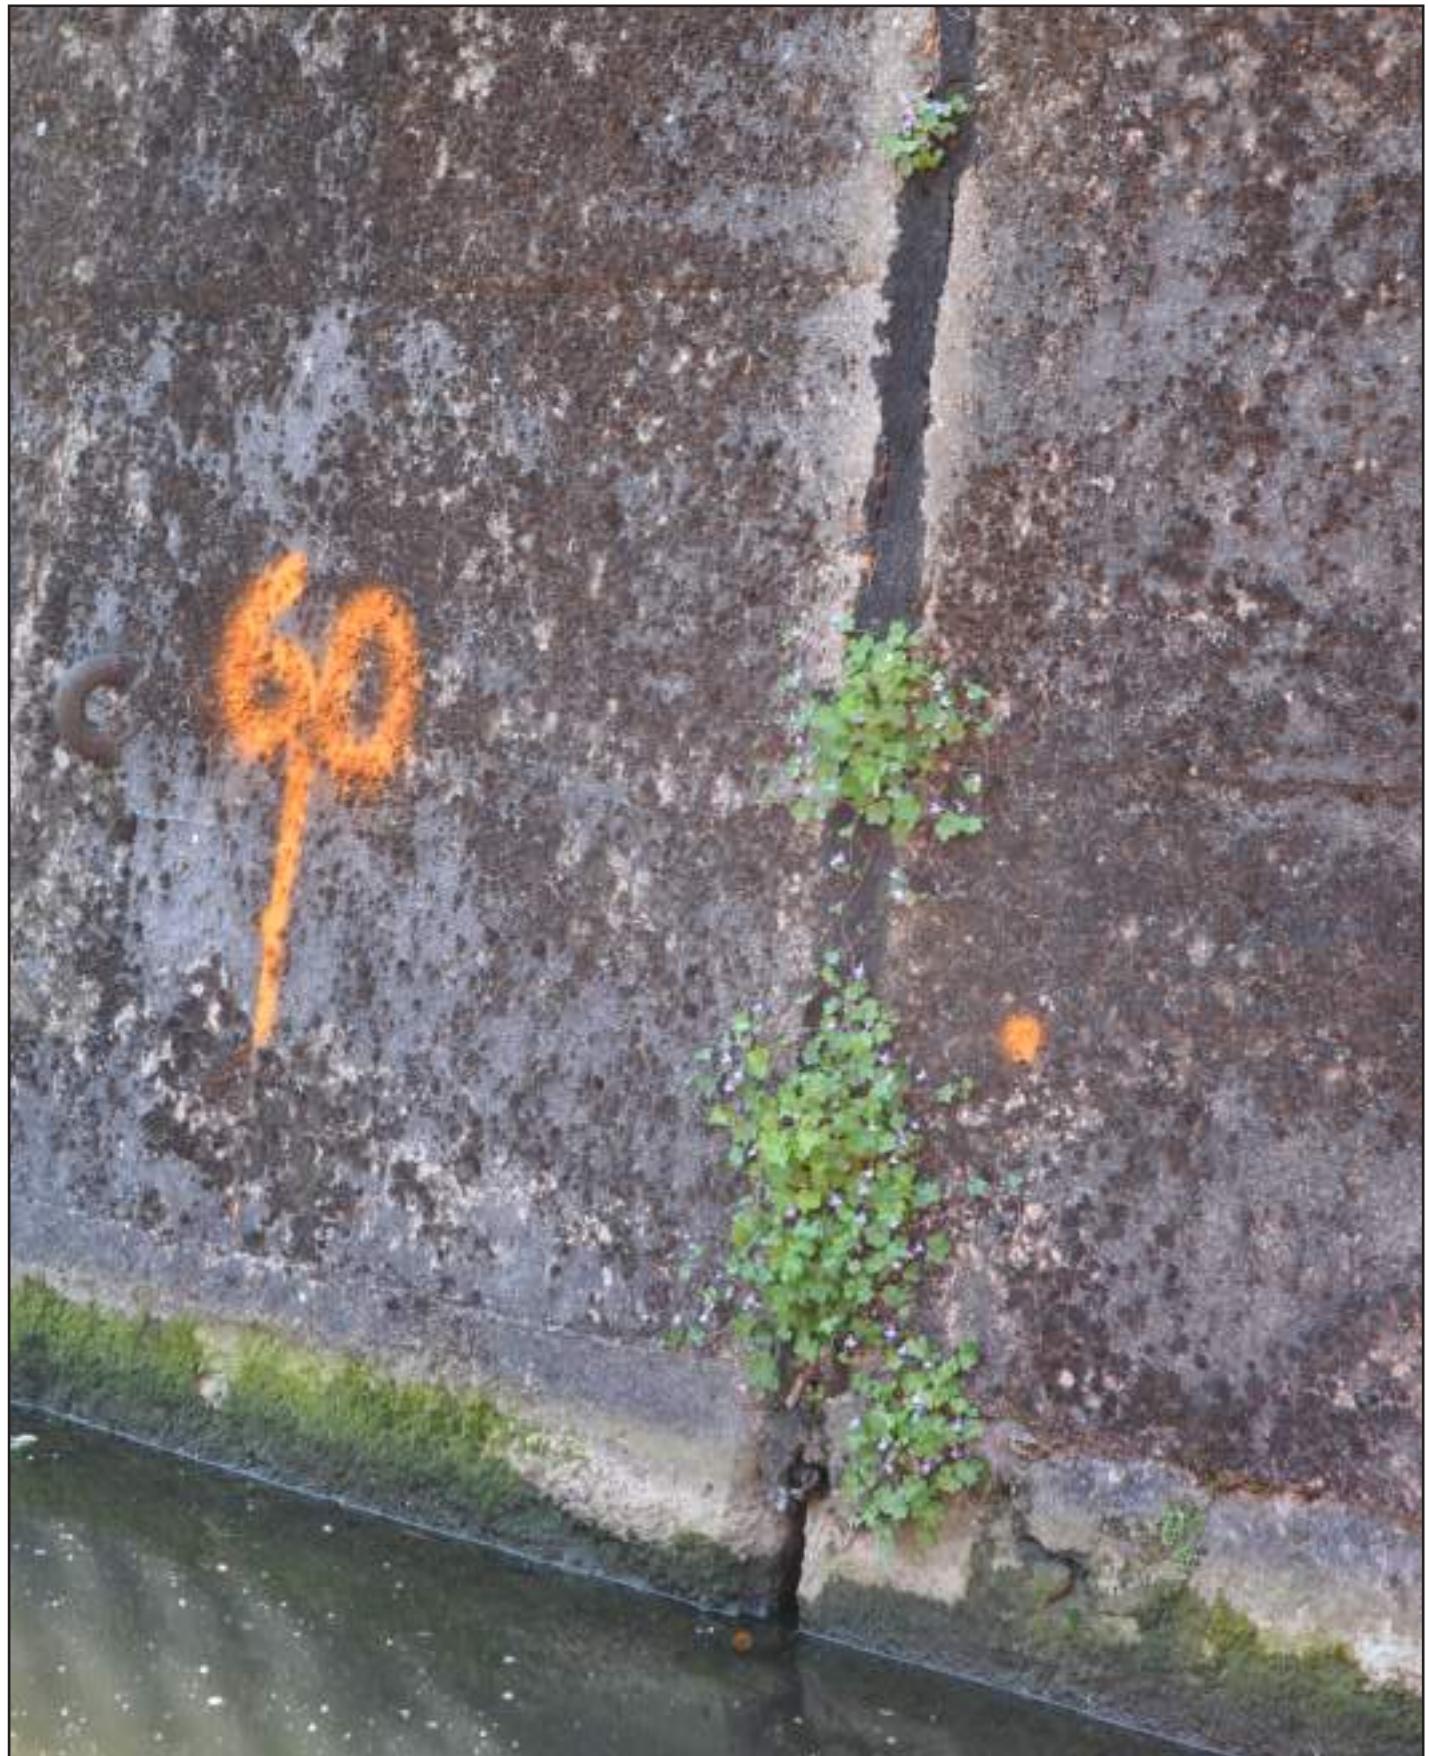
Fig.35

59.2m chainage - Construction joint (vertical) with expansion joint material displaced at W/L up to 400mm
- Below water material missing to bed level gap 65mm.

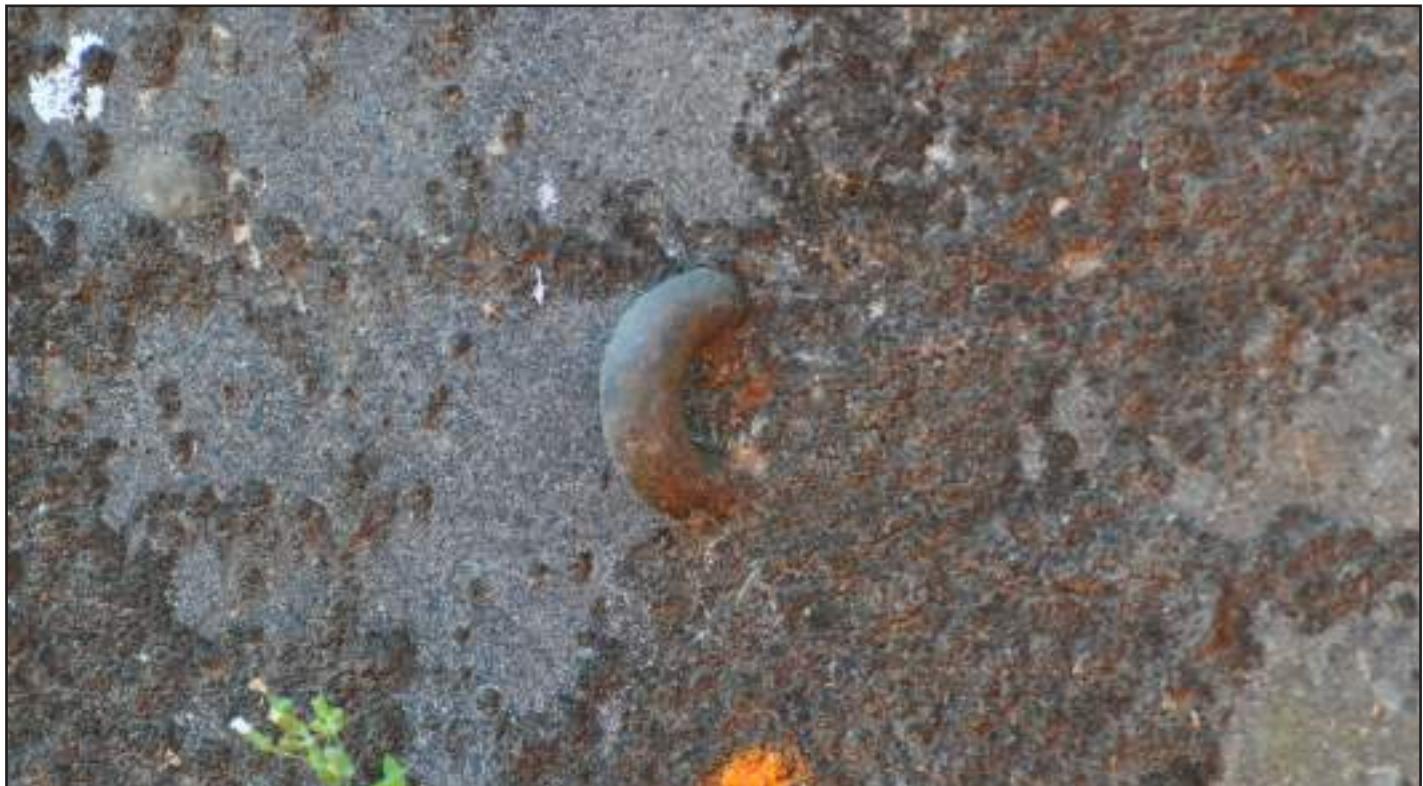
Fig.36

60.5m chainage - Ring in wall for grab chains. Wall toe sticking out - all satisfactory up to 63m small toe reduces to 10mm.

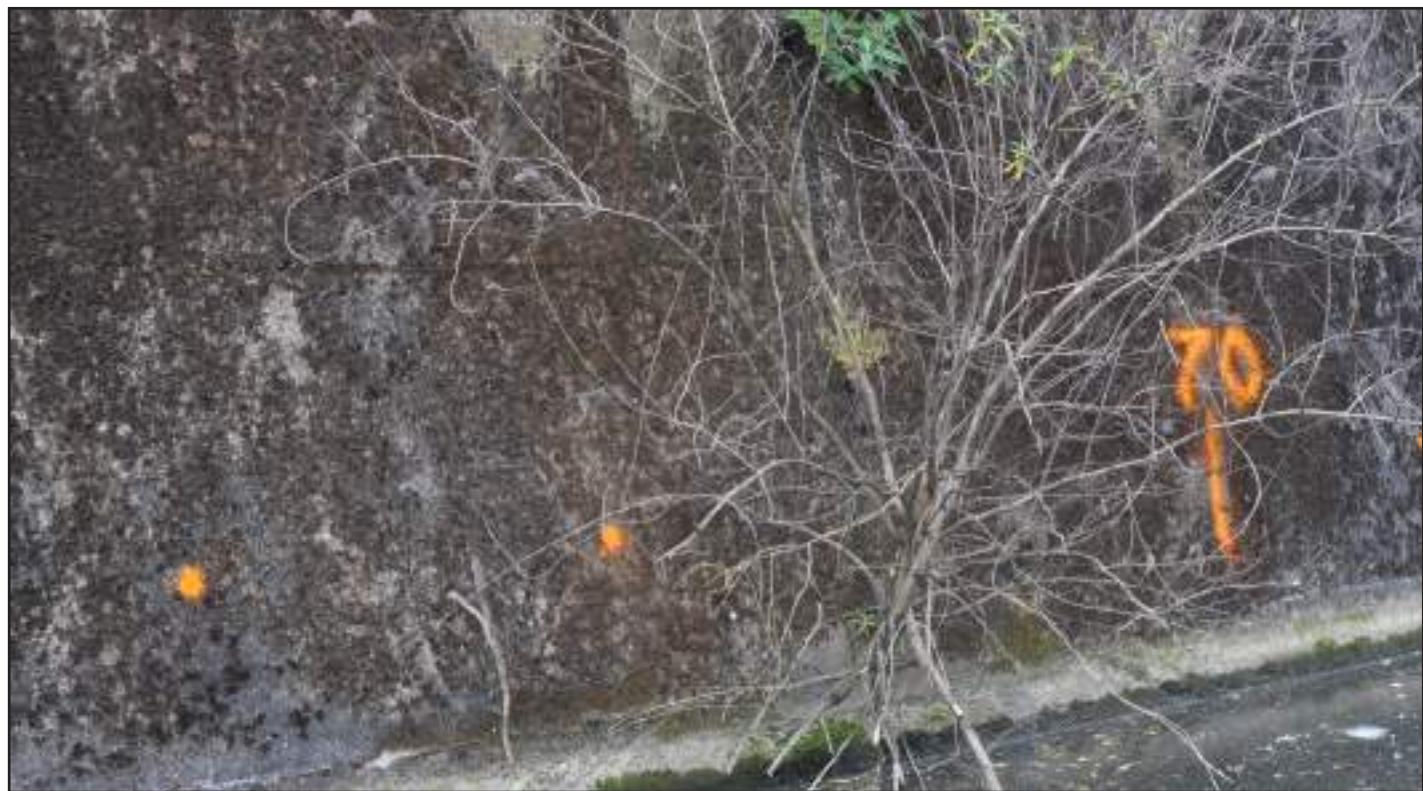
Fig.37

71.2m chainage - Vertical construction joint with tree in place 300mm at W/L growing in joint displaced expansion joint material
- Gap from bed level up to 400mm above W/L to tree location.

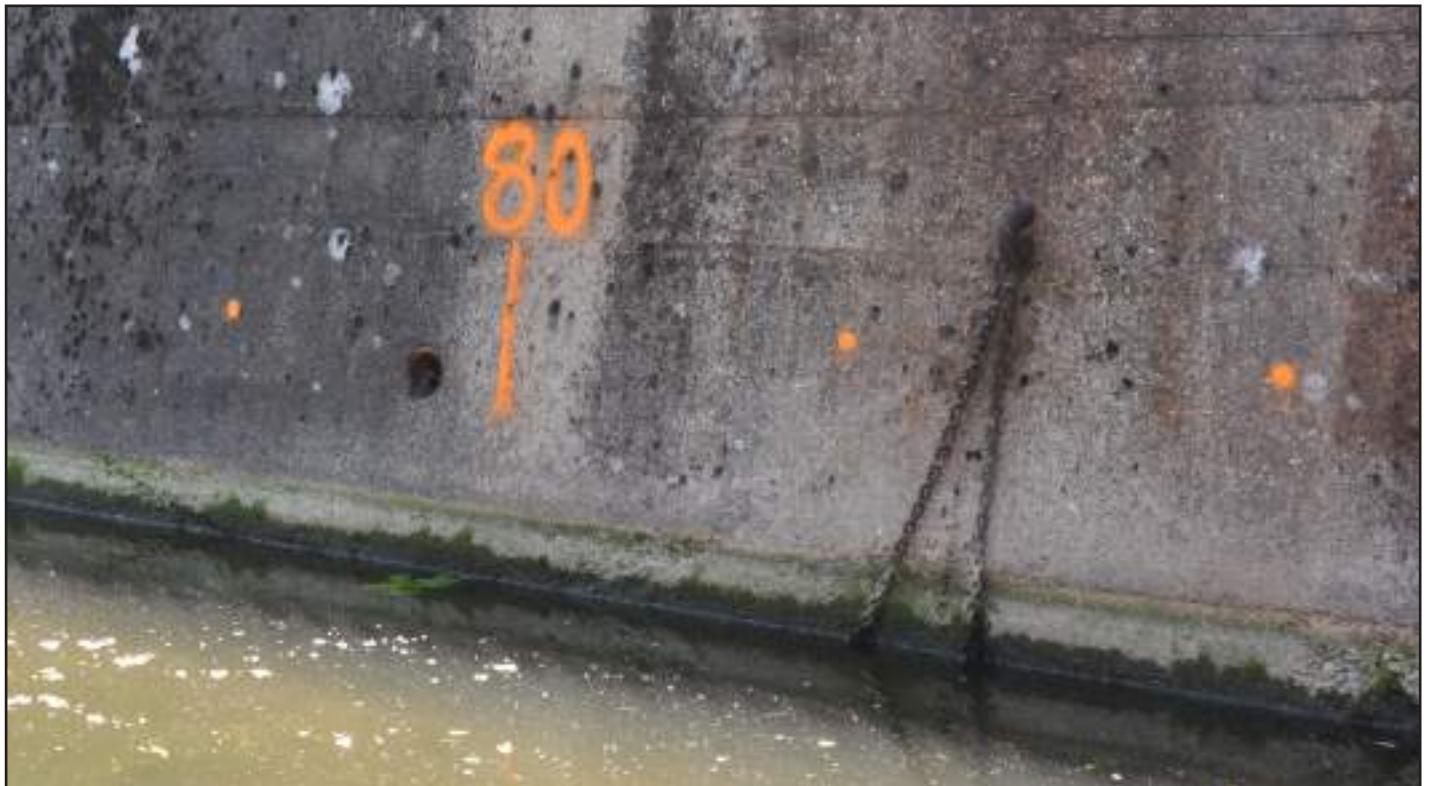
Fig.38

78.6m chainage - Ring in wall with detached chain in position to 109m up to this point all missing.

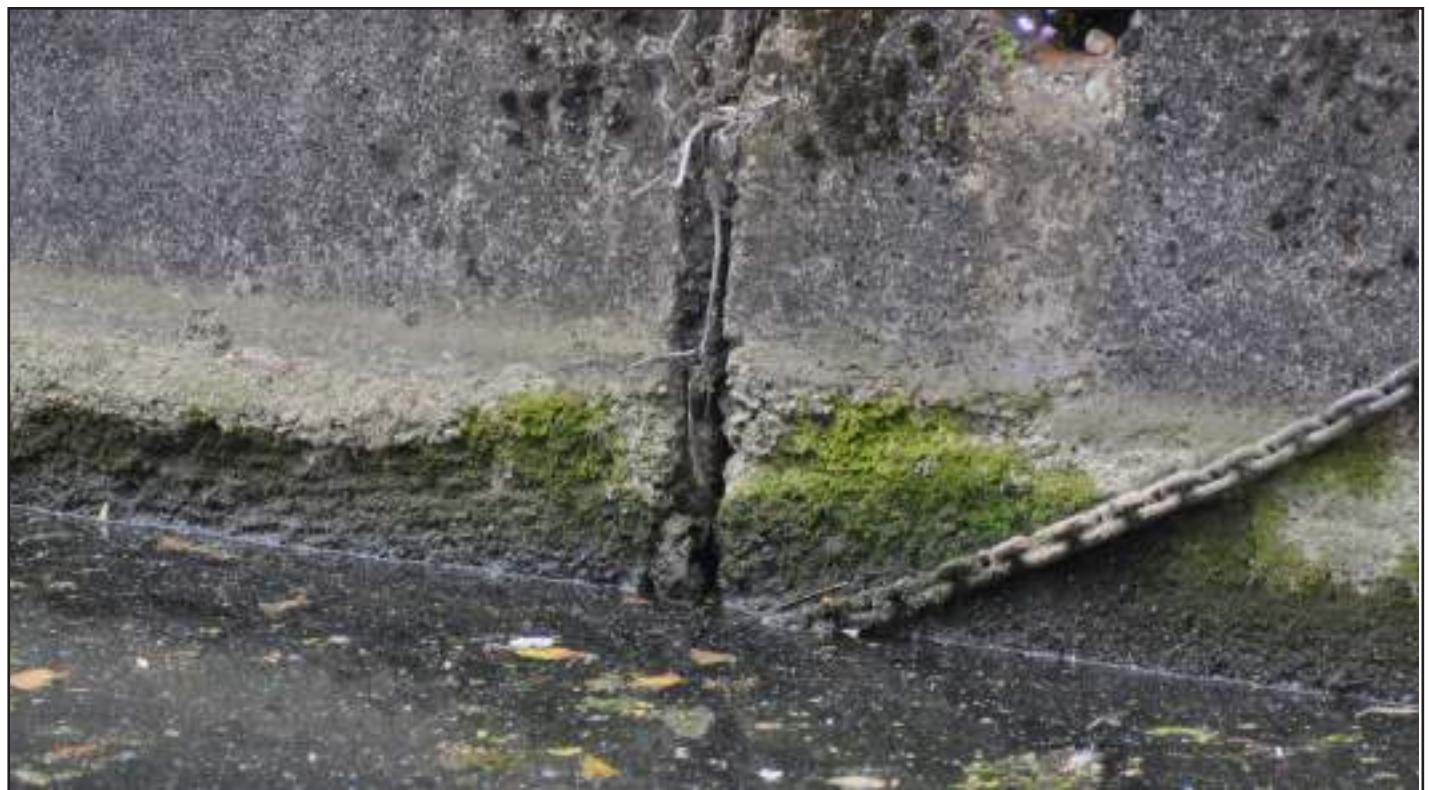
Fig.39

83.3m chainage - Construction joint (vertical) displaced expansion joint material from 150mm at W/L to bed level.
From Construction joint at 83.5m to chain ring loop at 86m evidence of weepage at pour joint - slight spalling and petrification.

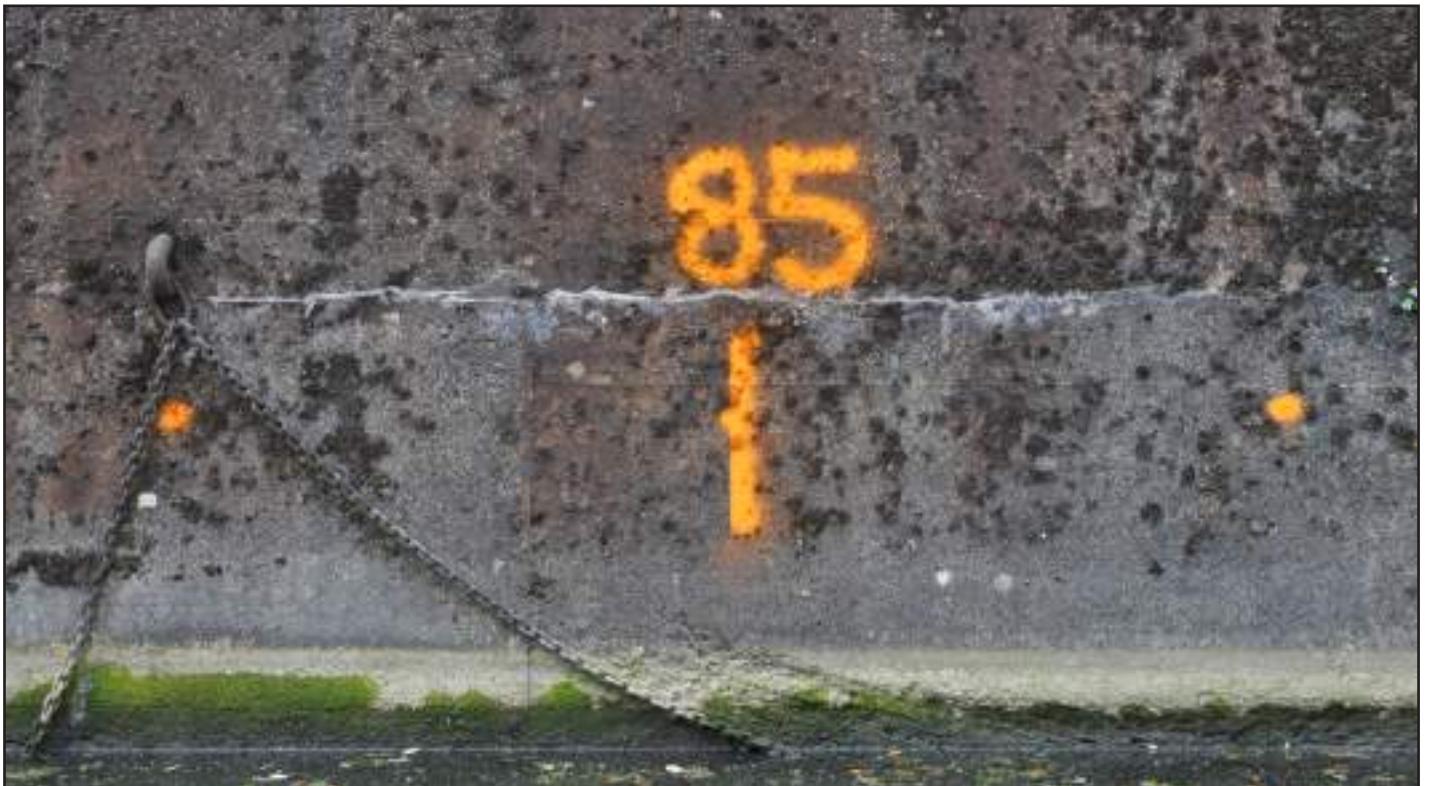
Fig.40
85m chainage - Debris steel tubing - on bed
10mm sticking out plinth along wall at base all satisfactory.

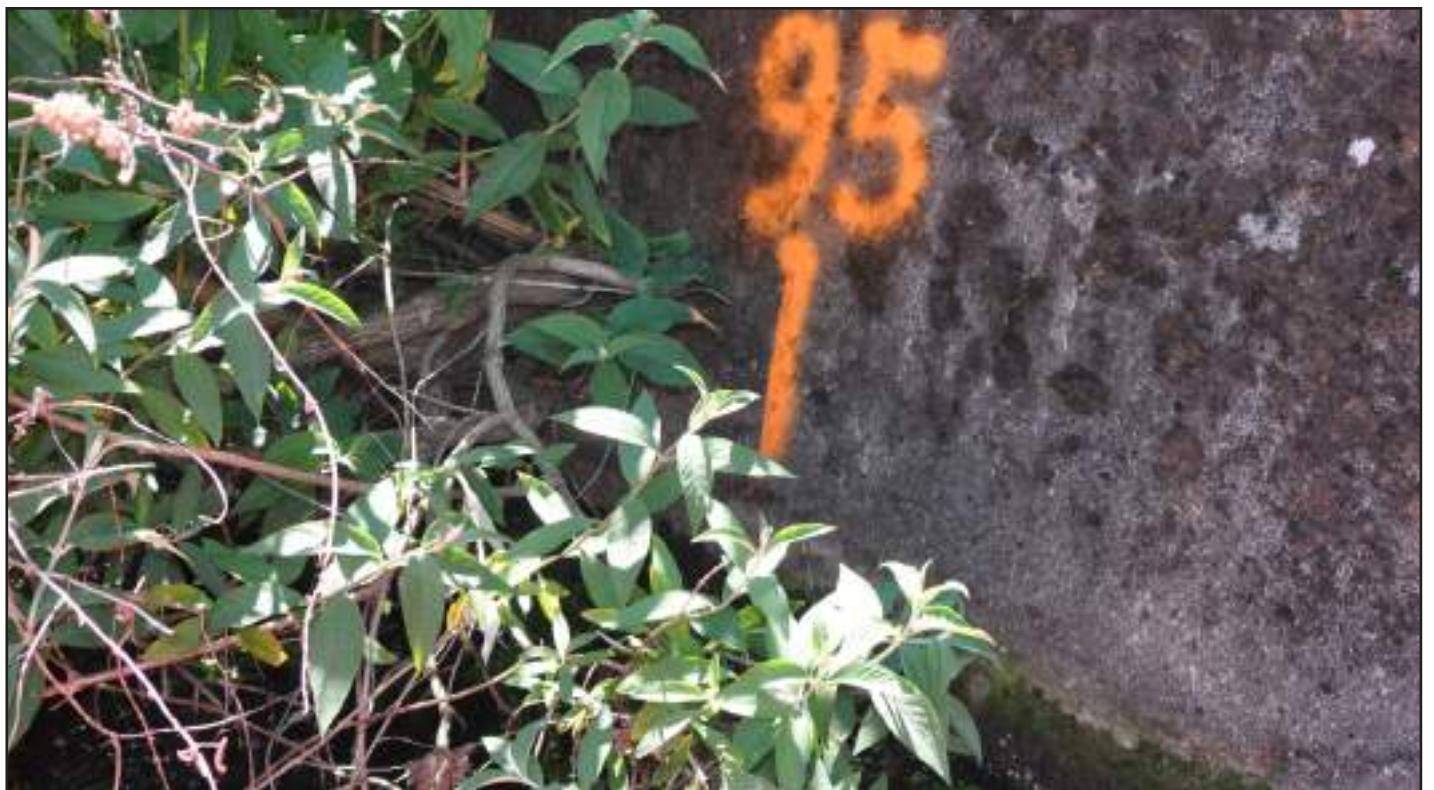
Fig.41
95.9m chainage - Vertical construction joint (in centre of Bush) 150mm above W/L to bed level.

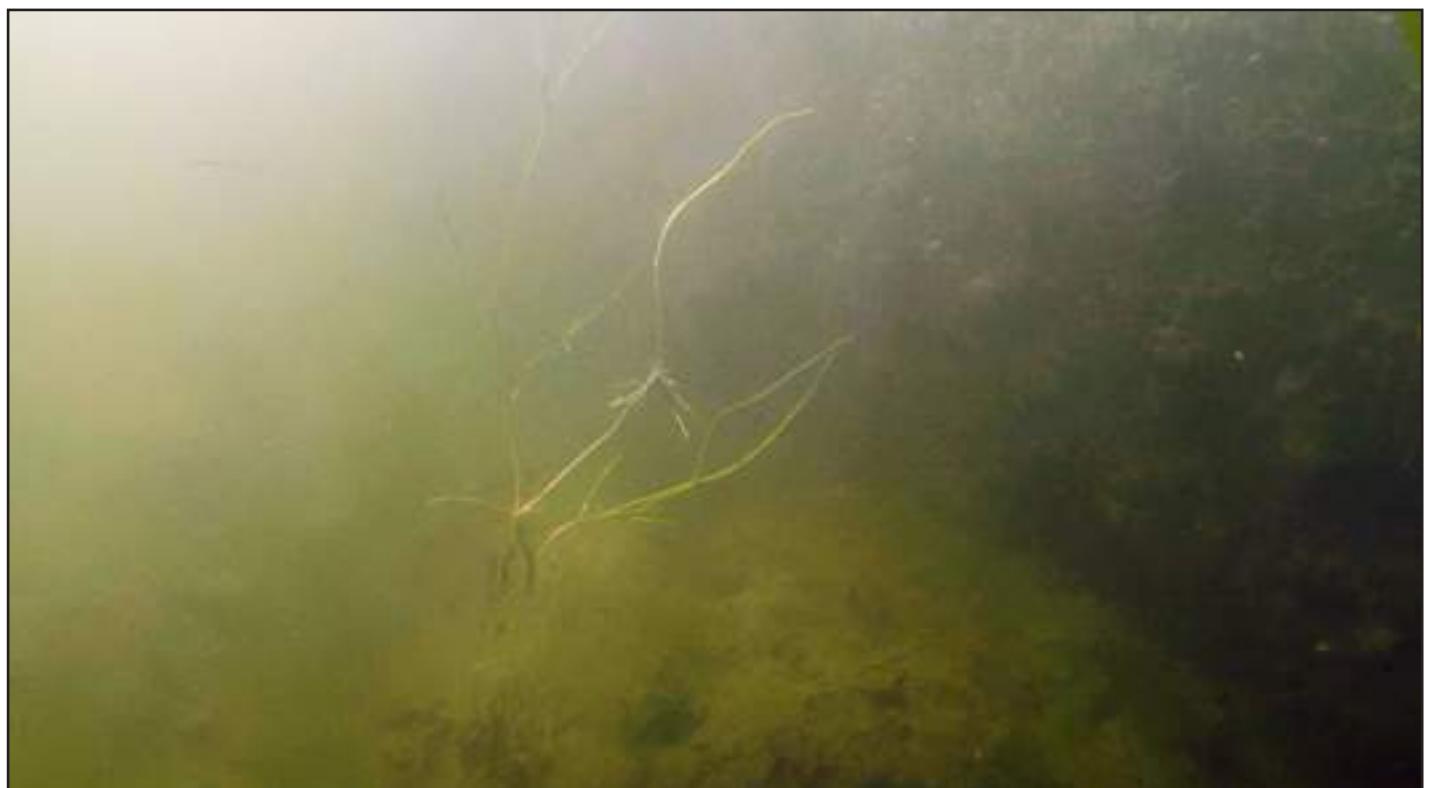
Fig.42B

50m to 109m chainage - Underwater photograph shows typical condition. No defects or undercutting located at bed level.

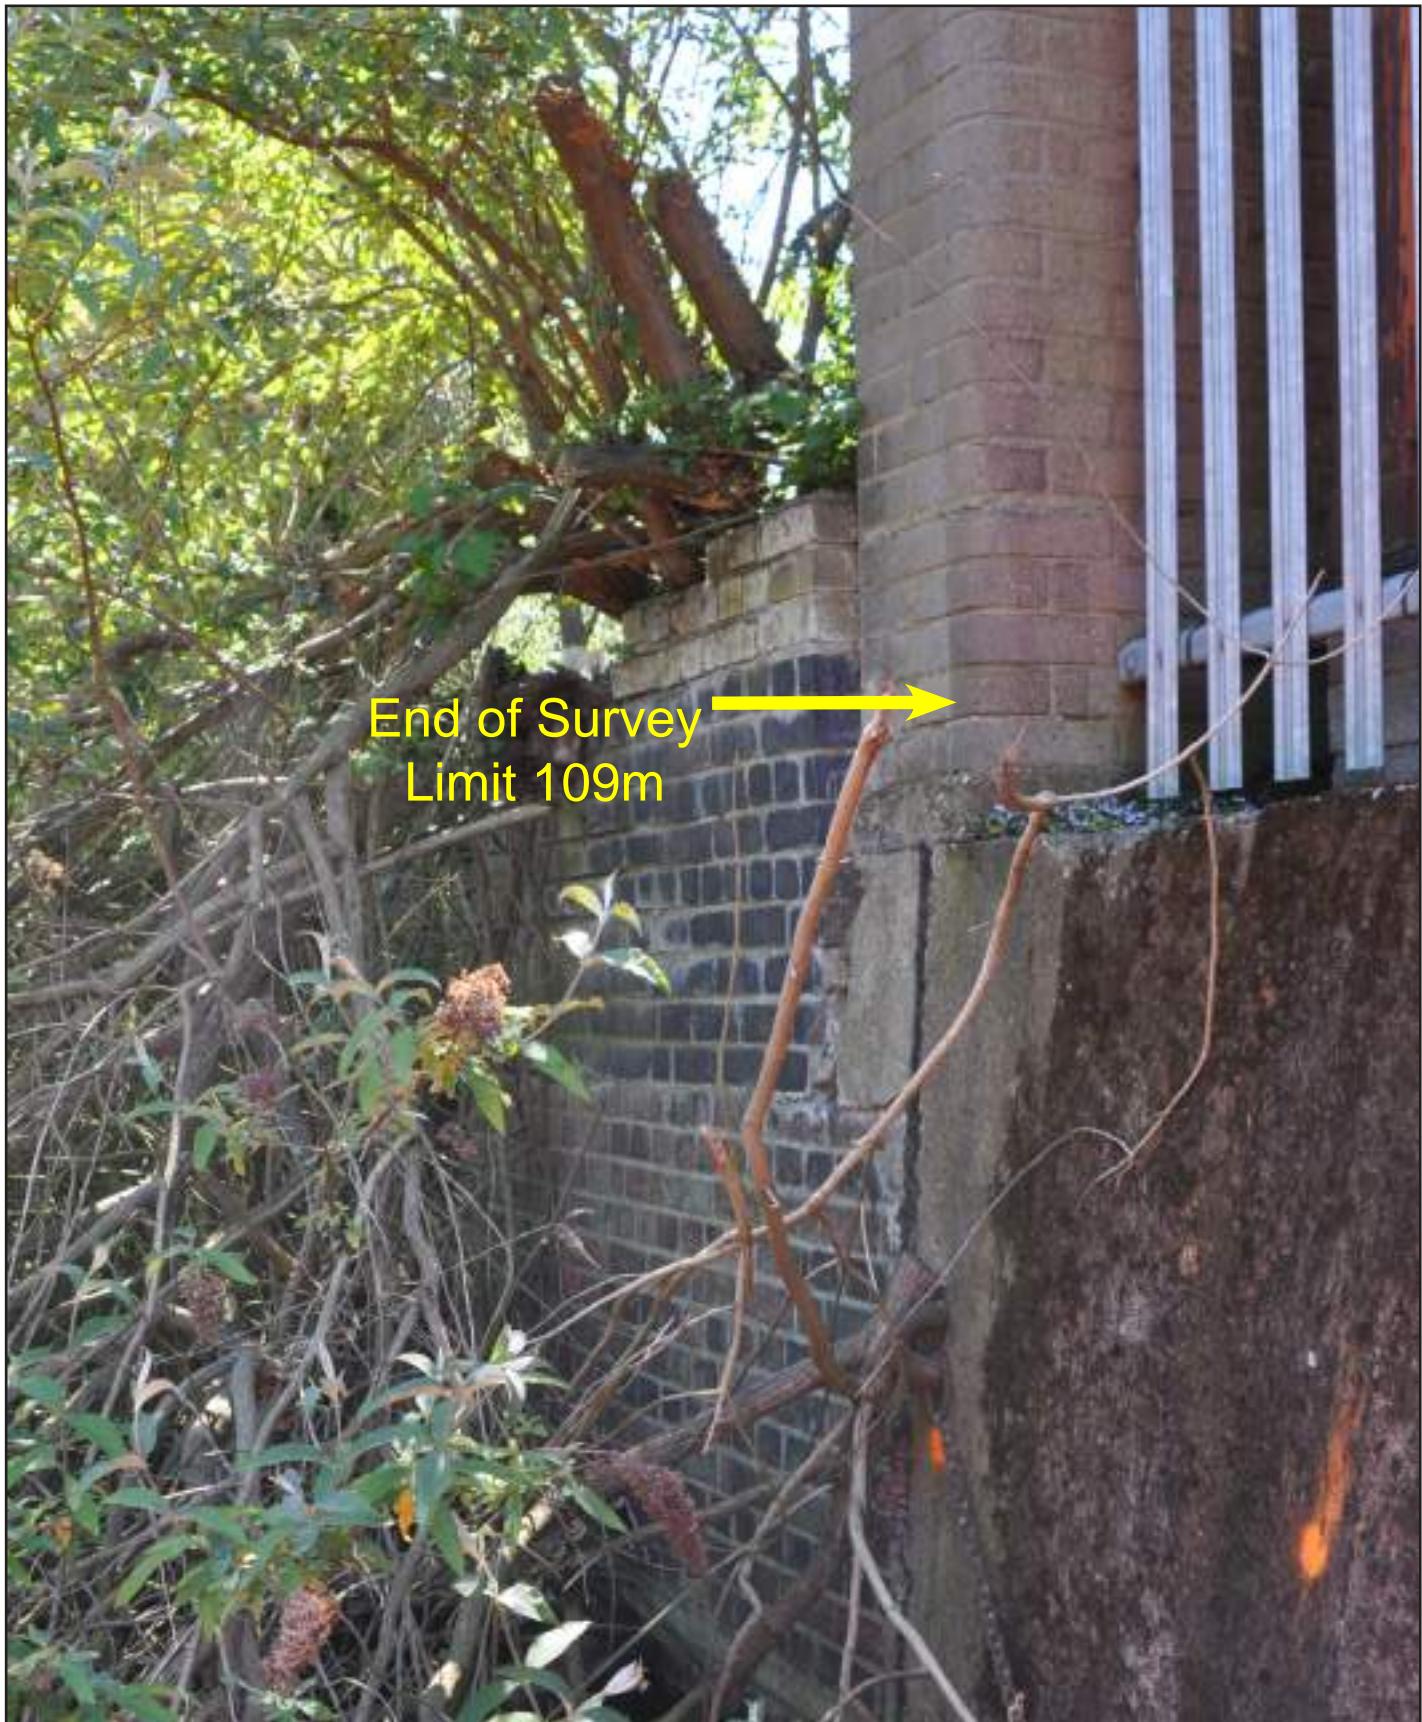
Fig.43

It was also noted that the return boundary brick wall at chainage 109m is defective with structural cracking and some displacement of masonry from its emergence of the canal edge to the brick building on the site (see figs 43 & 44). A full assessment was not possible due to restricted access created by Sea Containers and needs further evaluation.

108.1m chainage - Start of chain ring loops 35mm steel O bar. At corner tree growing from over boundary line pushing top x 12 courses of bricks out of perpendicular - extension foundation block cast in situ to accommodate boundary wall on concrete "Pad Stone" - Return boundary wall constructed of grey brick.

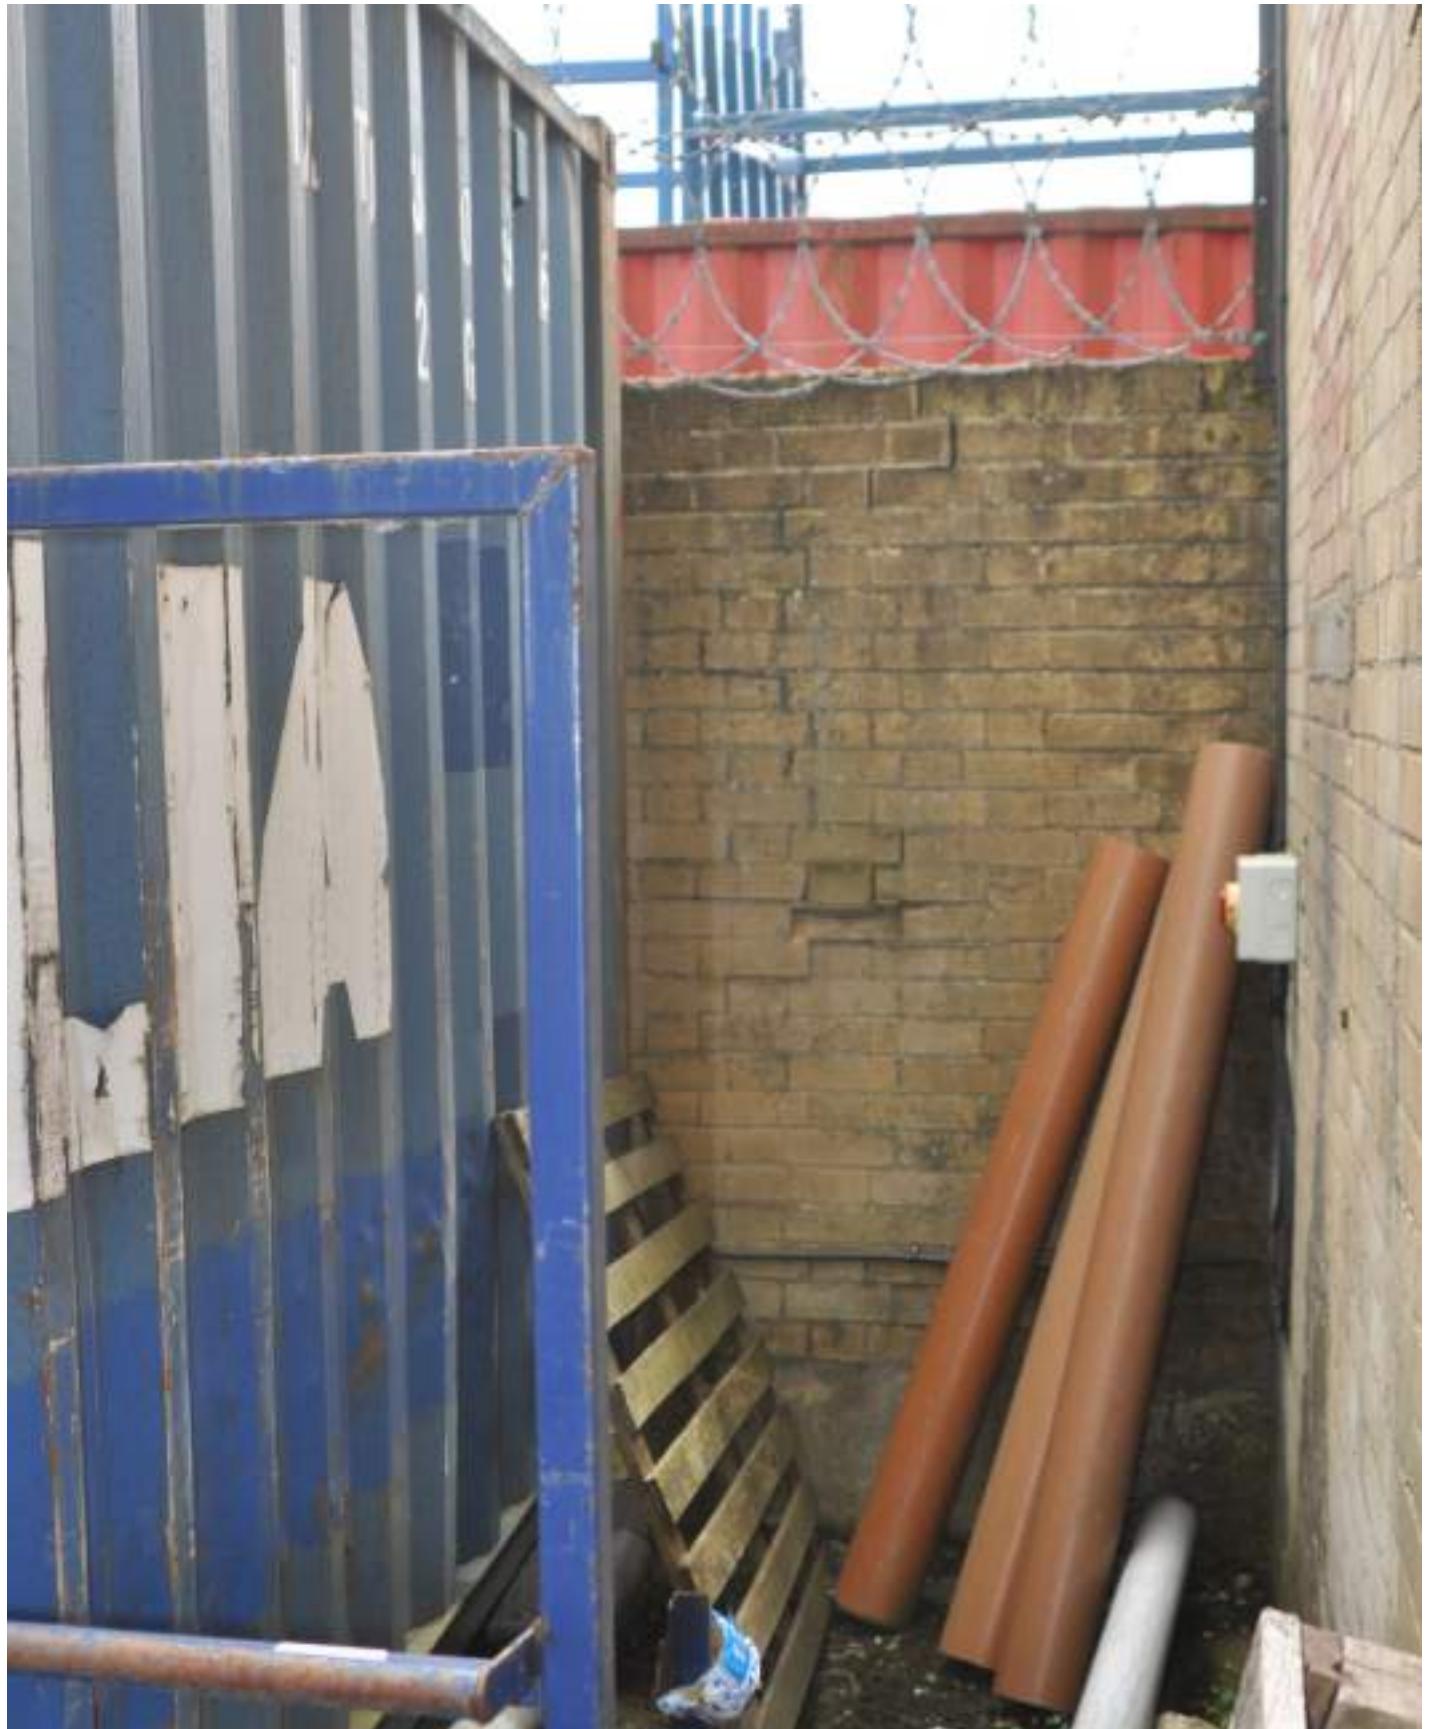
Fig.44

Secondary view of return boundary wall from top side showing angle brackets carrying barbed wire - Impact damage and some structural cracking present.

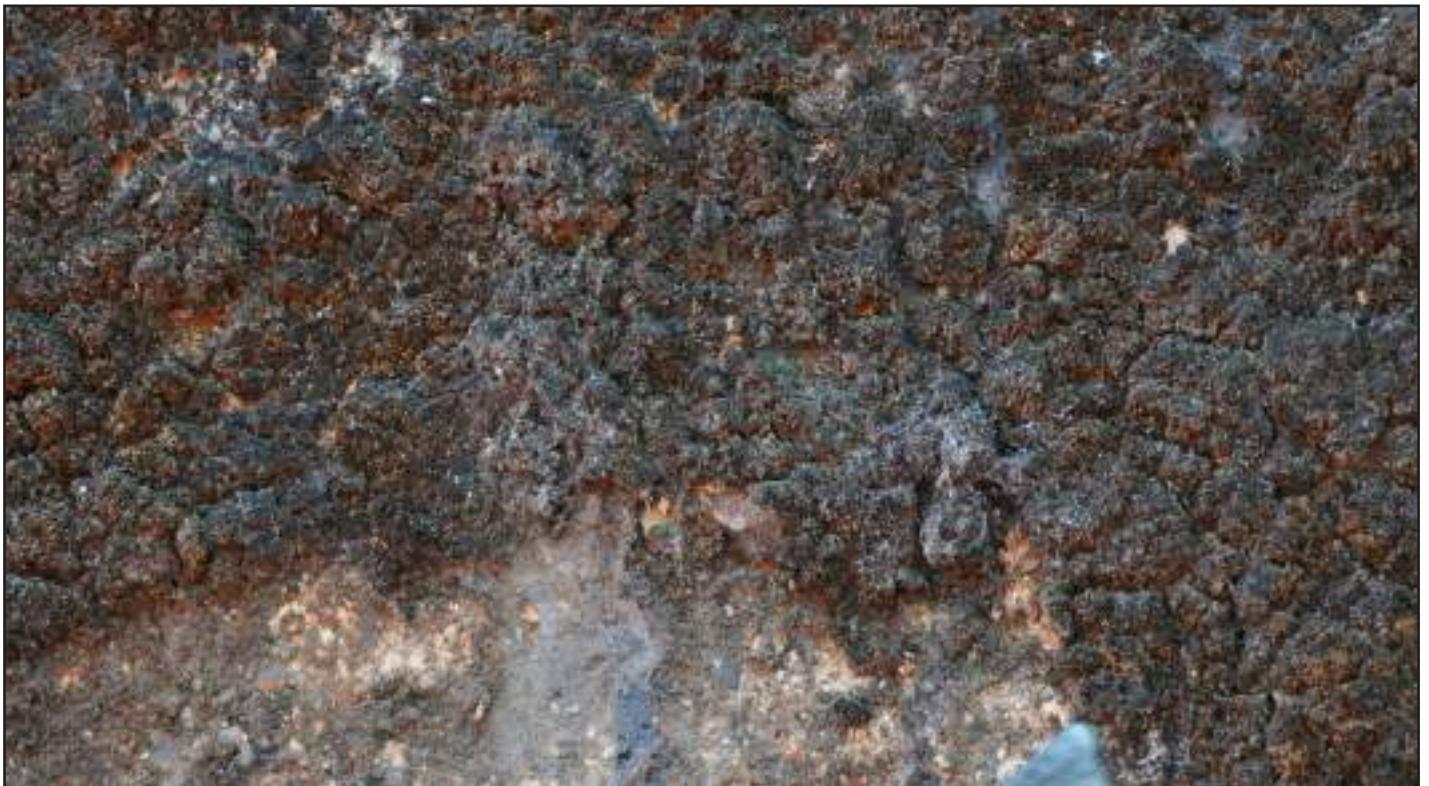
Fig.52

The Concrete section from 50m to 109m was satisfactory at the time of survey with only minor areas of small defects and/ or erosion. There is a covering of dead moss type vegetation which has formed a crust on the face. This is easily removable (See Figs 52 & 53).

General view of Moss type crust (marine growth) on face of concrete wharfage wall from chainage 50m to 109m

If an improvement in this section is sought high pressure jet washing would create a visual improvement at relatively low cost.

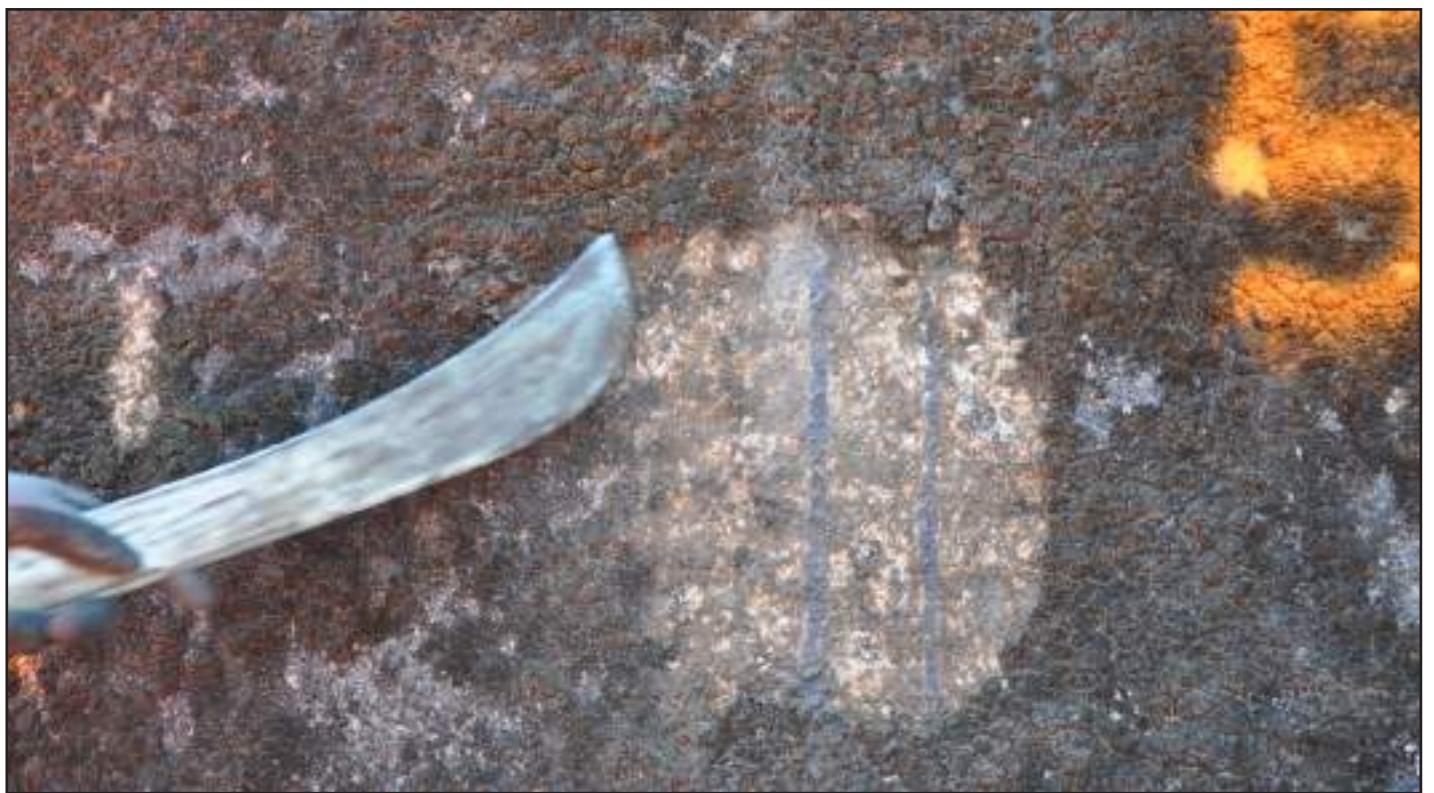
Fig.53

Removal of Moss type crust (marine growth) on face of concrete wharfage wall showing condition of concrete beneath.
