# Arboricultural Consultancy for Lloyds Bank

Insured	Mr and Mrs David and Julie Payne	Address	85C Green Lane, Northwood, HA6 1AH		
Client	Subsidence Management Services	Contact	Gary Hoban	Claim No.	IFS-LBG-SUB-25-0115754
ES Ref	SA-255654	Consultant	Kirk Thompson	Contact No.	0330 380 1036
Report Date	02/05/2025

The insured structure is a 2 storey detached house. The property occupies a level site with no adverse topographical features. We understand that the current damage relates to the right-hand flank of the insured garage, where cracking indicates downwards movement.

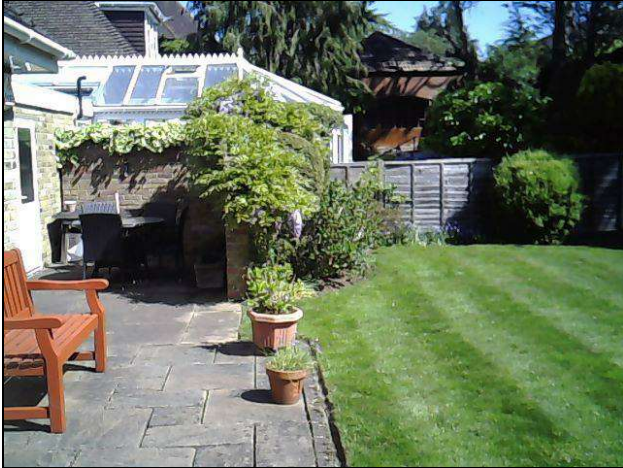
SG1 - Mixed species group

Tree No.	Species	Age Cat	Approx. Height (m)	Distance to Building (m) *	Ownership	Action	Requirement
H2	Laurel (Cherry)	1	3	3.5	A - Third Party	Action to avoid future risk	Maintain at broadly current dimensions by way of regular pruning.
SG1	Mixed Species Group: includes Wisteria, Hydrangea and Cypress.	1	2.5	2.5	C - Insured	Action to avoid future risk	Maintain at broadly current dimensions by way of regular pruning.
SG2	Mixed species shrubs: includes Pittosporum, Rhododendron, Photinia, Eleagnus, Holly and Buddleia.	1	2.2	1.3	C - Insured	Action to avoid future risk	Maintain at broadly current dimensions by way of regular pruning.
T1	Beech (Common)	2	15	16	A - Third Party	Action to avoid future risk	Maintain at broadly current dimensions by way of regular pruning.
T2	Cypress (Lawson)	1	12.5	13	C - Insured	Action to avoid future risk	Maintain at broadly current dimensions by way of regular pruning.

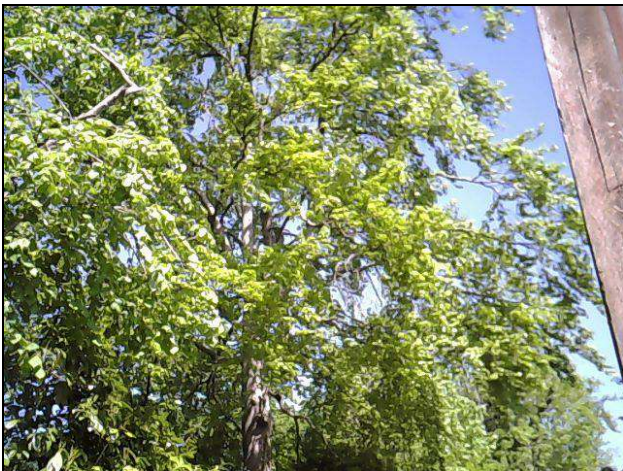
T4 - Beech (Common)

T3	Cypress (Lawson)	1	8.5	12.5	C - Insured	Action to avoid future risk	Maintain at broadly current dimensions by way of regular pruning.
T4	Beech (Common)	1	15.5	9.2	F - Commercial Third Party	Action to avoid future risk	Maintain at broadly current dimensions by way of regular pruning.
T6	Oak	3	24	25	F - Commercial Third Party	Action to avoid future risk	Crown reduce overall canopy by 30% (minimum) to achieve a crown volume reduction in line with BRE IP7/06. Maintain at reduced dimensions by re-pruning back to points of previous reduction on a 3 year (max) cycle.
TG1	Mixed Species Group: including Pine, Beech, Ash, Laurel, Lime and Oak.	1	21	9.5	F - Commercial Third Party	Action to avoid future risk	Maintain group at broadly current dimensions by way of regular pruning.

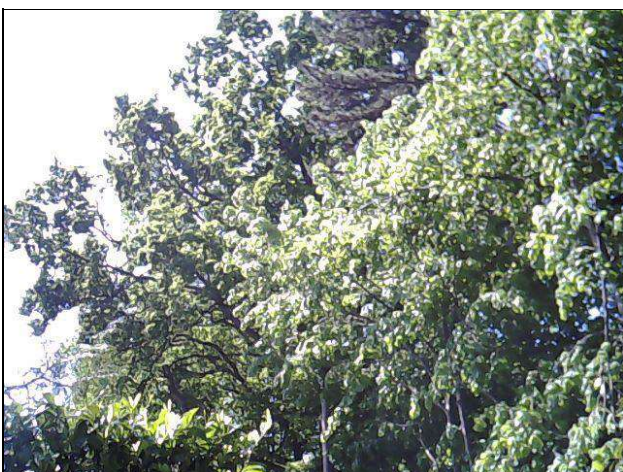
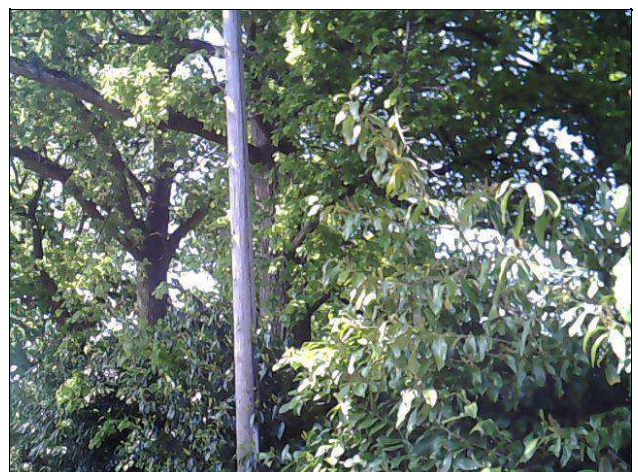
T5 - Oak

With due regards to species profile, size and proximity, H1 (Cypress) and T5 (Oak) are considered the dominant features

proximate to the focal area of movement and accordingly, where vegetation is confirmed as being causal, we have identified them as the primary cause of the current subsidence damage.

Tree No.	Species	Age Cat	Approx. Height (m)	Distance to Building (m) *	Ownership	Action	Requirement
H1	Cypress	1	6	0.5	A - Third Party	Remove	Remove close to ground level.
T5	Oak	3	24	19	F - Commercial Third Party	Remove	Remove close to ground level; do not treat stump due to translocation risk. Where such a risk exists, we advise that any emergent regrowth is removed annually.

Consequently, we have advocated the complete removal of H1 and T5 as it will offer the most certain arboricultural solution likely to restore long-term stability.
