The Garland Company UK, Ltd.

Roof Asset Management Programme

CLB Building

# Inspection Report

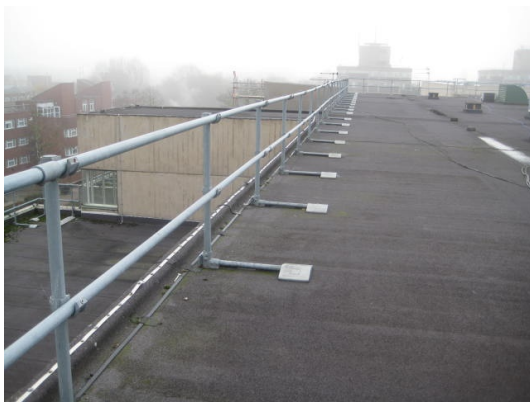
*Photo 1*

Image giving an overview of the higher roof section.

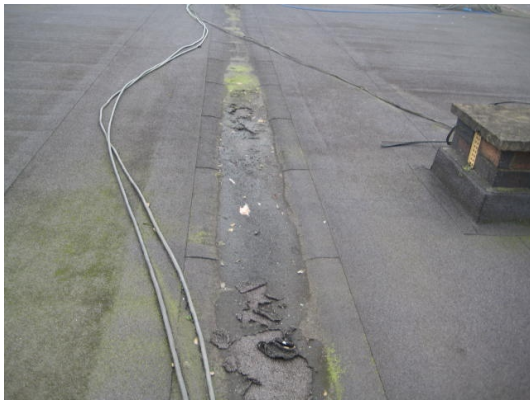
*Photo 2*

The field of the roof, on first visual inspection, appears to be in fair condition, with the 2 layer overlay appearing to have been quite well installed and probably under 10 years old. On closer inspection, however, it is clear that there are areas of the roof with water trapped within the system, most prevalently within the internal gutter details, where there is evidence of trapped water.

Image showing a central gutter, which has water between the layers of felt.

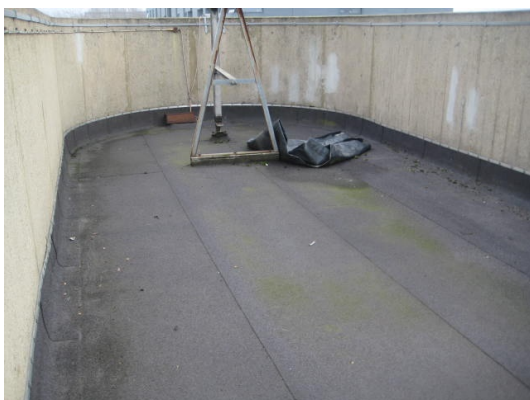
*Photo 3*

Image showing one of the curved side roof areas.

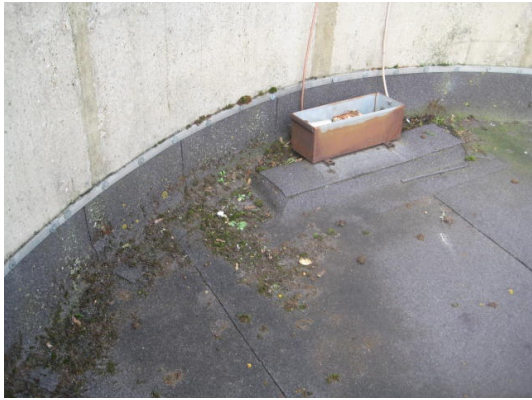
*Photo 4*

Image giving a closer view of the end detail.

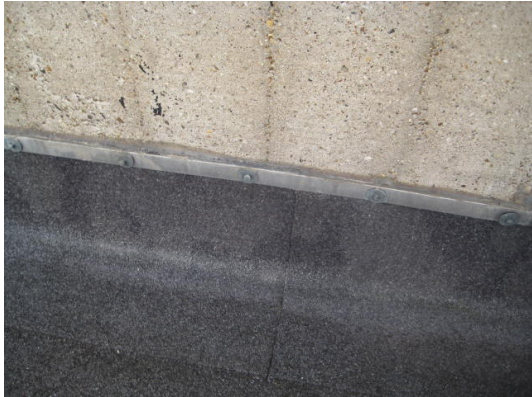
*Photo 5*

All of the wall upstand details are to concrete walls. The overlay felt has been installed up the walls, and in every details have been terminated with a narrow aluminium mechanically fixed termination bar, with the top joint sealed with mastic. The width of the aluminium bar gives no protection at all to the top joint of the felt, and the mastic seals are starting to fail in some areas. There are areas of the perimeter detail where water has got behind the termination bar and has caused water to enter the system. It is inevitable that as time progressed, the top joints will fail more and more water will enter the system, leading to ingress into the building below.

Image showing the very poor termination at the wall upstand detail, with a mechanically fixed thin aluminium bar used at all details.

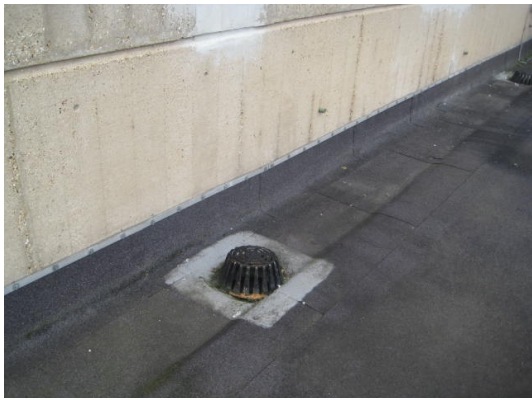
*Photo 6*

There are also some areas where paint on repairs have been installed, suggesting that there may have been ingress issues in the past, as well as some ruckling to the membrane.

Further image showing a wall upstand detail, with an internal outlet with a paint on repair also shown.

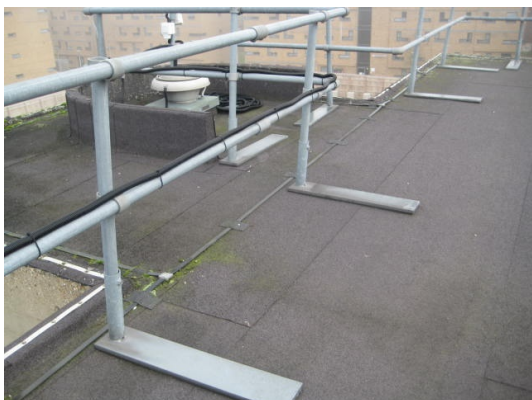
*Photo 7*

Image showing a small side area to the higher level roof area.

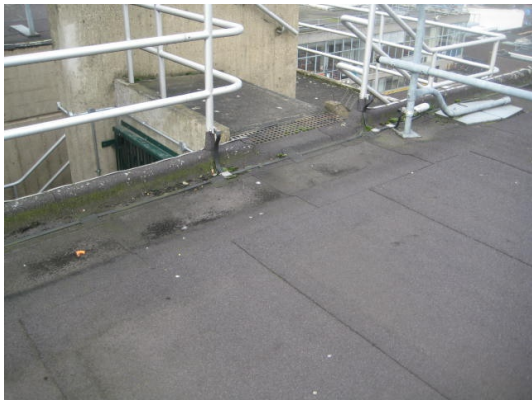
*Photo 8*

Image showing an area of the higher roof which leads to stairs and an access door.

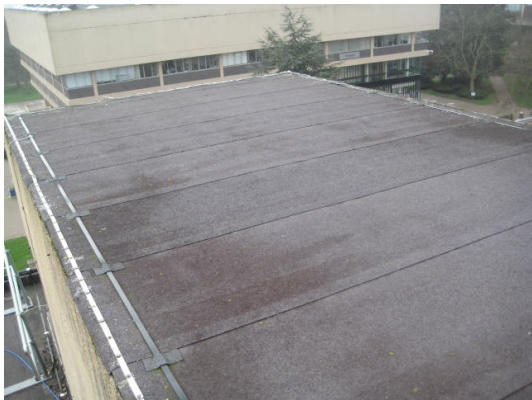
*Photo 9*

Image showing one of the small side roof sections, with no upstand heights at the perimeters.

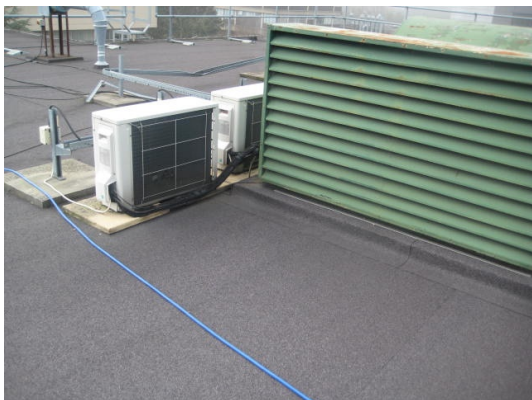
*Photo 10*

There is considerable plant on the roof, mainly on the higher level main roof area. The plant is a mixture of A/C units sited directly on the roof and larger items, such as vents and large trunking of extracts. The larger items of plant appear to be old and many items are in very poor condition. It is suggested that a full audit of the plant is undertaken, to assess which items are in use and which items are redundant. Measures should also be taken to adapt, or replace, items of plant which are sited directly on the roof and those that penetrate the roof.

Image showing one of the large vent units on the roof, with some small A/C units adjacent. All plant will need raising or setting aside during proposed roofing works.

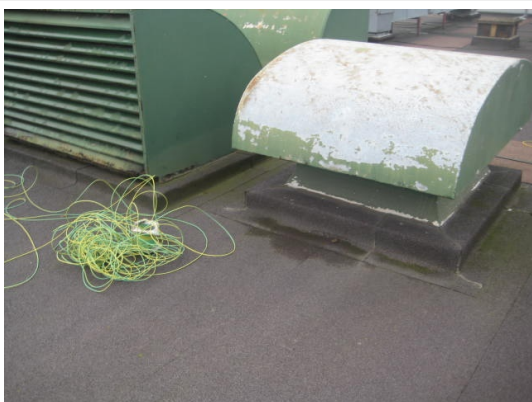
*Photo 11*

Image showing a smaller vent unit, which will also require adaption, or removal during proposed roofing works.

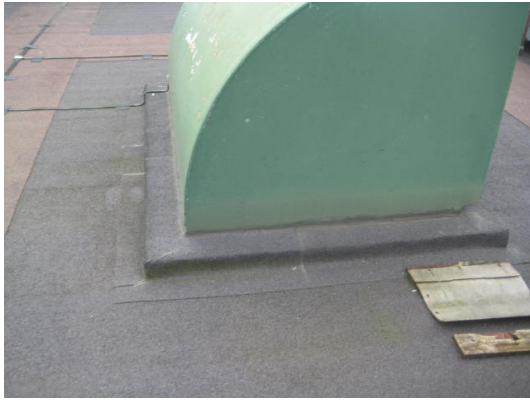
*Photo 12*

Image showing another of the large vents. The lower element of the metal units is rusted through.

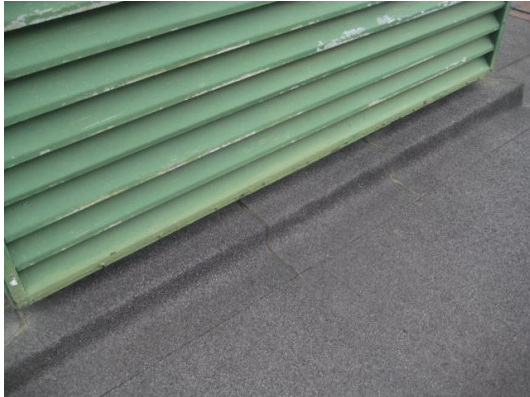
*Photo 13*

Image showing the very low threshold. Once insulation is introduced, this will be below roof level.

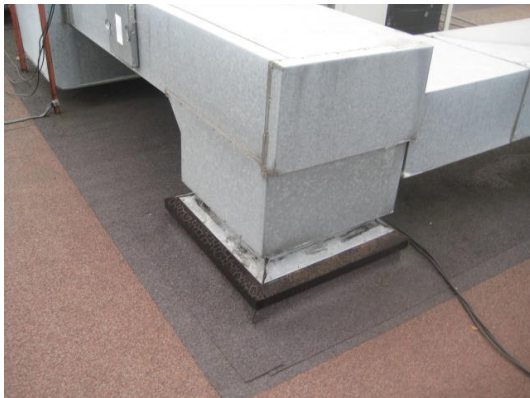
*Photo 14*

Image showing large trunking which will also require adapting to accommodate the new roof, and associated heights.

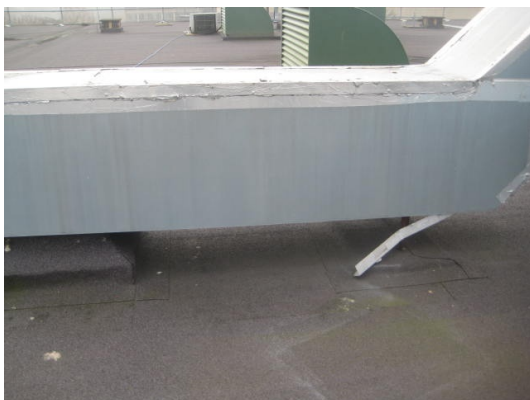
*Photo 15*

Further image showing the large trunking.

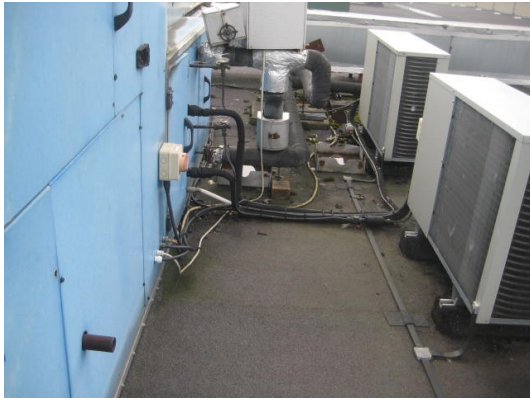
*Photo 16*

Image showing a large item of plant, which will require removal to facilitate roofing works.

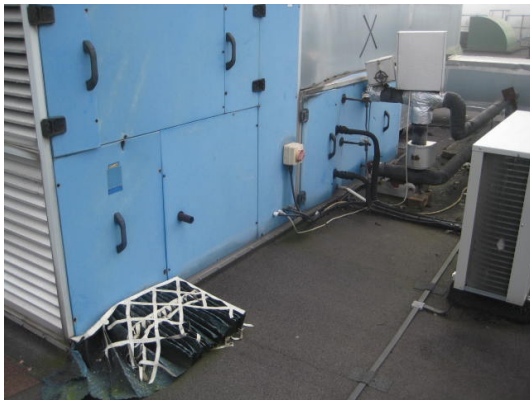
*Photo 17*

Further image showing the plant.

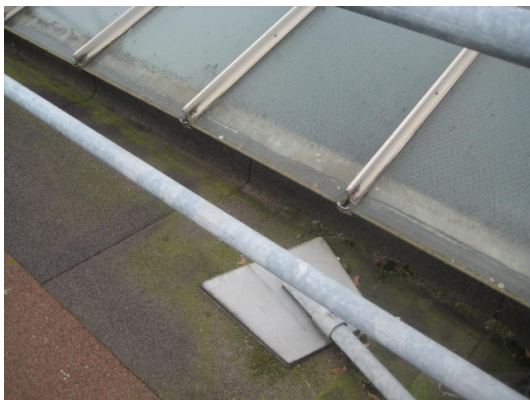
*Photo 18*

Image showing a low front detail to a glass mono pitch roof light.

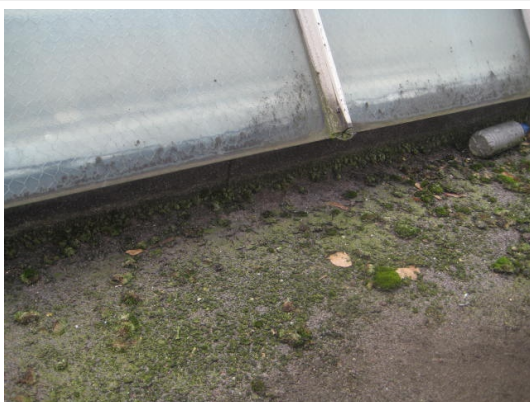
*Photo 19*

Image showing the rear elevation of the mono pitch roof light.

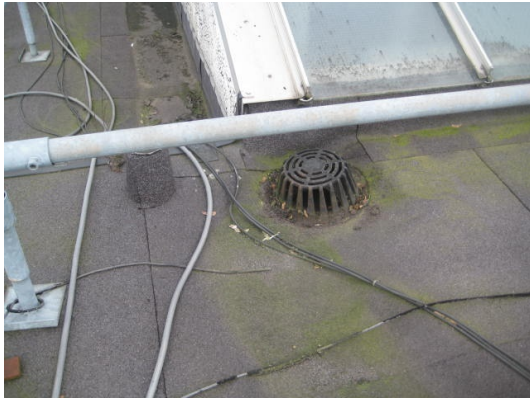
*Photo 20*

Image showing an adjacent internal outlet, which will enable a gutter to be introduced.

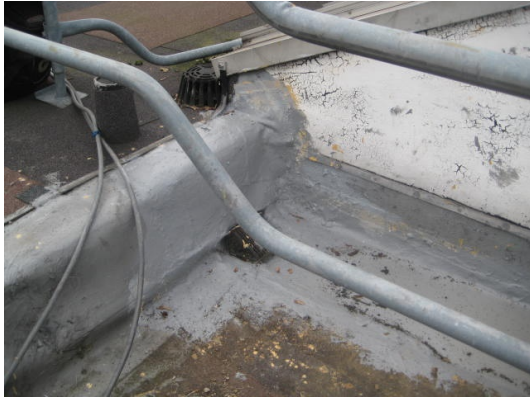
*Photo 21*

Image showing a temporary repair to a troublesome outlet adjacent to the mono pitch roof light. There has been significant ingress beneath this area.

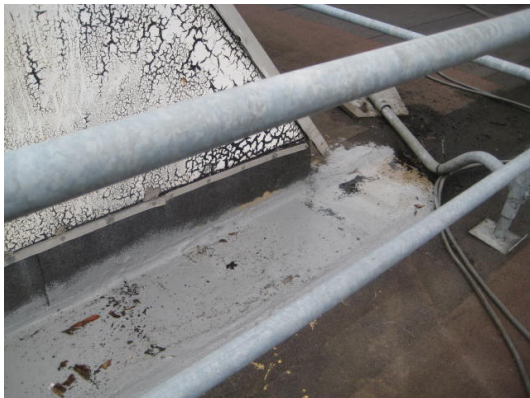
*Photo 22*

Further image showing the paint on repair.

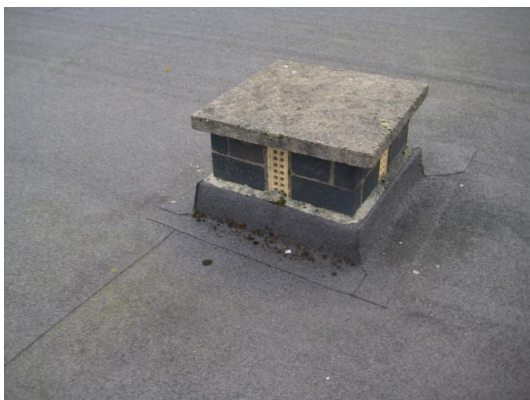
*Photo 23*

Image showing one of a number of brick built vents on the roof areas.

The brick built vents appear to be redundant, and it is recommended that these are removed during roofing works, to remove this potential weakness.

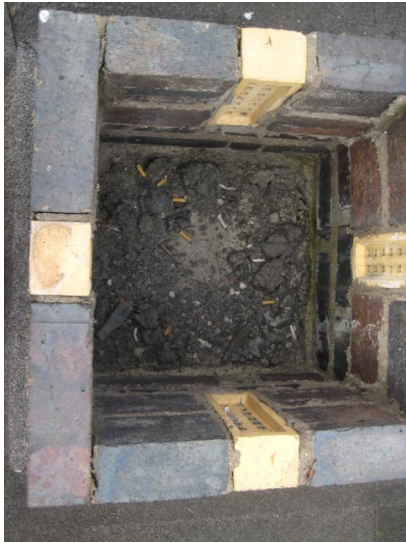
*Photo 24*

Image showing the brick vent with the concrete paver removed, revealing a simple void. The brick built vents can therefore be removed from the roof.

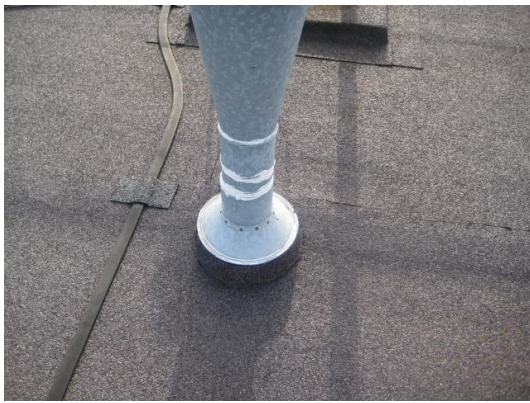
*Photo 25*

Image showing a pipe penetration on the roof, which will need alteration, or renewal to facilitate roofing works.

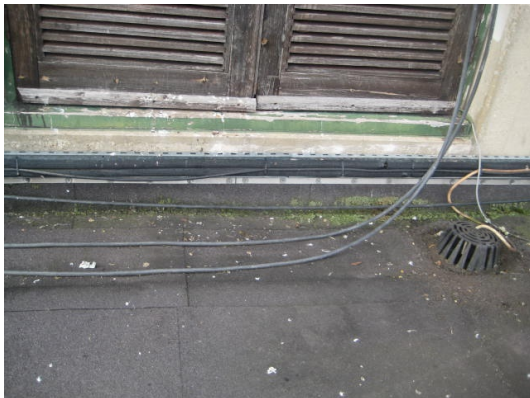
*Photo 26*

Image showing a low laying door threshold, which will require raising during proposed roof works.

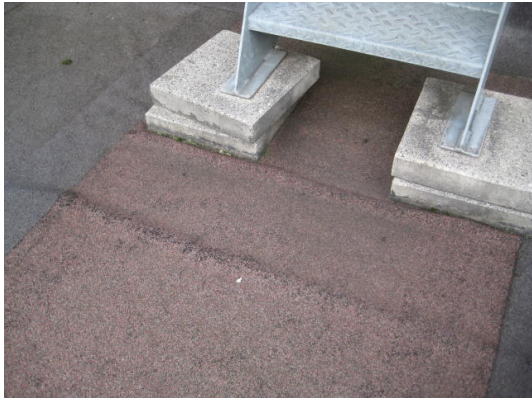
*Photo 27*

Image showing a set of stairs, which will require adapting during potential roofing works.

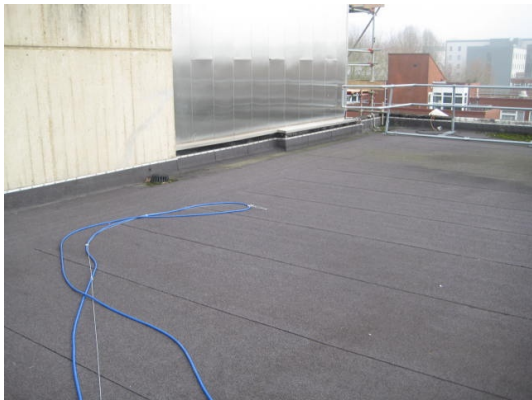
*Photo 28*

Image showing one of the lower level roof sections.

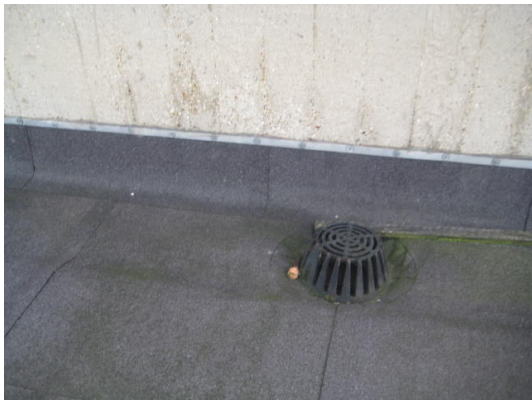
*Photo 29*

Image showing an internal gutter, adjacent to a wall upstand detail, with an internal outlet present. There is significant water held within the system in this area, and to a number of the internal gutters.

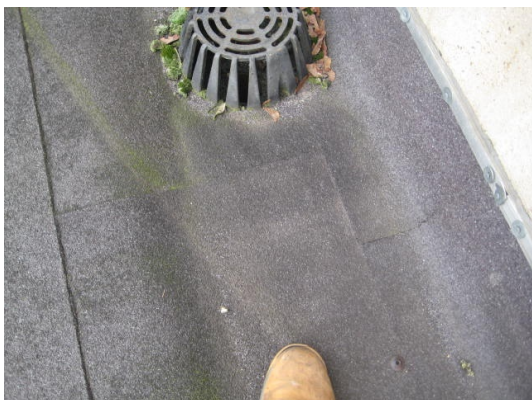
*Photo 30*

Image showing pressure being put on the water held within the system.

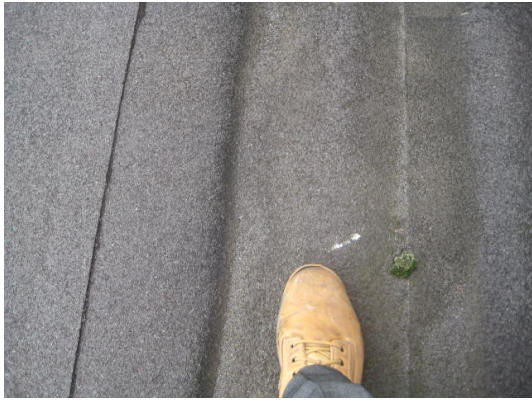
*Photo 31*

Further image showing the extent of the water held within the system.

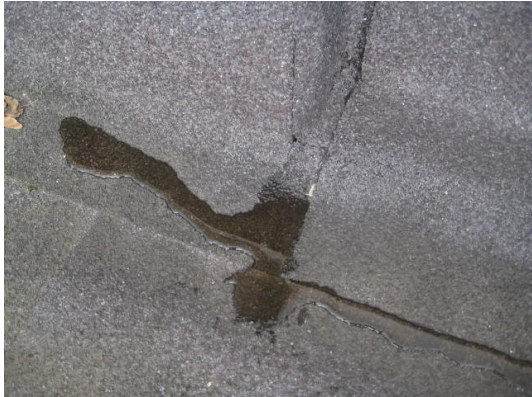
*Photo 32*

Image showing water exiting the system at an upstand detail.

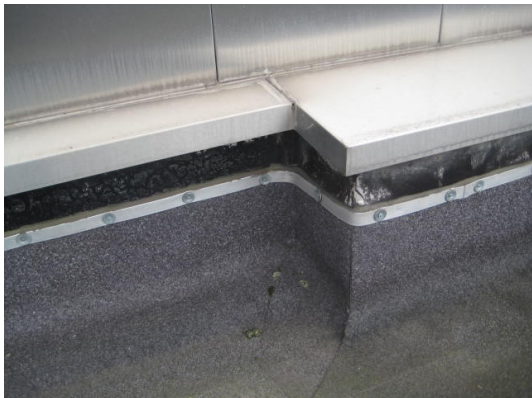
*Photo 33*

Image showing a poor area of detailing, adjacent to a a metal clad additional structure.

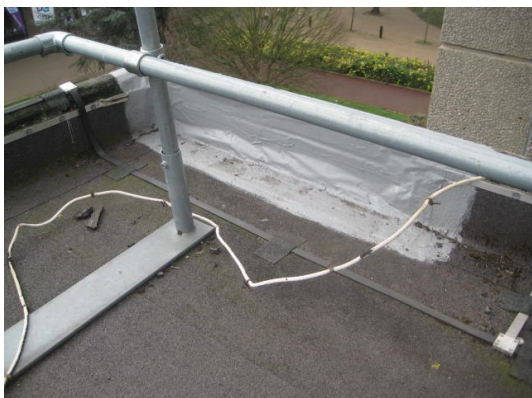
*Photo 34*

Image showing an area of patch repair to the perimeter check detail.

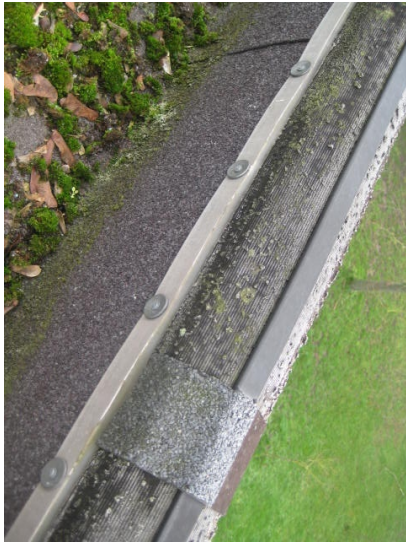
*Photo 35*

The perimeter parapet details also have the same aluminium termination bars used, both at the vertical upstands, and, in some areas, mechanically fixed in the horizontal plane. The vertical details are exactly the same as the wall upstand details, and are in the same condition, but the horizontal detail has numerous mechanical fixings penetrating the felt, and, inevitably, has lead to some water entering the system at these penetrations.

The check details, and all of the level details, have the same horizontally installed aluminium bar, with mechanical fixings, which is contrary to any good roofing practice.

Image showing the perimeter detail, with the membrane mechanically fixed with an aluminium bar, as used at all wall upstand details.

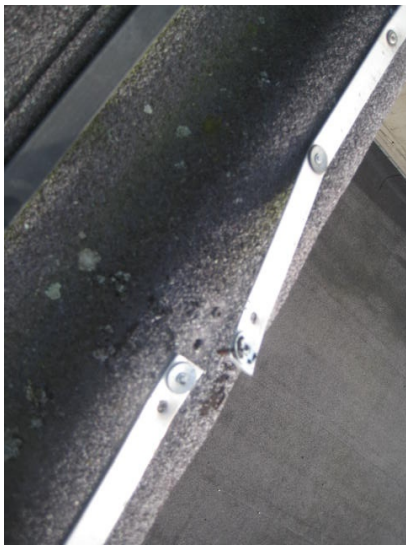
*Photo 36*

Image showing a broken section of the aluminium bar. Water can now get behind the membrane.

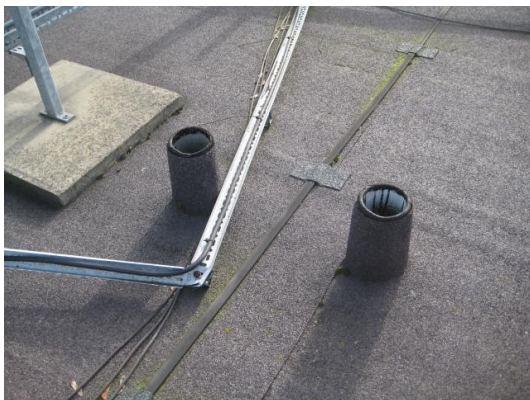
*Photo 37*

Image showing soil/vent pipes, wrapped with felt. This is very poor detailing and all pipes should have telescopic units installed.

The soil/vent pipes have been wrapped, incorrectly, with the overlay felt. It is therefore impossible to comment on the condition of the original pipes, but it is recommended that new telescopic refurbishment units are installed during potential roofing works, to ensure that the pipes do not present a weakness in the new system.

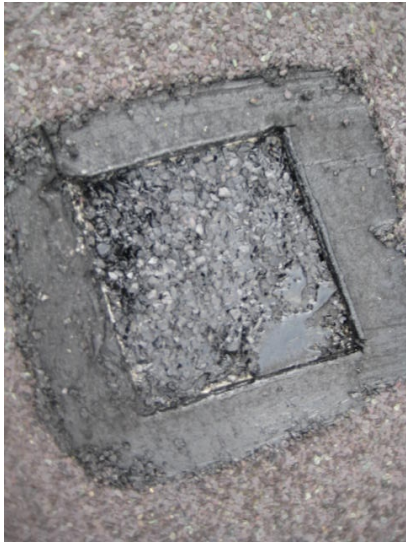
*Photo 38*

Image showing the 2 layer overlay membranes removed, exposing the asphalt beneath.

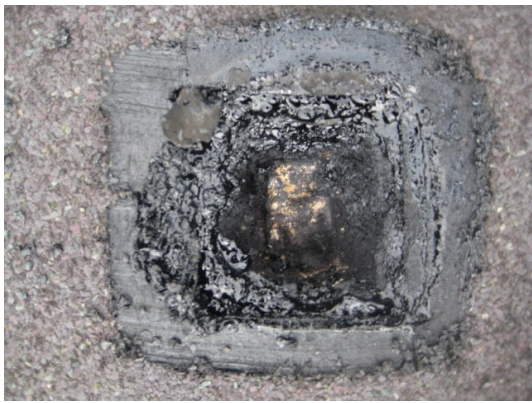
*Photo 39*

Image showing the core cut to the concrete deck.

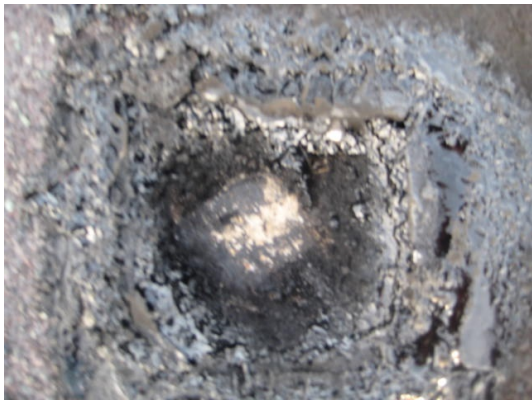
*Photo 40*

Image showing another core cut on the roof, with the same build up as the rest of the roof sections.

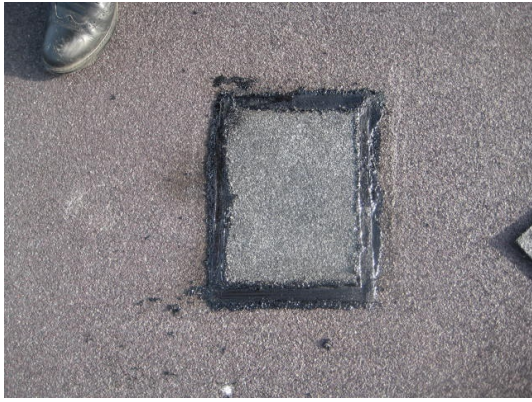
*Photo 41*

All cores are sealed with torch on membrane, to ensure continued waterproofing integrity.
