**Project Union**

I would like to update you following receipt of the 'Sewer Alignment and Condition Survey' from Infotec of the 2134mm diameter Thames Water Crane Valley Sewer.

**Infotec Sewer Alignment and Condition Survey**

**Project Description:** CCTV DRAINAGE SURVEY

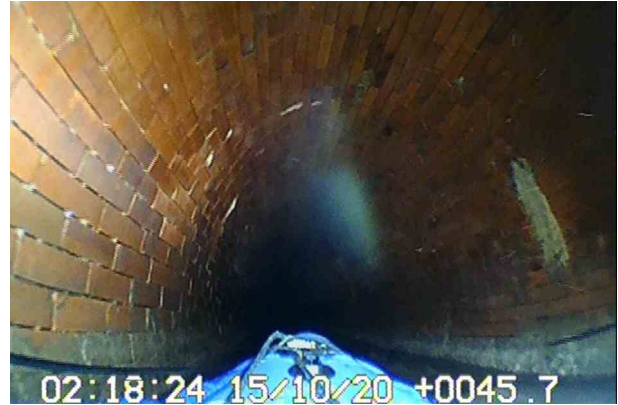
2, 45.80 m  
Attached deposits, encrustation from 2 o'clock to 4 o'clock, 5% cross-sectional area loss, SUGGESTS SLIGHT INFILTRATION

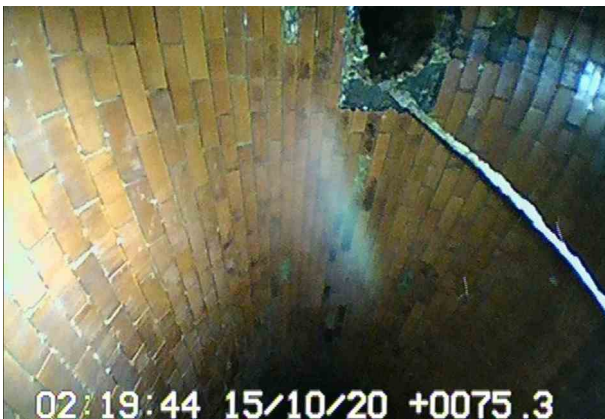
3, 75.30 m  
Connection other than junction at 12 o'clock, diameter: 300mm, LAMP HOLE (RAG HANGING)

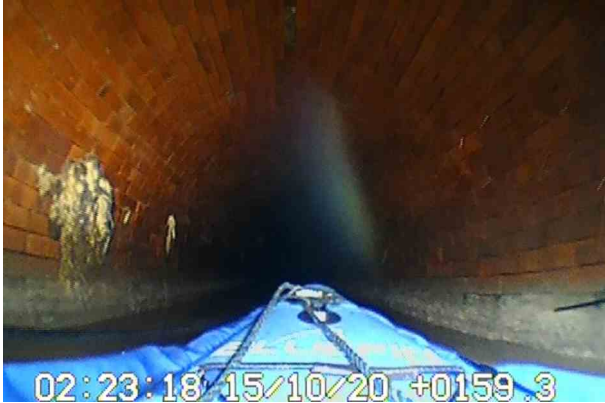
5, 159.20 m  
Attached deposits, encrustation from 8 o'clock to 10 o'clock,  
5% cross-sectional area loss, SUGGESTS SLIGHT  
INFILTRATION

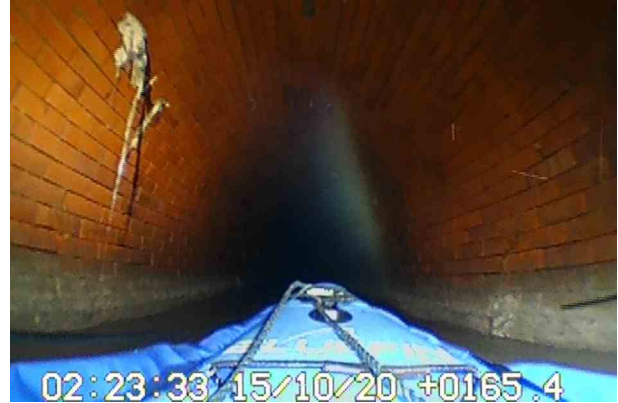
6, 165.80 m  
General remark, RAG HANGING AT 10 O'C

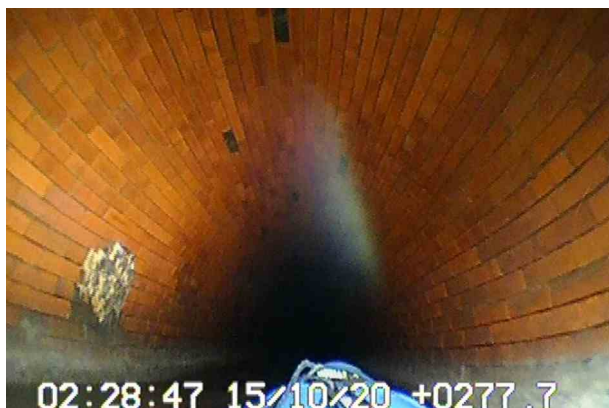
9, 277.90 m

Attached deposits, encrustation from 7 o'clock to 9 o'clock, 5% cross-sectional area loss, SUGGESTS SLIGHT INFILTRATION

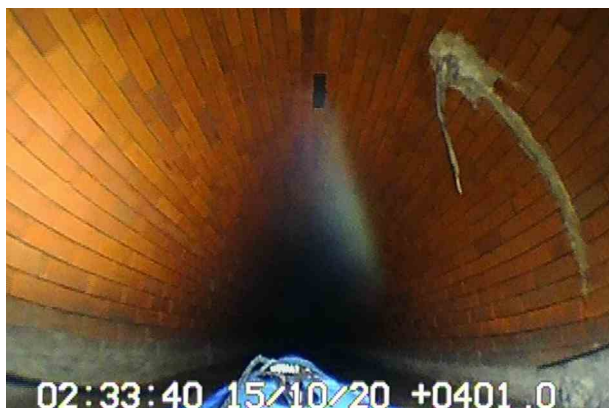
13, 401.10 m  
Attached deposits, encrustation from 1 o'clock to 4 o'clock, 5%  
cross-sectional area loss, SUGGESTS SLIGHT  
INFILTRATION

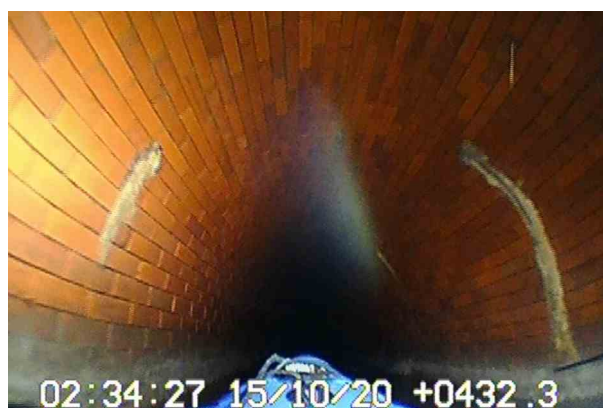
14, 432.20 m  
Attached deposits, encrustation from 1 o'clock to 4 o'clock, 5%  
cross-sectional area loss, SUGGESTS SLIGHT  
INFILTRATION

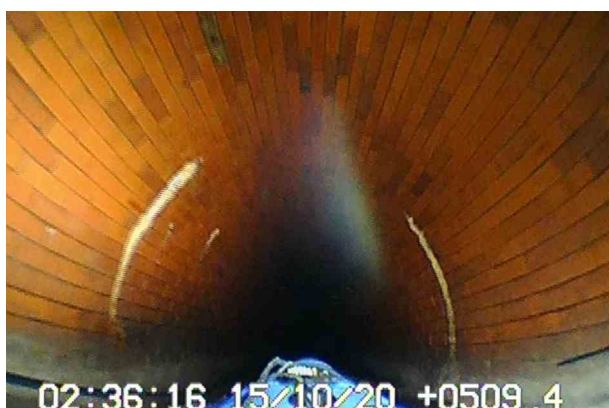
15, 510.00 m  
Attached deposits, encrustation from 1 o'clock to 4 o'clock, 5%  
cross-sectional area loss, SUGGESTS SLIGHT  
INFILTRATION

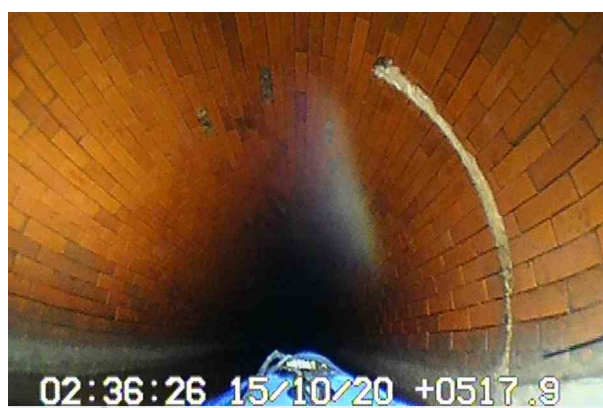
16, 518.10 m  
Attached deposits, encrustation from 1 o'clock to 4 o'clock, 5%  
cross-sectional area loss, SUGGESTS SLIGHT  
INFILTRATION

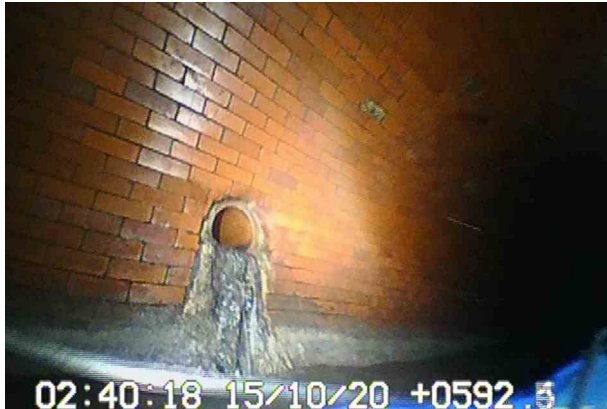
17, 592.80 m  
Connection other than junction at 9 o'clock, diameter: 225mm,  
RUNNING
