BS5837 2012 Trees in Relation To Design, Demolition and Construction

39 Evelyn Avenue
Ruislip
HA4 8AR

PBA Ref: Q14659

Report Date: 19th December 2024

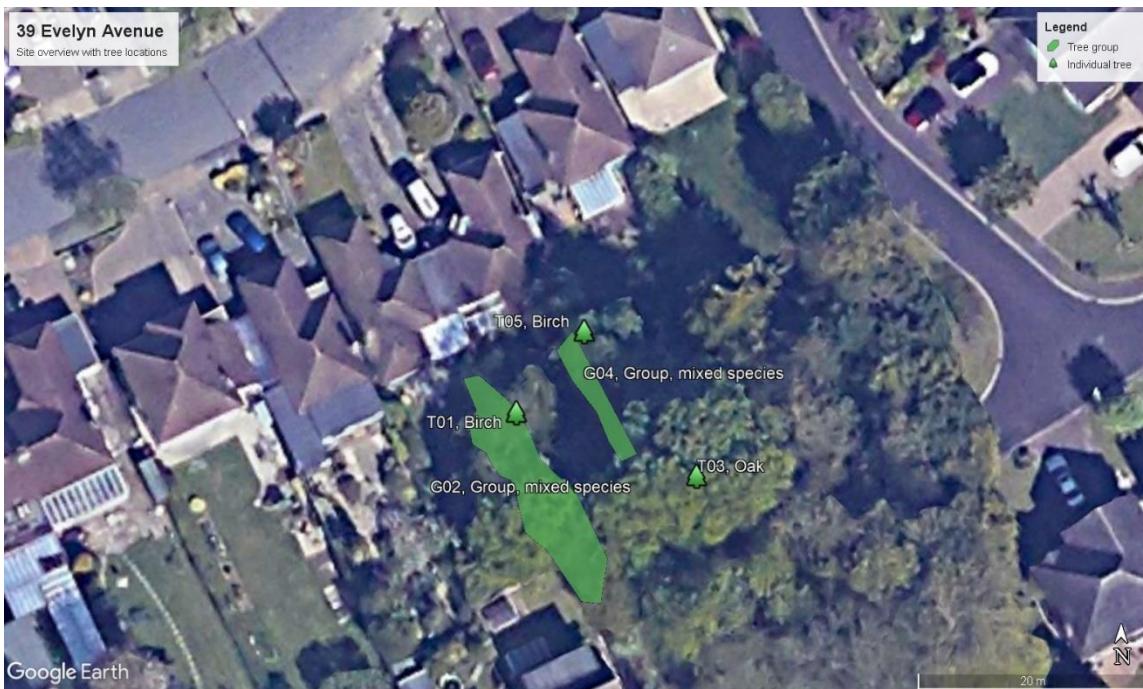
Figure 1 – Site overview showing tree locations

2.2.3 Trees T01 and T05 are early mature birch trees located close to the proposed development. The proposed extension footing is situated outside of the RPAs of these trees.

2.2.4 T03 is a mature oak tree located in the grounds of number 37. This tree is considered to be of high amenity value. The proposed extension footing is situated outside of the RPA of this tree.

2.2.5 Groups G02 and G04 are boundary trees and shrubs and are not considered to be a constraint to development.
