CONDITION SURVEY AND REPORT ON GATE PIER TO THE SW OF CEDARS  
HOUSE HILLINGDON

REES BOLTER ARCHITECTS  
NOVEMBER 2020

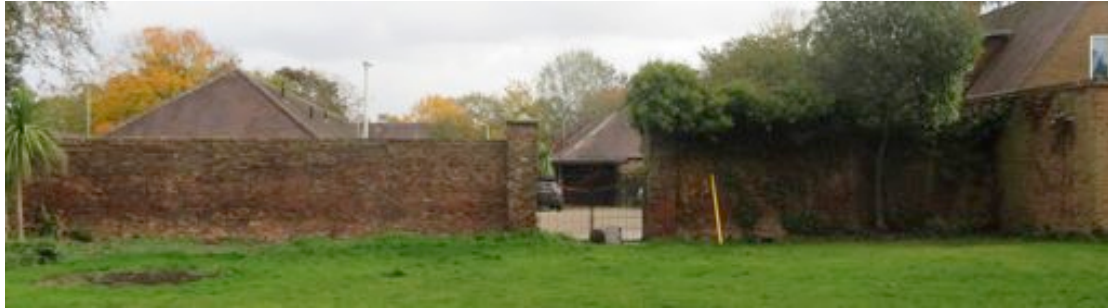
The wall is one and a half bricks in thickness laid in an imperfect English bond with a brick on edge coping and a sloping brick facing below on the east side. The wall is in reasonable structural condition, generally exhibiting a lean to the west of about 75-100mm.

View of the west side of the wall

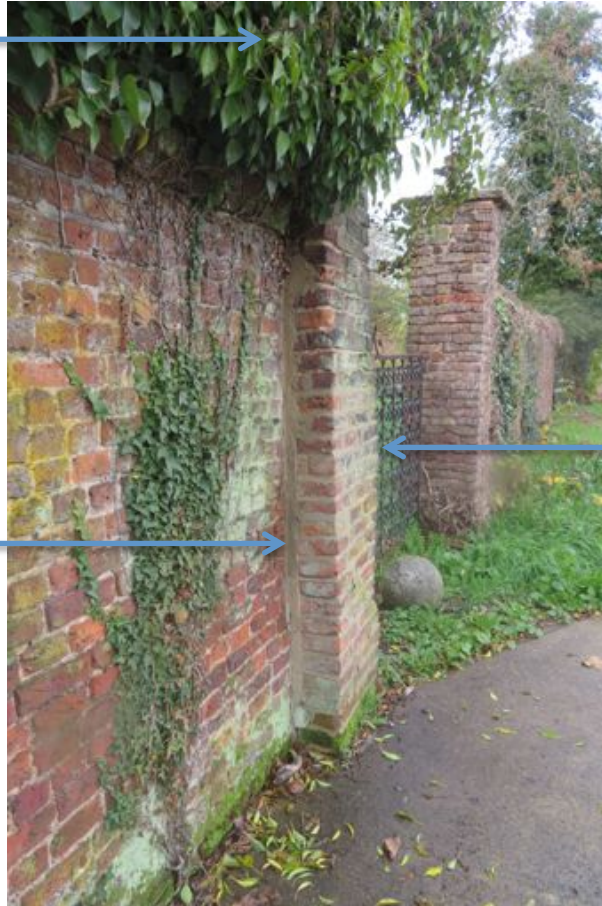
Top of pier obscured by vegetation

Facing skin has moved out by approx 60mm. The gap has been infilled with a cement mortar which now has cracks indicating further movement

Facing skin bulges out

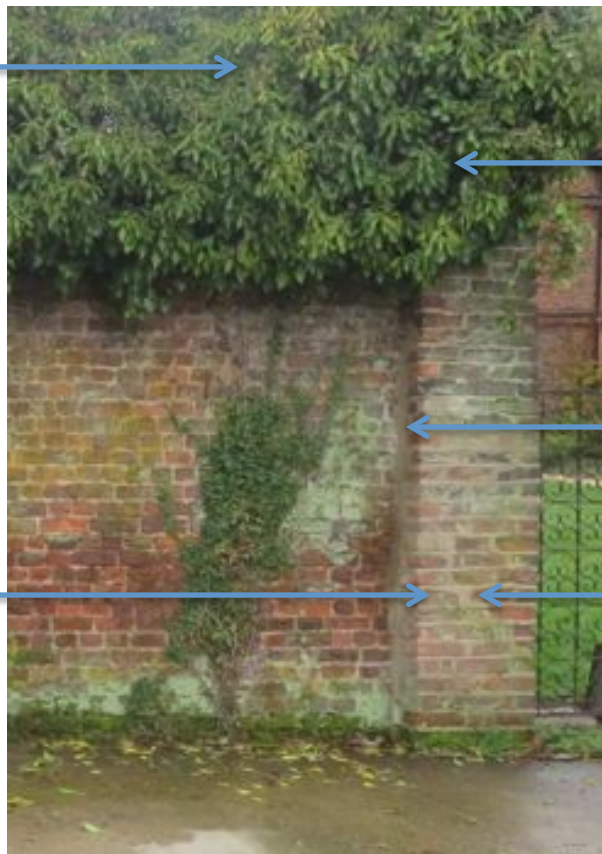
EAST FACE OF THE PIER

Top of pier obscured by vegetation

Brickwork has redder bricks at low level, possibly some salvaged from the original wall, with yellower bricks at high level

Brickwork at higher level appears reasonably well bonded

Bed joints of the pier do not align with bed joints of the wall

Cracking of joints in brickwork

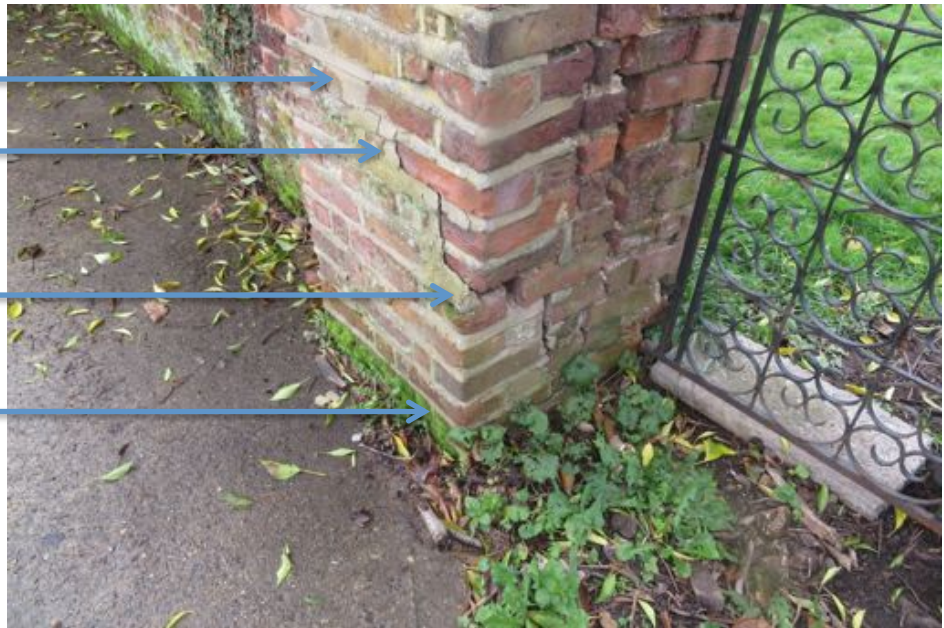
NE CORNER OF THE PIER.

Cracking in pointing

Stepped crack in brickwork,  
faced in cement

Low level brickwork steps  
out

Possible rotation of low level  
brickwork suggests  
inadequate foundations

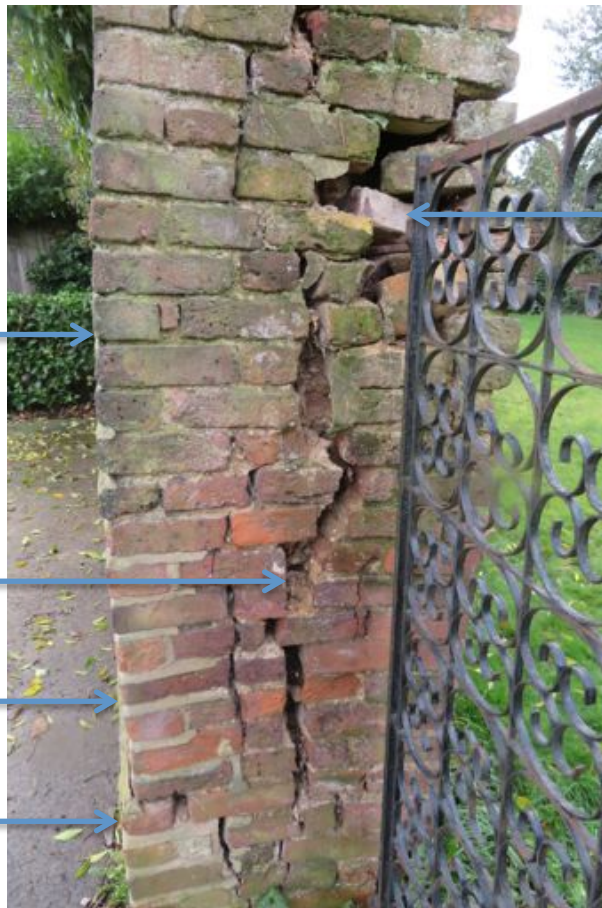
LH corner bulges out

Substantial cracking through  
brickwork. Fractures up to  
60mm wide. Left and right  
corners have no connection  
at this level

Cement pointing

Offset in brickwork

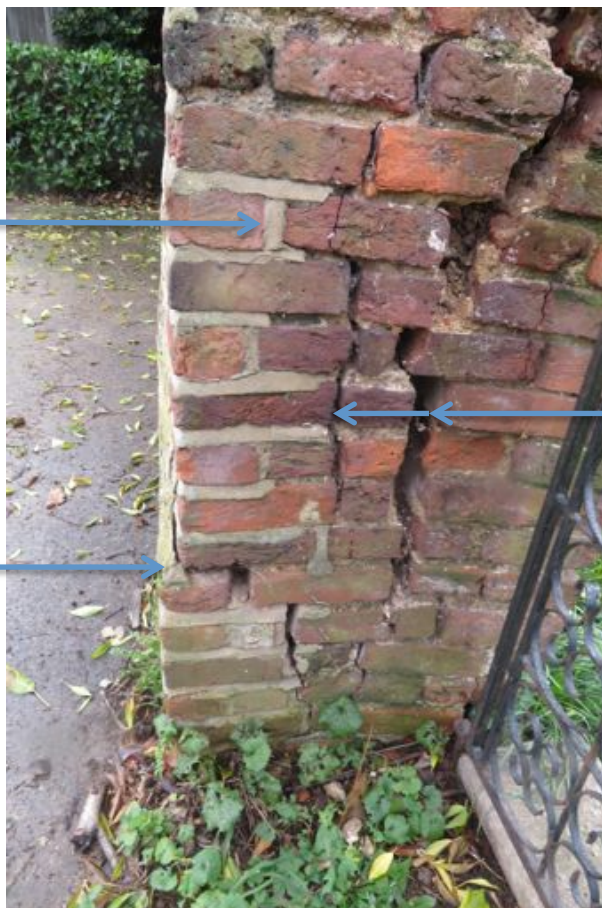
NORTH FACE OF THE PIER

Bricks falling out, exposing  
the interior of the wall

Cement pointing

Offset in brickwork

Significant cracking along two main lines, for the full height of this section

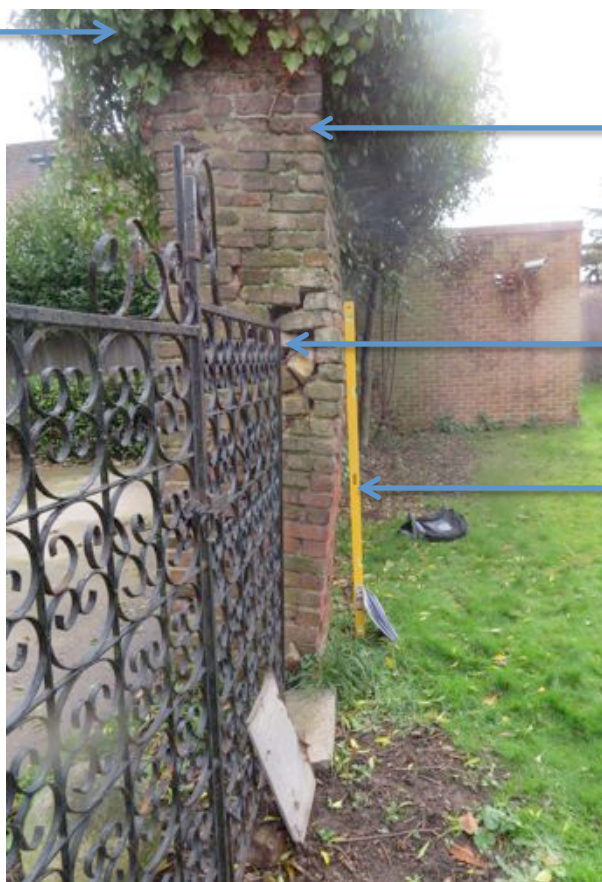
NORTH FACE OF THE PIER

Top of pier obscured by vegetation

Brickwork at higher level appears reasonably well bonded

Missing and loose bricks

Spirit level set plumb indicates extent of bulging in brickworks

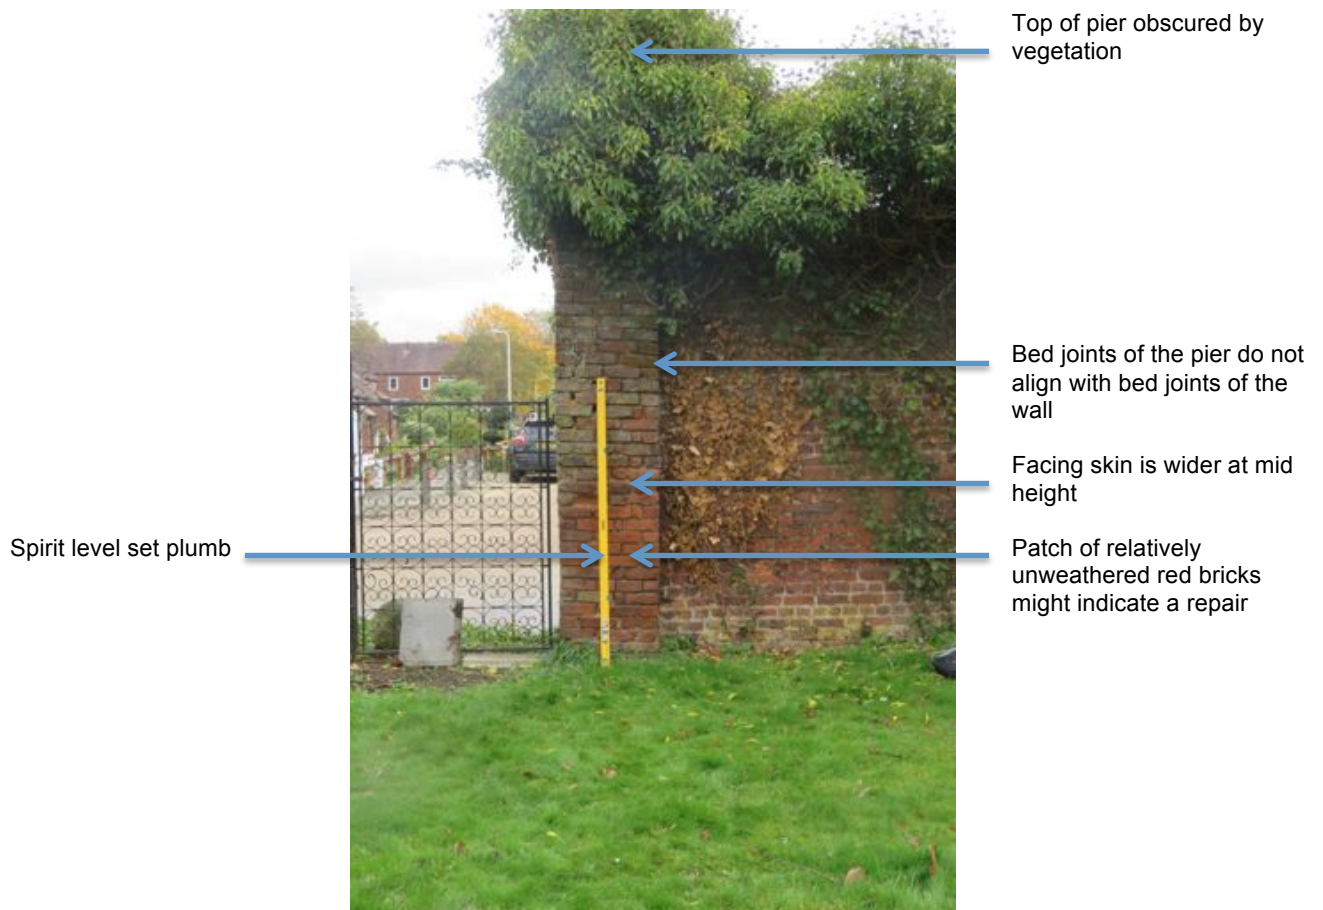
WEST FACE OF PIER

The bulging on the west side is considerably greater than on the east. Cracking in the infill on the east side indicates that this side is still moving. It is remarkable that the brickwork on the west side has not already collapsed. Any attempt at repair is likely to result in the loss of that section.

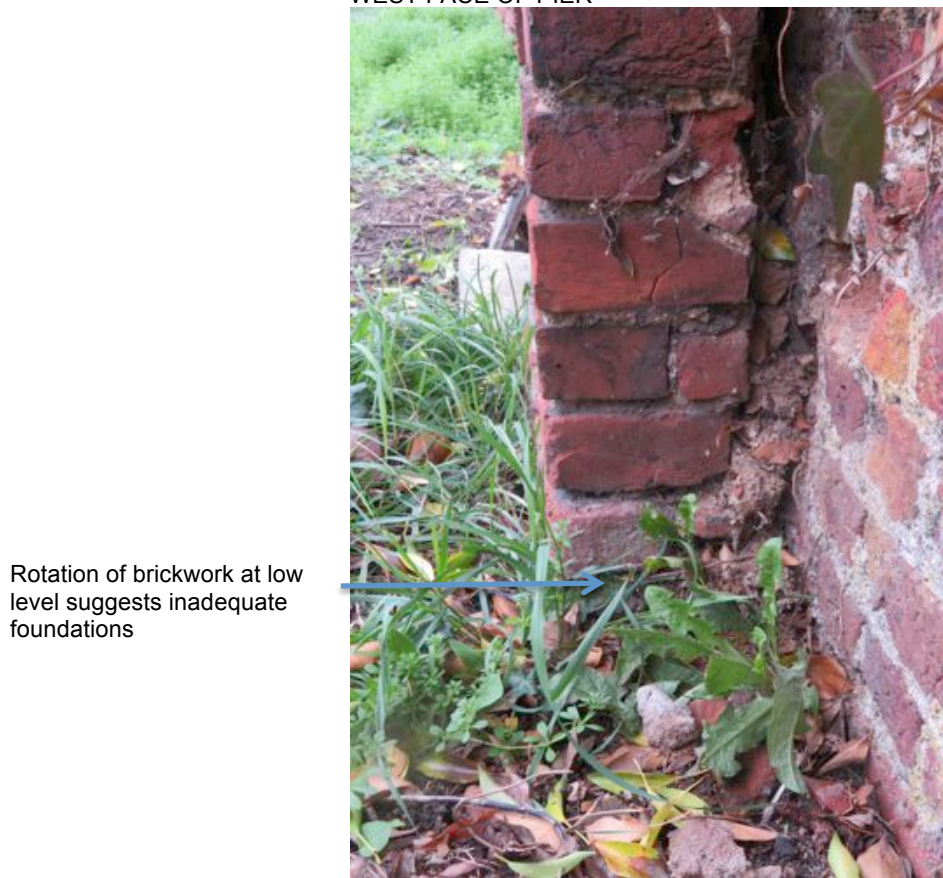
WEST FACE, AT LOW LEVEL, LOOKING NORTH.

Gap between the facing skin (left) and the original wall (right). Approx 100mm. Daylight can be seen through the wall.

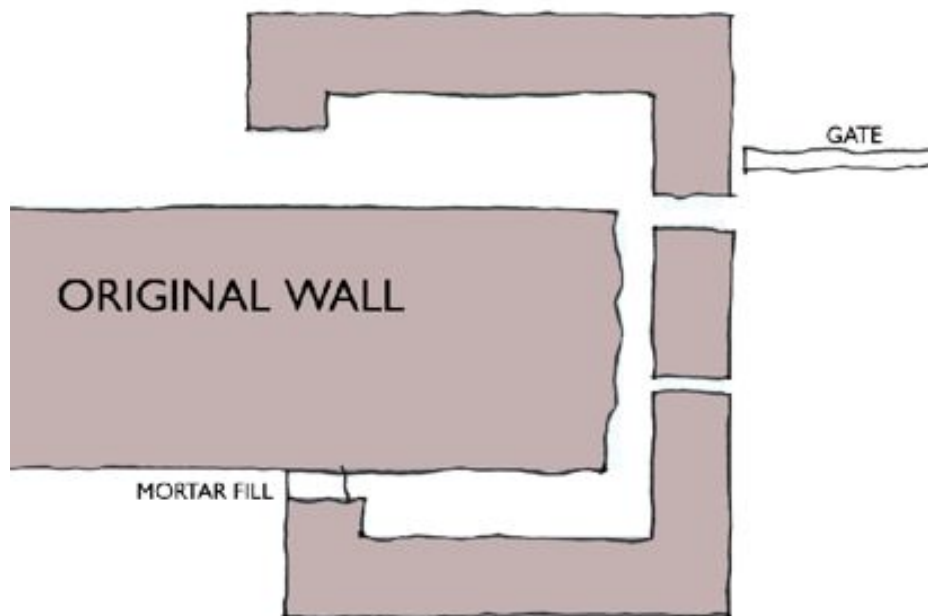
Sketch plan at mid height of pier showing the extent of voids within the masonry.
