## **GARDEN WALLS TO THE EAST OF CEDARS HOUSE, VINE LANE, HILLINGDON**

**Details in connection with conditions to LBC 76049/APP/2020/3900**

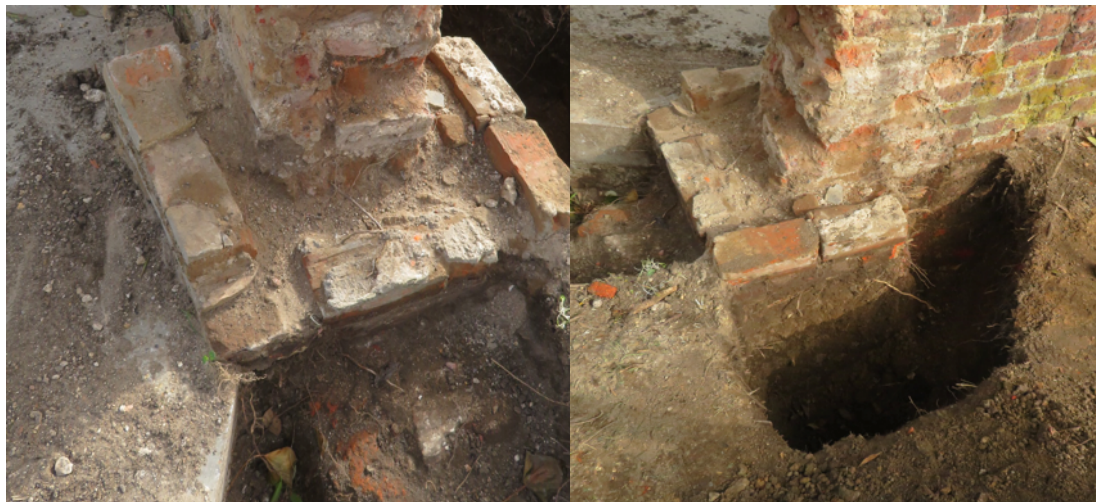
Base of the pier viewed from the NE. The original foundation to the historic wall can be seen at the base of the photo and the thick concrete slab to the left.

Trial hole on the west side of the wall.

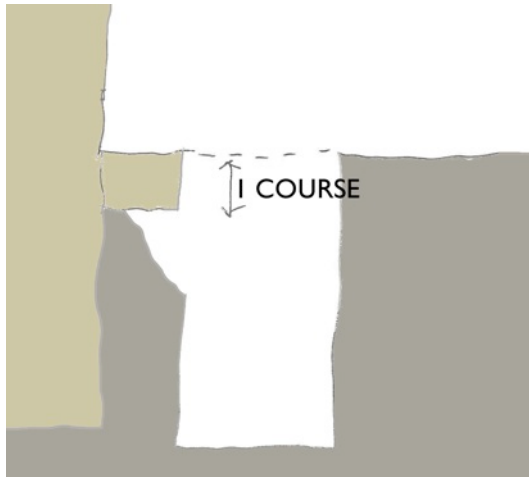
Section through trial hole on the west side of the pier.

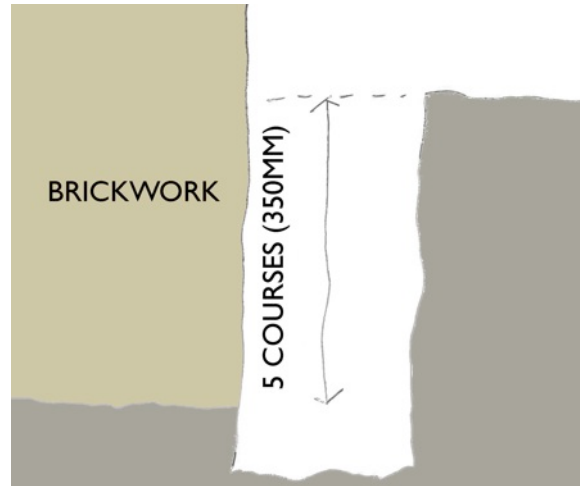
Section through trial hole against the historic wall

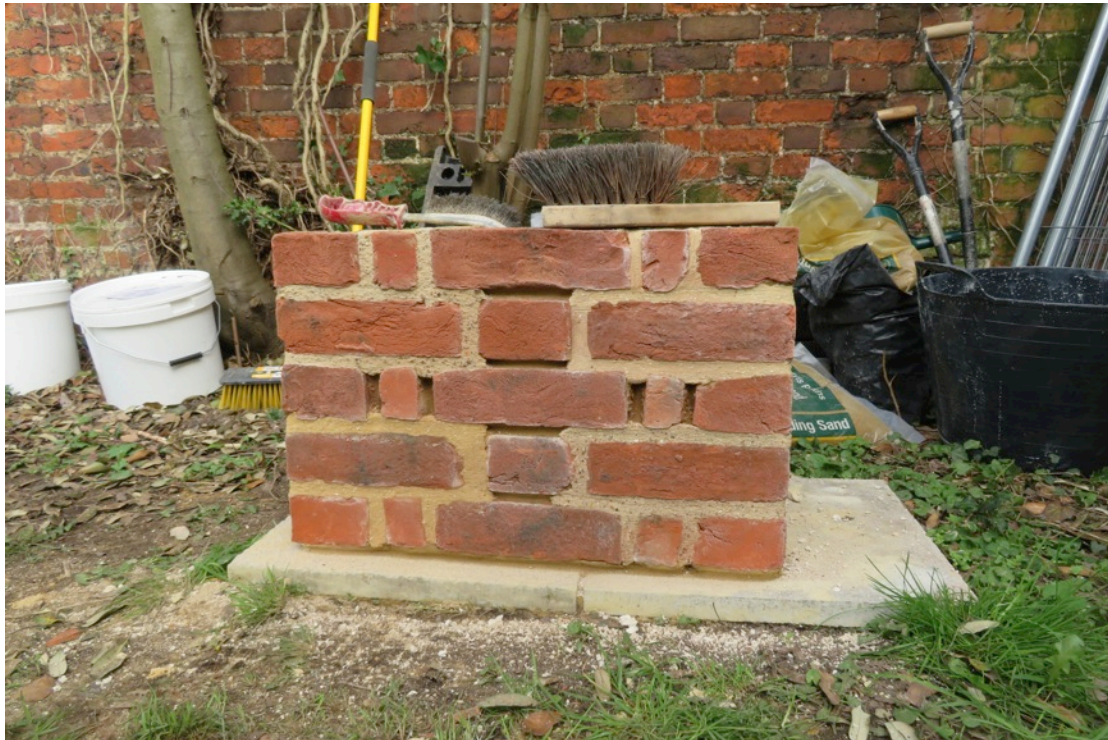
A trial panel for bricks and mortar and pointing has been constructed and is available for inspection adjacent to the gate pier.

laid in a 1:3 hot lime mortar with coarse aggregate. The sample panel trialed 4 different mortars. Top left is NHL 3 mortar with coarse aggregate. The other three are all hot lime mixes with fine aggregate at top right, medium aggregate at bottom left and coarse aggregate at bottom right.

Sound existing bricks have been salvaged and will be reused, although they are of mixed appearance; some appear to have been salvaged from the original wall when the gateway was formed but there have clearly been repairs using different bricks. About 200 new bricks will be required. The proposed brick is the Imperial Brick Country Blend
