**GATE PIER TO SOUTH EAST OF CEDARS HOUSE HILLINGDON.  
PHOTOGRAPHS**

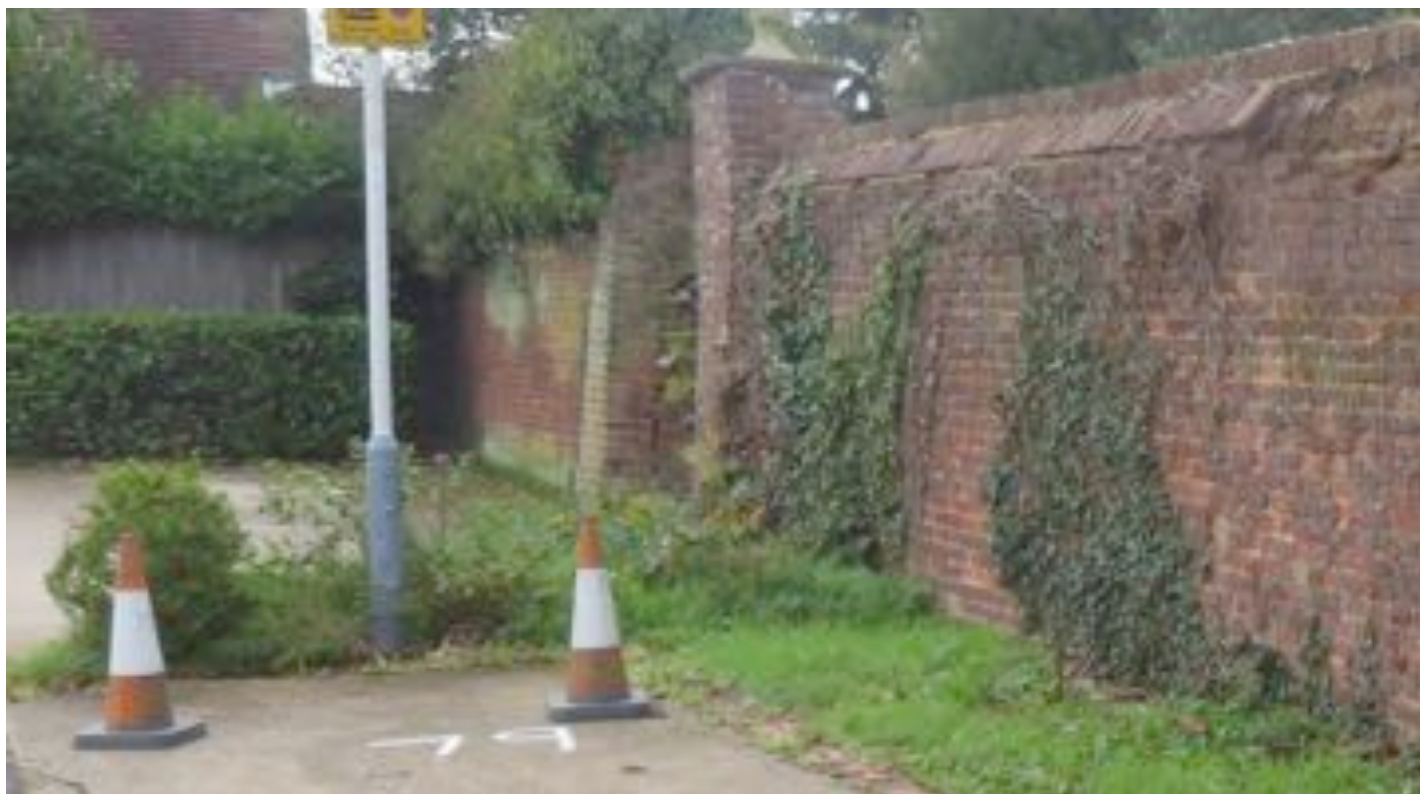
General view east side of wall looking south

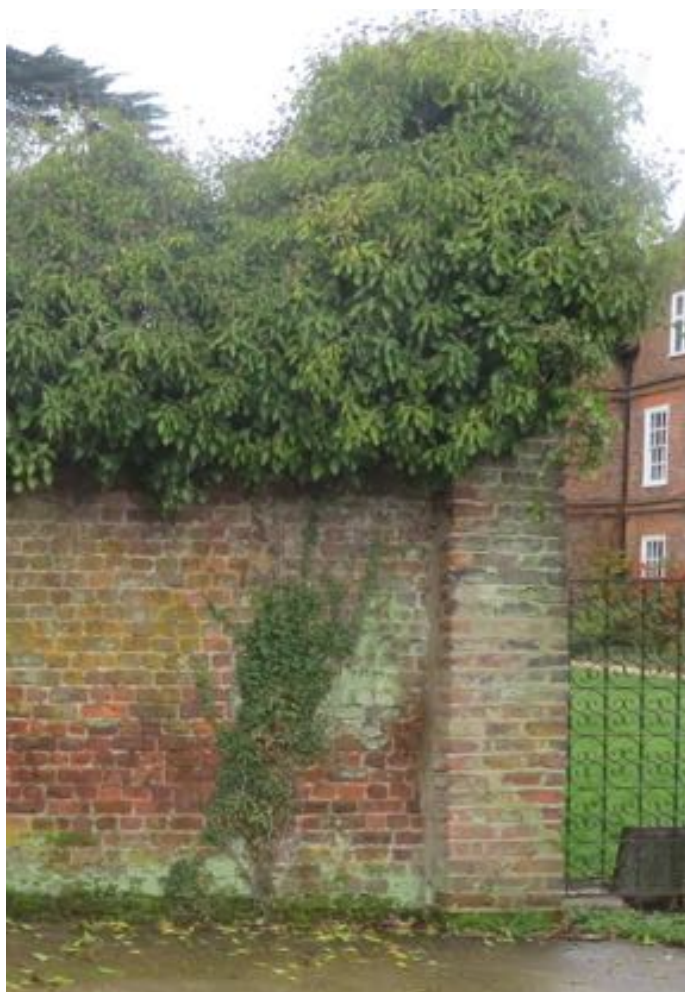
East face of pier, looking west

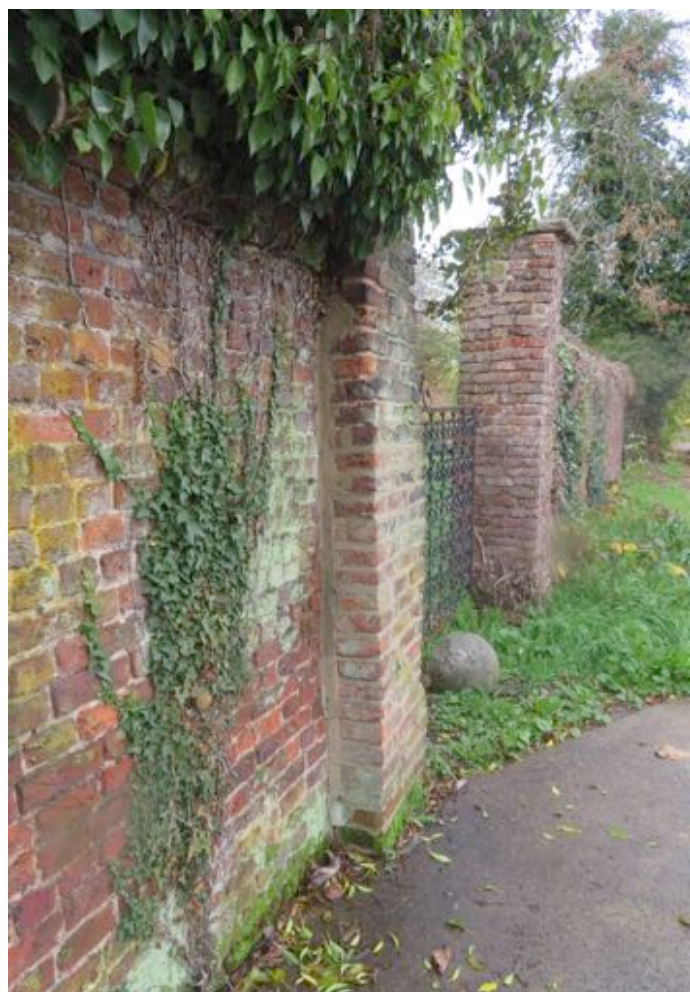
East face of pier looking north

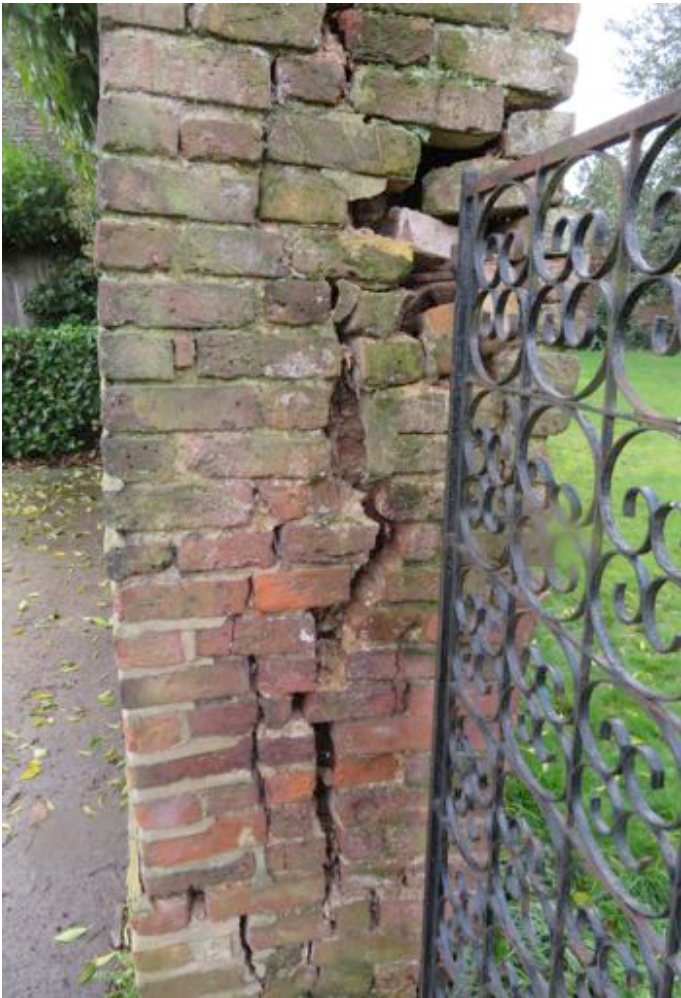
North face of pier

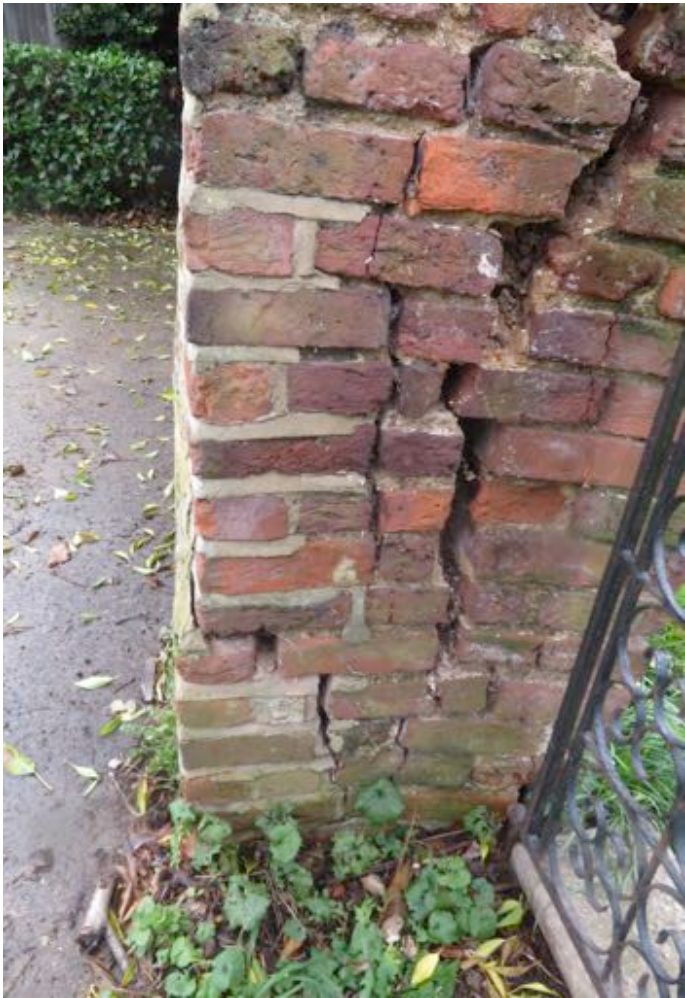
North face of pier

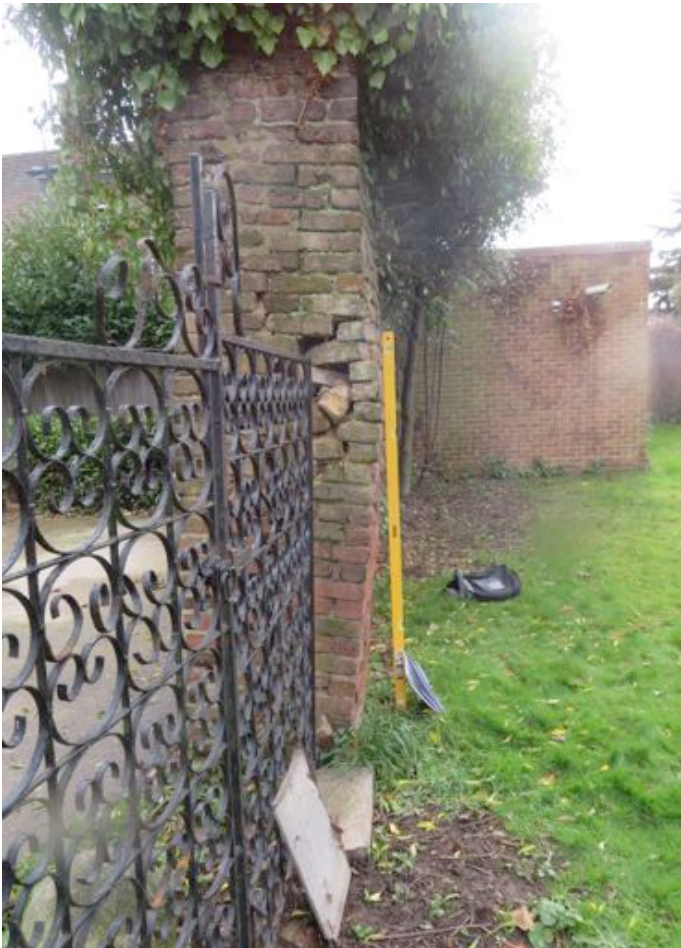
North face of pier prior to collapse. Spirit level is set plumb.

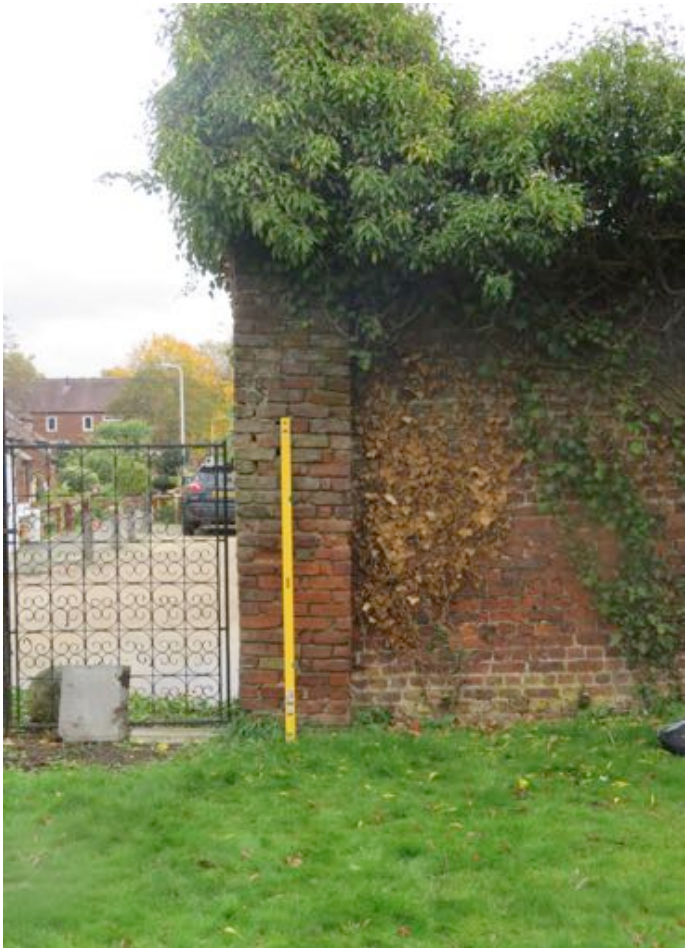
West face of pier prior to collapse. Spirit level is set plumb.

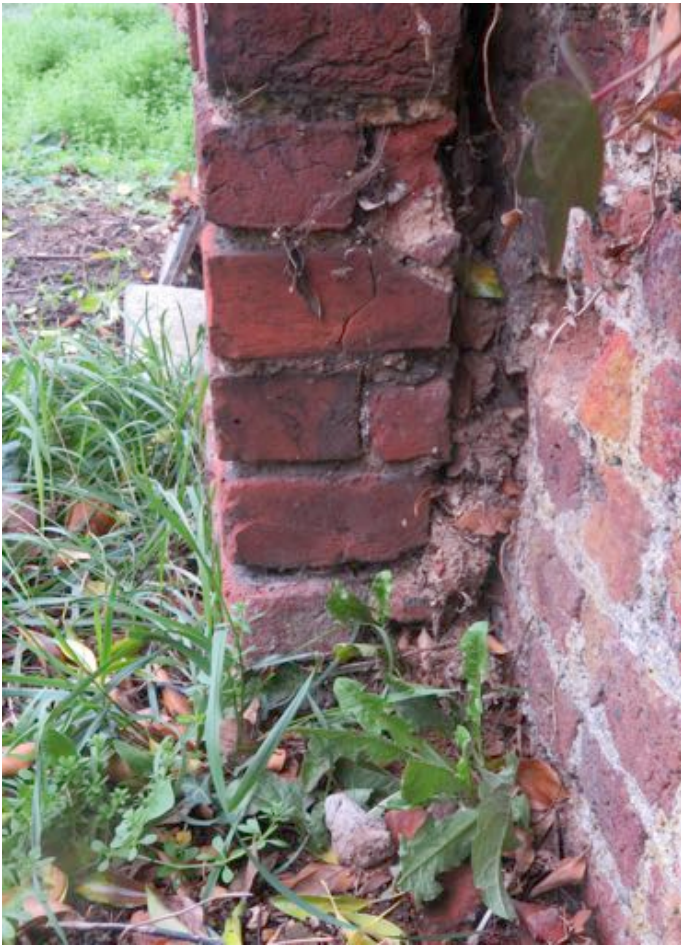
Base of west face of pier, looking north.

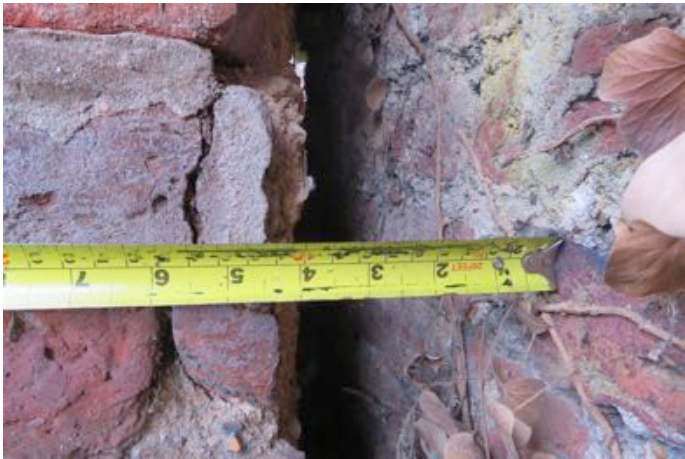
West face of pier looking north, prior to collapse taken at about 1000 above ground level.

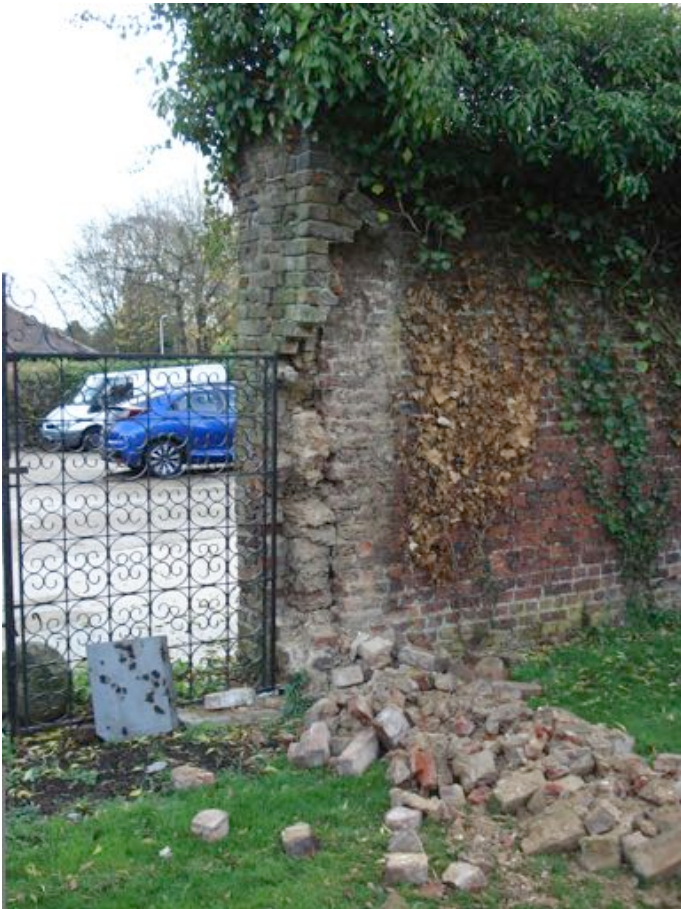
West face of pier following collapse

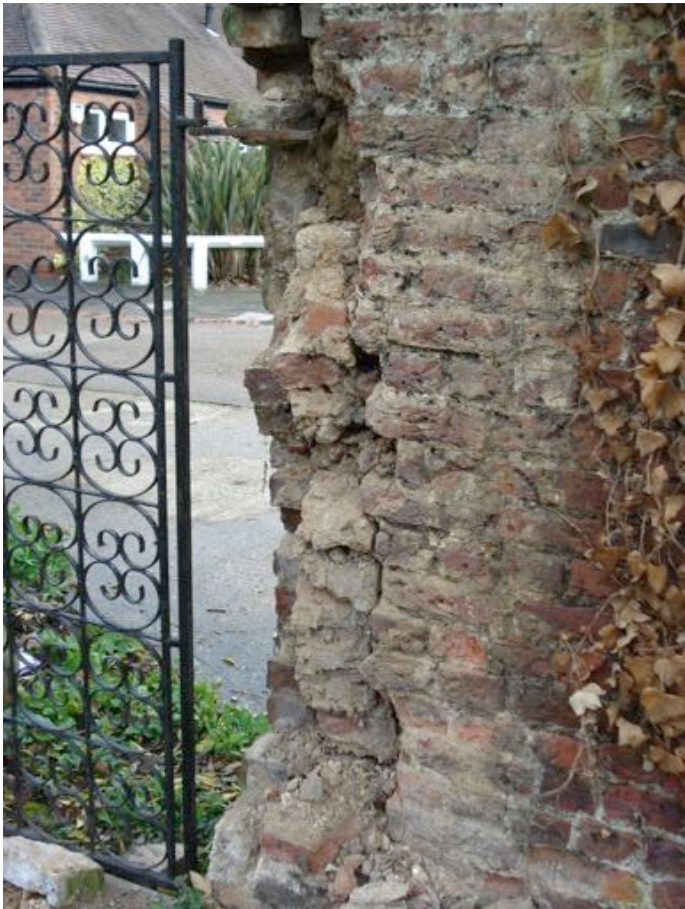
West side of pier following collapse. Note the brick rubble core within the wall and the continuation of the pattern of holes in the brickwork into this area.

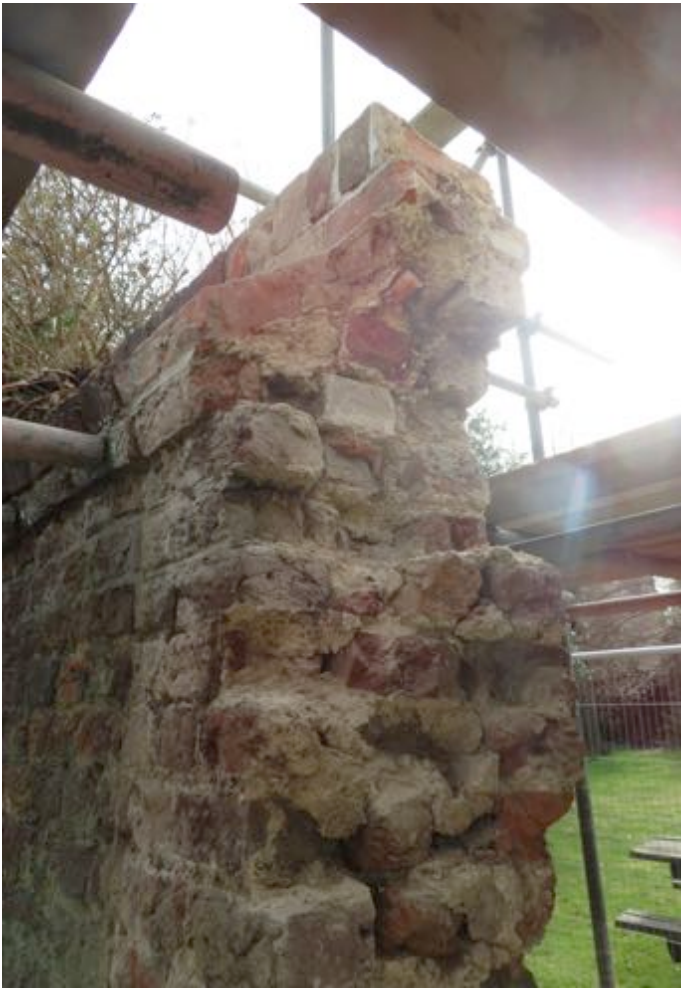
Exposed end of original wall after collapse.

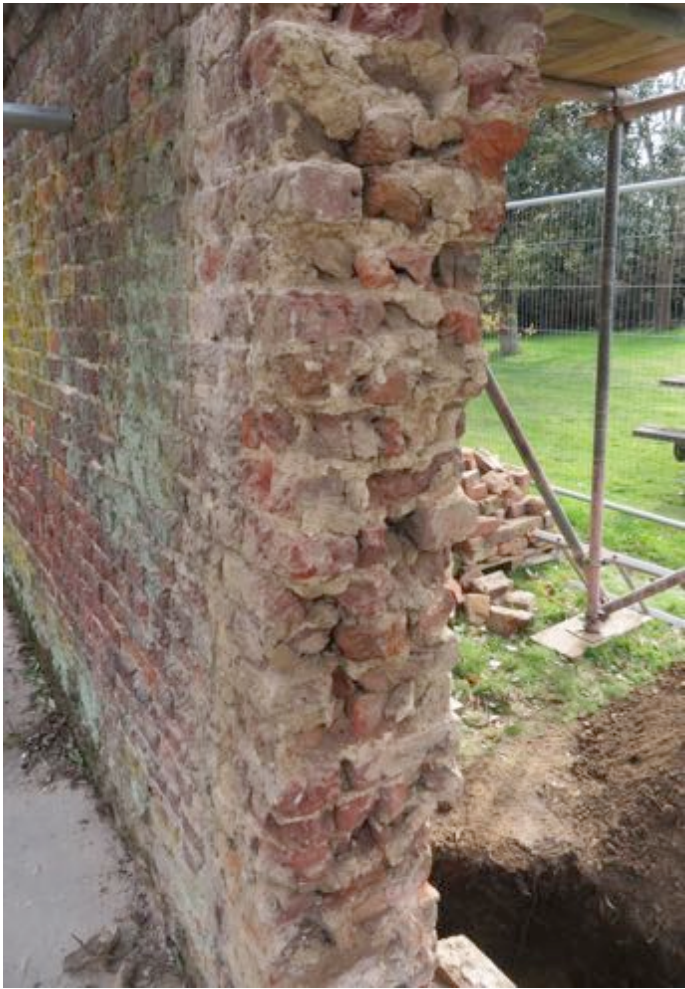
Exposed end of original wall after collapse.

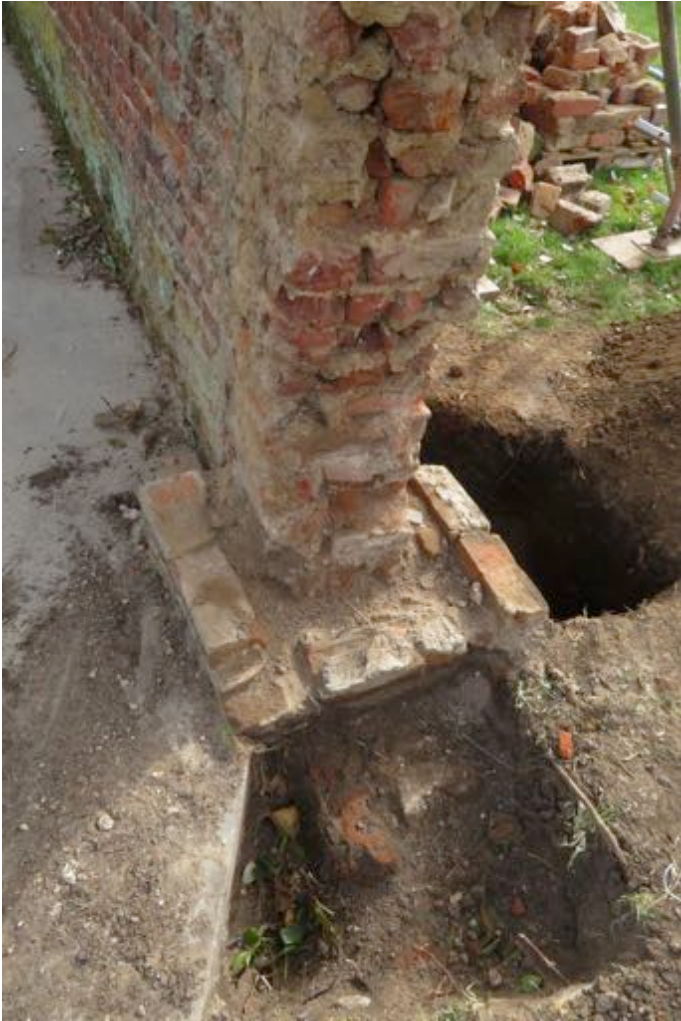
Base of original wall after collapse.

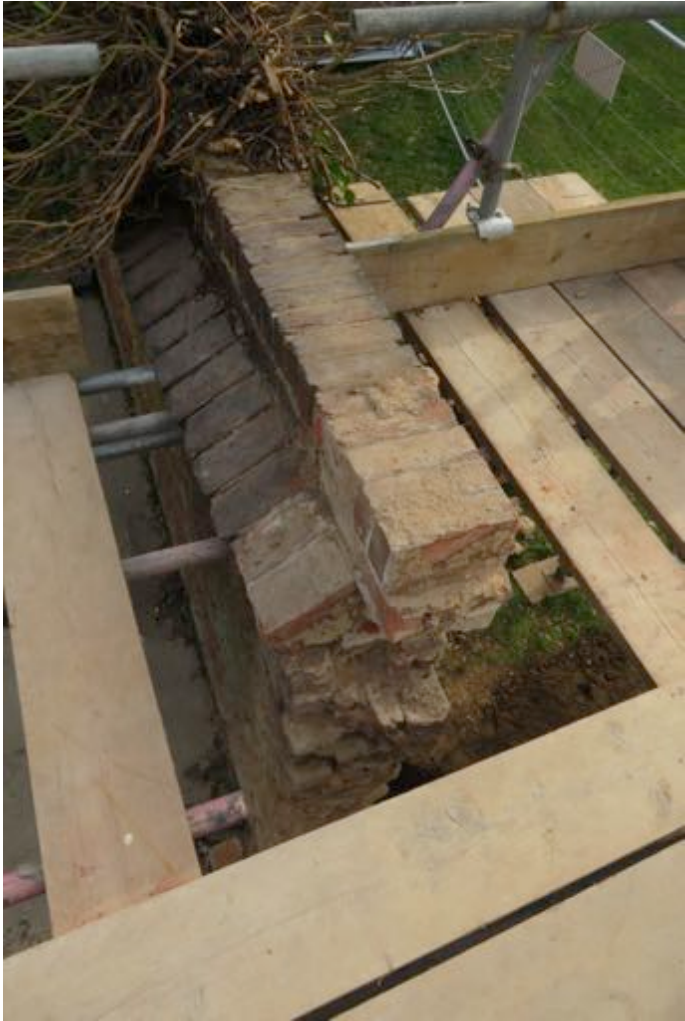
Top of original wall after collapse.

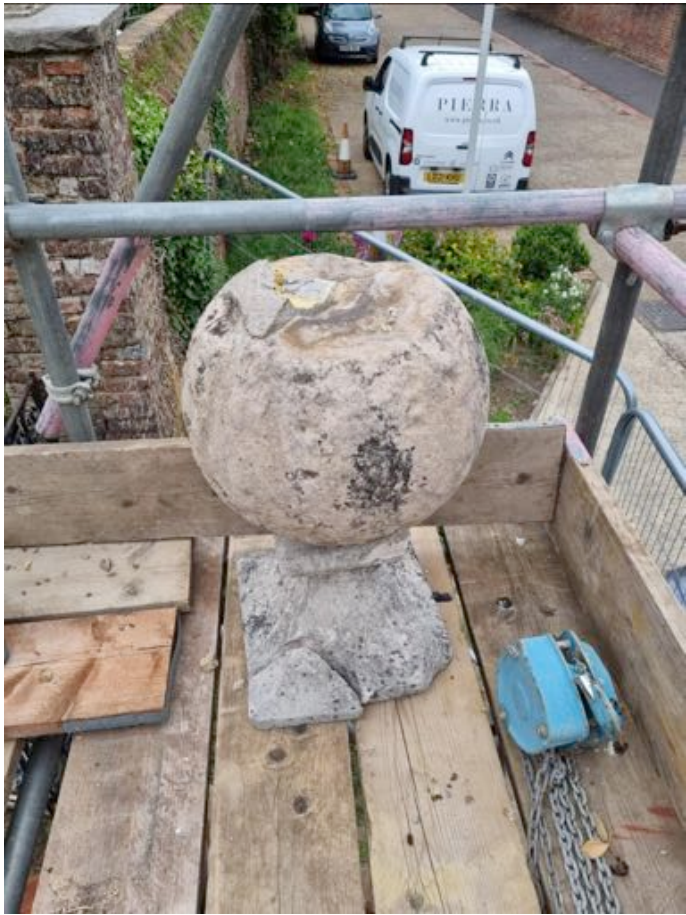
Ball cap prior to repair.

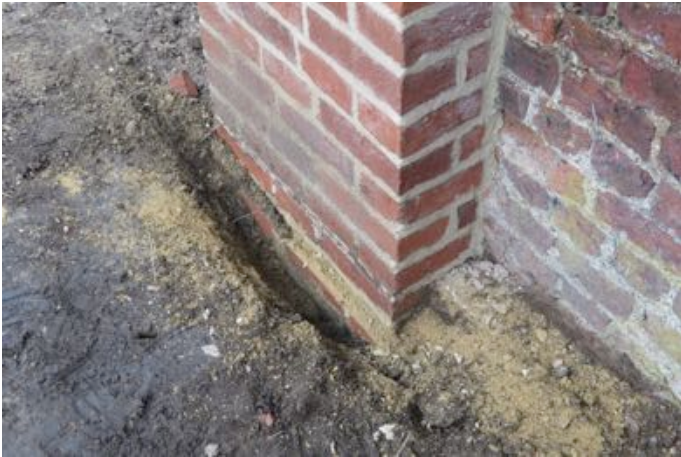
Ground part re-excavated to show foundation on west side

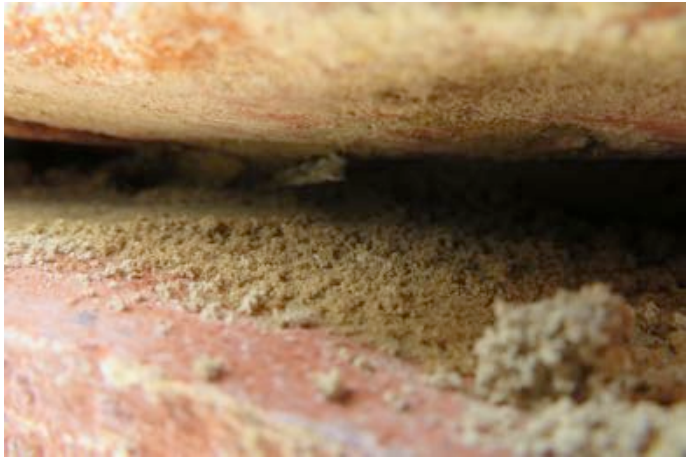
Mortar joint re-opened to show metal tie.
