**GATE PIER TO SOUTH EAST OF CEDARS HOUSE HILLINGDON.  
PHOTOGRAPHS**

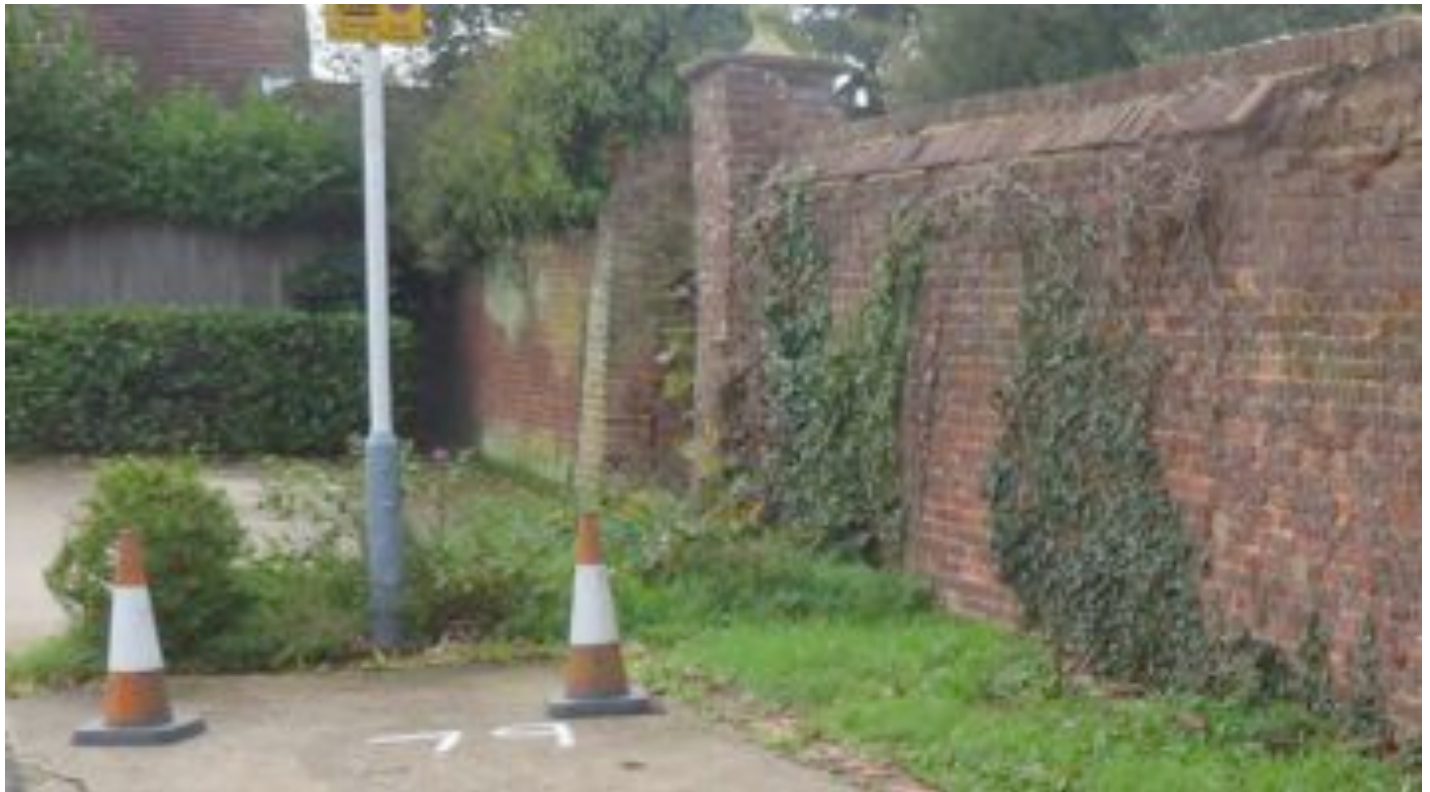
General view east side of wall looking south

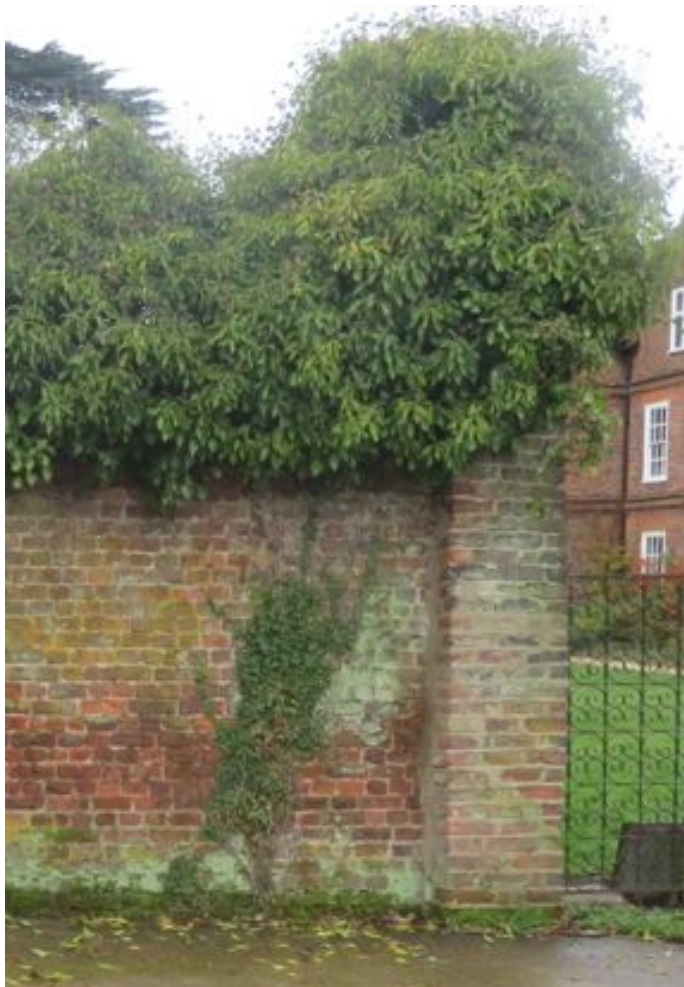
East face of pier, looking west

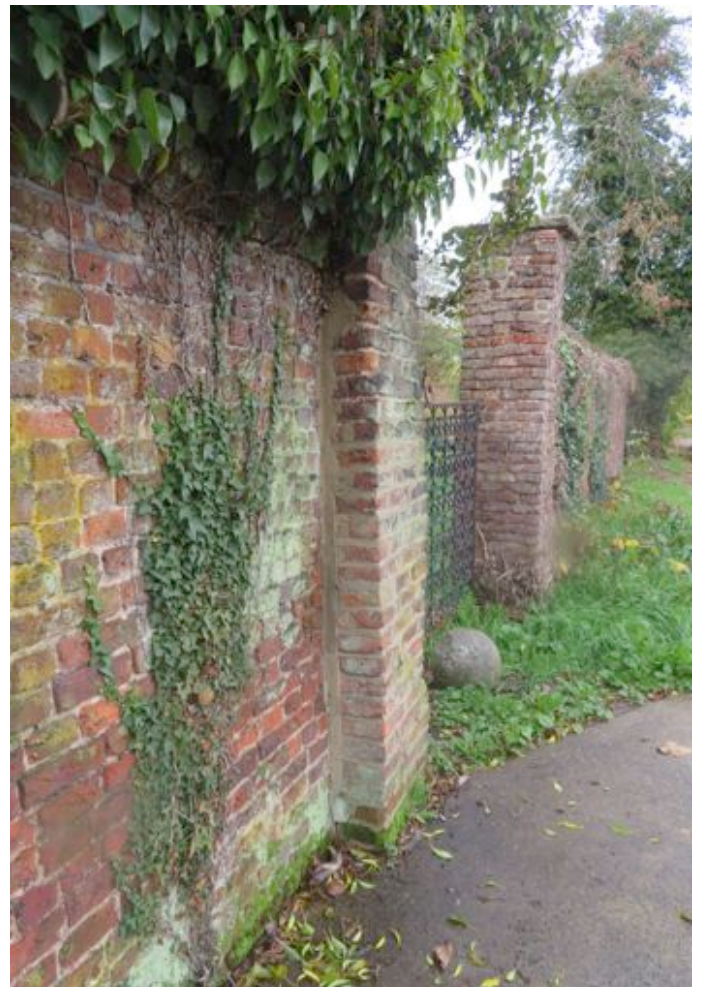
East face of pier looking north

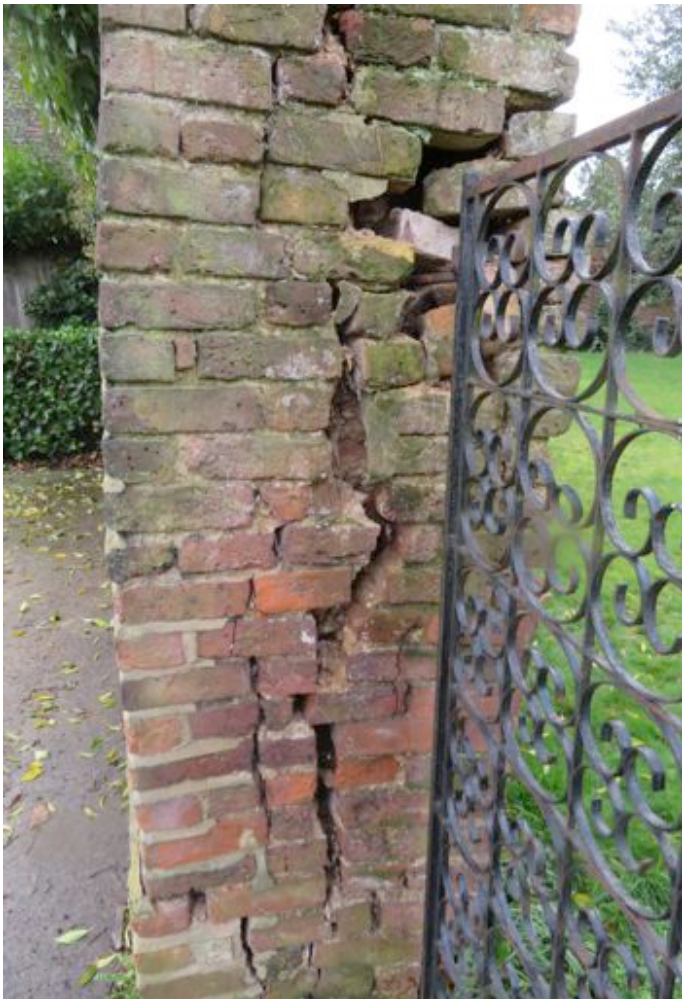
North face of pier

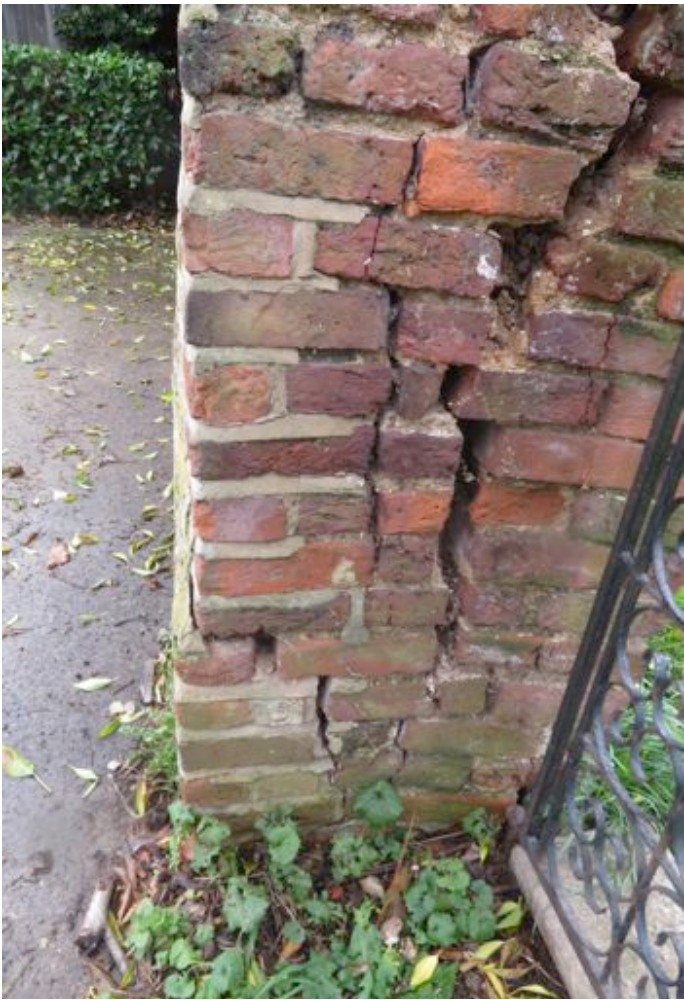
North face of pier

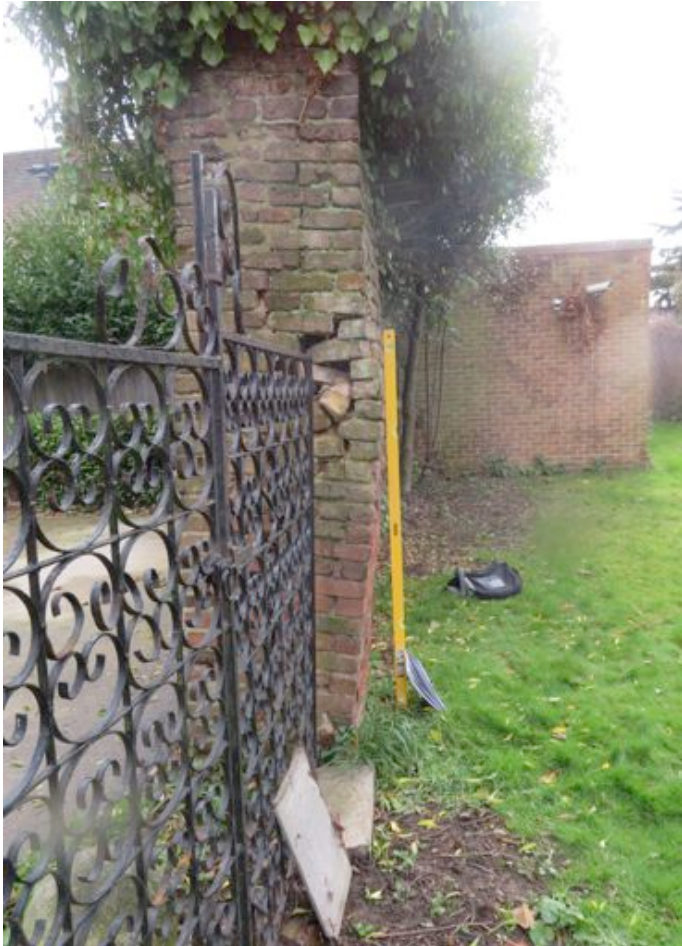
North face of pier prior to collapse. Spirit level is set plumb.

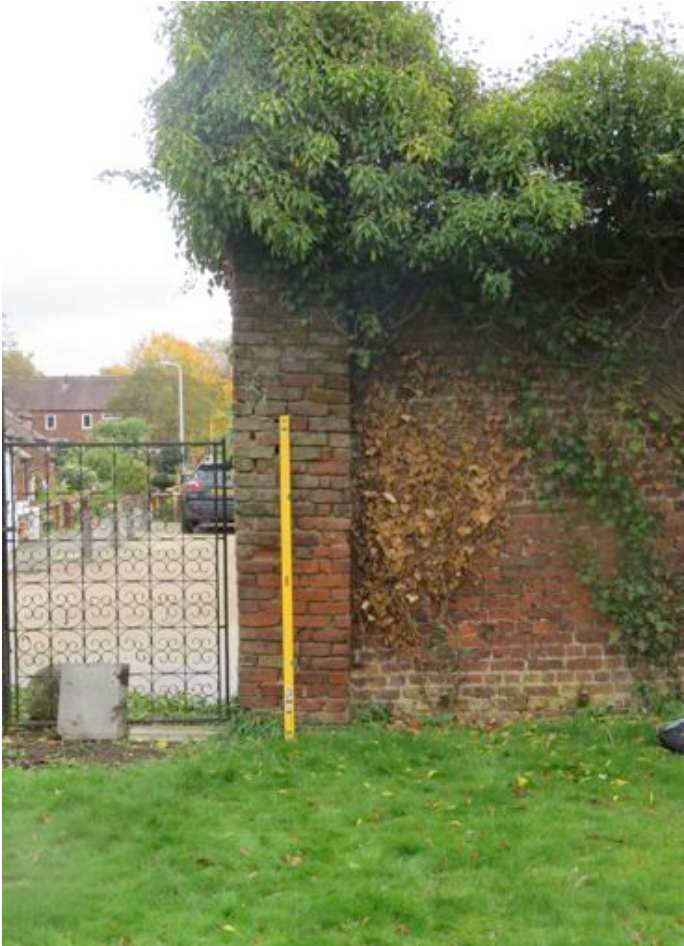
West face of pier prior to collapse. Spirit level is set plumb.

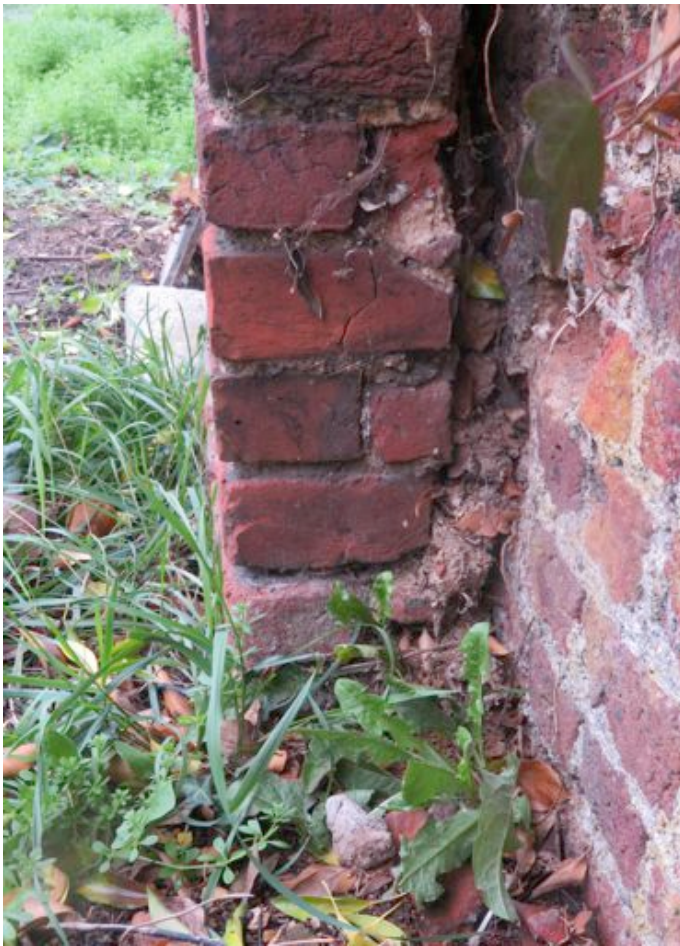
Base of west face of pier, looking north.

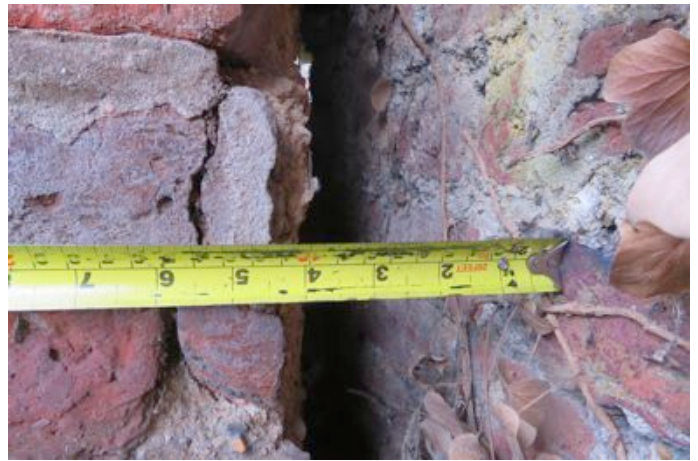
West face of pier looking north, prior to collapse taken at about 1000 above ground level.

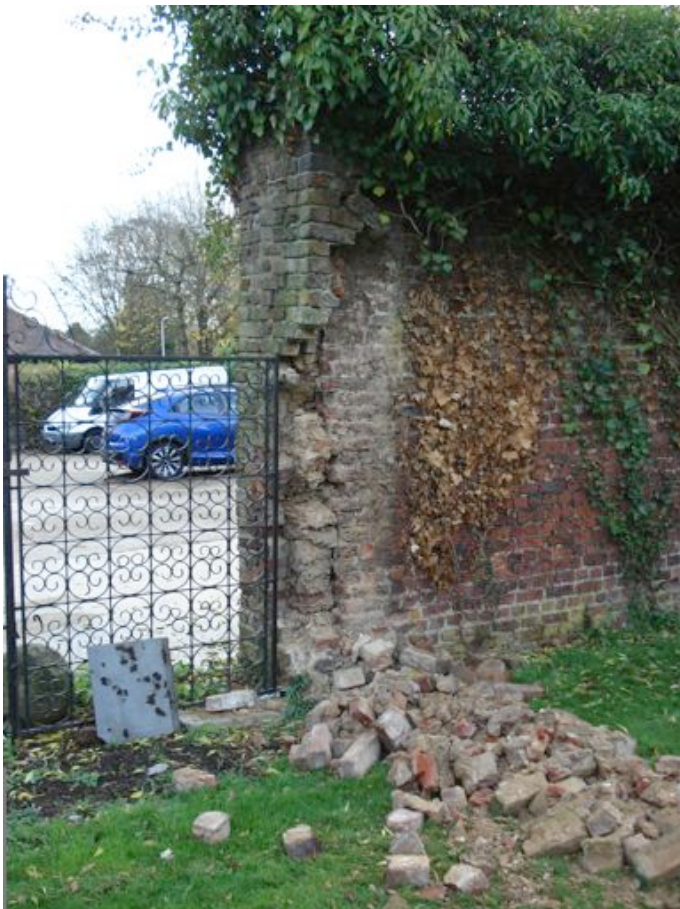
West face of pier following collapse

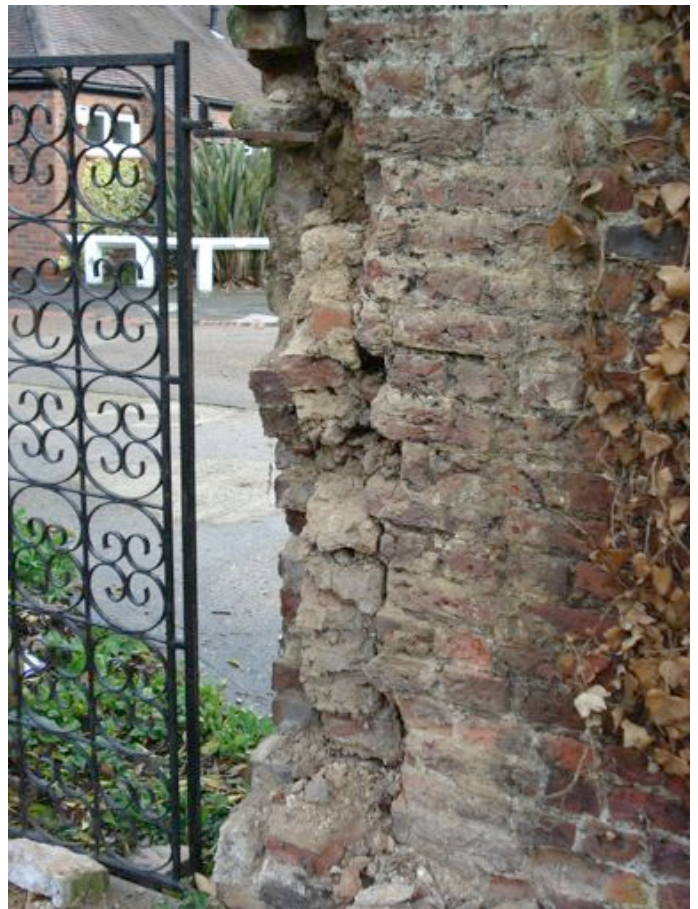
West side of pier following collapse. Note the brick rubble core within the wall and the continuation of the pattern of holes in the brickwork into this area.
