# **Phase 1 Land Contamination Risk Assessment**

**Demolition of Existing Building  
and Construction of 4 No.  
Dwellings  
on the site of  
No.382 Bath Road,  
Heathrow, London UB7 0DH**

**Date: October 2022**

Reference: 3412A P1 Verma – Heathrow, London

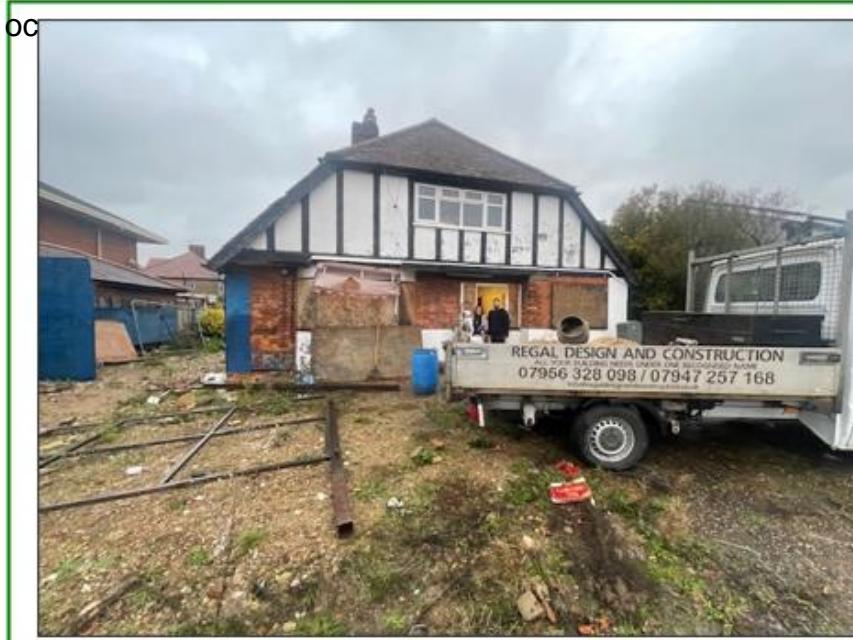
**Photo No.1: View facing north from Bath Road of No. 382 frontage, dated October 2022**

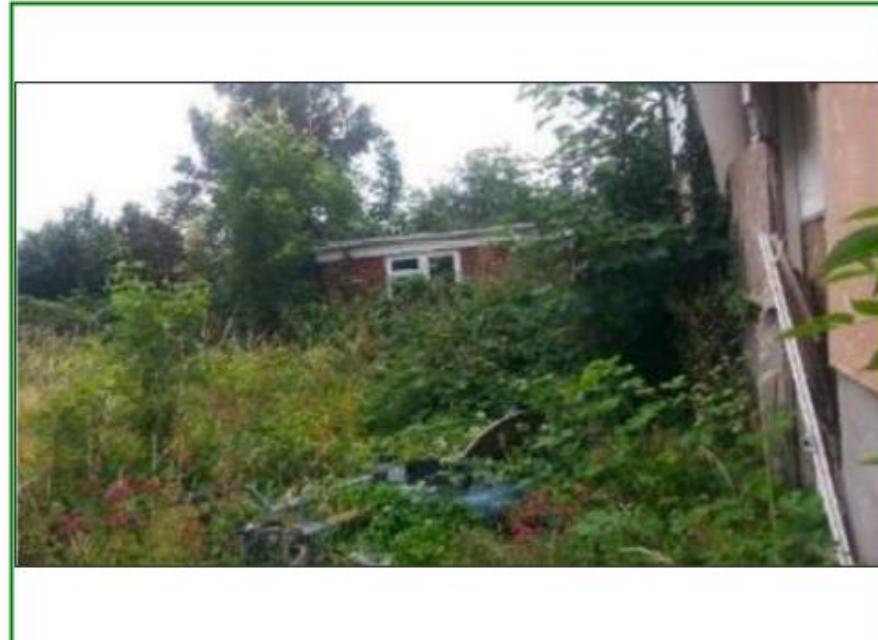
**Photo No.2: View facing northwards of rear gardens, dated July 2021**

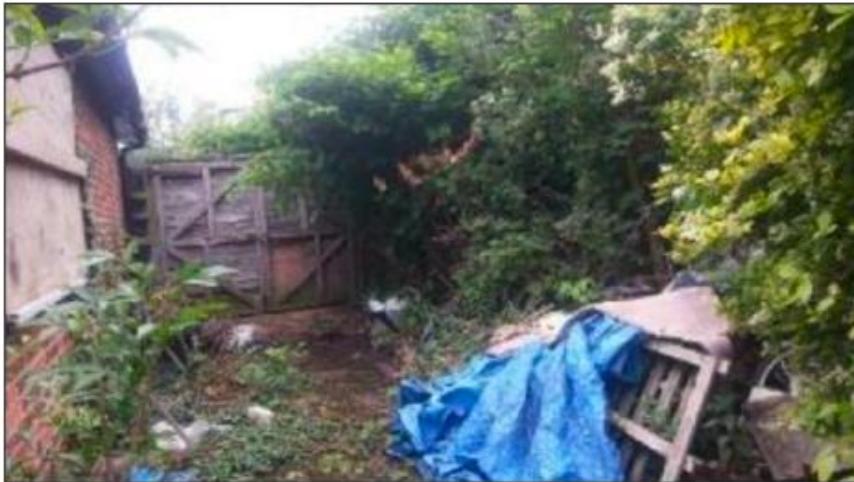
**Photo No.3: View of western access track to rear of property,  
dated July 2021**
