**Green Close
Green Close Lane
Northwood HA6 2UX**

Schedule of Conditions Part 6: Photographic Record

To provide an archival record of the historic development of the existing Building:
Photographic record of the living room fireplace:

Issue date: May 2022

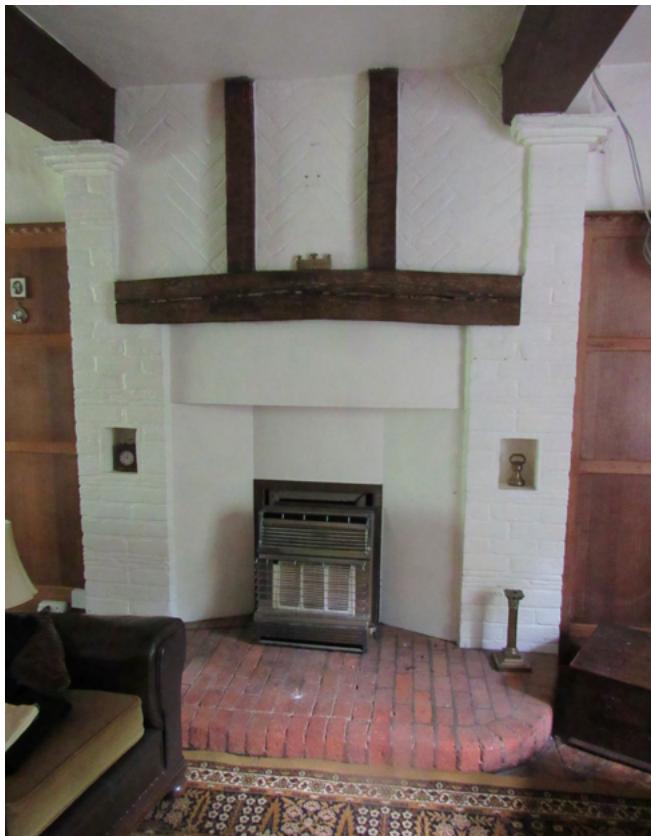
Photograph 1

The living room is lined with decorative oak panelling, possibly 1930's. It is likely that an earlier Victorian fireplace was refurbished during the same period to create a Mock Tudor appearance with timber mantle and decorative brickwork. The plastered infill, white paint and gas fire is likely to be 1970's or later.

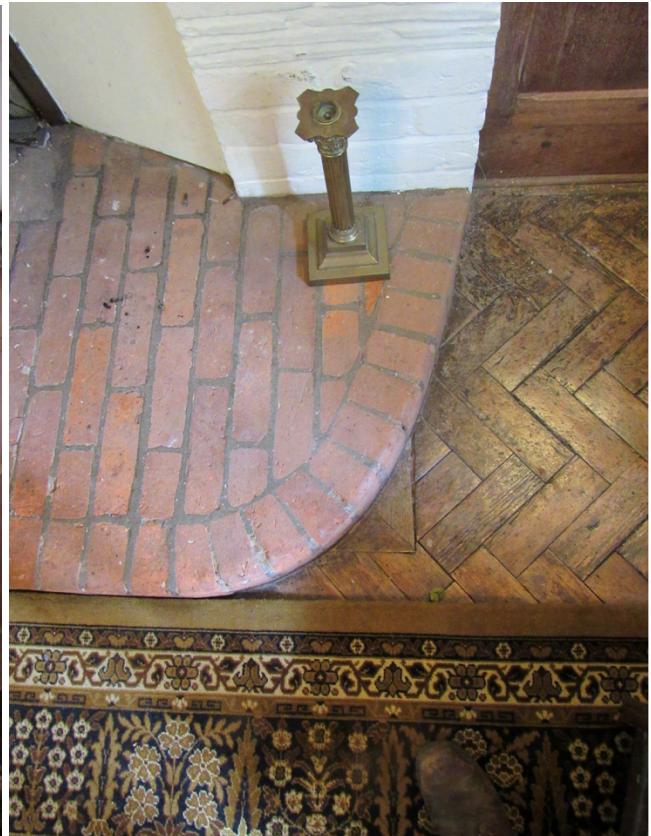
Photograph 2

The red brick hearth extends into the room and is built over the earlier timber parquet floor as evidenced by the partially exposed border.

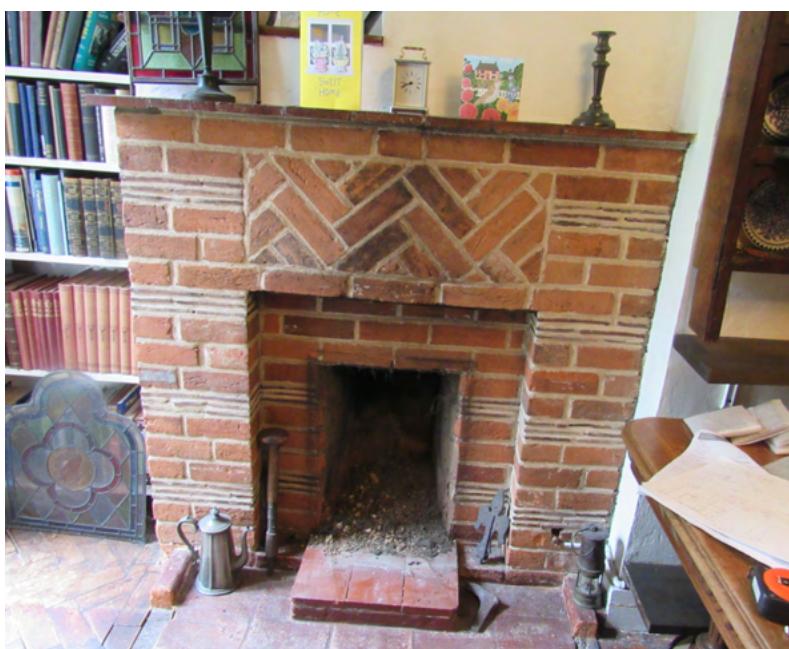
Photograph 3

A useful reference is the unpainted dining room fireplace which has a similar arrangement of decorative brick and creasing tiles to the fireplace and quarry tiles to the hearth.

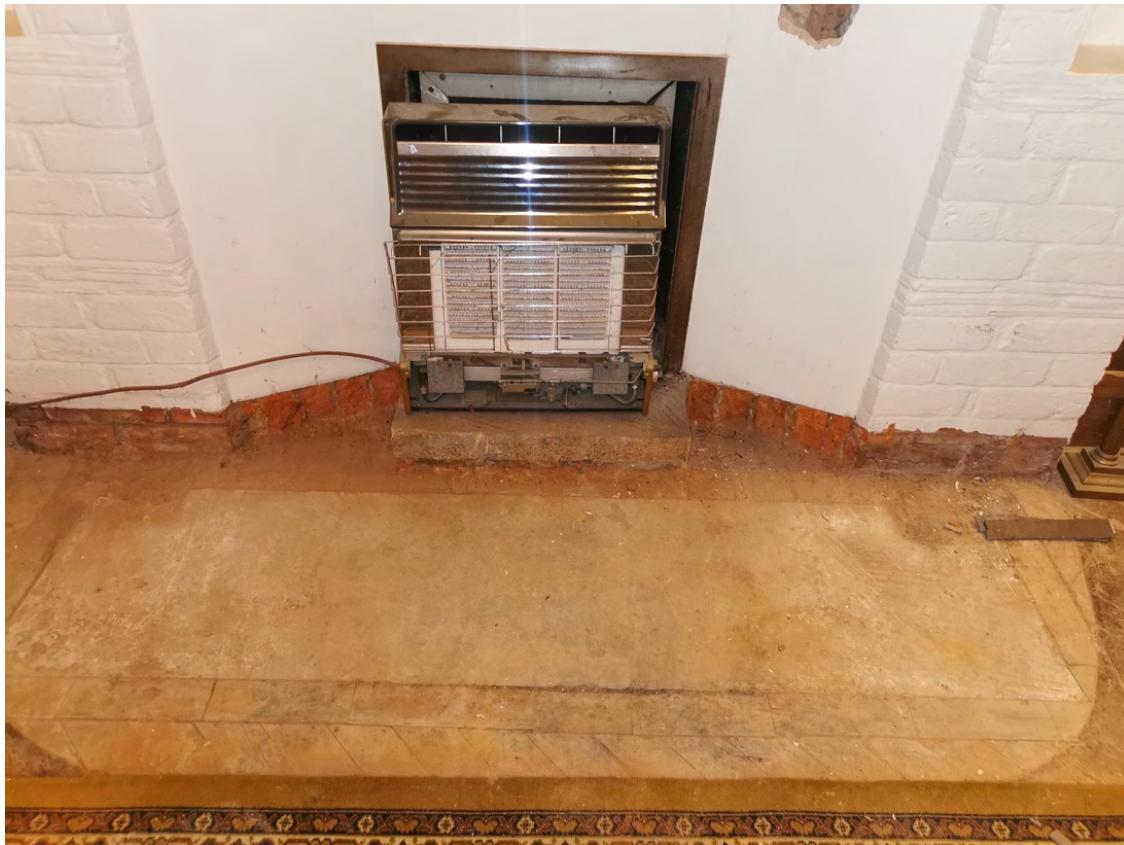
Photograph 4

The brick hearth once removed reveals an earlier hearth arrangement and the parquet flooring finished flush with a timber border. The hearth area has been infilled with a cement panel.

The inner hearth is edged with large flat red bricks overlaid with a concrete platform under the gas fire.

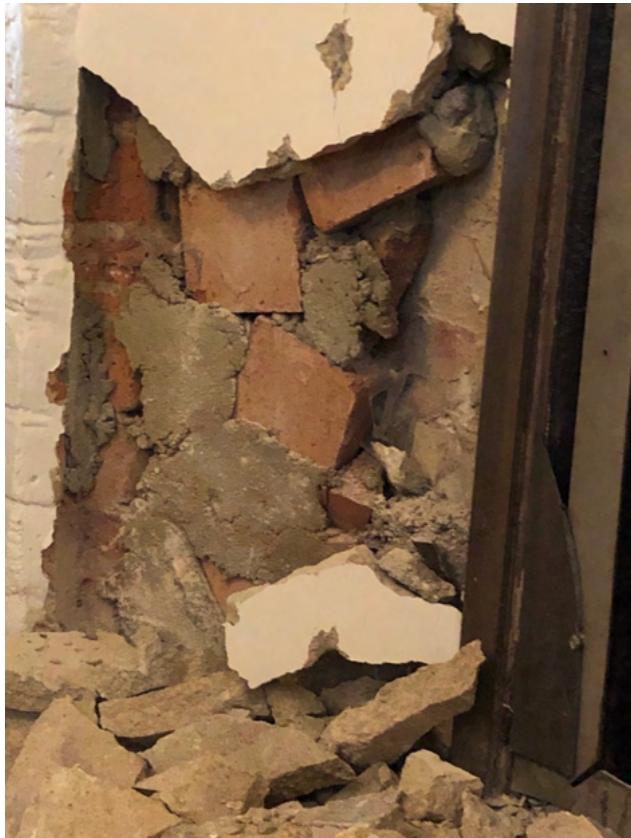
Photograph 5

Trial holes reveal the angled, plastered cheeks are formed by packing of cement and hollow clay bricks.

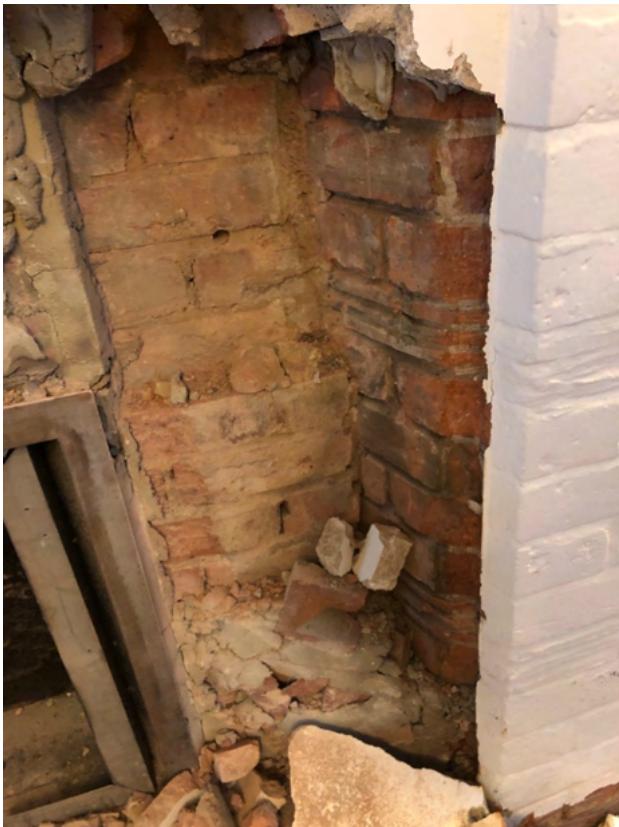
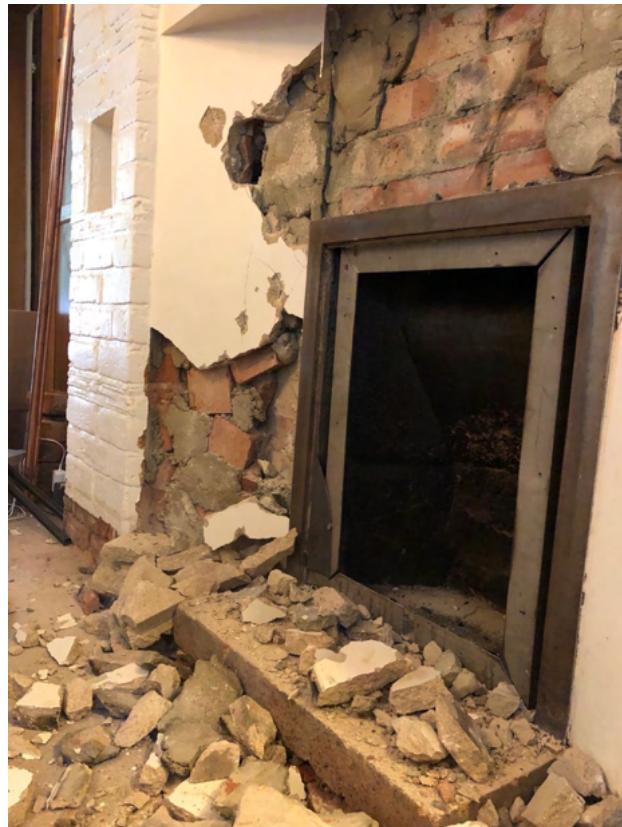
Photographs 6 and 7

Removal of the packing shows the decorative brick and creasing tile extending behind a rear panel of newer, harder bricks into which the gas fire and concrete platform has been recessed.

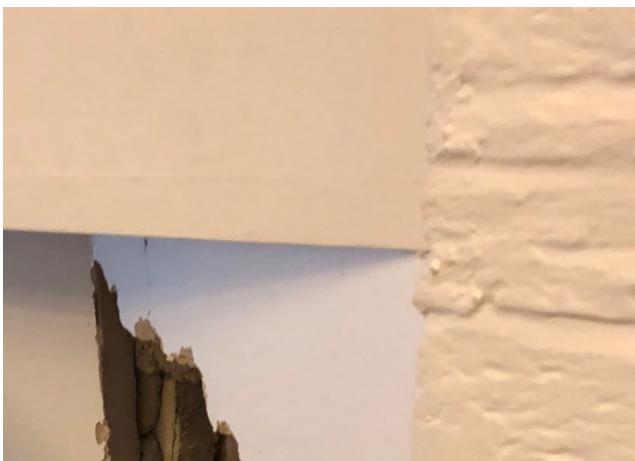
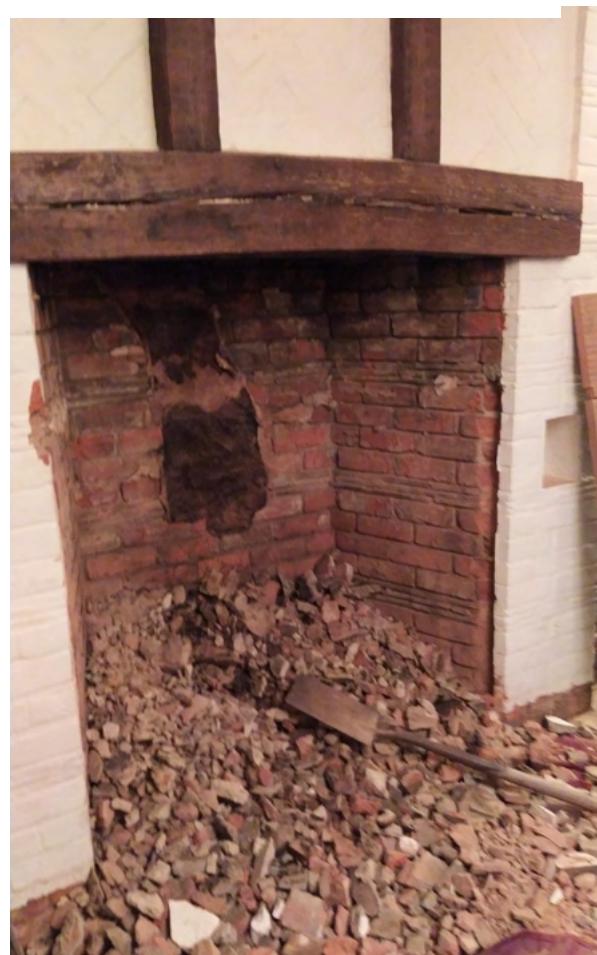
Photographs 8 and 9

The plastered panel above the angled cheeks is supported by the angled cheeks and a thin metal angle which is insufficient to support the panel once cheeks removed.

This reveals the full extent of the earlier fireplace formed of red brick and decorative interlayers of creasing tiles.

Removal of the cheeks and the brickwork surrounding the gas stove requires the panel above to be removed for safety purposes.
