Derek LOFTY & Associates

Project: Barn Conversion, Archies Field, Harefield.

Report on the Existing Barn Structure

Townsend Farm, Archies Field

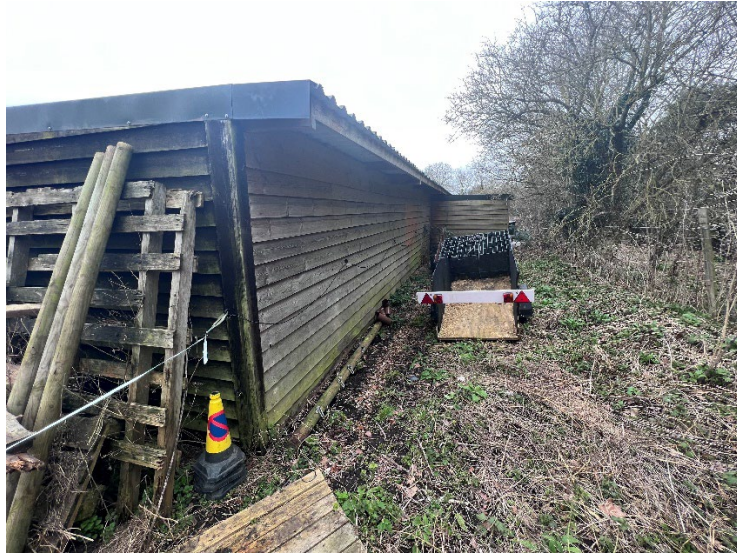
Figure 3 - Rear (West) Elevation

- 3.7. The external walls are slightly out of vertical alignment and are not particularly true to line. However, the structural integrity remains unaffected.

- 6.3. It is considered that the existing external walls could be retained, upgraded to meet modern thermal requirements. The external finishes should be light weight, as prescribed by the architect.

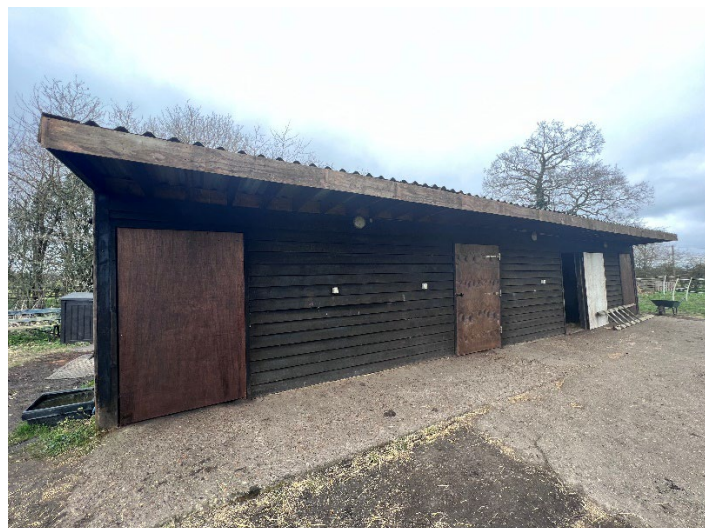
Figure 6 – Front (East) Elevation

- 3.1. The existing barn is an old agricultural building. The existing barn is of timber frame construction and is constructed beneath a series of flat roof joists at approximately 400mm centres. The joists are laid to fall and span from front to back., perpendicular to the long sides of the barn. The flat roof joists are supported on the external walls. Access to the barn is currently via 4 single door apertures on the east facing front elevation.

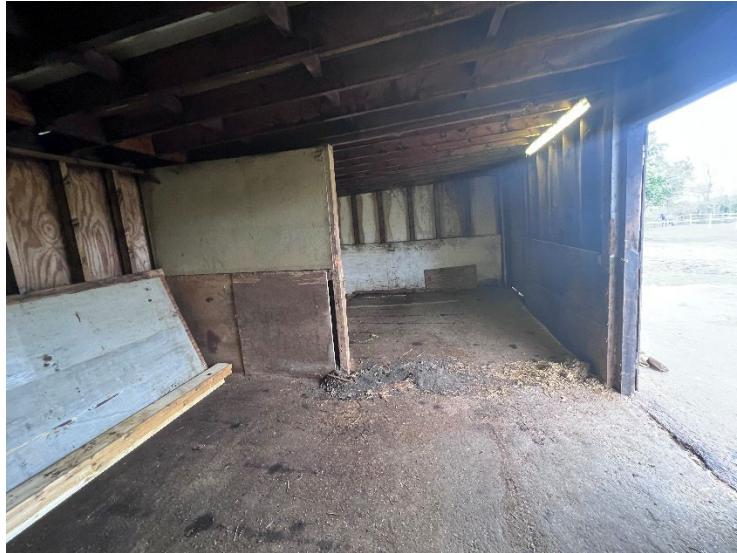
Figure 7 – Internal Floor Slab/Raft

- 3.8. The concrete floor slab, although considered substantial, slopes gently by approximately 30mm toward the south and east. The slab otherwise is considered to be in fair structural condition.

- 6.2. The modest site investigation has established the building is constructed off a concrete raft off which the external walls are raised, the raft is formed off an approximate 200mm layer of crushed hardcore. The hardcore appears to be formed on virgin ground. The ground appears reasonably free draining, and the geological maps for the area suggest favourable ground conditions for raft foundations.

- 6.4. The existing floor slab is substantial and can be reused; however, should be upgraded with the introduction of a damp proof membrane and the addition of thermal insulation and screed to bring the finished floor level approximately 150mm above external ground level.

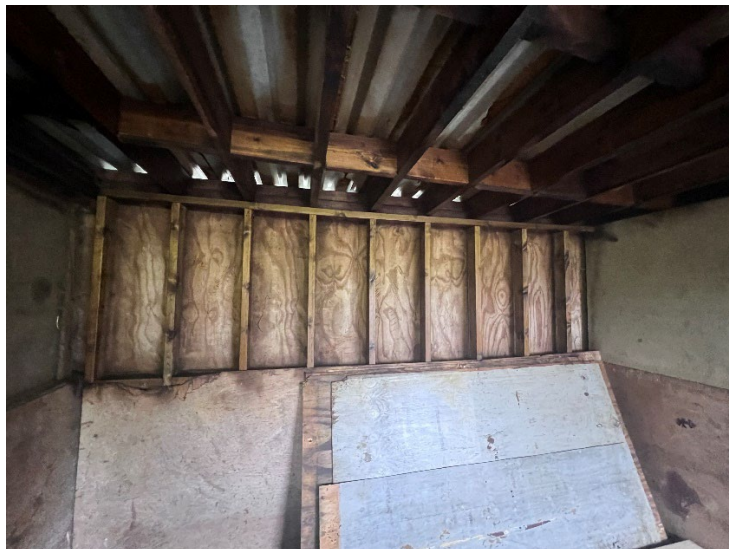
Figure 8 – Wall/Roof Construction

- 3.2. Secondary roof noggins span between the roof joists to support the single ply corrugated roof sheets.
- 3.3. The external walls are similarly constructed in an arrangement of timber studs at approximately 400mm cts. The external walls are clad with timber from eaves to ground level.

- 3.6. At the time of our inspection the barn is presented in what is considered to be fair structural condition. The roof remains reasonably true although undulates slightly the roof falls from front to back east to west.
