Report prepared for: Oldfield Construction Ltd.

For the Site of: 1 Boston Grove, Ruislip, HA4 7RY

Preliminary Roost Assessment (PRA)

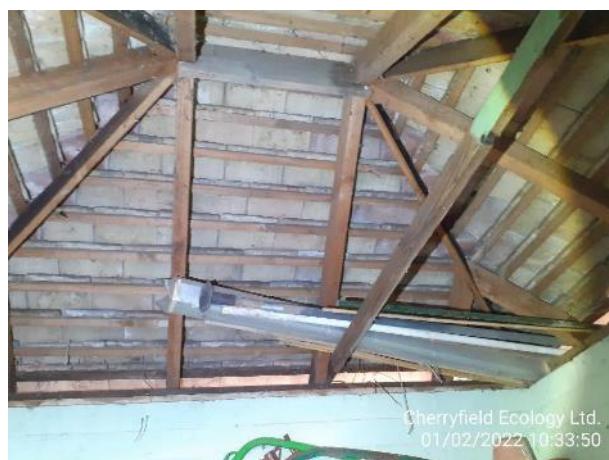
B1b has no internal loft void, and a vaulted ceiling. The roof is lined with bitumen felt. B2 has a very small internal space, there is no void or roof lining with a very small section of central ridge board.

Figure 11: Internal space in B2

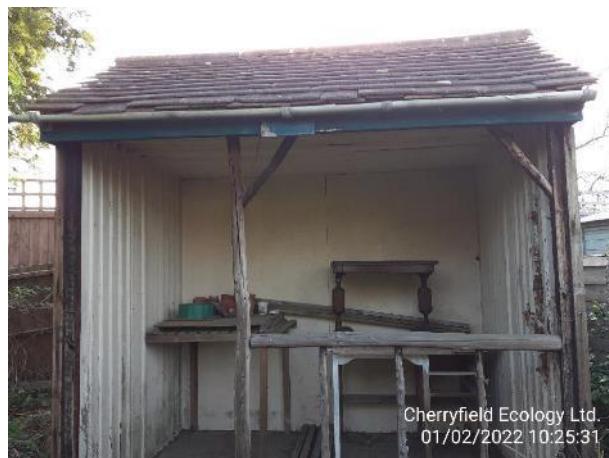
B3 is open sided and has a small inaccessible void.

Figure 12: Internal space and inaccessible void in B3

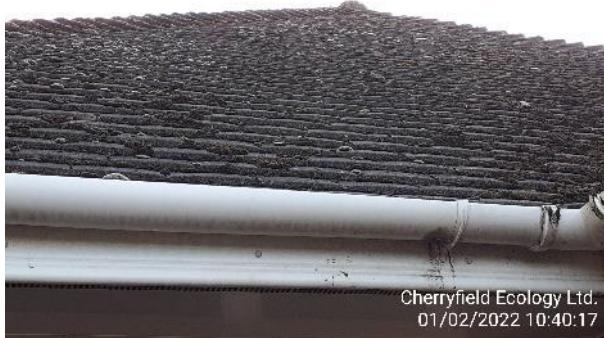
Bats found	No bats were found at the time of the survey.
Evidence of bat use	No evidence of bats was found at the time of the survey.
Potential for bat use	<p>Level of likelihood of presence -</p> <p>B1a - Negligible</p> <p>B1a provides negligible potential for roosting bats due to a lack of potential access points and roosting features. The roof tiles across B1a were intact and tight fitting (see figures 13 and 14), with the soffits also flush against the walls of the building (see figures 15 and 16). Internally the bitumen felt was tightly clad to the rafters (see figure 17) with no obvious entry points.</p> <div style="text-align: center;">

<p>Cherryfield Ecology Ltd. 01/02/2022 10:40:17</p> </div> <p>Figure 13: Example of tight-fitting roof tiles on B1a</p> <div style="text-align: center;">

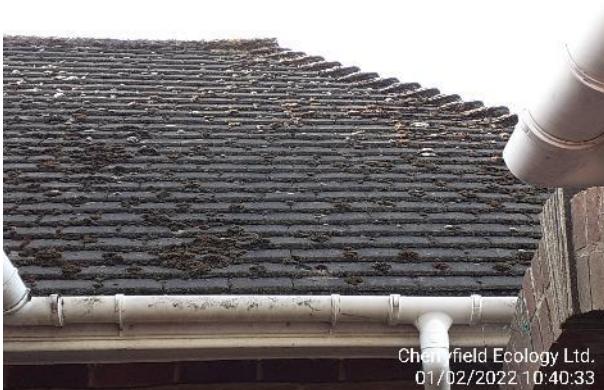
<p>Cherryfield Ecology Ltd. 01/02/2022 10:40:33</p> </div> <p>Figure 14: Further example of tight-fitting roof tiles on B1a</p>

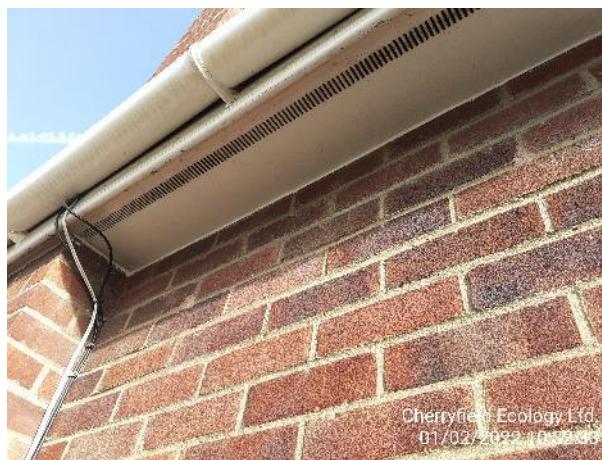
Figure 15: Example of soffits flush against walls of B1a

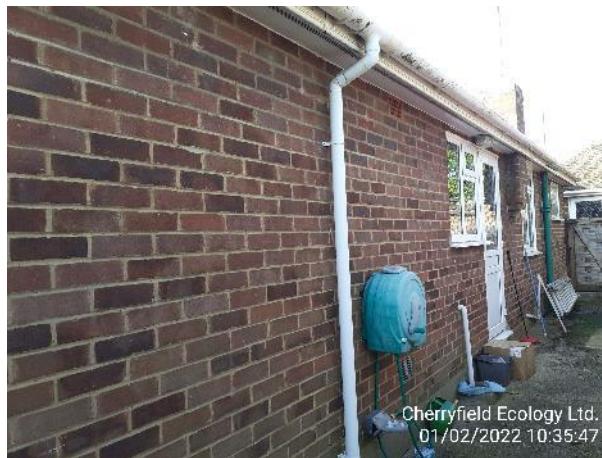
Figure 16: Further example of soffits flush against walls of B1a

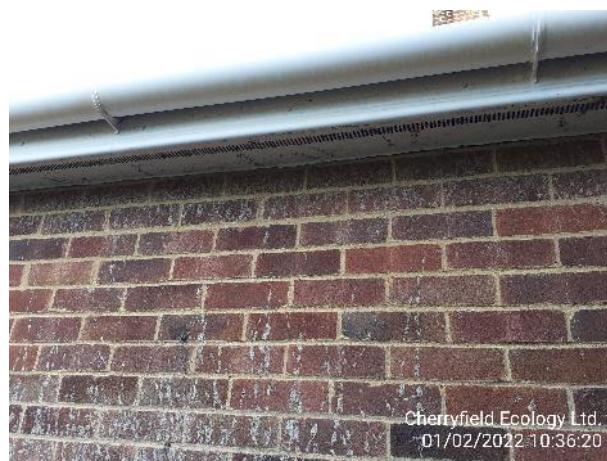
B1b provides negligible potential for roosting bats. Internally there were no obvious access points, with the roofing felt tight-fitting to the rafters. Externally, the brick walls were intact and in a good condition with the soffits also tight fitting to the walls (see figure 17). Overall, the roof tiles across the building were intact and tight-fitting, with only one gap present under a lifted roof tile. Though this could act as a potential access point, more suitable roosting opportunities were present in neighbouring buildings including numerous gaps under clay roof tiles.

Figure 17: Example of brick work in good condition and tight-fitting soffits on B1b

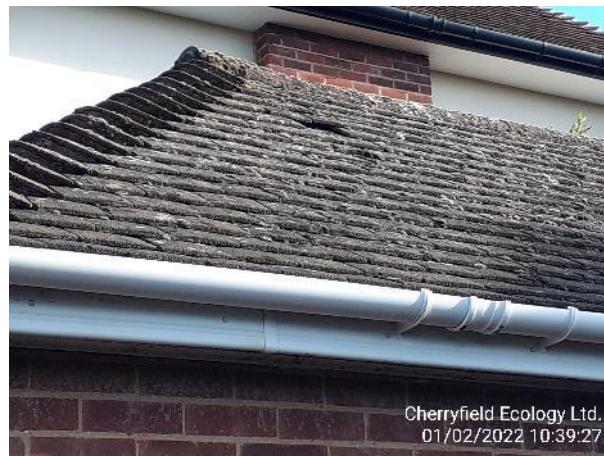
Figure 18: Example of mostly tight-fitting roof tiles but one gap present

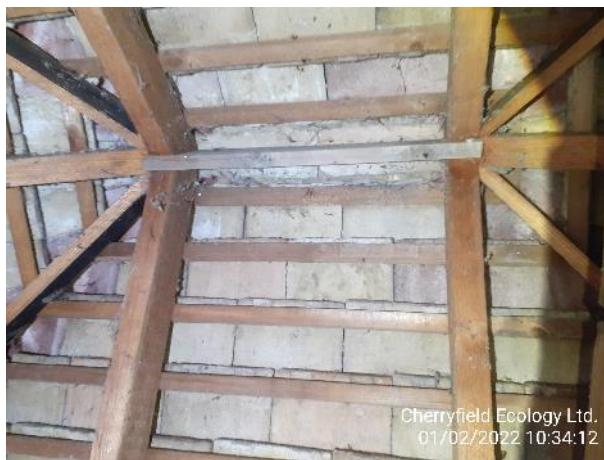
B2 provides negligible potential for roosting bats. Though potential access points were present in the structure via small gaps under the eaves, inside there is a very small internal space, with a very short section of central ridge board which was tightly fitted to the roof and a lack of roof lining the tight-fitting tiles, and therefore the internals are considered to provide sub optimal roosting opportunities for bats.

Figure 19: Very small internal space in B2

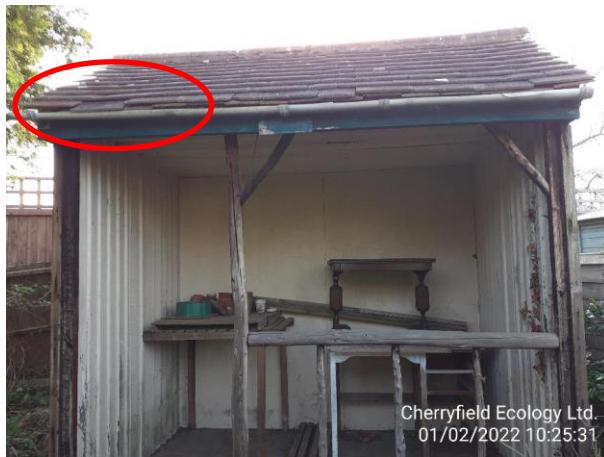
B3 provides low potential for roosting bats, due to a small number of potential access points / roosting features. A small number of gaps were present under loose roof tiles and a small gap was present in the cladded sides which led into the inaccessible, but small void above.

Figure 20: Small number of gaps in roof tiles in B3

If the proposals change and B3 is to be affected one presence/Likely Absence survey, with two surveyors will be required. If bats are found to be using B3, two further surveys will be required, a minimum of two weeks apart. These surveys must be undertaken within the May to September window (with September considered sub-optimal). Two of these surveys will need to be undertaken during the optimal timeframe of mid-May to August.
