**Report on  
Structural Inspection  
at  
18 Roker Park Avenue, Ickenham UB10 8ED**

Ref: 015724/KC

Date: 04.08.2022

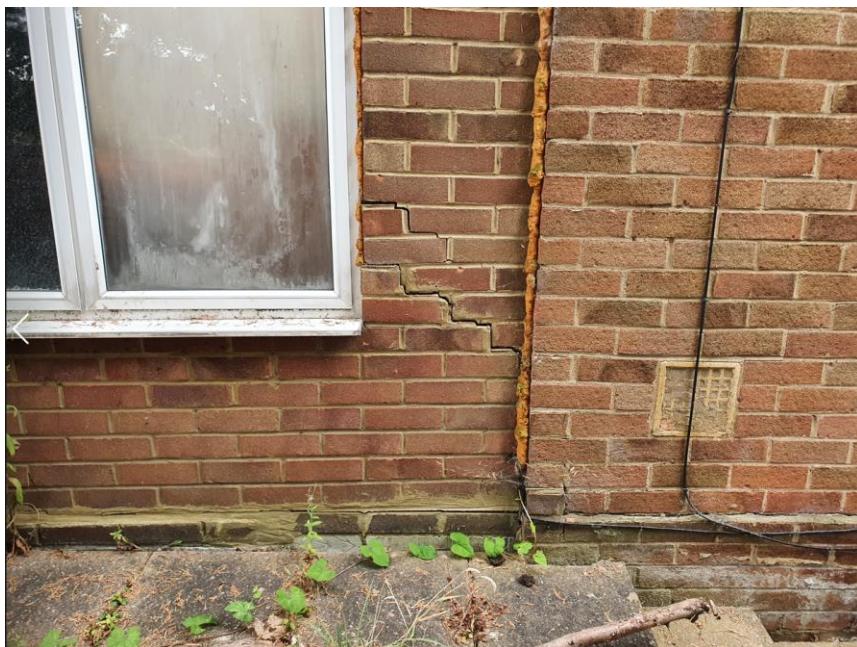
- 2.4 There are cracks visible externally on the rear and left flank walls of the conservatory. The crack widths range from 0.5mm to 15mm. The cracks appear at the bottom, top and sides of the windows.

- 2.6 Internally, there are various cracks visible on the conservatory walls. The crack widths range from 5mm to 25mm.
- 2.7 The conservatory is rotating away from the adjacent walls of the original house. This rotation has created a gap that varies from 5mm to 50mm, although this gap has previously been infilled.

Cracking at rear of conservatory and infilled gap at joint with main house

- 4.2 The conservatory building should be demolished. The homeowner may choose to rebuild it on new foundations that are deep enough to cater for tree roots and subsidence.

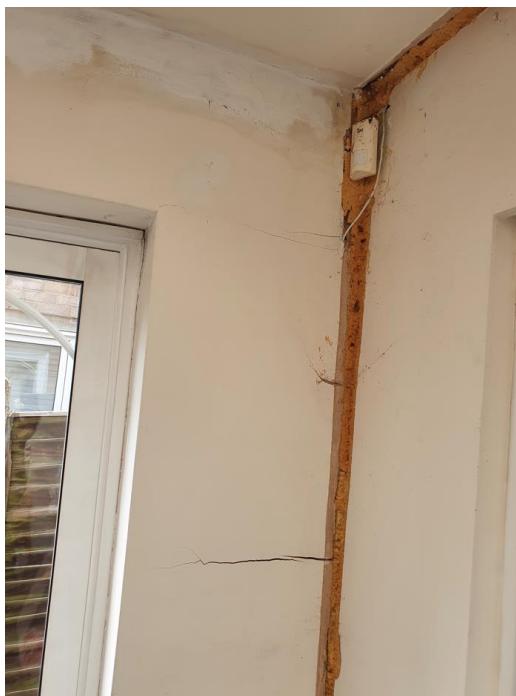
Infilled gap where conservatory is rotating away from original house

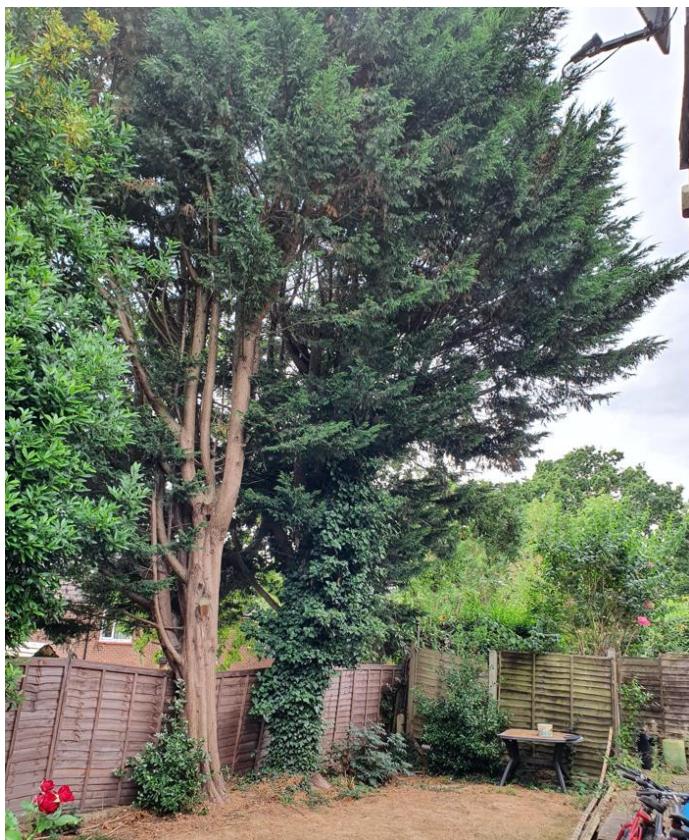
- 2.12 There are no other structurally significant cracks at first floor level.
- 2.13 There are two tall trees at the rear garden at approximately 4.5 metres opposite the conservatory. These are conifers and appear to be pine or Douglas fir trees. These two trees are within a zone of influence where they can cause subsidence<sup>[1]</sup>. Trees can cause subsidence damage to buildings through normal growth functions. Clay shrinkage subsidence occurs where tree (or vegetation) roots extract moisture from the soil causing it to shrink, which could in turn cause building foundations to move and walls to crack.

- 3.1 It appears the two large conifers in the rear garden opposite the conservatory are causing subsidence of the building due to their proximity, maturity, and water demand nature. The conservatory is affected more than the main building as it is closer to the trees, and the foundations are likely to be shallower than the main building.

Conifers at rear garden opposite conservatory building

- 4.1 The two large conifers at the rear of the garden are recommended to be removed. If these trees have Tree Preservation Orders, permission should be sought from the local council prior to removing them.

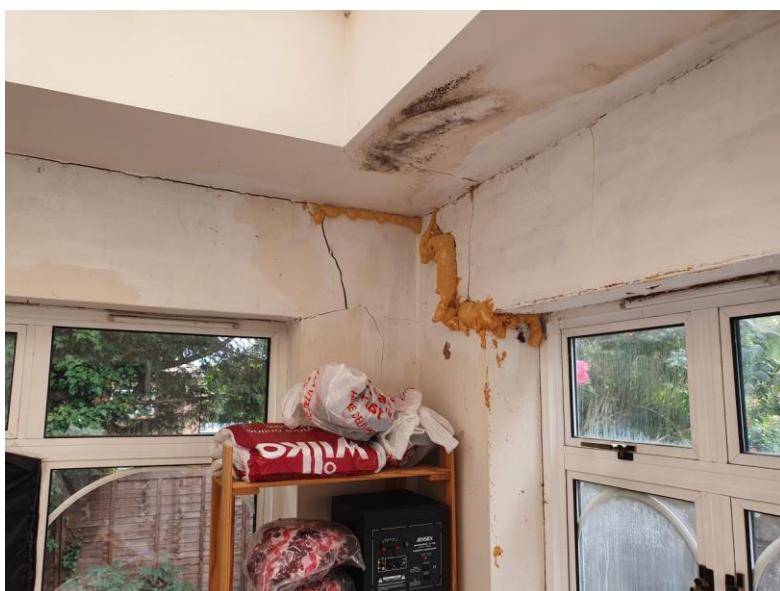
Cracking inside conservatory

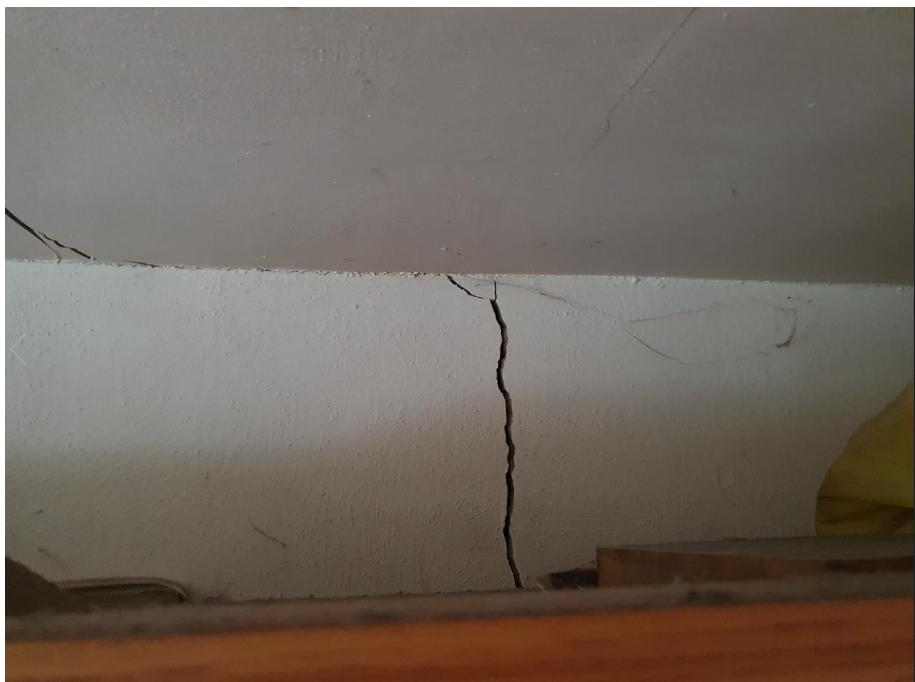
- 2.10 There is a significant crack seen internally at ground floor between the kitchen and conservatory. This crack appears at the top of the wall and varies from 0.5mm to 10mm.

Crack in ground floor wall between kitchen and conservatory

- 4.3 Based on the current evidence, cosmetic crack repair may be carried out to the existing cracks in the original building if the visual impact of the cracks is causing an uneasy feeling.

- 4.4 Whether crack repairs are carried out or not, it is recommended that the cracks are monitored over the years to verify if they are getting worse.

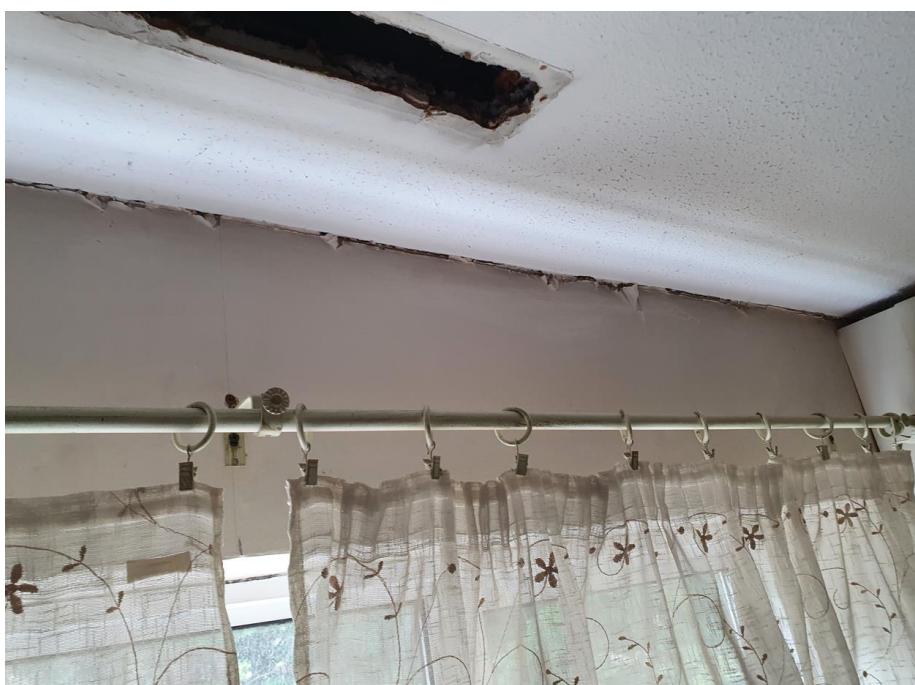
- 2.11 Internally at first floor level, there is a crack visible in the rear bedroom at the junction between the wall and ceiling. There is another crack in the hallway at the junction between the rear bedroom and the front right bedroom. The crack widths range from 0.5 to 5mm.

Gap at first floor rear bedroom between wall and ceiling
