Masonwood Design Ltd

SCHEDULE OF WORKS:

**270 High Street,
Harlington,
Hayes
UB3 5DD**

Mr S Bhandare
Ref. MW.2022.043/PHOTOS
28 October 2022

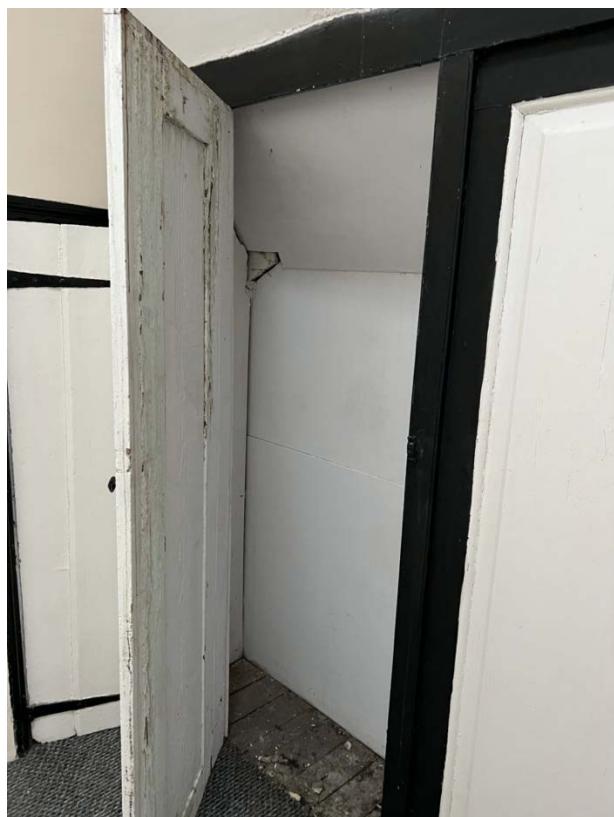
Fig.44 Doors DF.02 and DF.03

9.3. Retain and repair doors with reference DF.02, DF.03 and DF.04

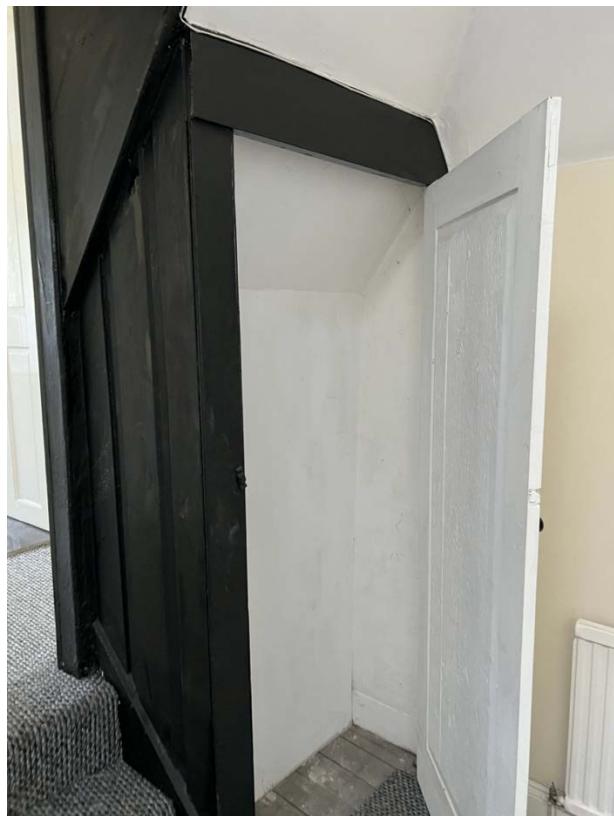
Fig.45 Doors DF.04
