Masonwood Design Ltd

SCHEDULE OF WORKS:

**270 High Street,
Harlington,
Hayes
UB3 5DD**

Ref. MW.2022.043/PHOTOS_RevB
28 October 2022

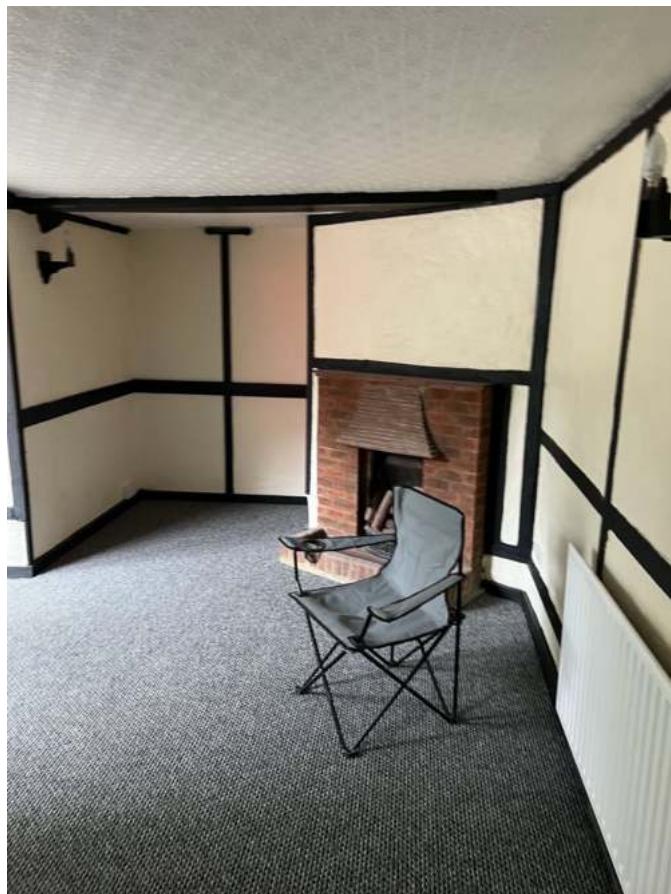
Fig 5. Existing fireplace

1.4. Case for replacement and upgrade fireplace with example attached

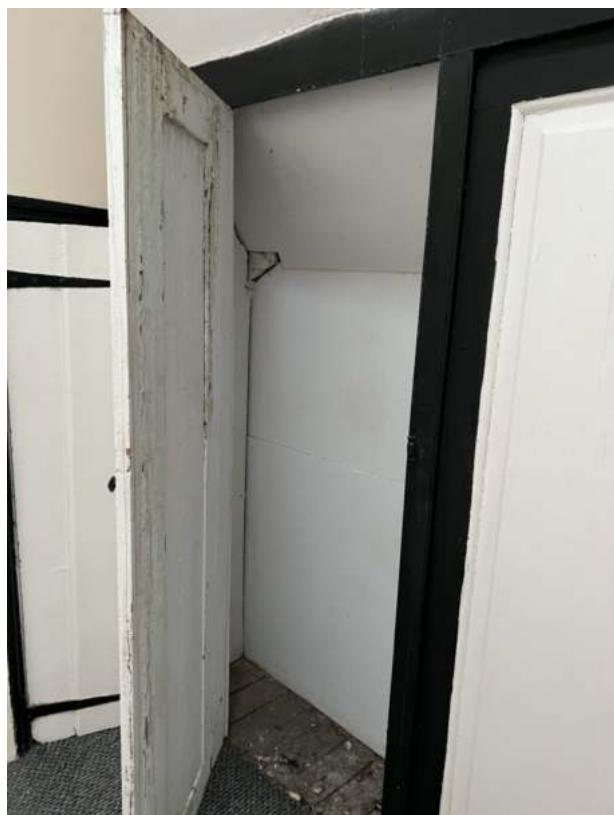
Fig.44 Doors DF.02 and DF.03

9.3. Retain and repair doors with reference DF.02, DF.03 and DF.04

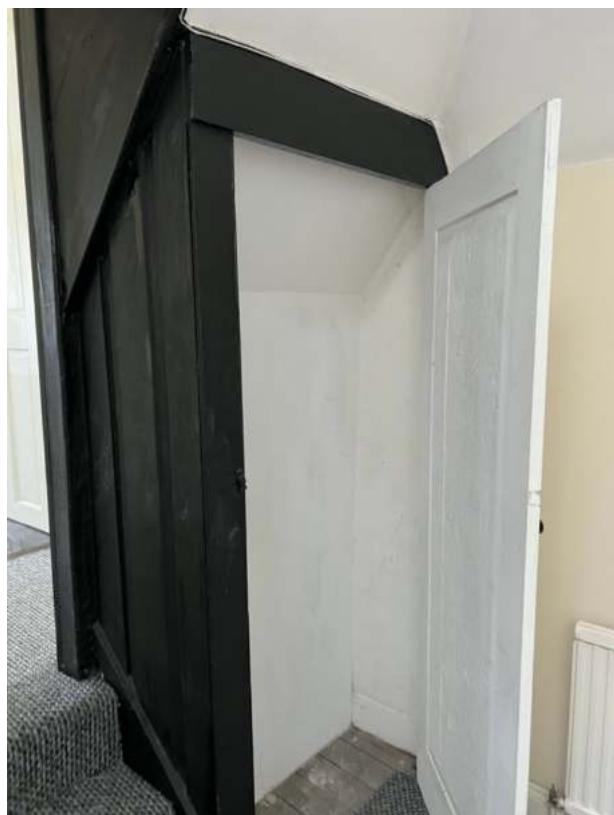
Fig.45 Doors DF.04
