ROOF SURVEY

Client Name: Sachin Bhandre
Address: 270 High Street
Harlington
Hayes
Middlesex
UB3 5DD
Purpose of Report: ROOF CONDITION SURVEY
Report Reference: RCS|MSB|23
Inspection Date: 15 Dec 2023
Surveyor Name: David Bird BCI, CII, BDMA, MIOR

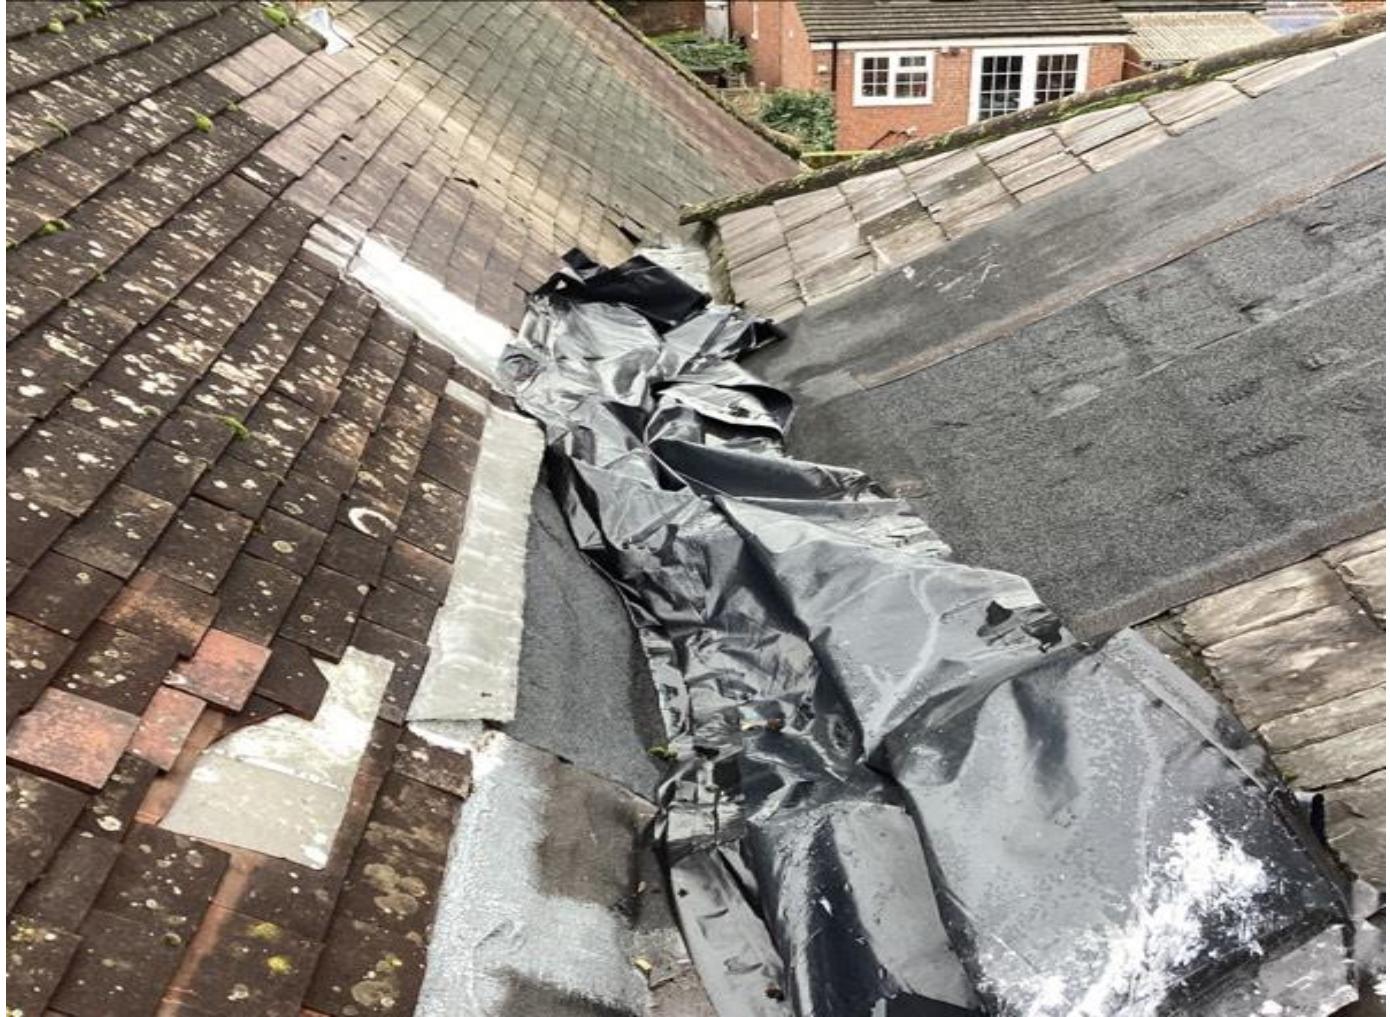
Valley between roof pitches

- The mineral felt lined valley between the two pitched roof areas is in very poor condition.
- Rainwater has become trapped between the felt layers, and bonding at the felt laps are poor and not effective.
- The roof surfaces of both the Rosemary tiles of the front roof section and the slates fitted to the rear roof areas are also in generally poor condition and all areas would benefit from replacement.

- The central valley area should be stripped out and all supporting timbers assessed for water damage and replaced Accordingly.
- The central valley area should be fully re-lined and resurfaced, we recommend lead or an EPDM material, all pitched roof surfaces should then be fitted with waterproof breathable membranes, fully lapped, and layered to ensure effective water runoff and efficient drainage into gutter and gulley areas.

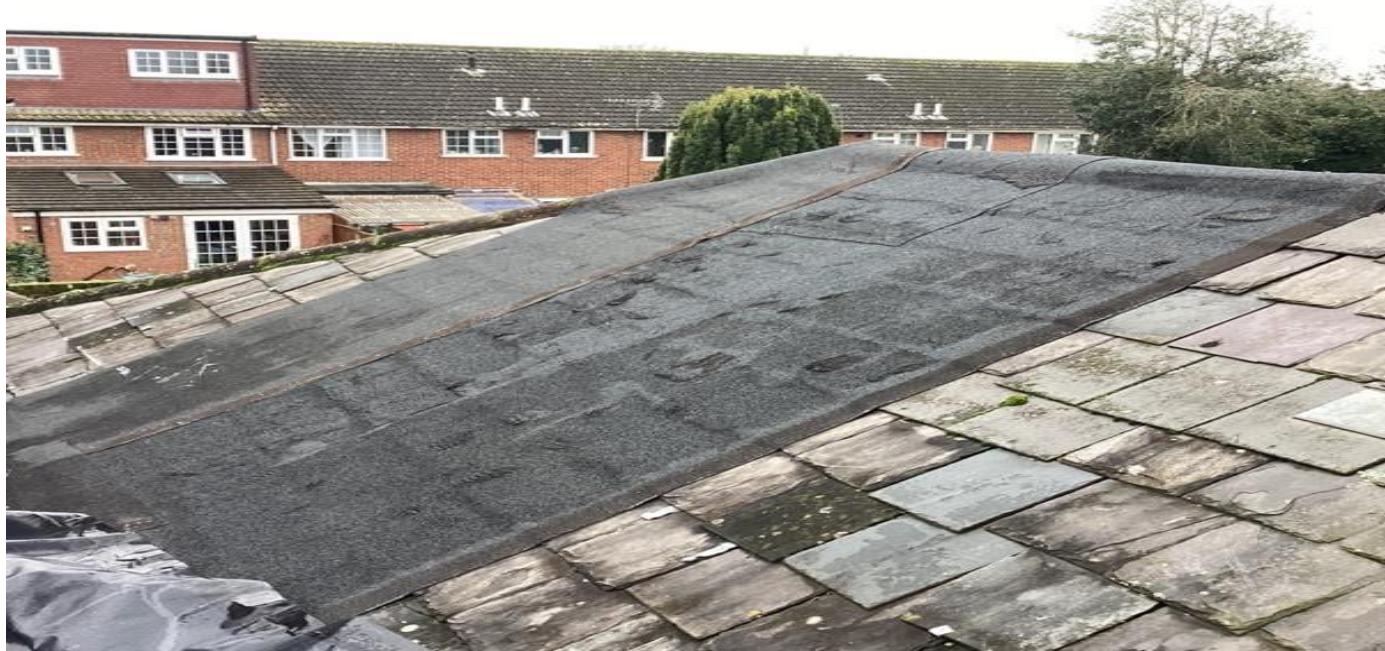
Rear pitched roof is slate (with temporary mineral felt covering)

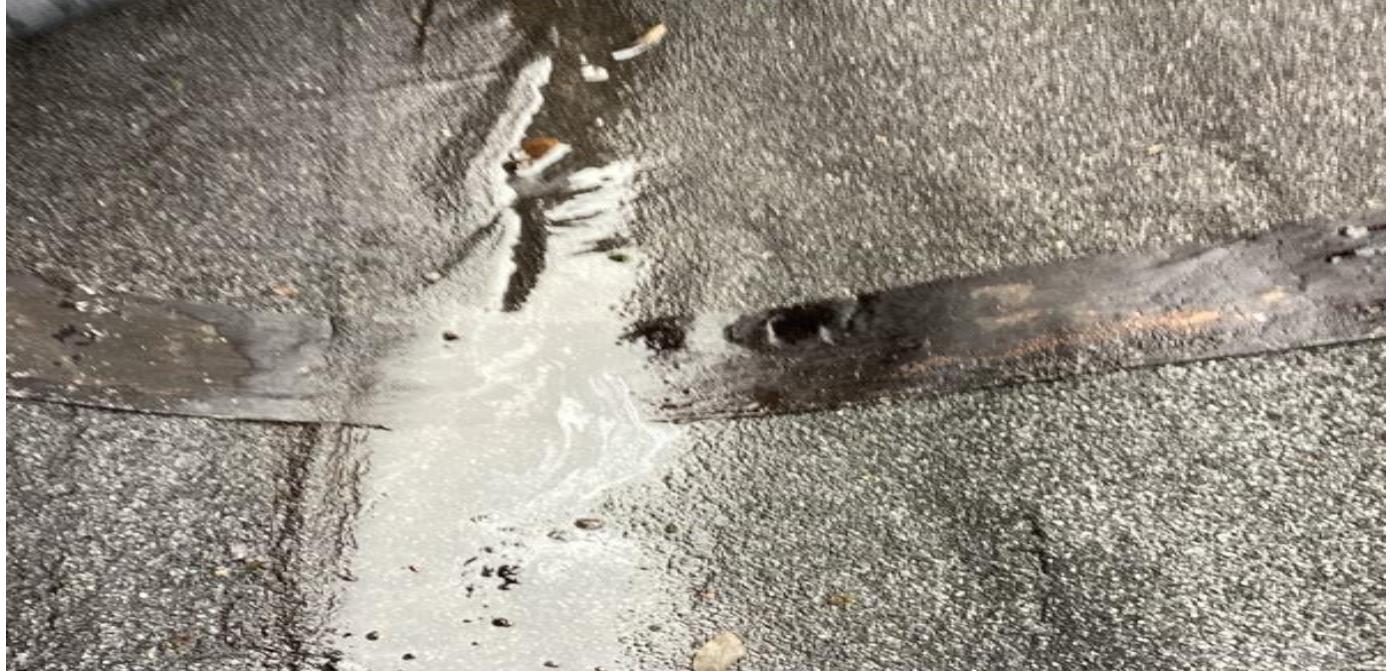
Felt laid in valley is lapped incorrectly (against the flow of water)

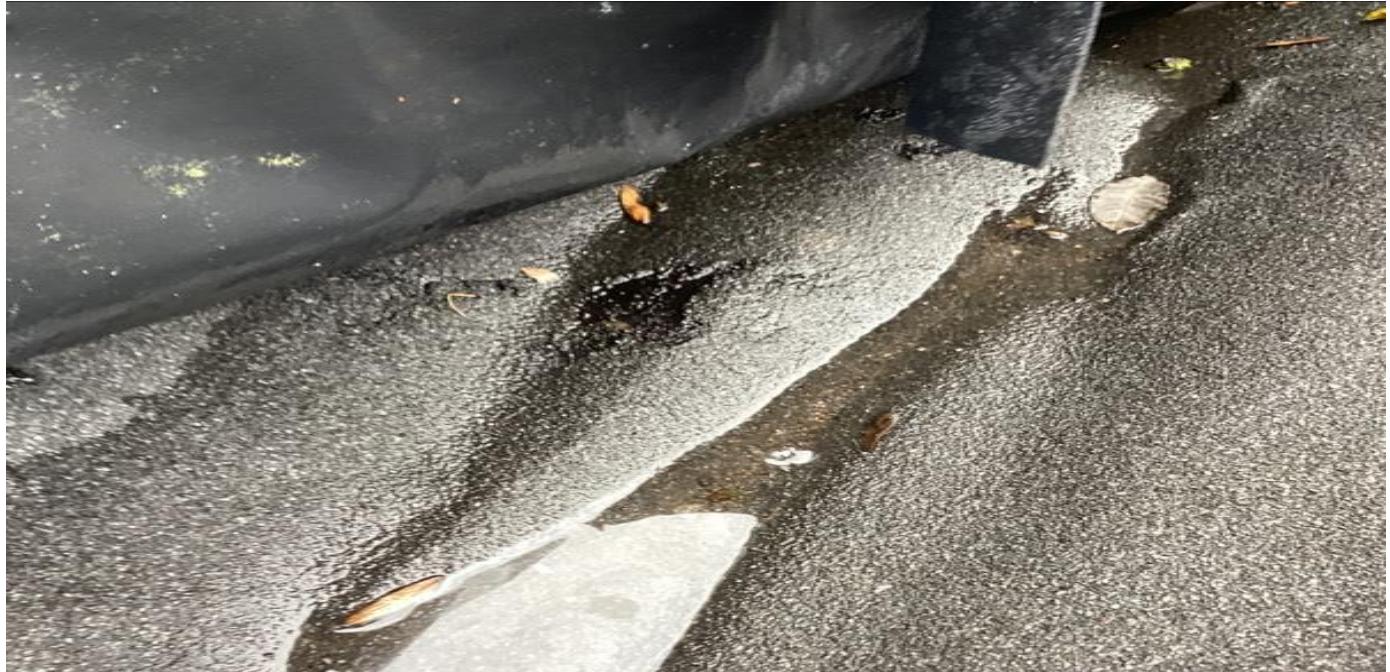
Water is trapped below layers of felt fitted to valley

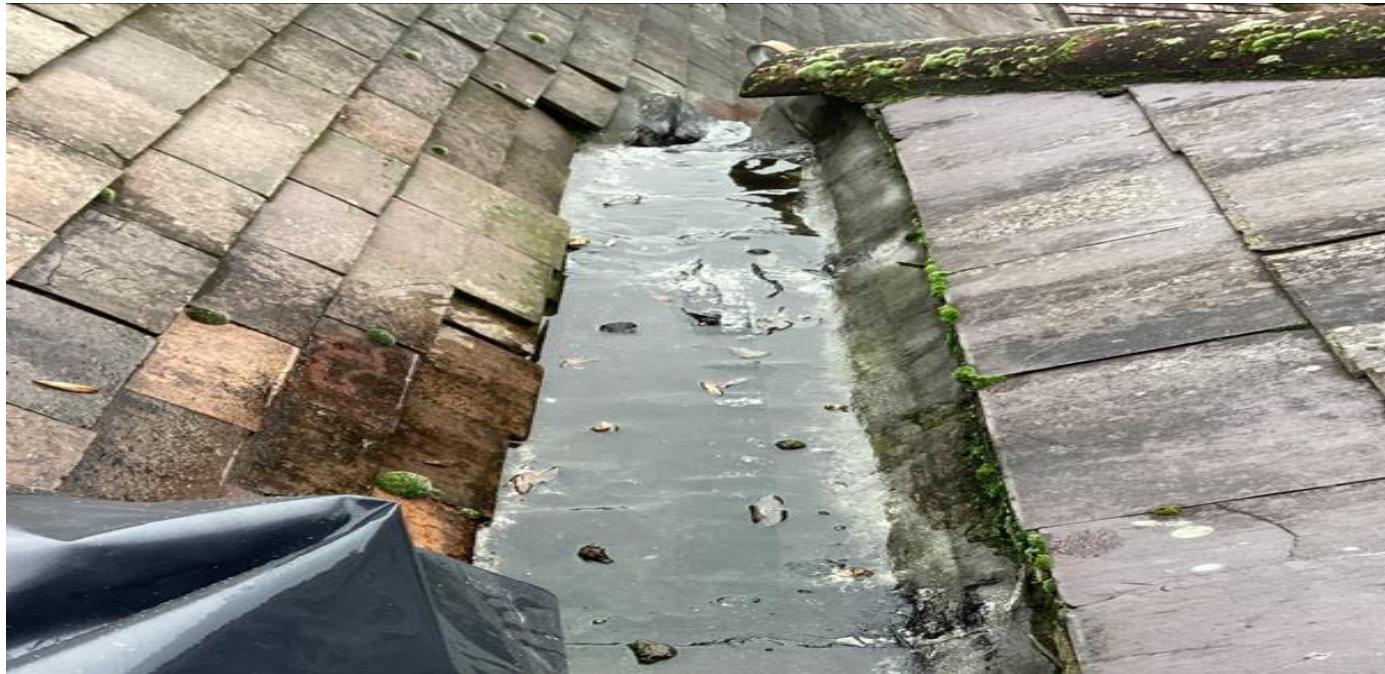
Original valley lining is aged

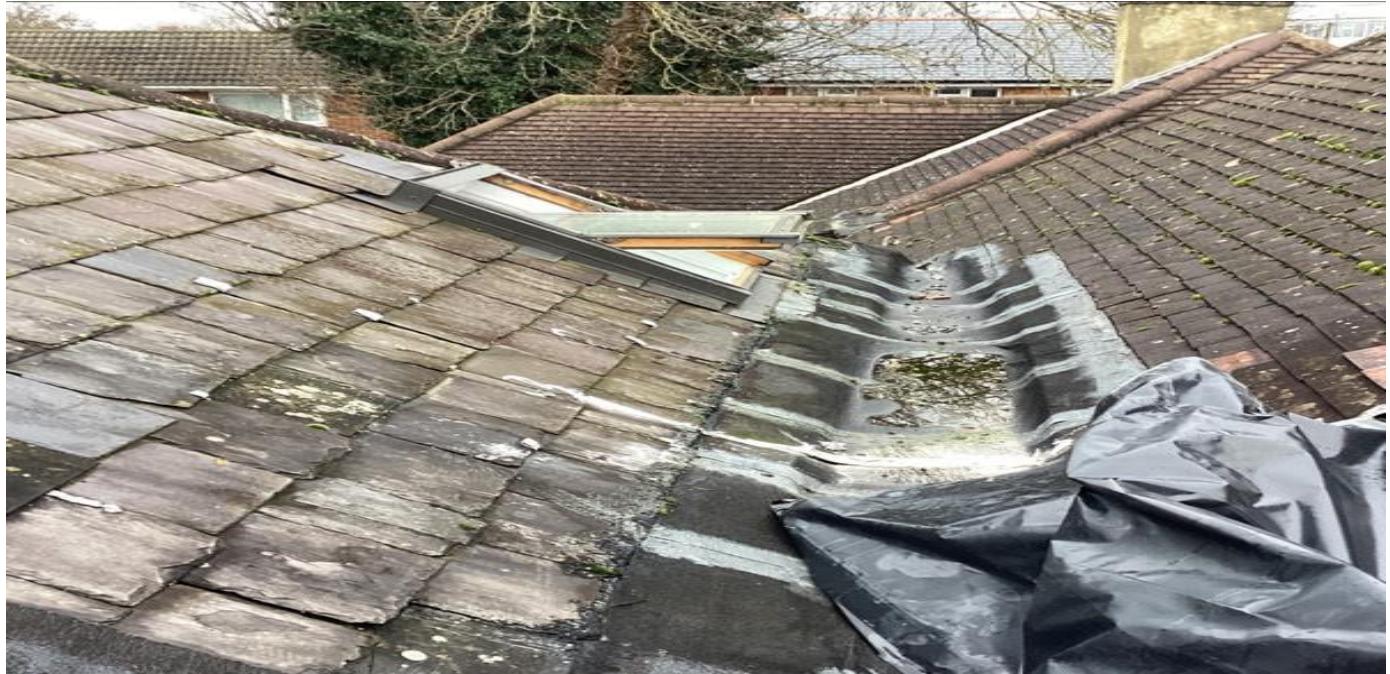
Central area of valley is pooling

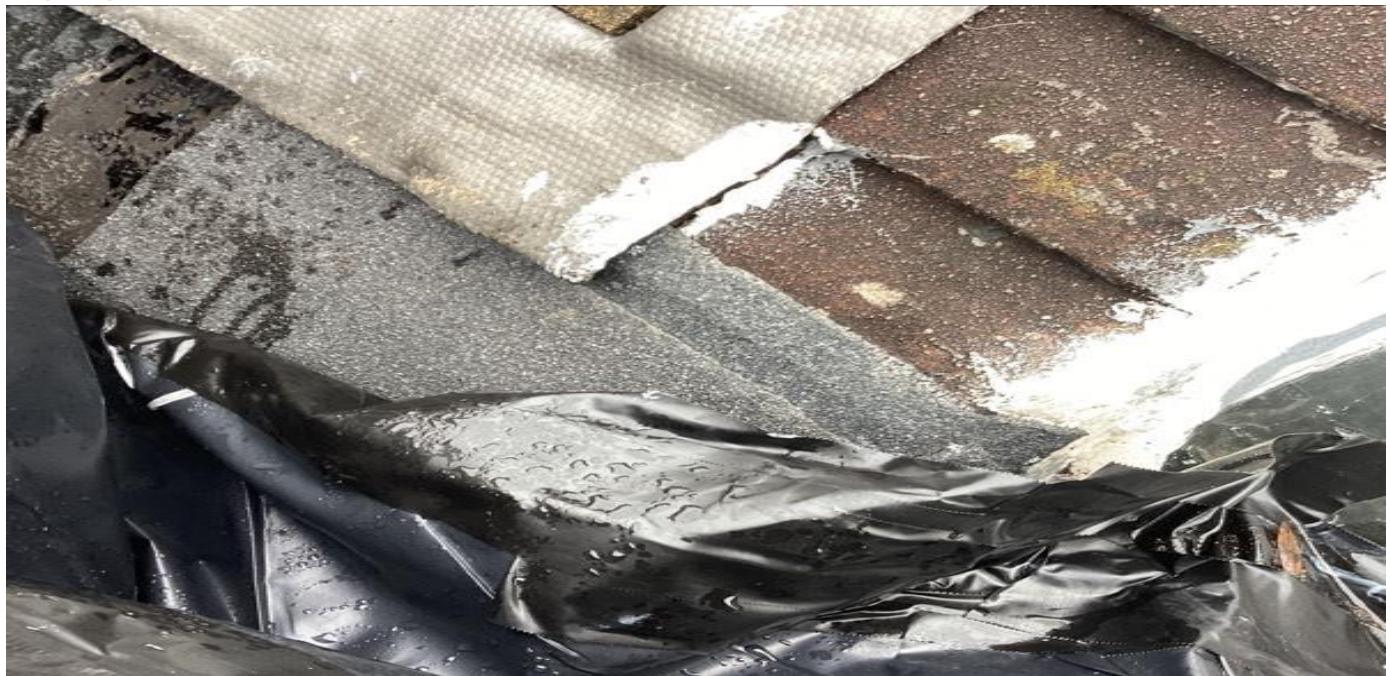
Repair patches are installed above tiles,

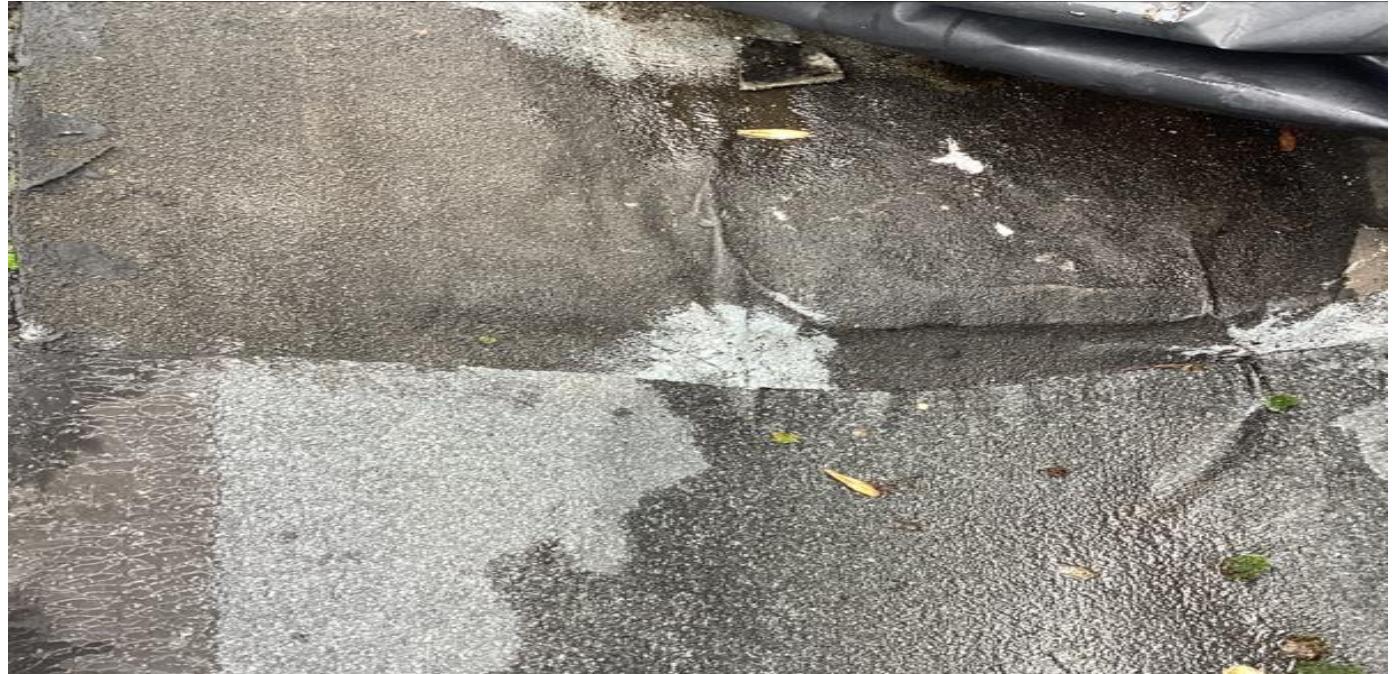
Water ingress at joints, then traps under felt

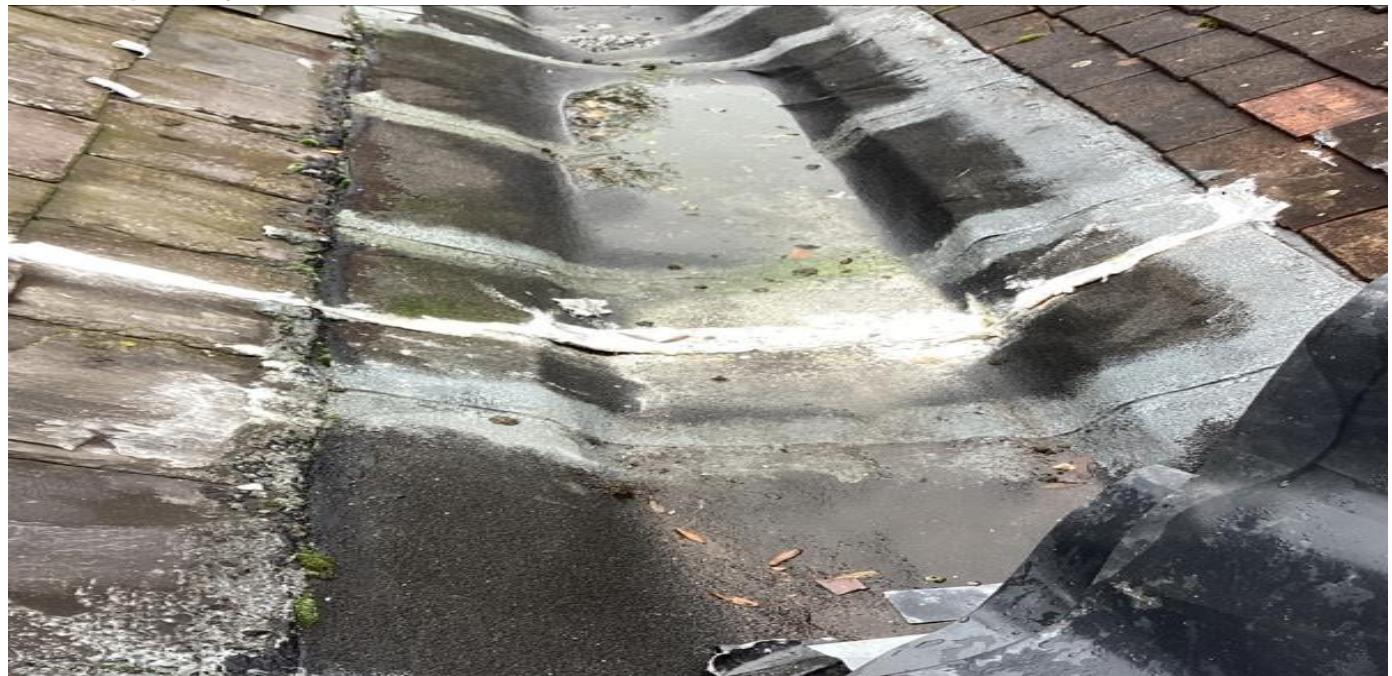
Failed repair at joints

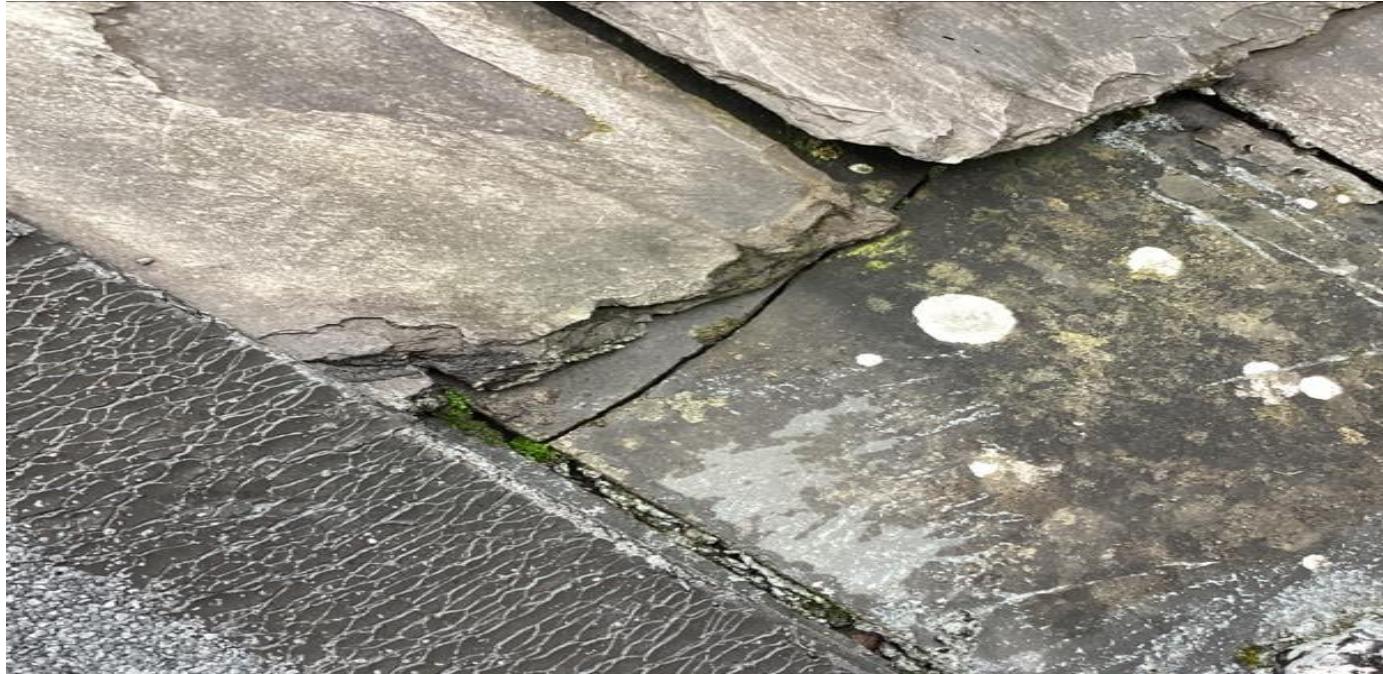
Water can enter the valley below the lining at a number of areas (broken slate)

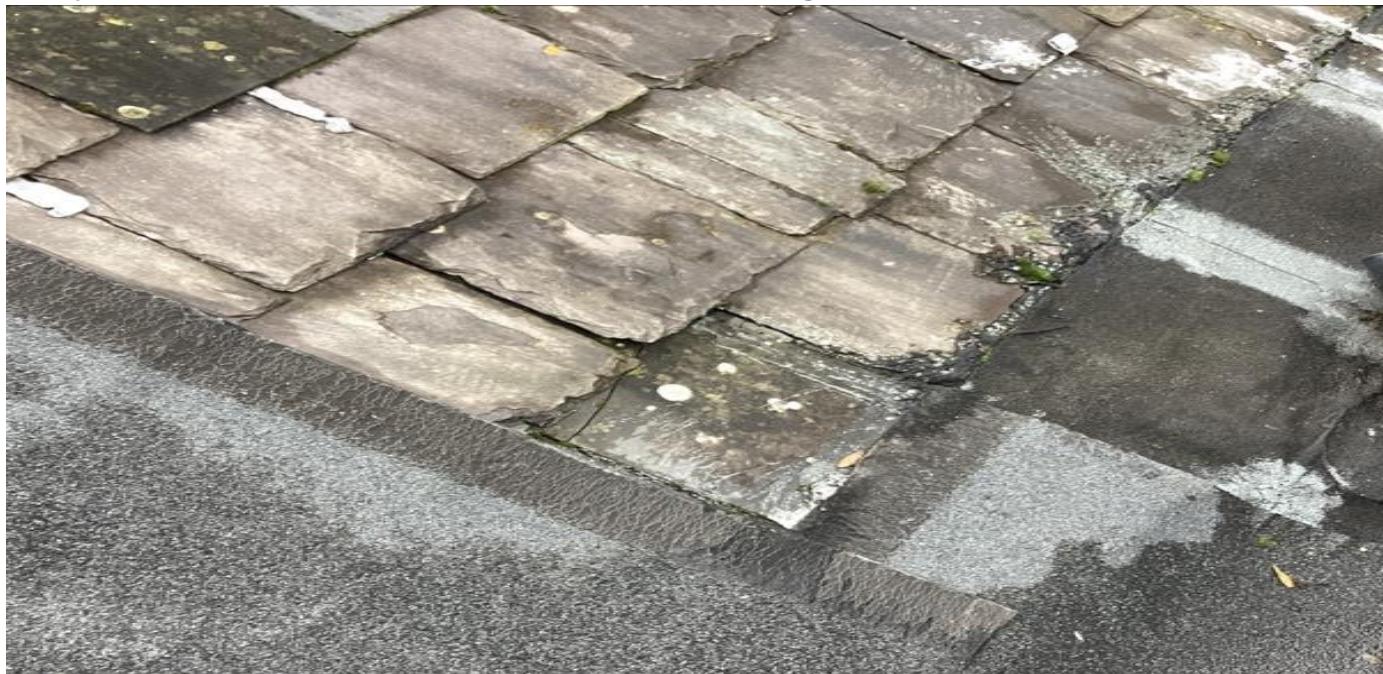
Valley felt laid above slates, broken slate above allows ingress

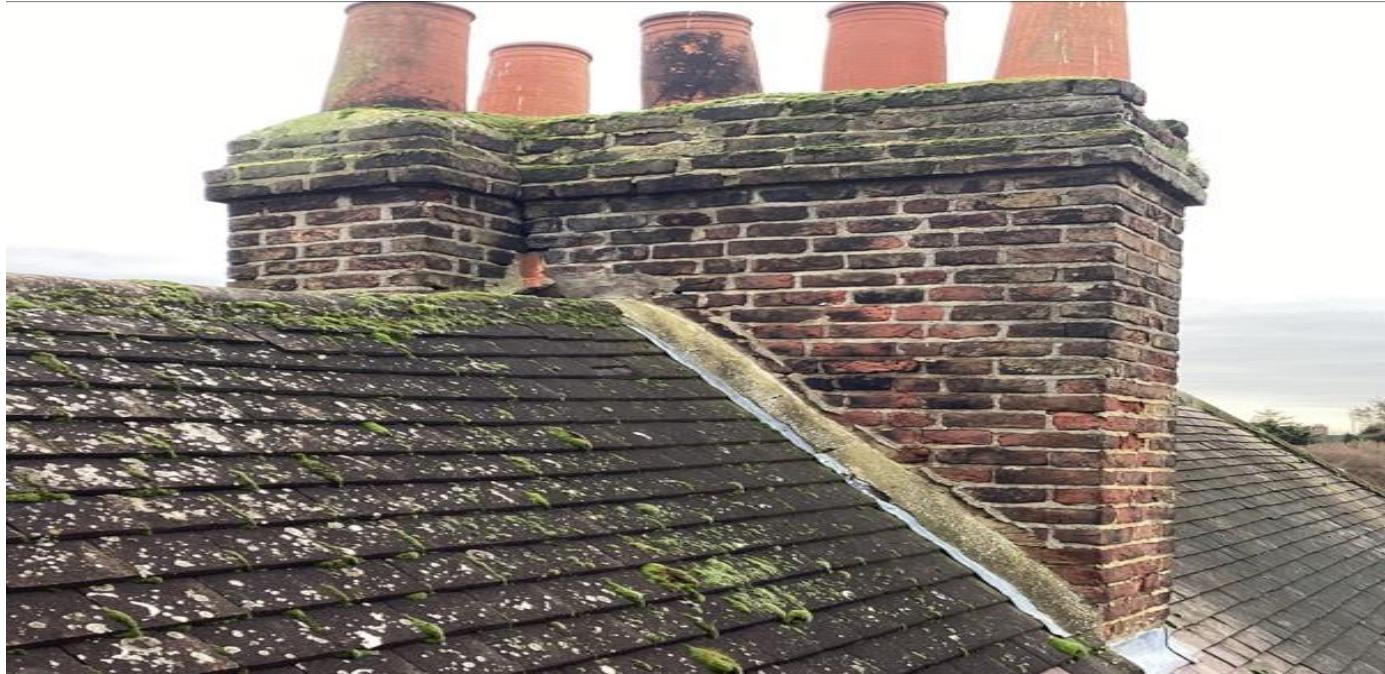
Chimney stack would benefit from repointing

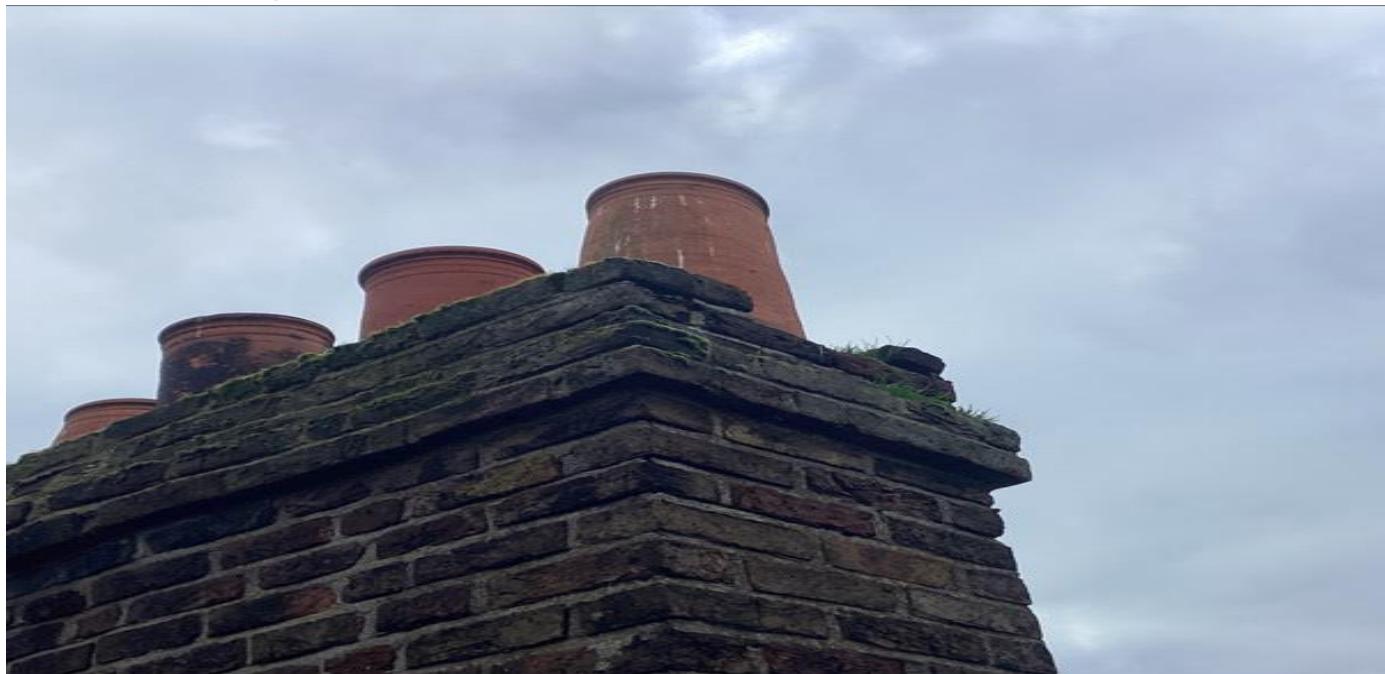
Head of stack is in poor condition

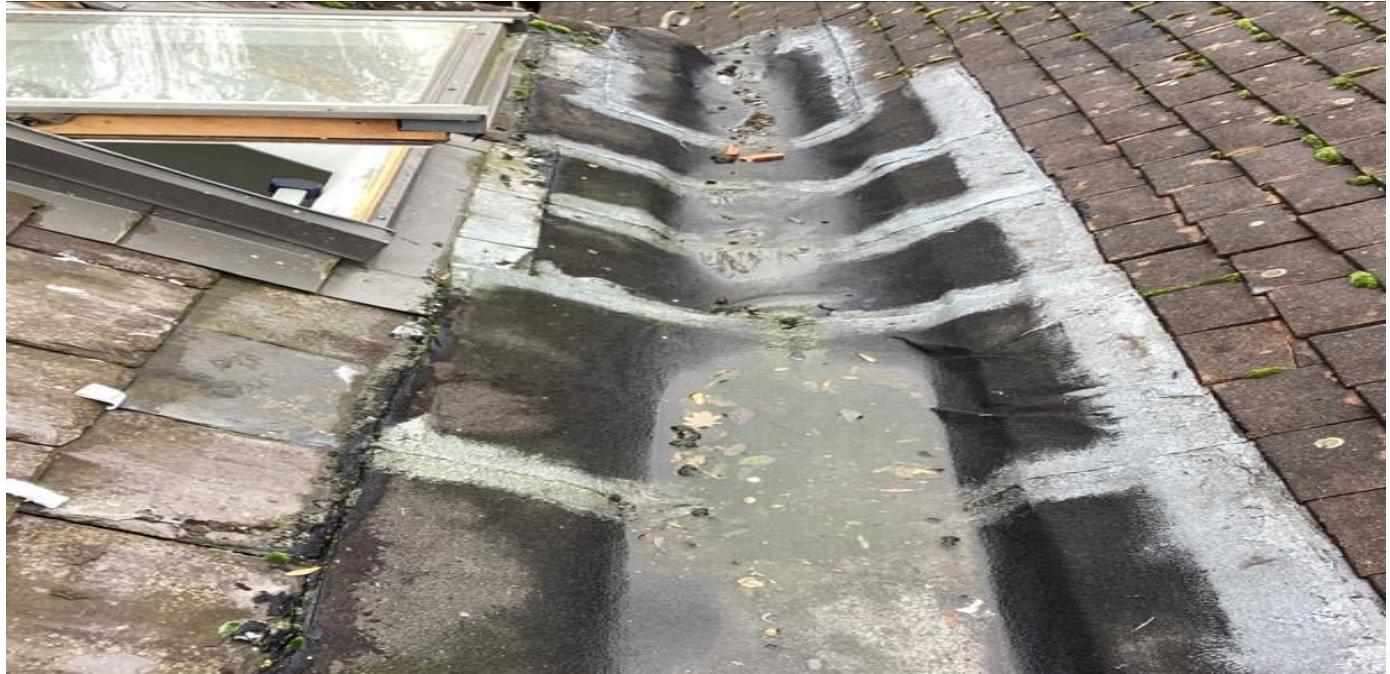
Valley lining in poor condition

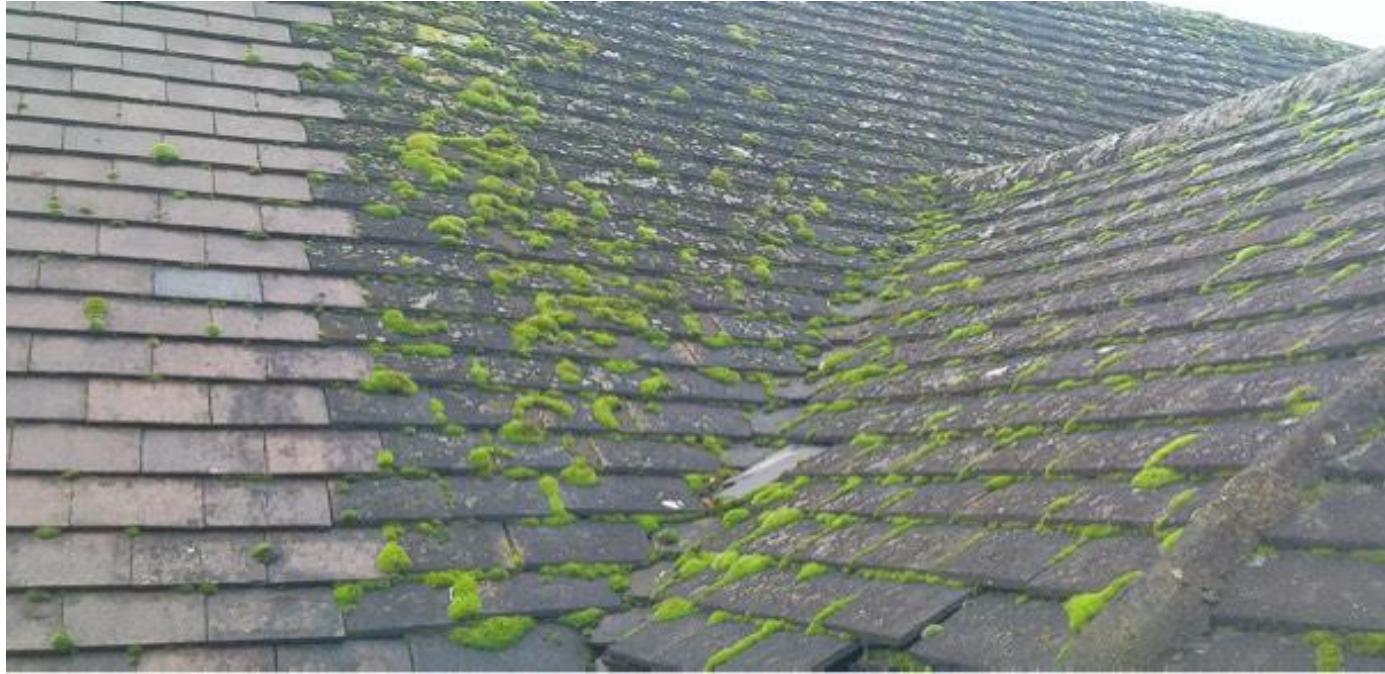
Front pitch, general condition is poor due to dislodged tiles and moss build up.

- Pitched roof surfaces can then be battened and finished with new Clay Rosemary tiles, matching those of the adjoining roof areas, the rear roof section related using an appropriate slate in accordance with the Grade 2 listed status.

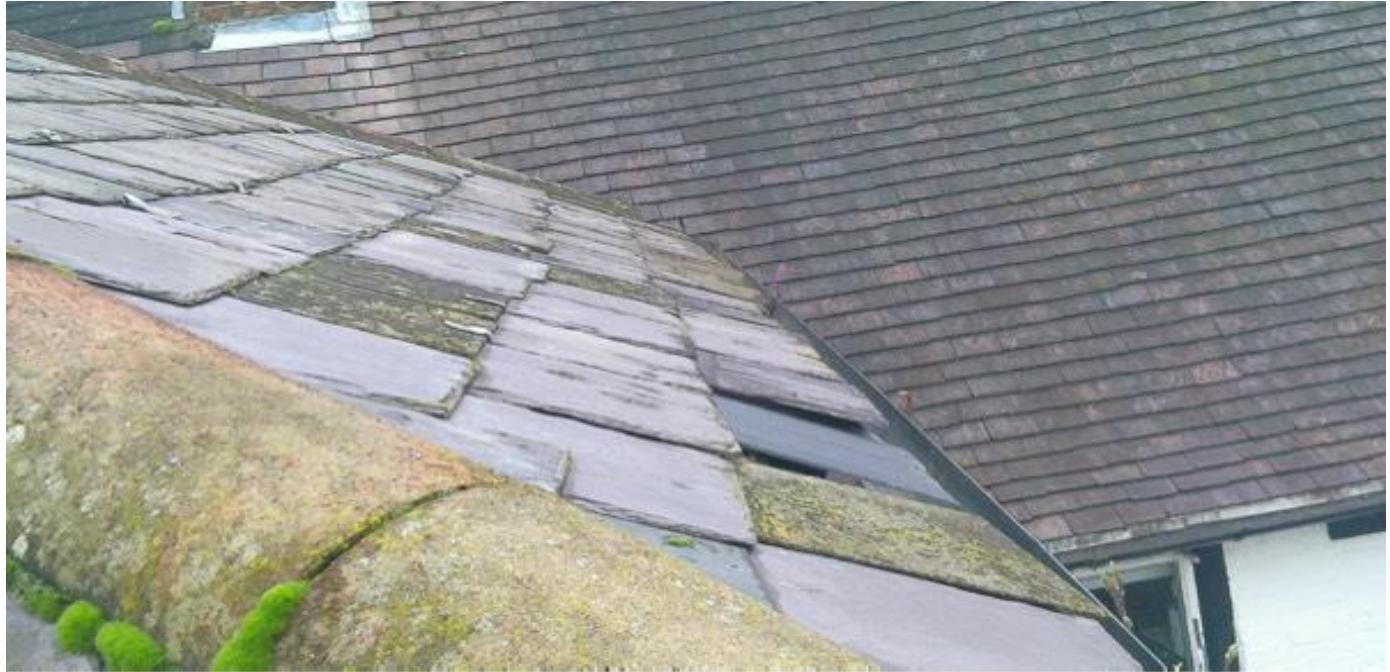
Missing slates from hip.

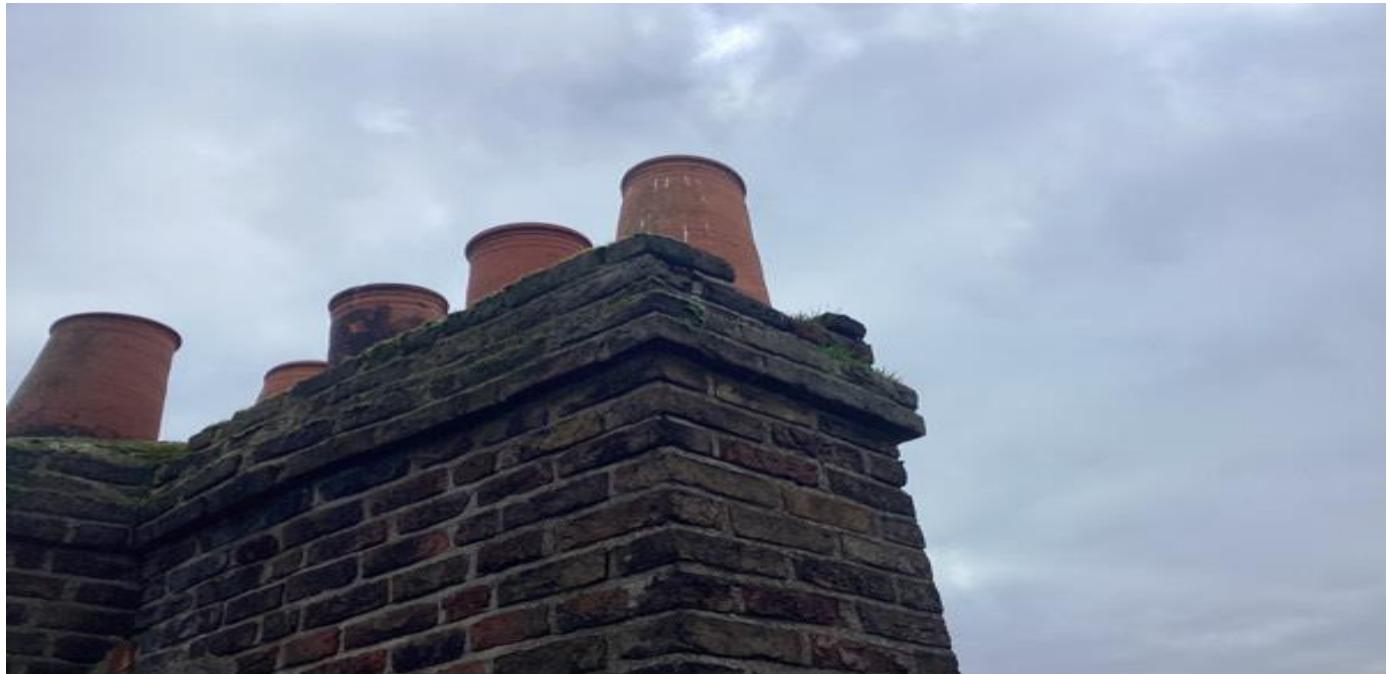
Chimney stack requires repairs and repointing.

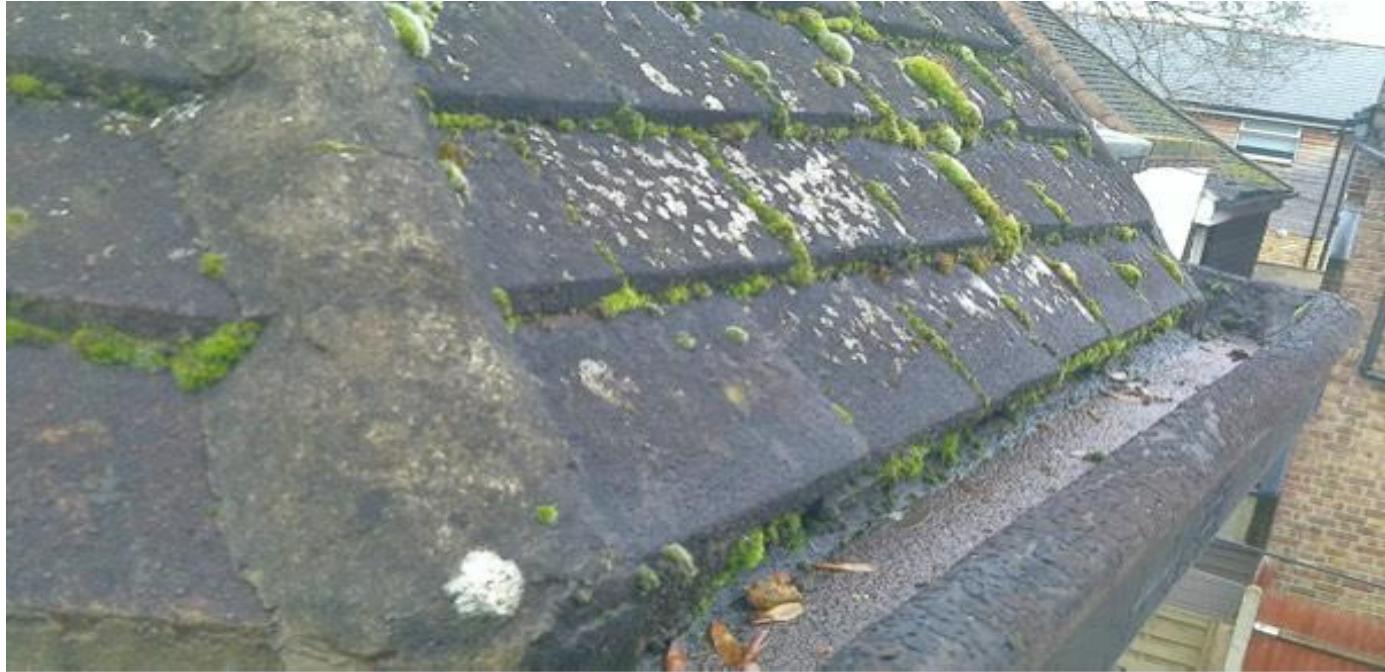
Mineral felt lined gutter at bay window, felt is degraded.

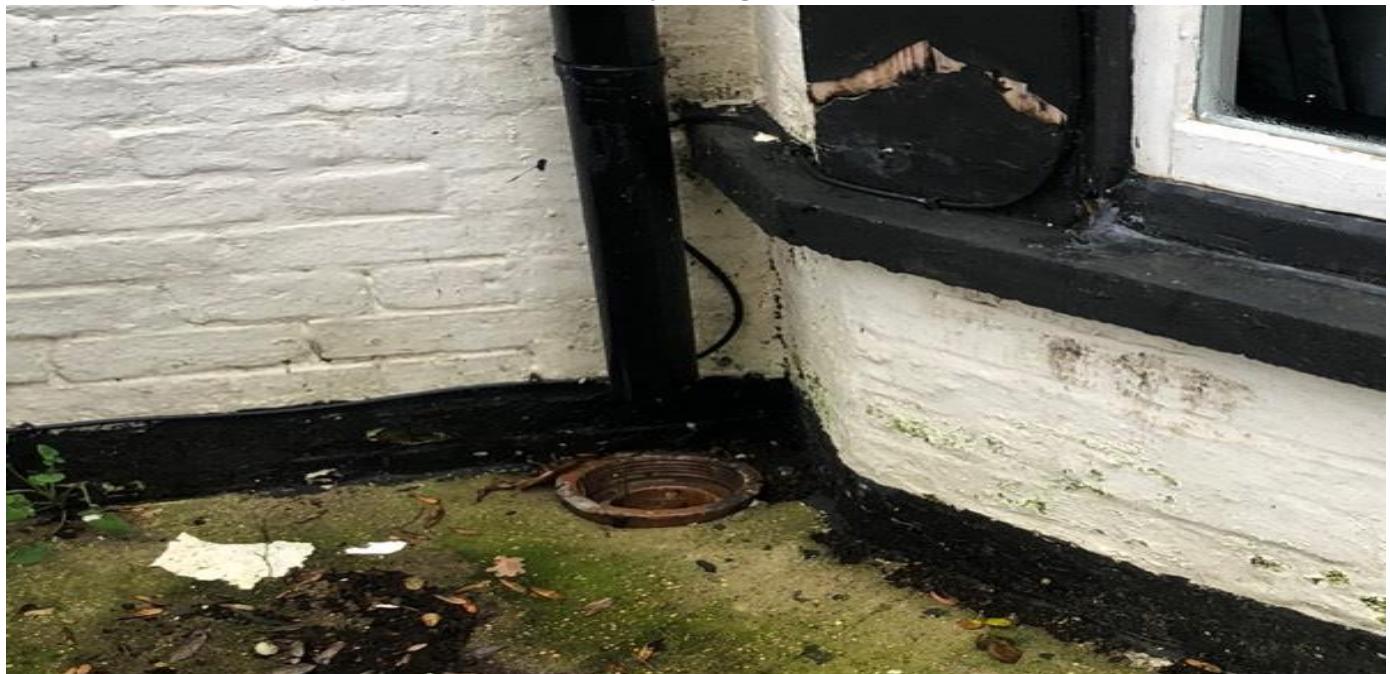
Front elevation, Downpipe does not fall directly into ground water drain.

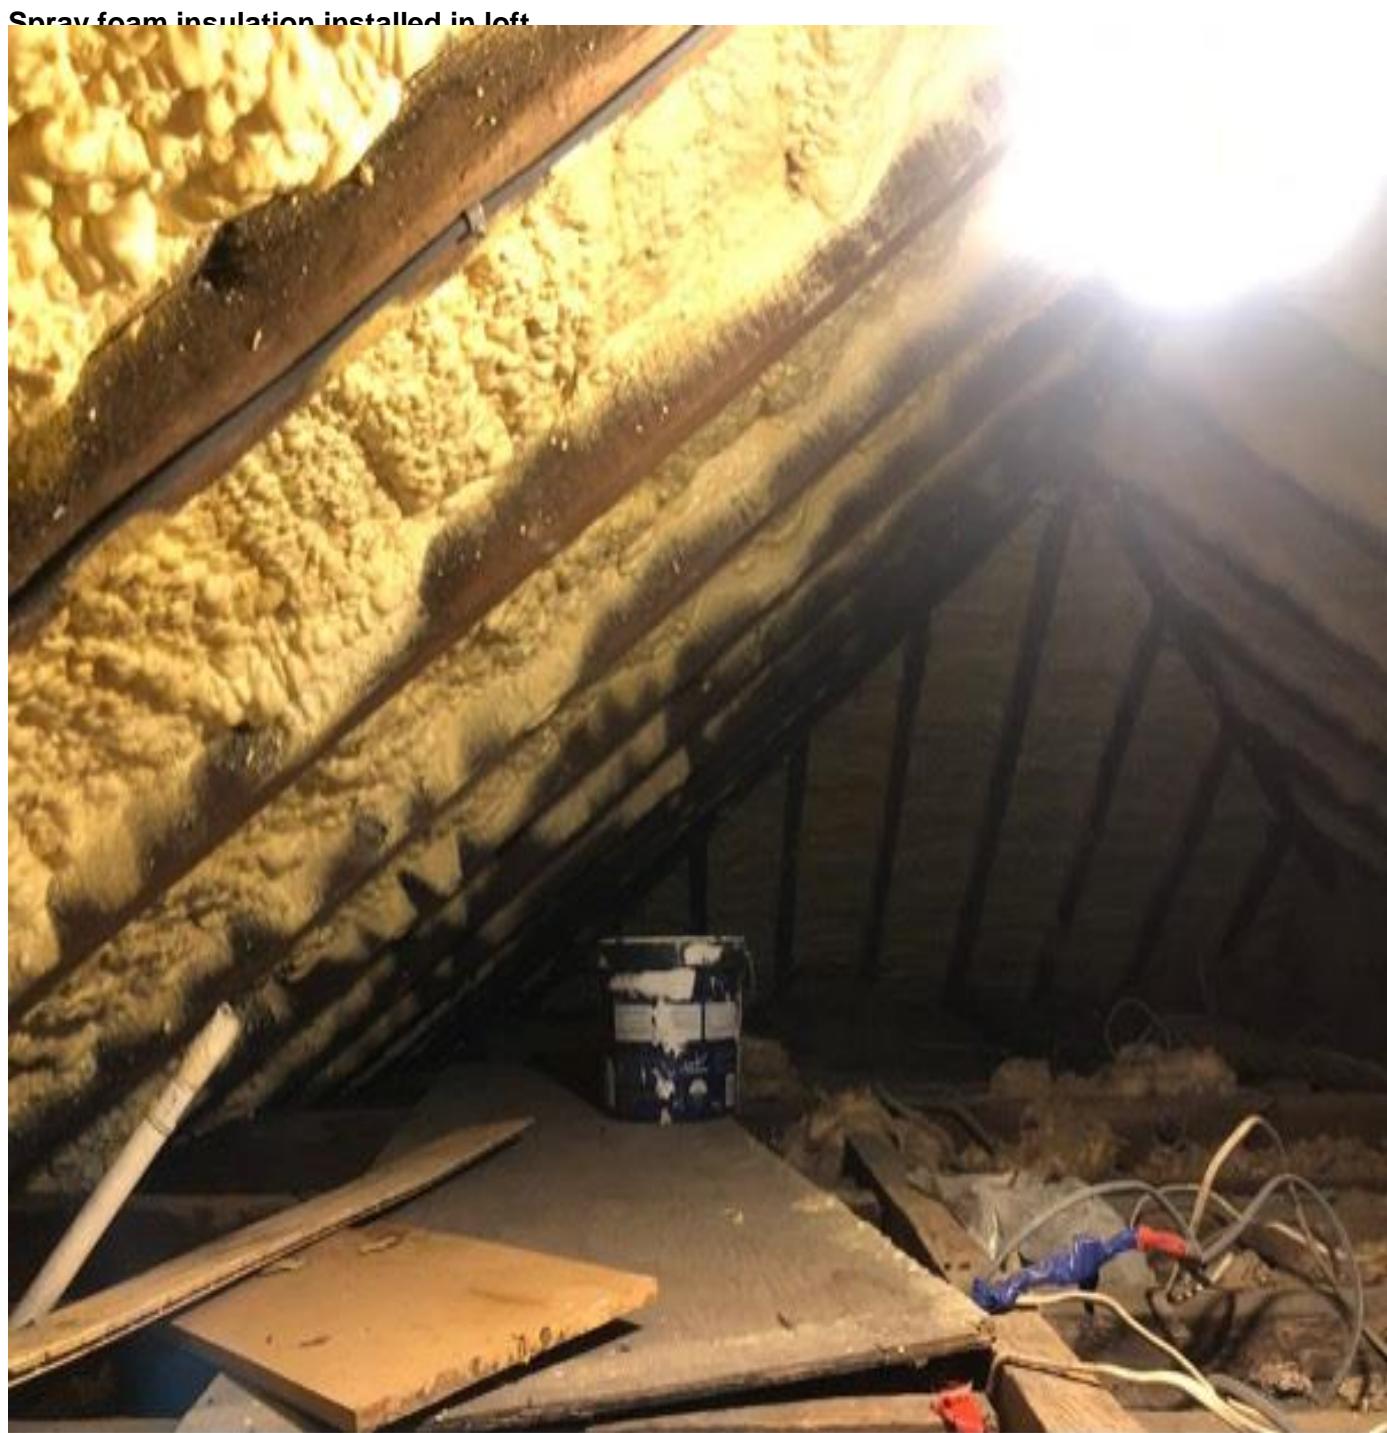
- Inspection revealed Open Cell Spray foam insulation installed in the loft areas of the building should also be removed, and as such, removing the slate finish, assessing, and repairing rafters, removing spray foam insulation, and then restating the roof would be the most effective way to keep the building free from water ingress and timber defects resulting from the incorrect spray foam insulation.

- The presence of spray foam within a loft space can effect buyers obtaining a mortgage ultimately rendering a property valueless and impacting the resale prospects for a property. Spray foam insulation seals the roof space restricting airflow to the roof and timbers leading to condensation and potential rotting of the roof supports. By removing the spray foam they are able to freely inspect the condition of the roof timber and the potential hazards for future buyers are eliminated.

Spray foam insulation installed in loft.

- Modern spray Foam Removal Solutions offer a quick and effective service to remove spray foam insulation from loft spaces to an acceptable level for mortgage lenders, in order to for them to assess the condition of the roof and the roof timbers.

- Modern Spray Foam Removal Solutions use the process of dry ice blasting to remove the spray foam insulation from the roof tiles and timbers.
- The method of dry ice blasting to remove spray foam removal leaves no secondary waste, removes foam without causing pitting or harm to any fixed tiles. Dry ice blasting removes contaminants by thermal shock, removing spray foam insulation in large chunks rather than traditional way of scraping.

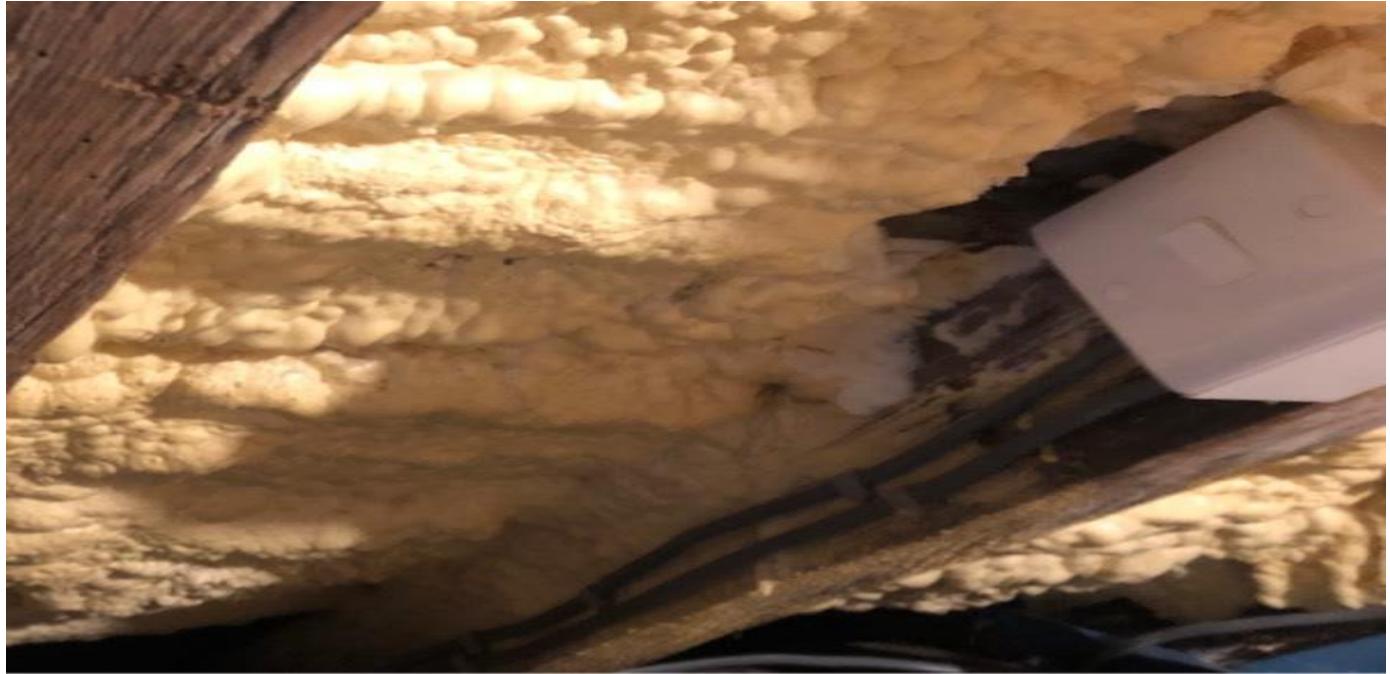
Mould spores forming on timber rafters

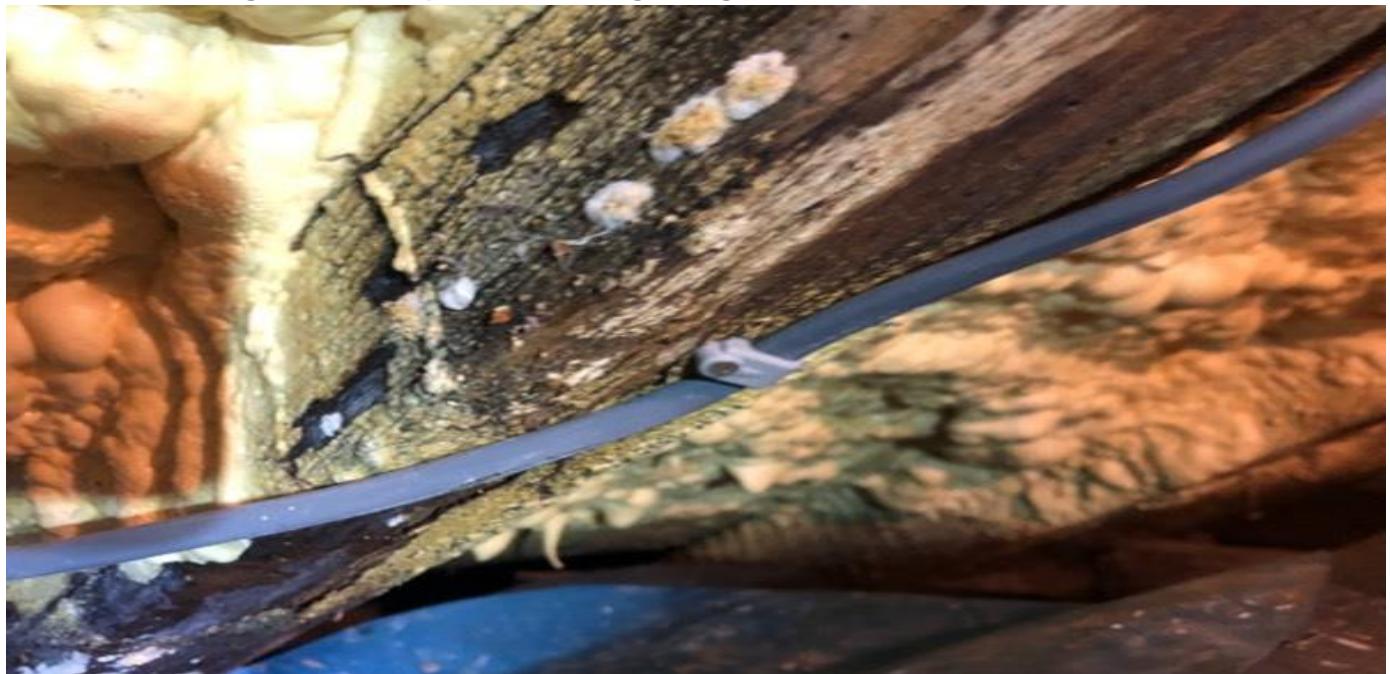
Rafters are rotting and mould presence is degrading timbers and indicates moisture.

- It is the Surveyors considered opinion that the roof requires extensive repairs in order to safeguard the property.
- It is recommended that all the pitched roof surfaces be removed to party wall boundaries, any installed spray foam insulation be completely removed from rafter areas and any and all damaged rafters be removed and disposed of, remaining roof timbers be treated with an appropriate fungicide to prevent returning mould growth.
