**BS5837 Arboricultural Report and
Arboricultural Impact Assessment**

OUR REFERENCE	AC.2025.819
CLIENT	Mr Mohammed Sahid
SITE	152-156 High Street, Yiewsley, West Drayton, UB7 7BE
REPORT BY	I S Thompson (known as Tom) M. Arbor. A., BSc. (Hons) Arb, MSc. eFor
DATE	26 th October 2025
DATE OF SITE VISIT	24 th October 2025

152-156 High Street, Yiewsley, West Drayton, UB7 7BE

A small front extension to the existing building.

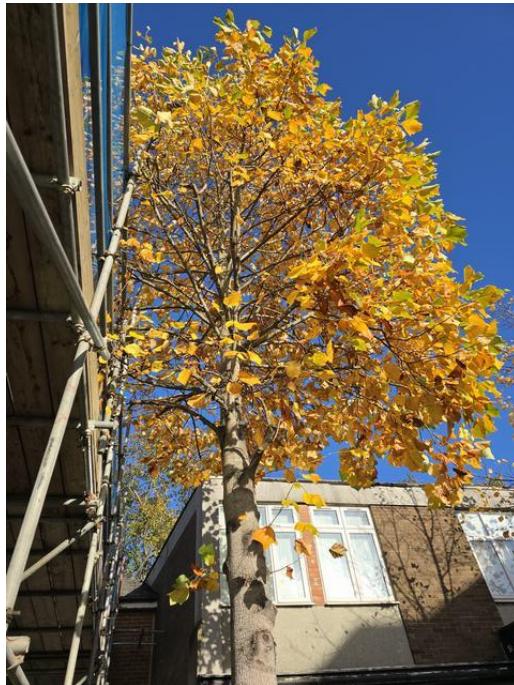
Image 1 T01, a tulip tree growing in a small planting pit in the pavement.

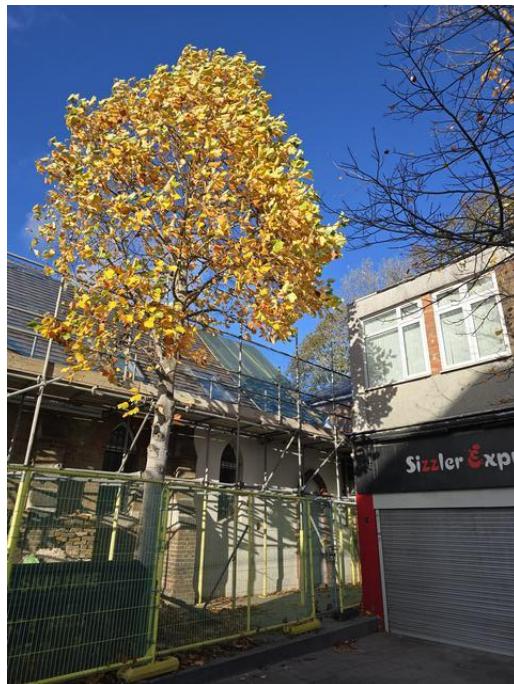
Image 2 T01, a tulip tree growing in a small planting pit in the pavement.

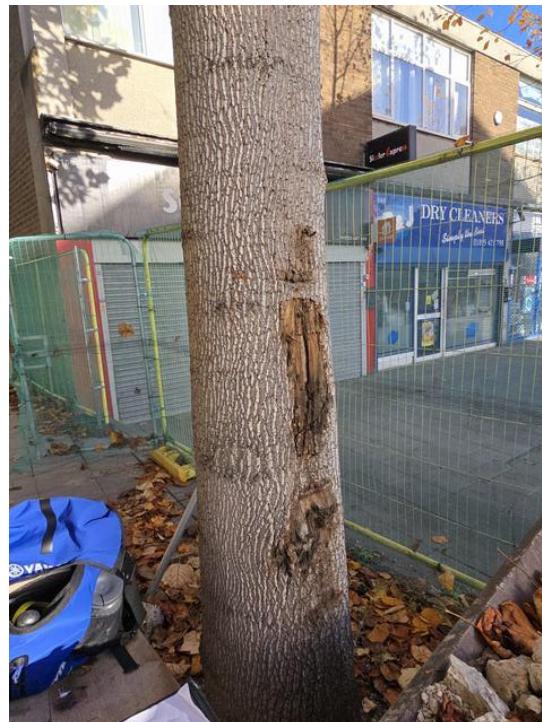
Image 3 Small amount of trunk damage that occurred before this development commenced.
