TREE SURVEY - HEALTH & SAFETY

Proj. No 10077	7 Ravenscourt Close, Ruislip, Middlesex, HA4 7PP	
Client:	David Morrow	
Date of Report:	03/03/2023

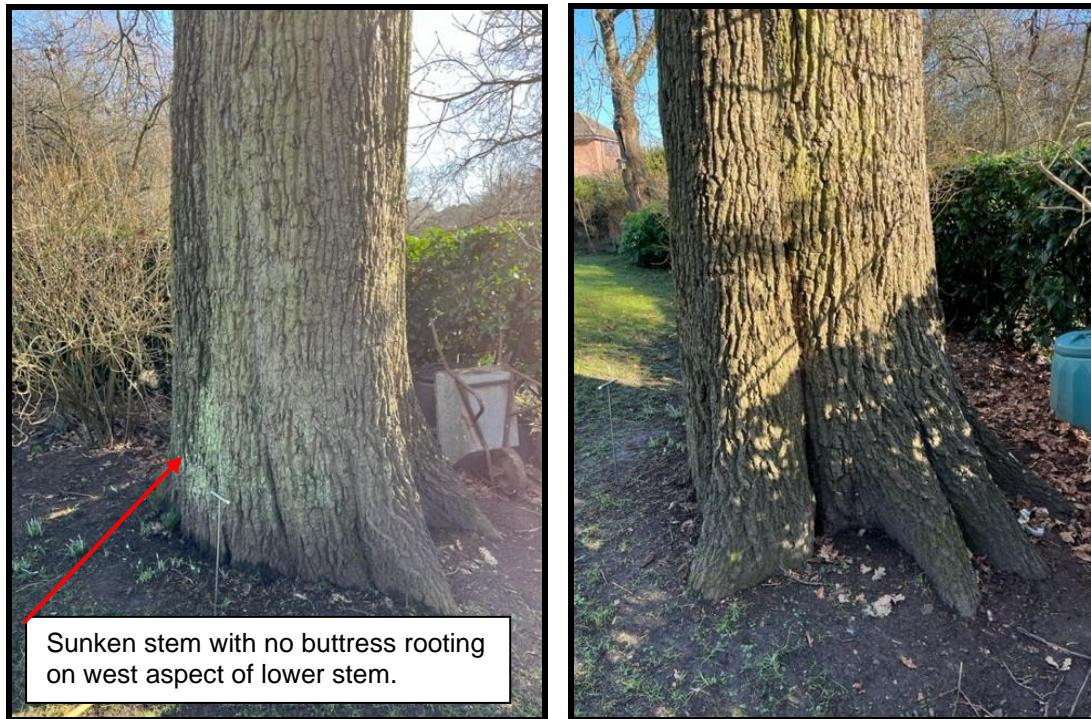
3.8 Exposed buttress roots are evident on the tree's north, east and south aspects. On the stem's west aspect is a sunken column of wood. This growth characteristic is often associated with localised root decay and / or death, which is further evidenced by the absence of any buttress rooting on this aspect of the tree's stem. Tapping the lower stem with a sounding hammer on its west aspect did reveal localised decay, but this was not considered to be significant at the time of inspection. The sunken stem is identified in the photograph below.

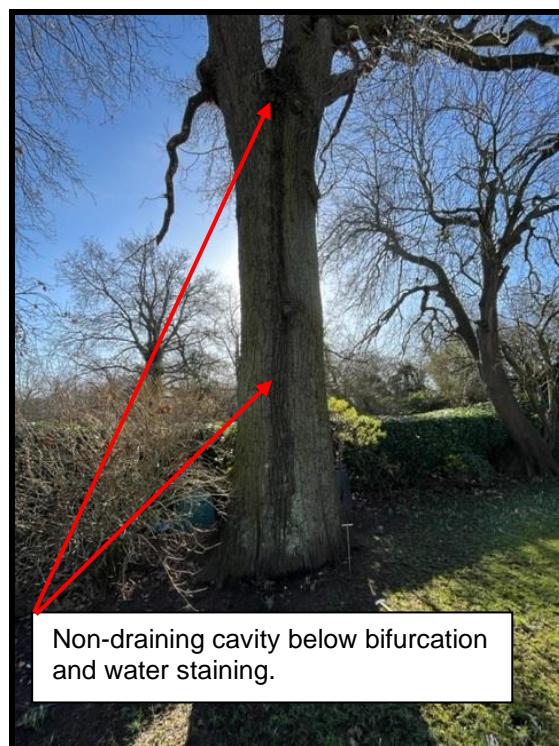
3.9 The stem bifurcates at circa. 6m agl and the sunken column of wood extending from the union to the base is accentuated by staining along its entire length, which appears to originate from a non-draining cavity on the northwest aspect of the stem just beneath the bifurcation point. The non-draining cavity and staining are identified in the photograph below.

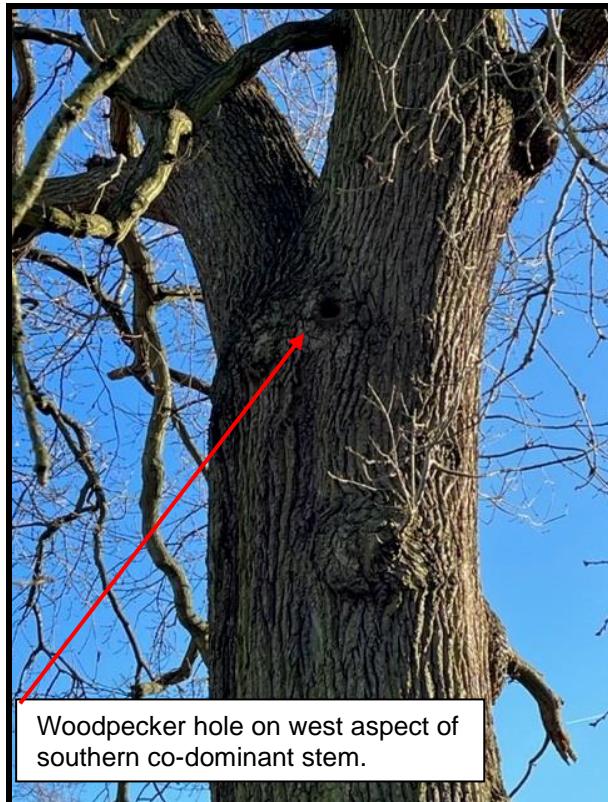
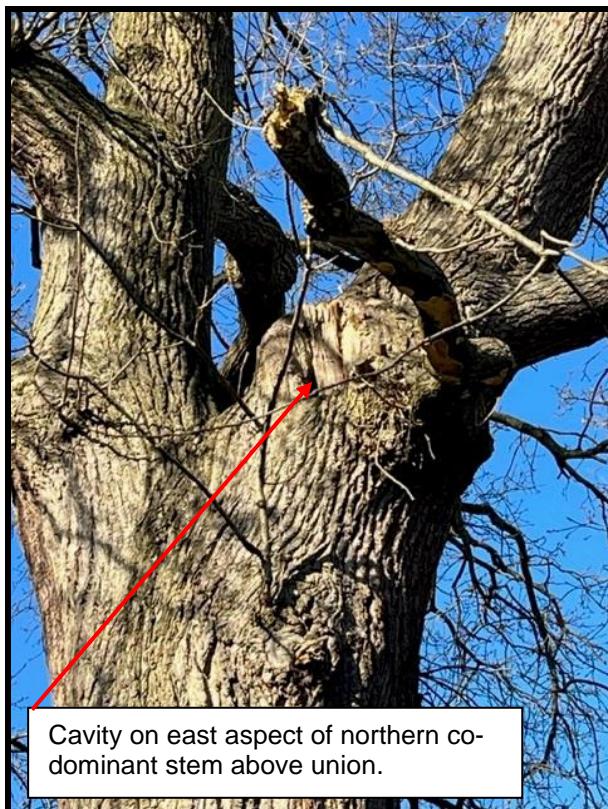
3.10 Within 0.5m of the non-draining cavity, on the west aspect of the southern co-dominant stem, is a large woodpecker hole. It is possible there is a cavity at this point which may extend across the stem and beneath the union. On the east aspect of the northern co-dominant stem above the union is a further cavity. It is recommended these cavities are inspected to ascertain the size and condition of the cavity within the stem beneath the union. The woodpecker hole and tear out wound are identified in the photographs below.

3.16 It is also recommended that a detailed inspection of the woodpecker holes / cavities is undertaken to ascertain the extent of decay in the affected part of the tree's stem and crown.

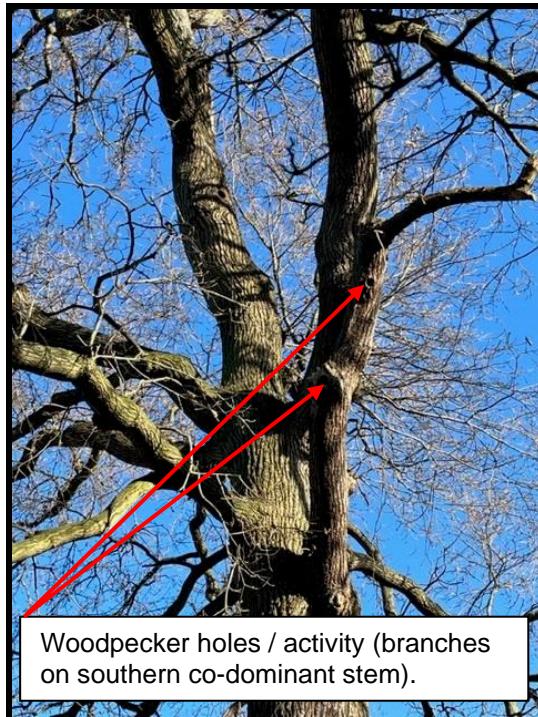
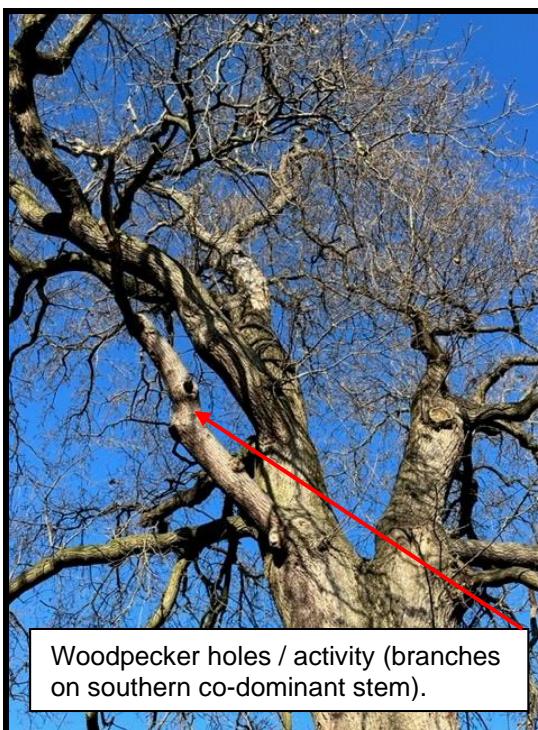
3.11 On the southern co-dominant stem the lowest primary branch extending south has been reduced to circa. 2.5m in length. The branch is dead and has multiple woodpecker holes throughout which are potentially being utilised by bats, as evidenced by the black staining around their openings. The dominant primary branch extending south directly above has further woodpecker holes on its underside circa. 1m from the union and the dominant secondary branch extending east above has historically failed and has further woodpecker holes present in the decayed section of the branch. The lowest primary branch extending west has historically failed and decay is present throughout the end 1m of the branch, from which regrowth circa. 3m in length emanates. The photographs below identify the woodpecker activity and possible bat activity.

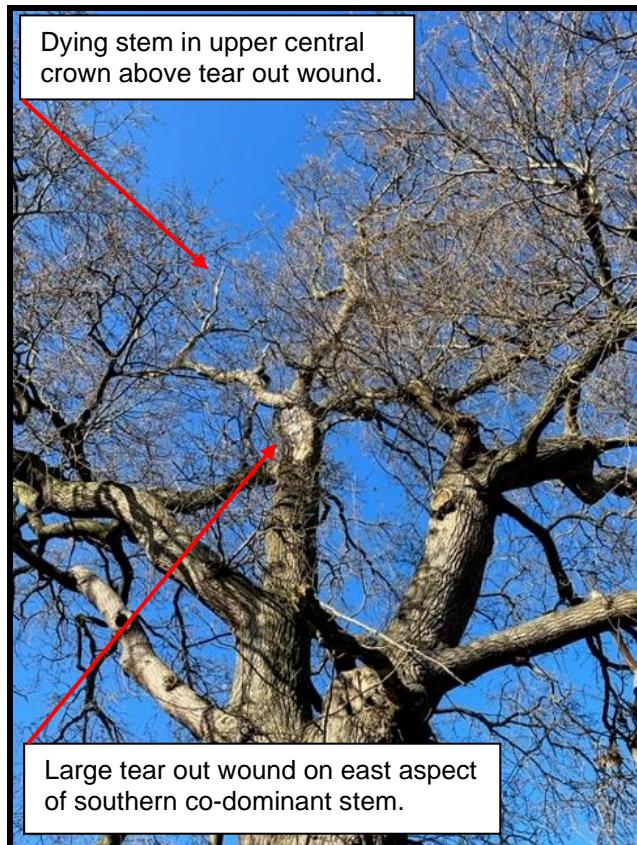
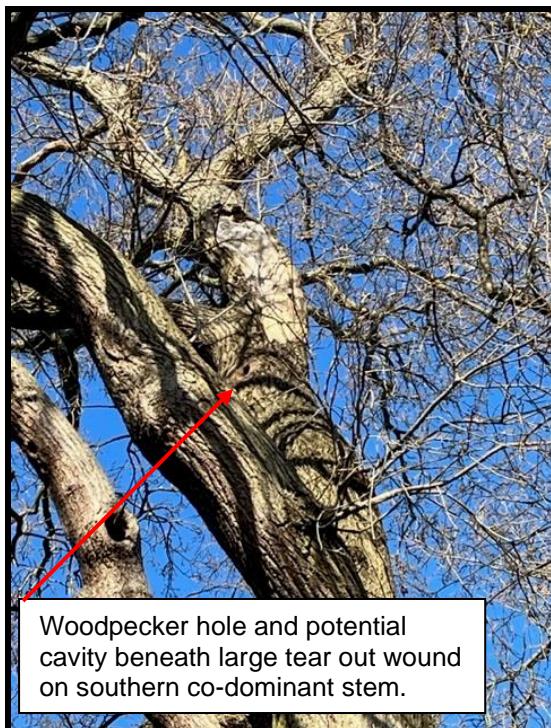
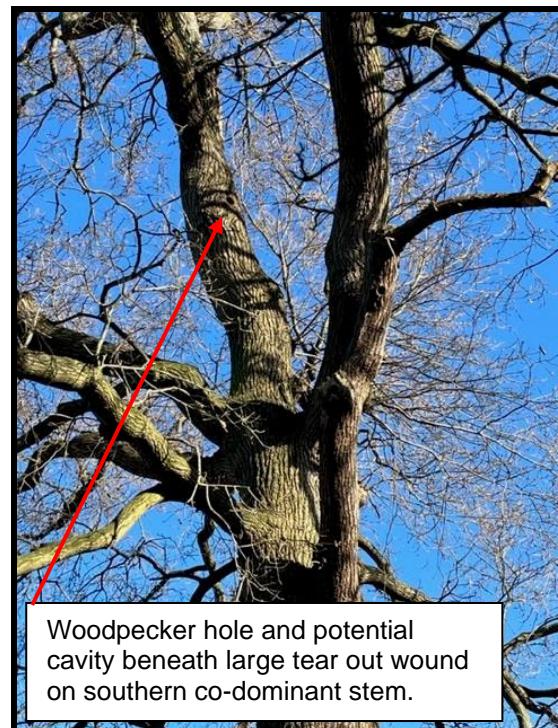
3.12 At circa. 12.5m agl on the southern codominant stem's east aspect is a significant tear out wound, circa. 1.5m in length, with a woodpecker hole and potential cavity at the base of the wound on the south aspect. Above this wound is a further bifurcation, above which the southern extending stem is in severe decline / almost dead. The tear out wound, woodpecker hole and dead stem are identified in the photographs below.

3.15 To ensure the safety of people using the garden and neighbouring gardens, it is recommended that deadwood is removed and a crown reduction undertaken. The reduction should not exceed the specification provided at item 3.3 and its final dimensions following the works will leave a final height of 20m with a crown spread of 6m to the north, 5m to the east, 6.5m to the south and 5.5m to the west.

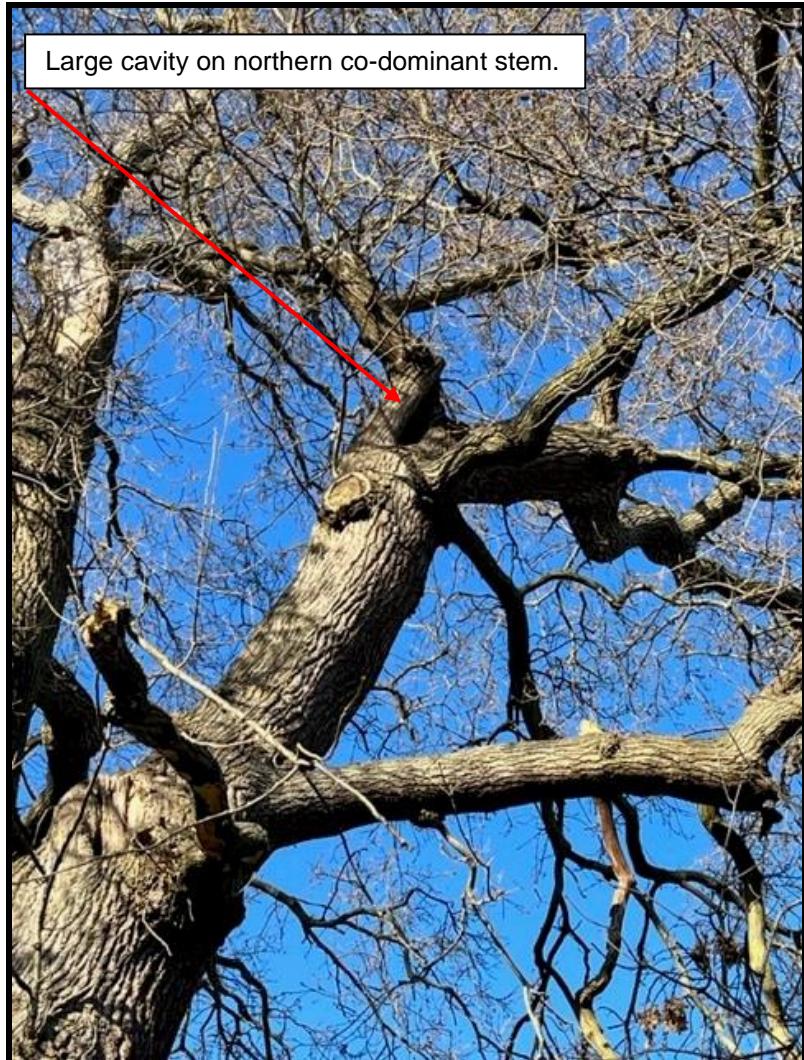
3.13 Finally, on the east aspect of the northern co-dominant stem that extends over the rear garden and towards the dwelling, is a large cavity at circa. 10m agl. Woodpecker holes are also present on the underside of the stem, circa. 2.5m from the cavity. During the site visit an Owl appeared from the cavity and therefore it is potentially a nesting site. The photograph below identifies the cavity.

3.14 Oak T001 has been subject to storm damage and as a result multiple cavities have formed and subsequently become decayed. The proposed work will reduce end loading and mitigate the potential risk of further branch failure occurring.
