Work Schedule

Quote Number: QT-9036

Client Name:	Mr Ivor Selby	Contact Numbers:	Telephone: 01923 826205 Mobile: 07733291518
Site Contact Name:	Ivor Selby	Site Specific Ref No:	
Contact No:	01923 826205	Business Name:	
Site Address:	30 Anthus Mews Northwood Middlesex HA6 2GX

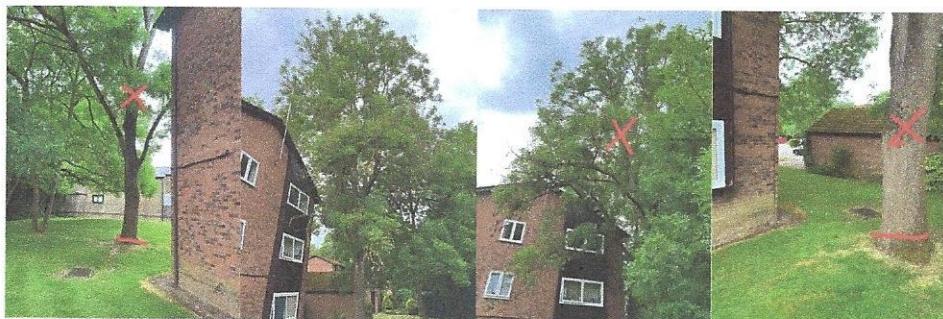
No: T1

Details: Large tree growing on the rear corner of the block containing 20-28. This tree is showing classic symptoms of ash dieback in its upper canopy and the tree appears to be retrenching to a lower level. The tree could be reduced by approximately 4 m down to the health line but its long-term survival is doubtful. Given potential risks with of this tree with ash dieback being so close to the property and in this communal area, I feel it's removal is the best long-term course of action. To remove this tree by dismantling in sections and into available space. Tree stump to be cut low and level and remain in location.

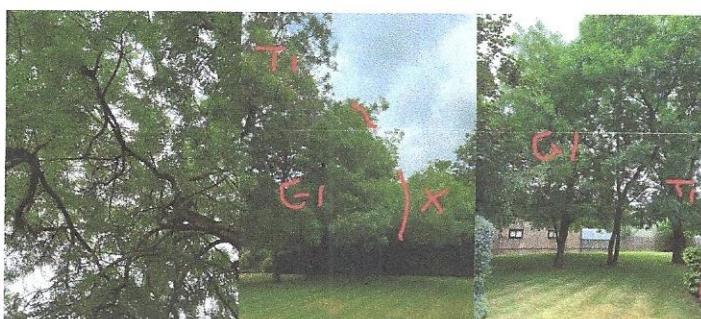
No: G1

Details: Two trees located within the grass beside T1. Both appear in good general condition but one large dead limb is hanging within the canopy and other large deadwood is evident within the crown. It's also has a large projecting limb towards the adjacent building and one other projecting section higher in the canopy. Both of these branches should be reduced by up to 3 m in longest areas.

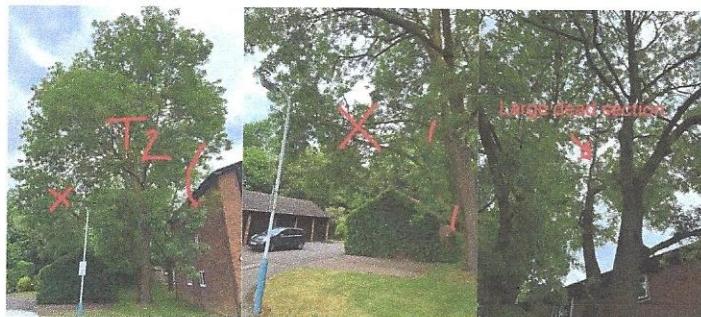
No: T2
Type: Ash

Details: Tree located on the side of block 20–28 closest to garages and parking area. This tree is in good general condition but the crown contains one large section of deadwood and other smaller sections throughout the canopy. Two long low side limbs extending over parking area are becoming over long and should be removed back to the branch collars on the main stem. Other branch tips close to the roofline of block 20–28 should be pruned away from the roofline to give a 2m clearance. Small branches around streetlight should also be removed.

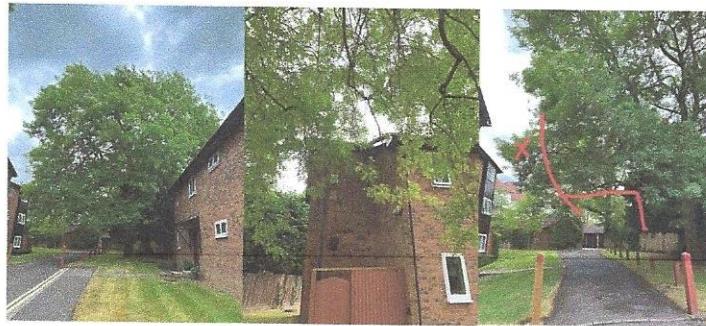
No: T3
Type: Ash

Details: Large tree located within the grass on the corner of 29–32. This tree is also in very good general condition but sides of the canopy are encroaching heavily around the corner of the building touching roof and gutters. I recommend the tips are reduced away from the building creating a space of approximately 2 m. This will mean removing approximately 2 m of end growth from encroaching branches. One lower limb on the side of the canopy extending towards block 20–28 is overlong and encroaching. This section should be reduced back by 2 m. The crown also contains significant deadwood which should be removed.

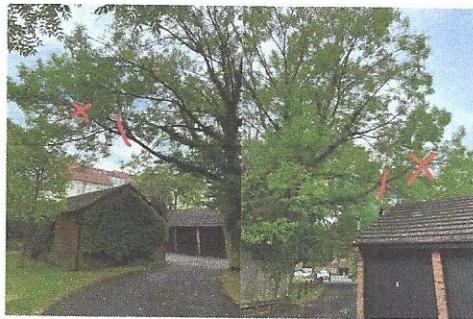
No: T4
Type: Ash

Details: Tree located in the extreme corner of neighbouring garden overhanging garage block and access road.
This branch is also above a smaller rowan tree in this location and it's starting to cause suppression.
I recommend the end of this branch is removed back to a good vertical growth point. This will remove approximately 4.5 m of branch length.

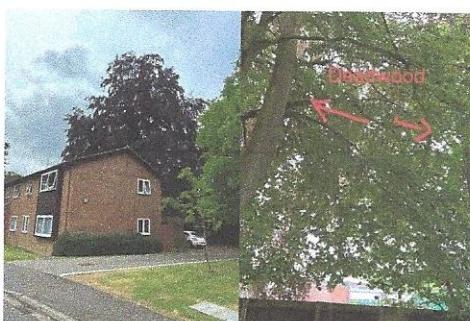
No: T5
Type: Copper beech

Details: This is a fine specimen tree and appears in good health.
Deadwood is present in the canopy with one piece broken off and hanging.
The tree is encroaching around roof and gutter line.
I recommend larger deadwood is removed from the canopy and branch ends are pruned away from the gutter and roofline to create up to 2 m of clearance.
