Arboricultural Consultancy for Aviva

1. Case Details

Insured	Mr Michael Epstein	Address	10 Nicholas Way, Northwood, HA6 2TS		
Client	Subsidence Management Services	Contact	Ian Domigan	Claim No.	IFS-AVI-SUB-22-0101616
ES Ref	SA-250311	Consultant	Keith Burgess	Contact No.	0330 380 1036
Report Date	16/09/2022

GEOTECHNICAL

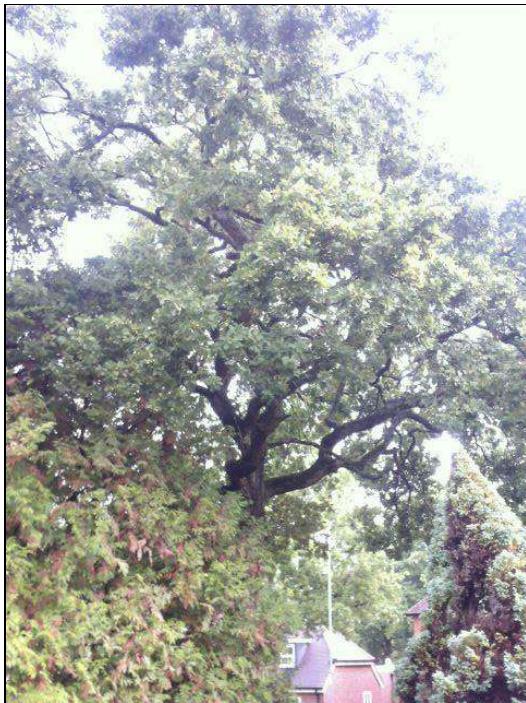
T1 - Oak

With due regards to species profile, size and proximity, T1 and H1 are considered the dominant features proximate to the focal area of movement and accordingly, where vegetation is confirmed as being causal, we have identified them as the primary cause of the current subsidence damage.

The size and proximity of the above vegetation is consistent with the advised location of damage and it is our opinion, on balance of probability, that roots from the above vegetation will be in proximity to the footings of the insured property.

Consequently, we have advocated the complete removal of T1 in conjunction with management, to include partial removal of a section of H1 (as detailed) as it will offer the most certain arboricultural solution likely to restore long-term stability.

Tree No.	Species	Age Cat	Approx. Height (m)	Distance to Building (m) *	Ownership	Action	Requirement
H1	Thuja	1	9	4.4	E - Boundary Veg (ownership to be confirmed)	Maintain as detailed	Remove the two stems closest to the property (garage) close to ground level; reduce height of remaining hedge to 5m and maintain at reduced dimensions by way of regular pruning. Distance relates to area of damage, hedge 1.2m from garage.
T1	Oak	3	12	14.9	D - Unknown	Remove	Remove close to ground level and treat stump to inhibit regrowth.

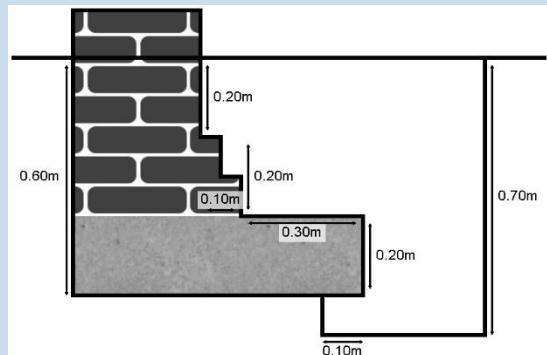
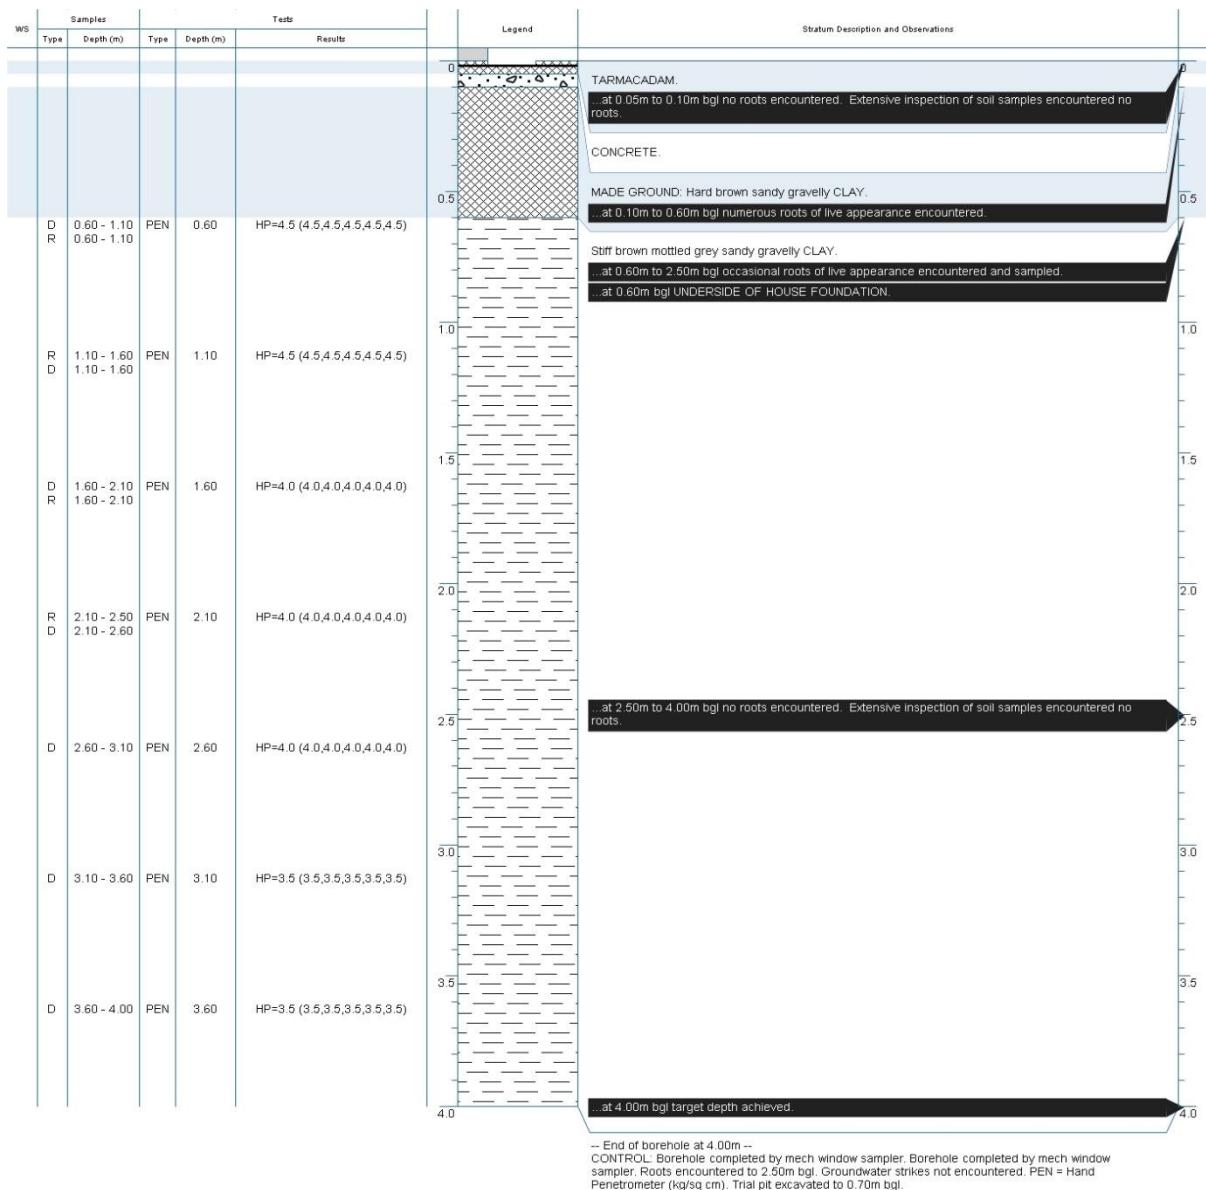
TP/BH2 Foundation Detail and Borehole Log

House foundation comprised of brick wall to 200mm bgl, bearing on stepped brickwork to 400mm bgl with a total projection of 100mm from the elevation, bearing on concrete to 600mm bgl with a total projection of 400mm from the elevation. Underside of foundation (USF) was exposed to 100mm back from the face of the foundation and probed 500mm back from the face of the foundation.

At 0.60m bgl UNDERSIDE OF HOUSE FOUNDATION in TP/BH2.

At 0.05m to 0.10m bgl no roots encountered. Extensive inspection of soil samples encountered no roots in TP/BH2.

At 0.10m to 0.60m bgl numerous roots of live appearance encountered in TP/BH2.

At 0.60m to 2.50m bgl occasional roots of live appearance encountered and sampled in TP/BH2.

At 2.50m to 4.00m bgl no roots encountered. Extensive inspection of soil samples encountered no roots in TP/BH2.
