**Castledine  
Environmental**

**Phase 1 Land Contamination  
Risk Assessment  
for  
The Proposed Change of use  
from Sui Generis to Class C3  
(Commercial to Residential) and  
Fenestration Changes  
on the site of  
Units 14-16 Ryefield Crescent,  
Pinner, Northwood HA6 1LT**

3787D P1 Bankway Properties Ltd – Northwood Rev 1

30/09/2024

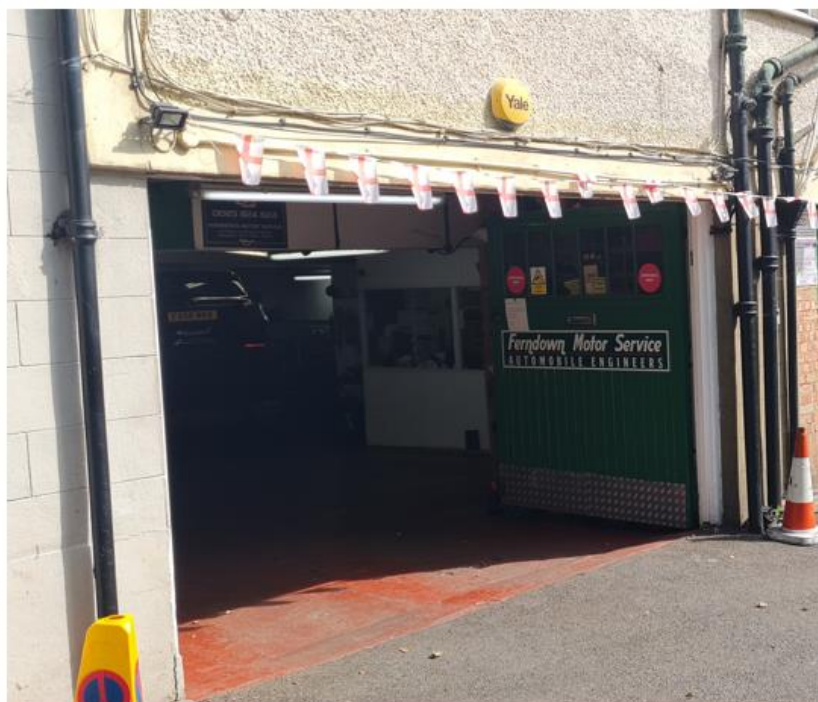
**Photo No.1: Facing slightly NE outside the southern boundary of site (demarcated by wall) showing vehicular access**

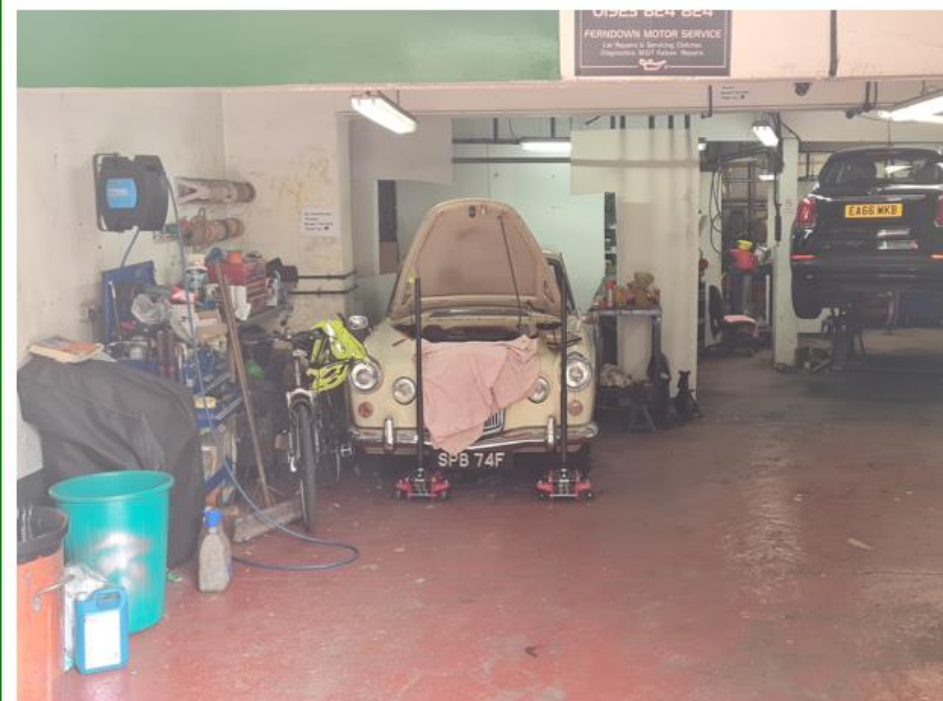
**Photo No.2: facing north within the vehicle access showing the vehicle repair garage usage of the interior of site**

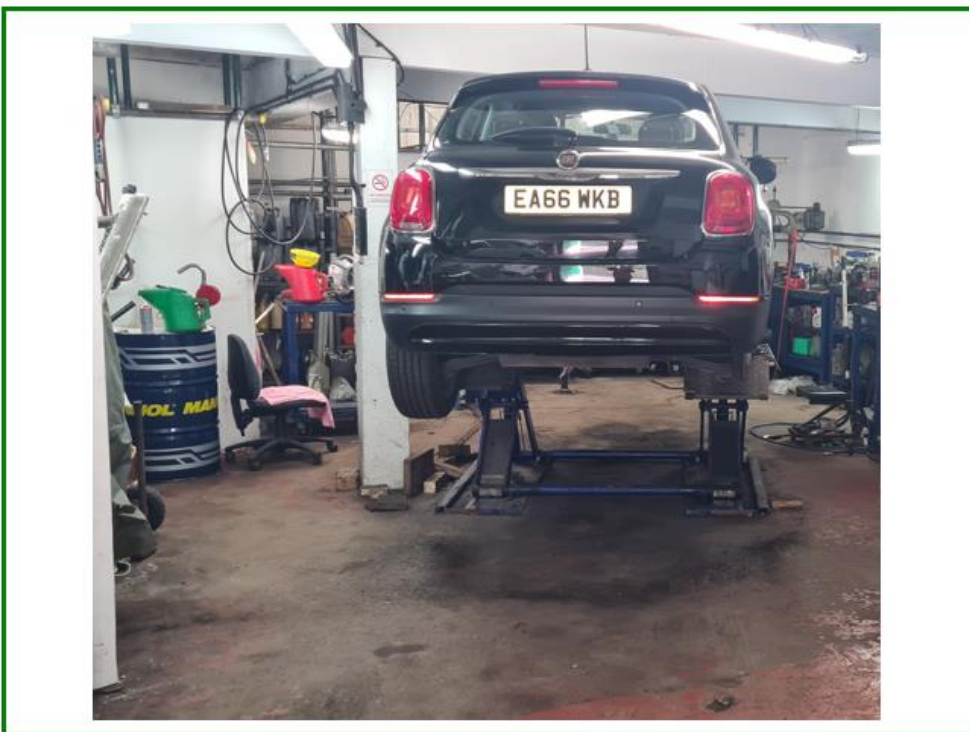
**Photo No.3: Facing slightly NE from within the garage**

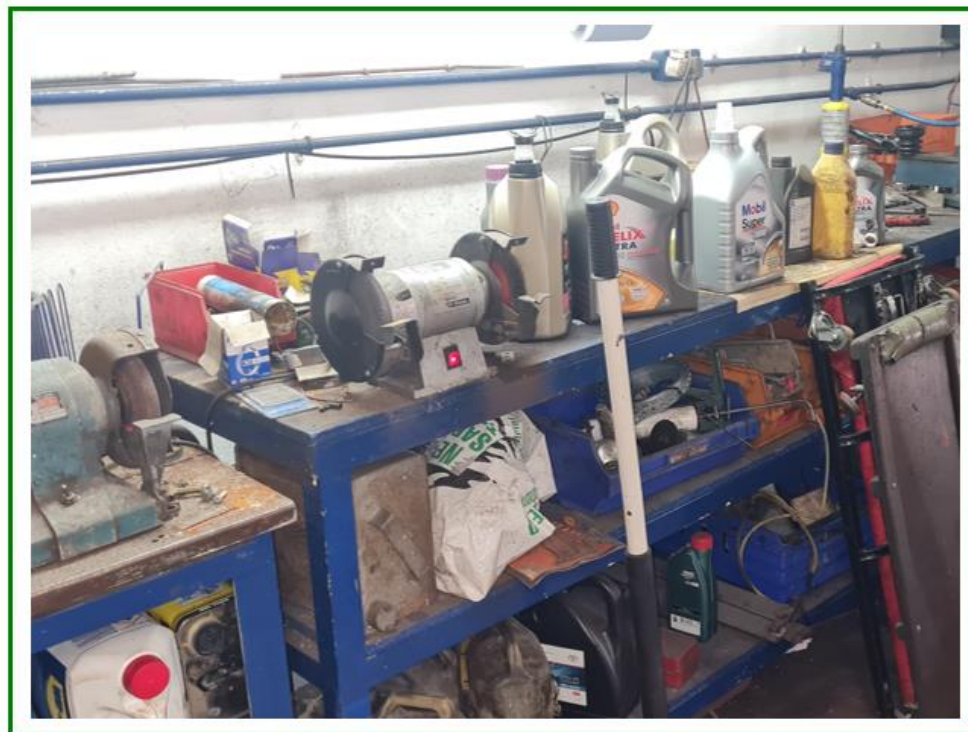
**Photo No.4: Facing SE showing the tools and benches**  
**arrayed along and inside the eastern boundary of site**

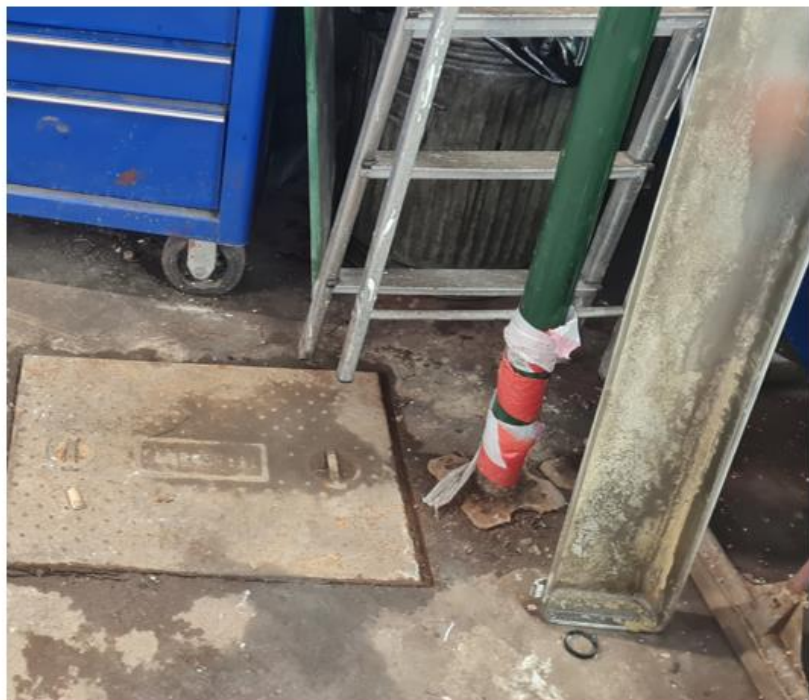
The vehicle repair garage usage, noted staining on the flooring (and around the manhole covering) are considered potential sources of contamination noted on the site walkover. Topographically, the interior of site is level; however, the surrounding area drops off gently from the west down to the east.

**Photo No.5: Manhole covering noted in concrete-flooring of the garage unit, some staining noted around the feature**

It is recommended that a proportionate Phase II Site Investigation is planned and carried out on site, ideally following the site being vacated and emptied of associated vehicles, machinery and tools. The site works should involve the formation of either hand-excavated or cored-out inspection pits within the site itself (including within the garage work area and particularly at the manhole cover and likely drain below). Following

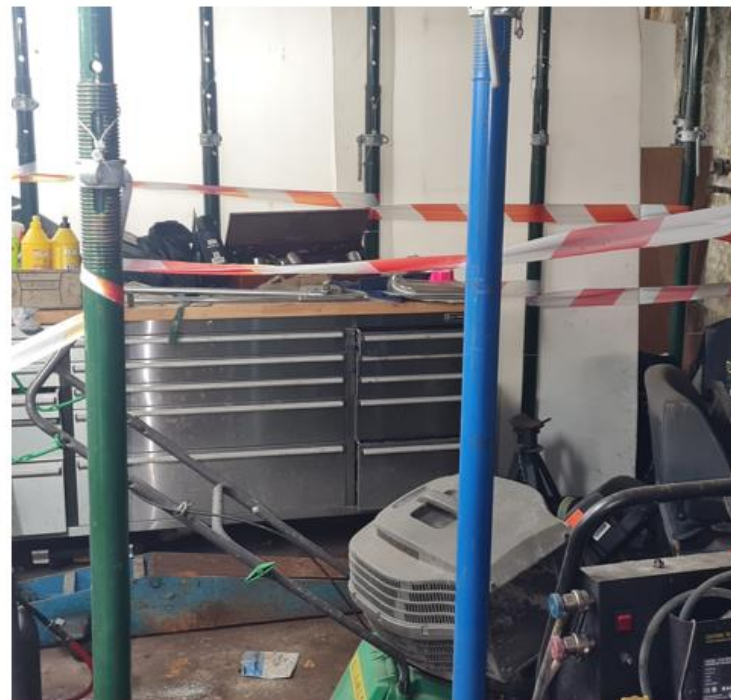
**Photo No.6: Facing west showing the rear of the garage**

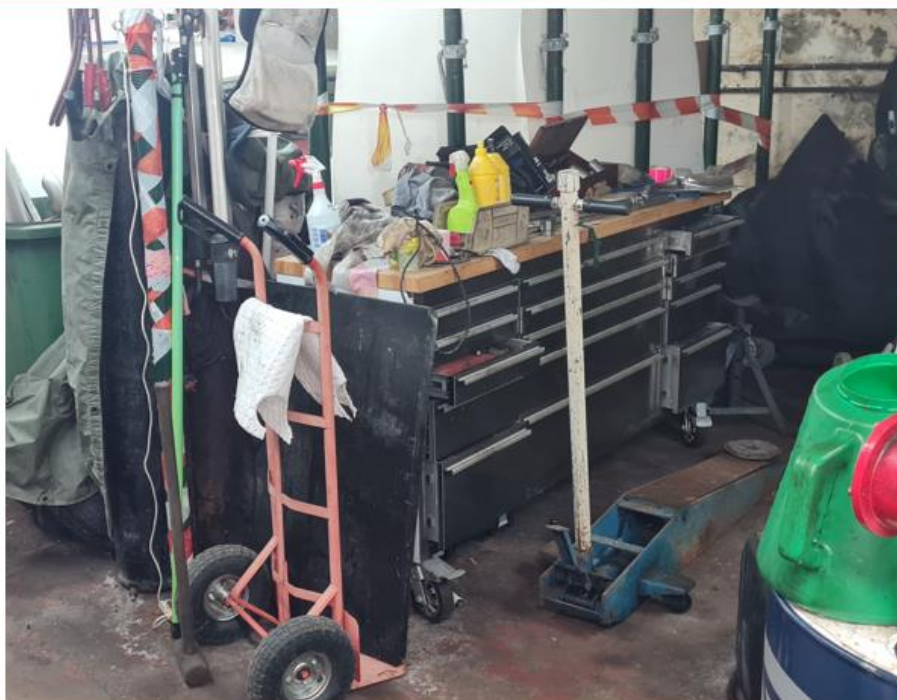
**Photo No.7: Further shot showing the rear of the garage unit**

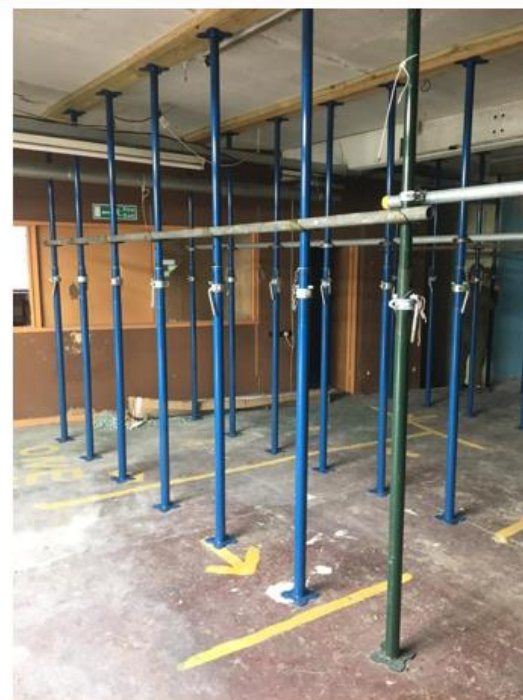
**Photo No.8: Again showing rear rooms to the garage units**
