Site Investigation Report

144286.1.USI

Auger were commissioned by Crawford & Co to undertake a site investigation and CCTV inspection of the underground drainage within the area of concern (AOC) at the property.

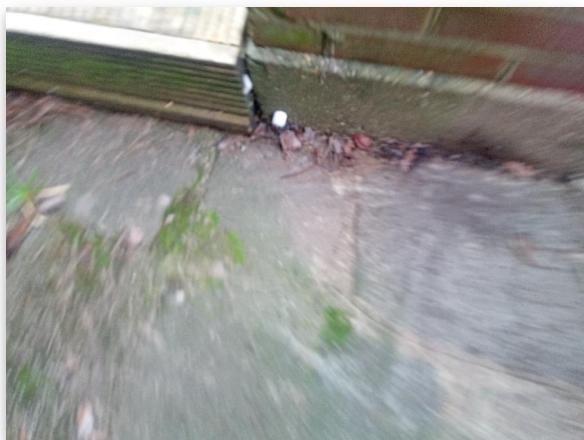
Fig 1.1: Trial Hole 1 Location

Within Trial hole 1 we revealed the footing but were unable to auger to the required depth (3m) in the proposed location. This was due to desiccated hard ground at 2.1m that prevented our engineer being able to auger any further. We took soil and root samples. These measurements are shown in Trial hole log 1 below.

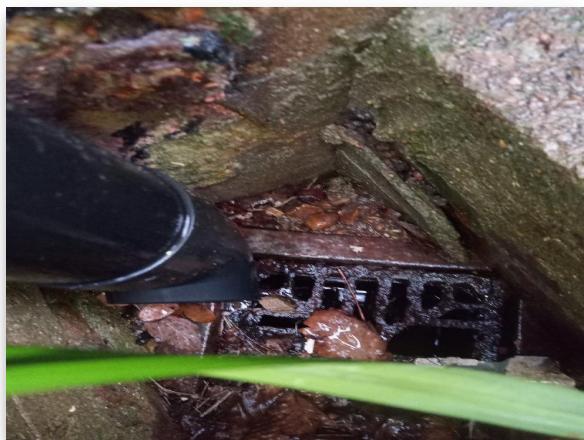
Fig 2.1: RWG

A visual inspection of the site revealed WG, which was noted to serve foul water, and RWG have sunken/ are displaced and both are leading to water escaping to the surrounding ground.

The visible defects identified are affecting the function of the system.

Refer Back to Client	<p>It is recommended that the following repairs are carried out to prevent an escape of water from the system:</p> <p>Line 1 Excavate and replace RWG and 1m of 100mm pipework at a depth no greater than 1.0m through concrete. We will then need to conduct a further CCTV investigation downstream on this line.</p> <p>Line 2 Excavate and replace WG and 1m of 100mm pipework at a depth no greater than 1.0m through concrete and crazy paving. The surface will be temporarily reinstated with stone to ground level to leave the area safe and tidy. A specialist contractor will be required to reinstate the crazy paving which would incur additional costs. We will then need to conduct a further CCTV investigation downstream on this line.</p> <p>Please note that the further CCTV investigation may reveal additional defects to the drainage system. This will be reported whilst on-site and could potentially cause an increase in repair costs and provide further inconvenience to the customer/occupants.</p> <p>Auger have not allowed or will not be held responsible for any alteration or modification to the above ground drainage following the removal of the existing gully and reinstatement of a new gully. The customer must ensure that the above ground drainage correctly expels into the gully pot and avoids overcrowding the gully with numerous downpipes which could lead to the gully overflowing.</p> <p>During the clean-up/reinstatement process we will endeavour to leave the area we are working in clean and tidy and as close to how we found it as possible. There will always be an element of general debris/mud/waste that will build up in the area which cannot be prevented. There may however be elements of this process that are outside our remit i.e., Repainting or cleaning. If this is the case, then we will need to speak to the customer's insuree to help in this regard.</p> <p>We will now refer the claim back to the client in order to progress the claim.</p>
