ADDENDUM ARBORICULTURAL REPORT

SUBSIDENCE CLAIM

Crawford Reference: 1784863
Insurer Claim Reference: 202209010214

33 St. Martins Approach, Ruislip, Middlesex, HA4 7QH

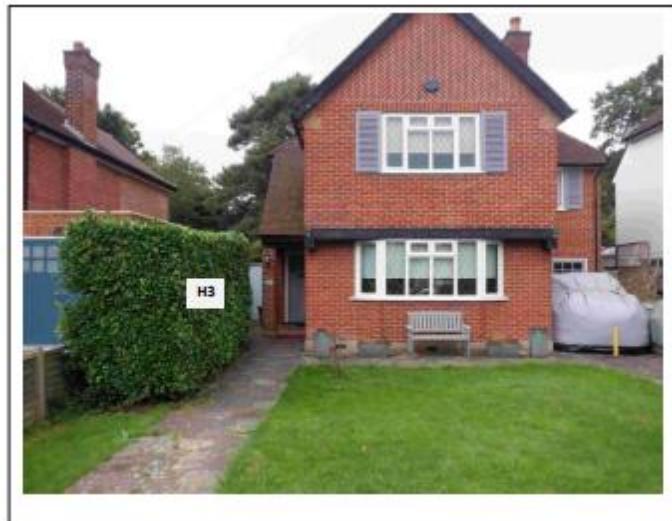
View of the front elevation and H3

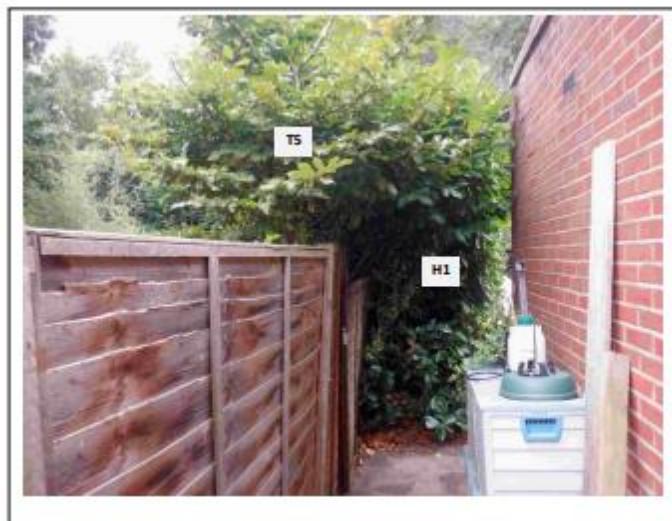
Roots were observed to a depth of 0.8m bgl in TP/BH1 and recovered samples have been positively identified (using anatomical analysis) as Quercus spp. (Oak) and Prunus spp., the origin of which will be the Oak trees (T2 and T4) and the Laurel hedge (H1).

View of H1 & TS

H1	Laurel	3	125 Ms *	3.5	2	Younger than Property	Boundary Policy Holder and/or Third Party 31 St Martins Approach HA4 7QH
Management history		Managed hedge.					
Recommendation		Remove (fell) to near ground level and treat stumps to inhibit regrowth.

H1 Removed March 2024 T5 Removed February 2024

Tree reduction option – Laurel hedge H1 and Hornbeam T5 were so close to the area of damage that pruning would not have provided an effective long-term remedy therefore their removal was undertaken.

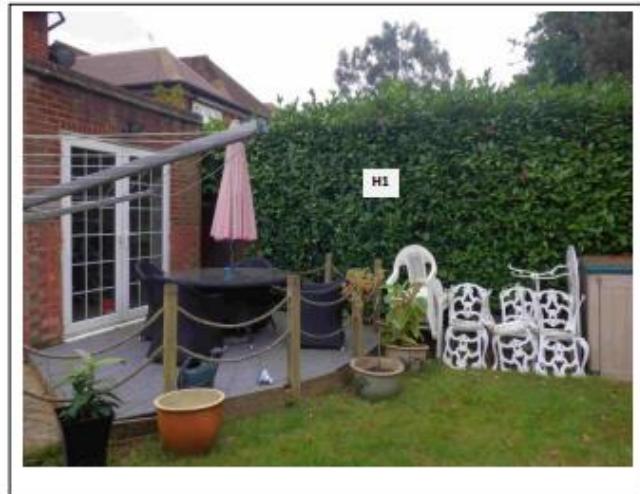
View of H1

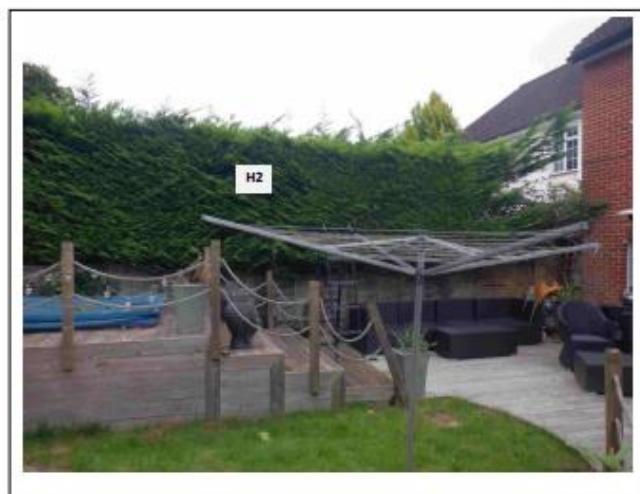
View of H2

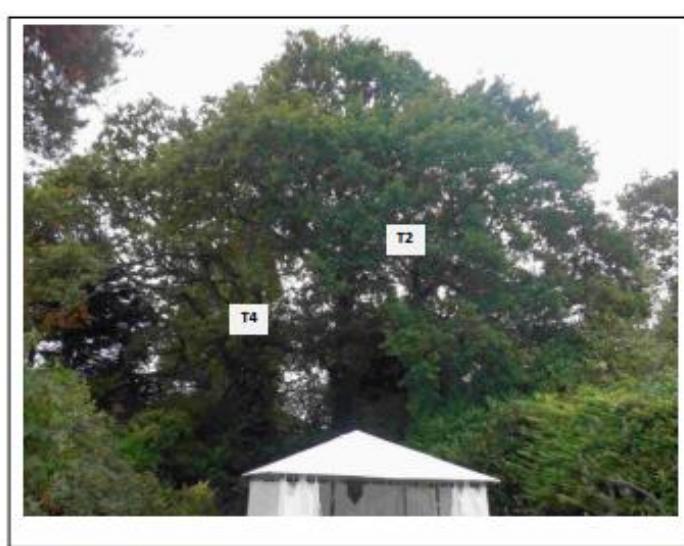
View of T2 & T4

The Oaks T2 & T4, at 26.7m and 28.5m, are therefore within the species' potential rooting and influencing distance of the building and would be capable of causing seasonal soil drying beneath foundations. The site investigations confirm rooting of Oak beneath foundations in any event.

If the subject Oak trees are not reduced in size, then damage will almost certainly continue and possibly worsen. Roots from these trees have encroached beneath foundations and have contributed to seasonal soil drying that has led to the damage.

T2 Oak – Reduce height from 23m to 18m and reduce spread from 21m to 16m, leaving a well-balanced crown (subject to consent being granted under the TPO)

T4 Oak – Reduce height from 23m to 18m and reduce spread from 21m to 16m, leaving a well-balanced crown (subject to consent being granted under the TPO)

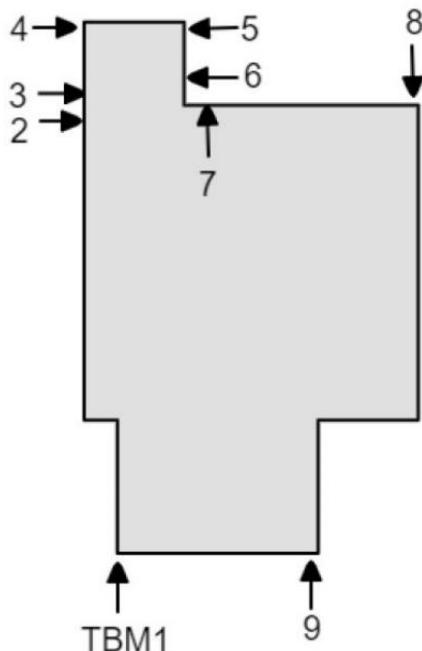
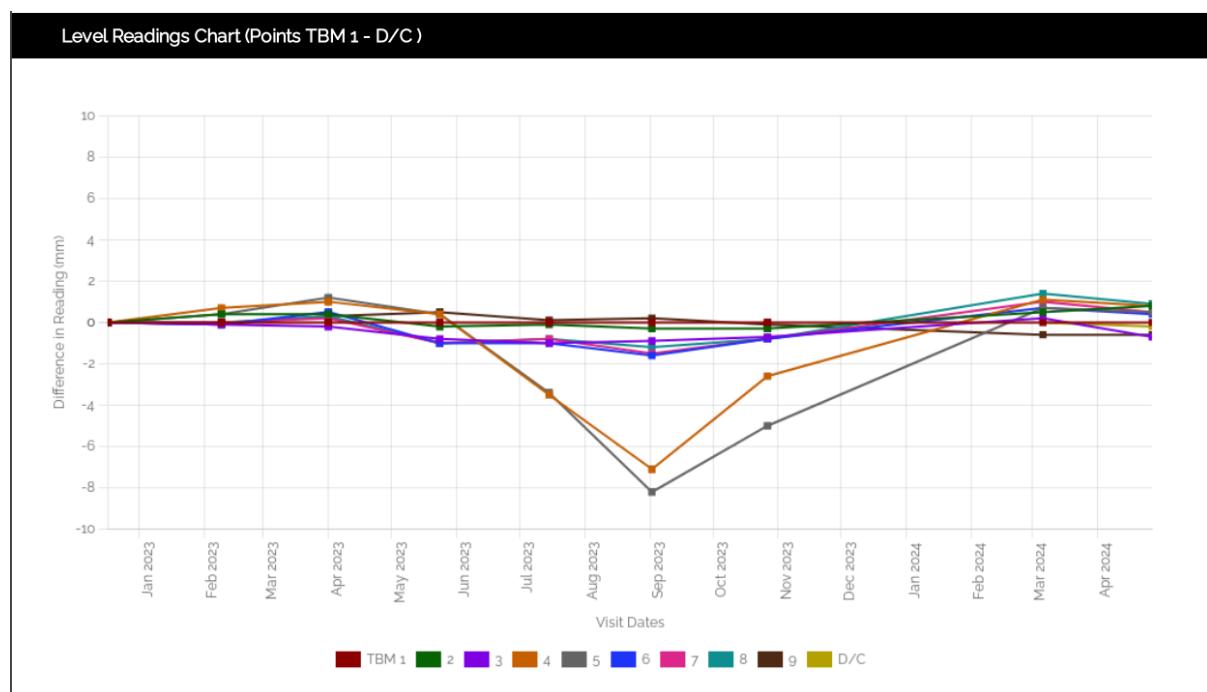
The level monitoring indicates a clear seasonal and cyclical pattern of movement consistent with root induced clay shrinkage with the greatest amplitude of movement being consistent with the locations of the removed items H1 and T5 as well as the Oaks T2 & T4.

The level monitoring indicates a cyclical pattern of movement which shows both downwards movement during the drier summer months; when trees are in leaf and actively demanding

moisture from the ground; and subsequent recovery and upward movement during the wetter winter months when the trees lose leaf and become dormant. Patterns of movement such as those observed at the risk address are consistent with clay shrinkage subsidence and are only consistent with the effects of shrinking and swelling of clay soils exacerbated by the presence of roots. The main influence would have been from laurel hedge H1 and Hornbeam T5. The presence of Oak roots has been confirmed thus confirming the contribution of Oaks T2 & T4 on soil moisture beneath foundations.
