Arboricultural Appraisal Report

Subsidence Damage Investigation at:

33 St. Martins Approach
Ruislip
HA4 7QH

CLIENT: Crawford & Company
CLIENT REF: SU2204240
MWA REF: SUB230918-14249
MWA CONSULTANT: Giles Mercer
REPORT DATE: 23/11/2023

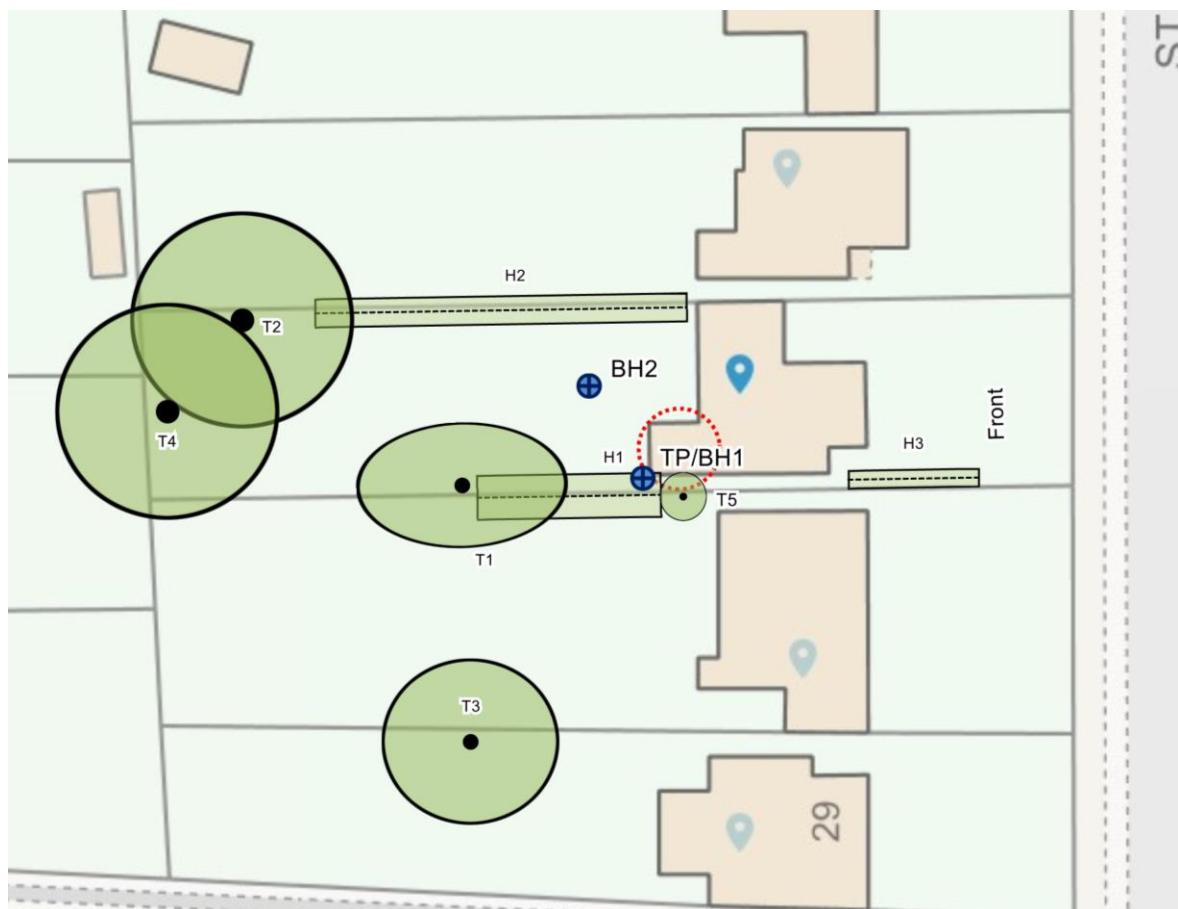
Site Plan

Approximate areas of damage

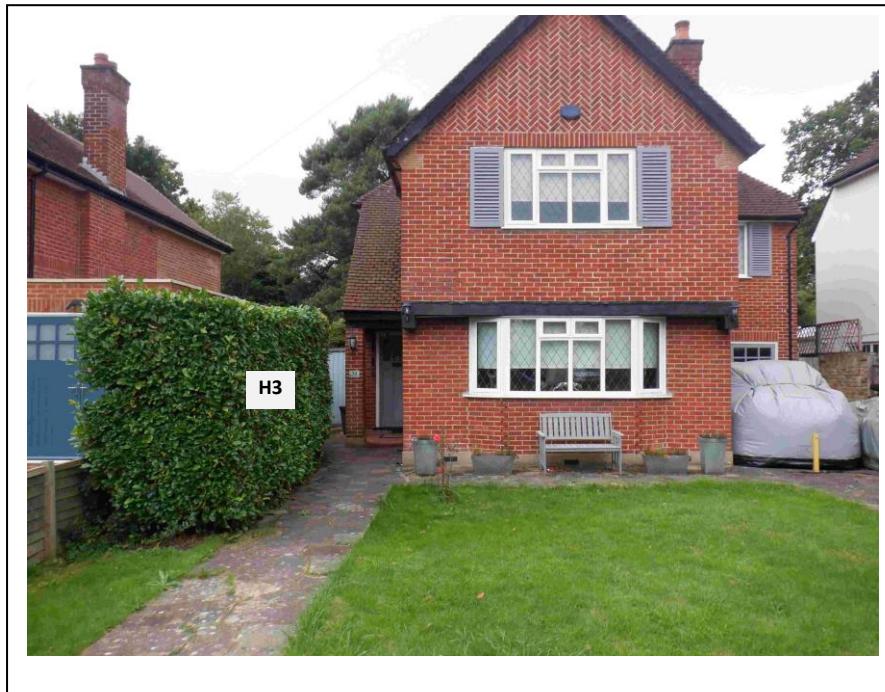
View of the front elevation and H3

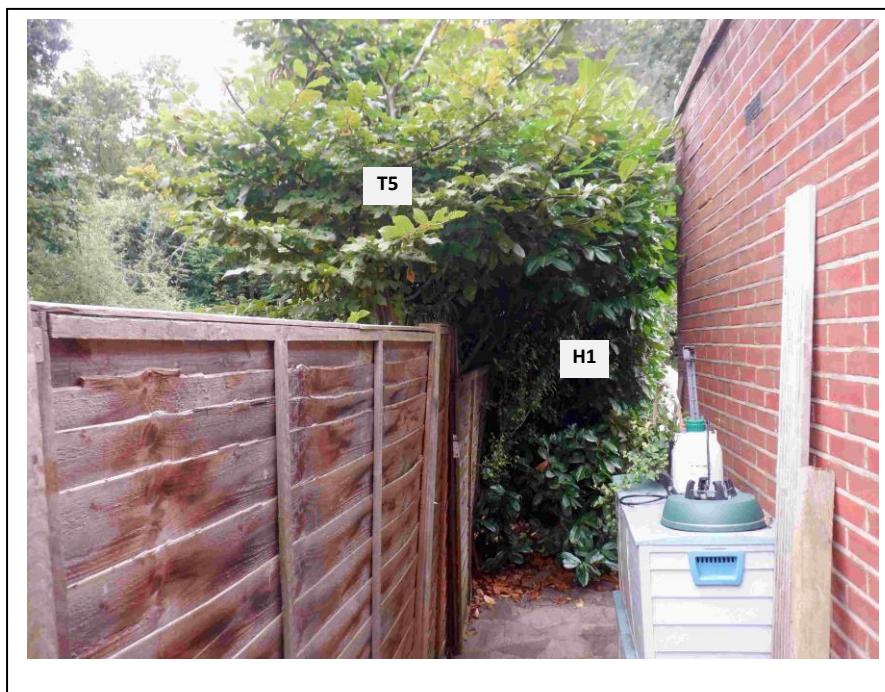
Based on the technical reports currently available, engineering opinion and our own site assessment we conclude the damage is consistent with shrinkage of the clay subsoil related to moisture abstraction by vegetation. Having considered the information currently available, it is our opinion that the Hornbeam (T5) and the Laurel hedge (H1) the principal cause of or the current subsidence damage.

View of H1 & T5

If an arboricultural solution is to be implemented to mitigate the influence of the implicated trees/vegetation we recommend that the Hornbeam (T5) and the Laurel hedge (H1) are removed and the Oaks (T2 and T4) reduced. Other vegetation recorded presents a potential future risk to building stability and management is therefore recommended.

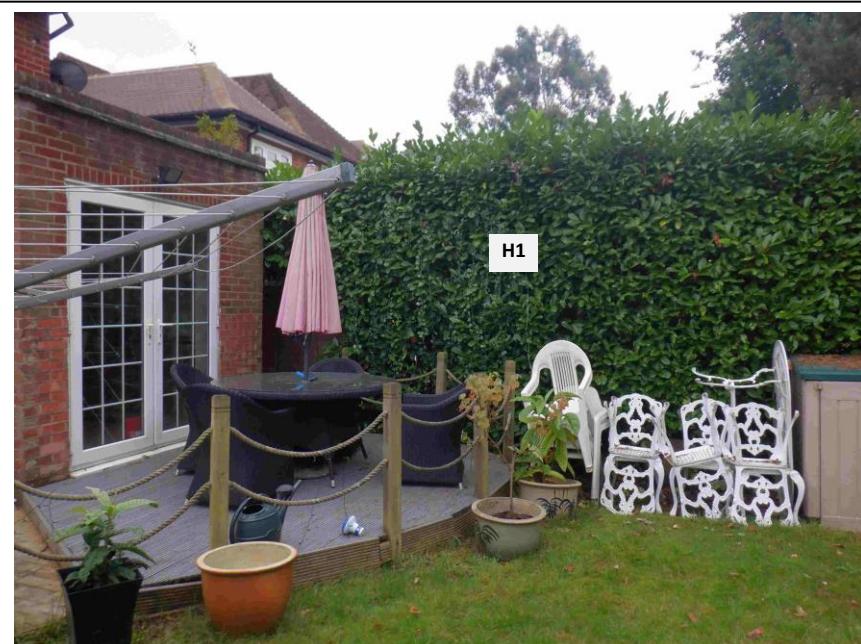
H1	Laurel	3	125 Ms *	3.5	2	Younger than Property	Boundary Policy Holder and/or Third Party 31 St Martins Approach HA4 7QH
Management history		Managed hedge.					
Recommendation		Remove (fell) to near ground level and treat stumps to inhibit regrowth.

View of H1

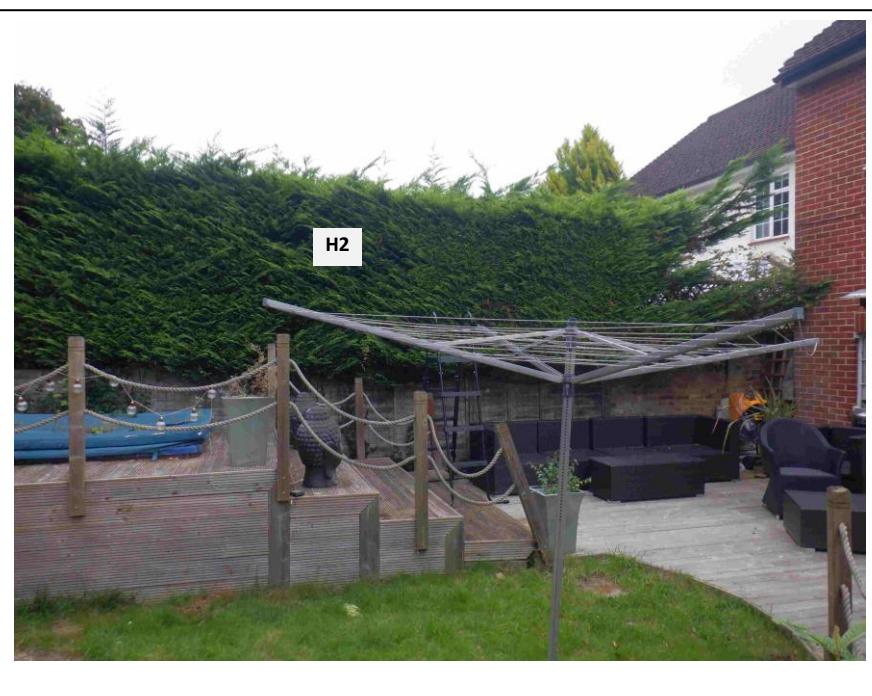
View of H2

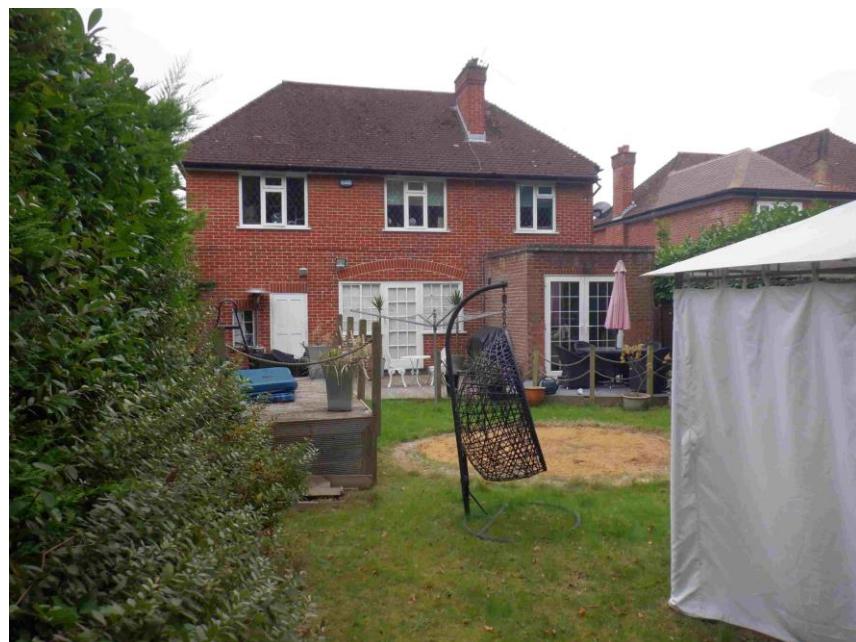
Damage relates to the rear extension where cracking indicates downward movement.

View of the rear elevation

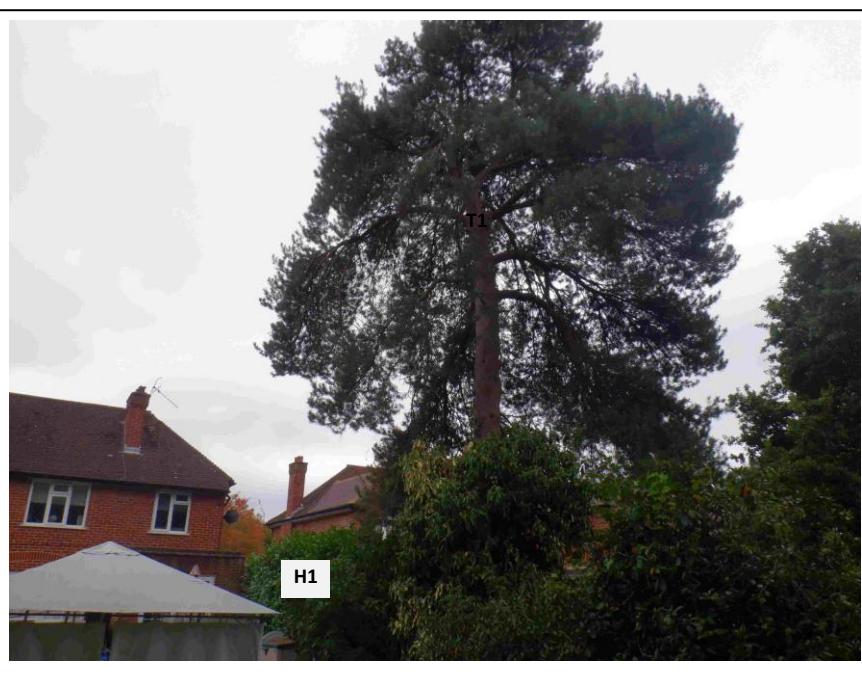
View of H1 & T1

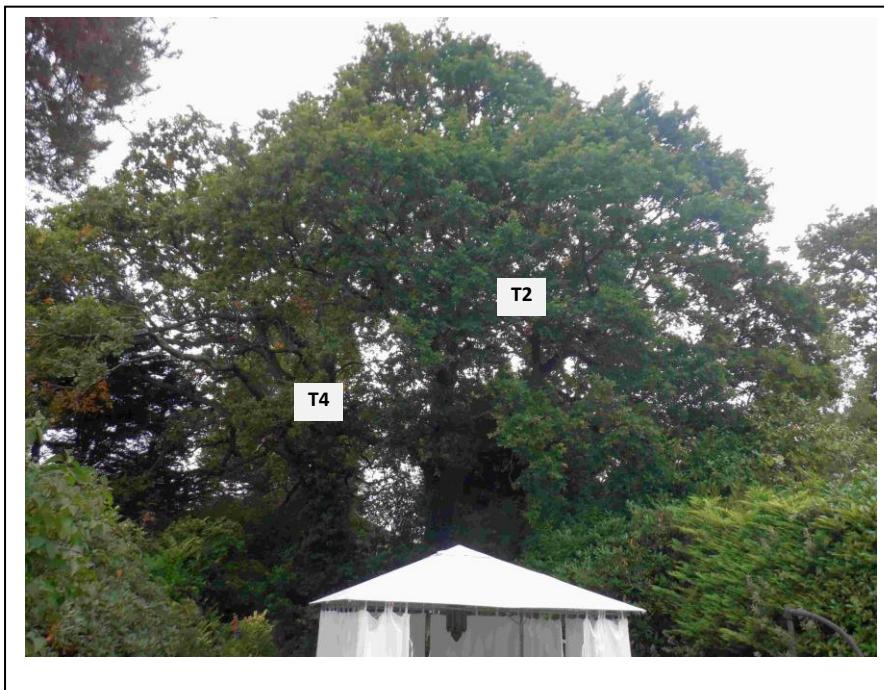
Whilst the influence of the Oak is confirmed by the root identification the trees are positioned at the limit of their normally accepted influencing distance and their influence will in our view be secondary to that of H1 and T5.

View of T2 & T4

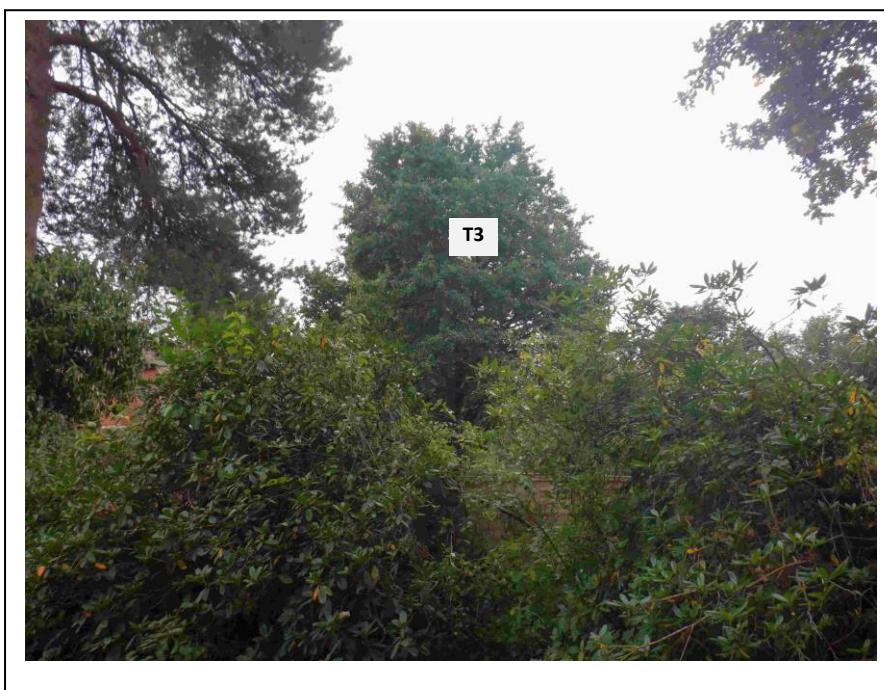
View of T3
