TREE CONDITION SURVEY

MANAGEMENT WORK RECOMMENDATIONS

SUNDAY, 28 SEPTEMBER 2025
M ARCHITECTURE PLANNING
SANTOS TIMBER
35 The Grove, Ickenham, Uxbridge UB10 8QJ

Arboricultural Tree Survey

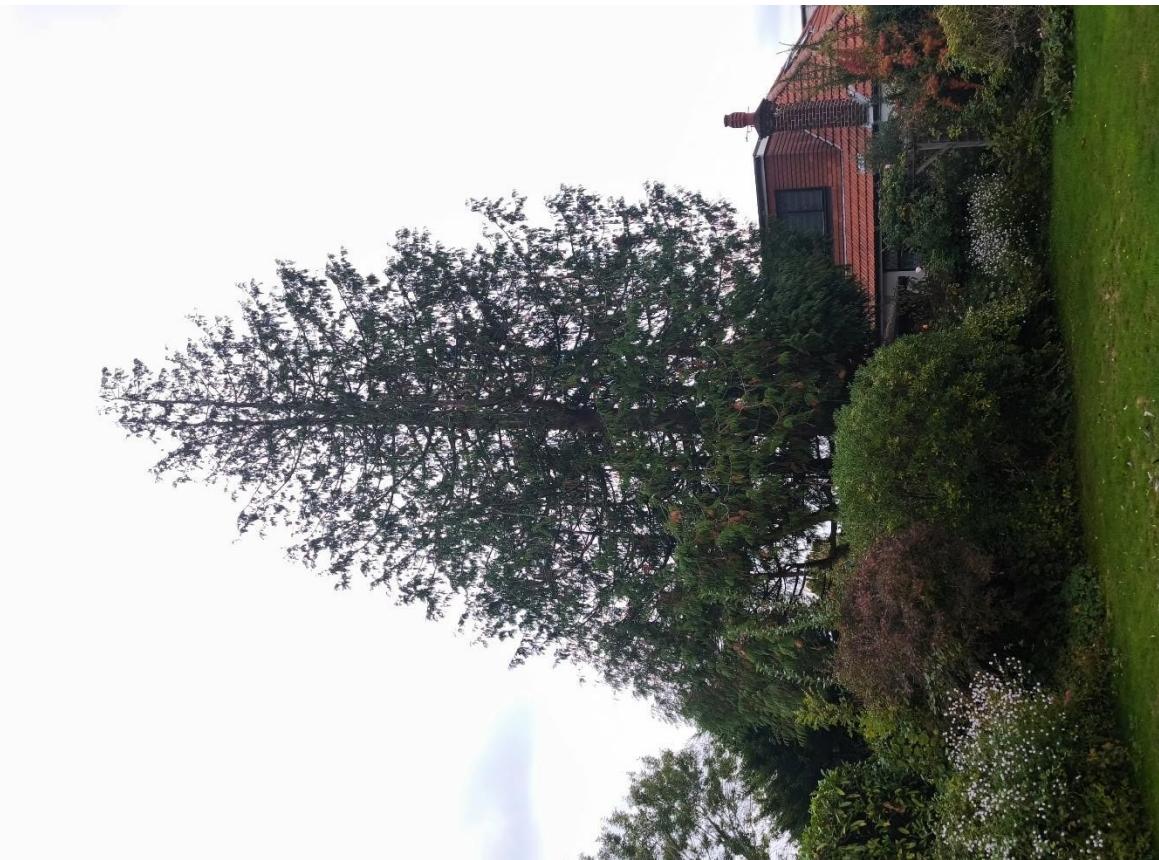
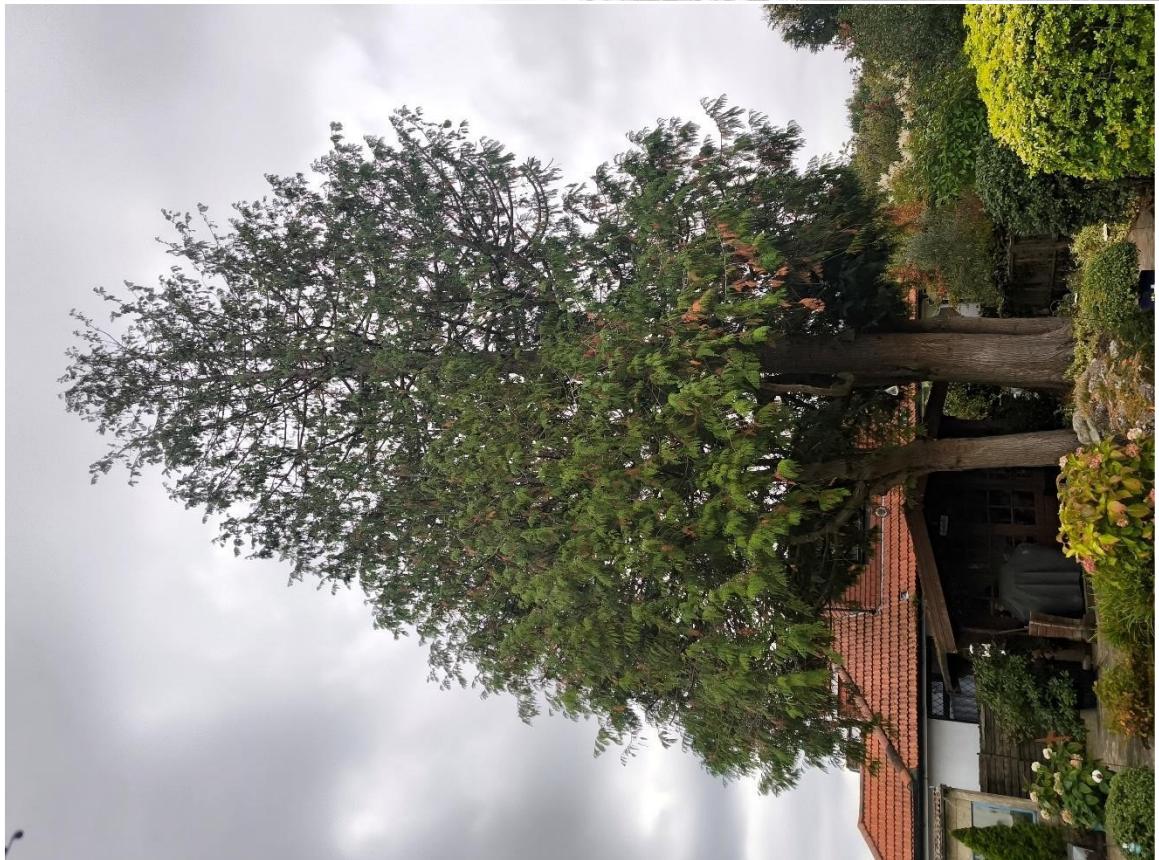
T1 – From no.35 and no.33 The Grove

- 6.2 T1 is located in the neighbouring property of no.33 The Grove. It is a species of *Thuja*, *Thuja spp.*
The crown appears sparse, more so towards the top, but this is normal for the species.
There are small brown patches of foliage in the crown, but again this is normal. It has been slightly reduced on the south side where it overhangs the garden of no.35 The Grove a few years ago as the pruning cuts have darkened in colour.
There is a co-dominant stem on the south side of the crown at approx. 10m from ground level, growing to approx. 8m tall.

7.2 The proposal of a 'summer house' style building at the back of the rear garden has been suggested. Due to the size of the root system from T1, which covers approx. 2/3^{rds} of the east side of the rear garden, with T2 making up the final 1/3rd, the options for foundations are limited.

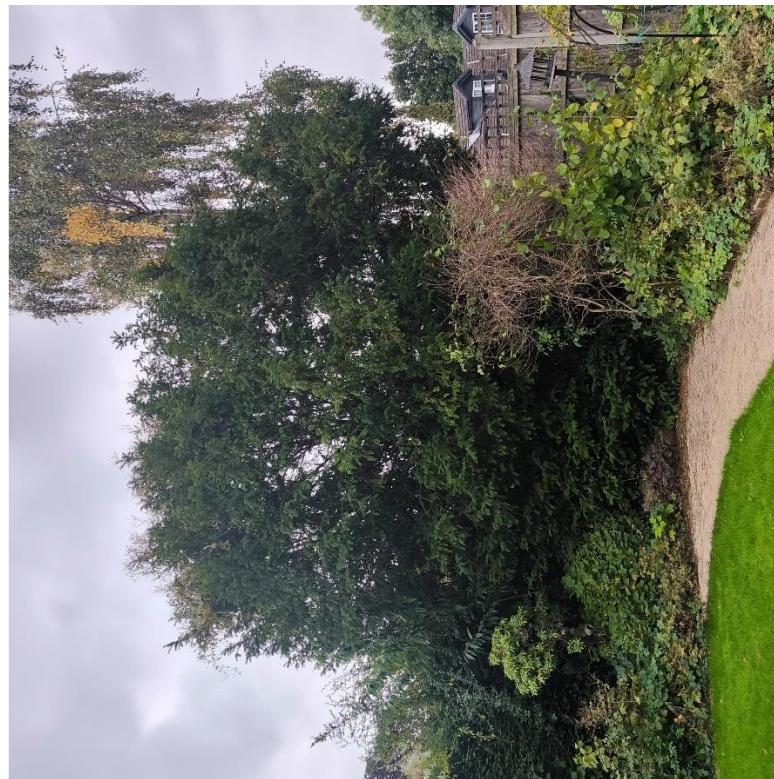
- 6.3 T2 is a Common Yew, *Taxus baccata*, and is in the south east corner of the rear garden of no.35 The Grove.
The base of the tree is growing on a small raised earth bank.
It has been trimmed back on occasion, likely with hedge cutters.
The crown hangs over the footpath with a clearance just under 2m.

7.6 T2 may need to be removed for construction to take place, so replanting within the property will need to be undertaken due to the development taking place in a conservation area.

- 8.1. No tree work needs to be undertaken at this time.
- 8.2. There are a number of options for the foundations as outlined above. Once the final design and placement of the building is agreed, then the foundation design can be finalised as well.
- 8.3. If T2 is to be removed, replanting will need to take place. This would ideally be the same or similar species or at minimum a British native tree to help maintain the natural food chain.

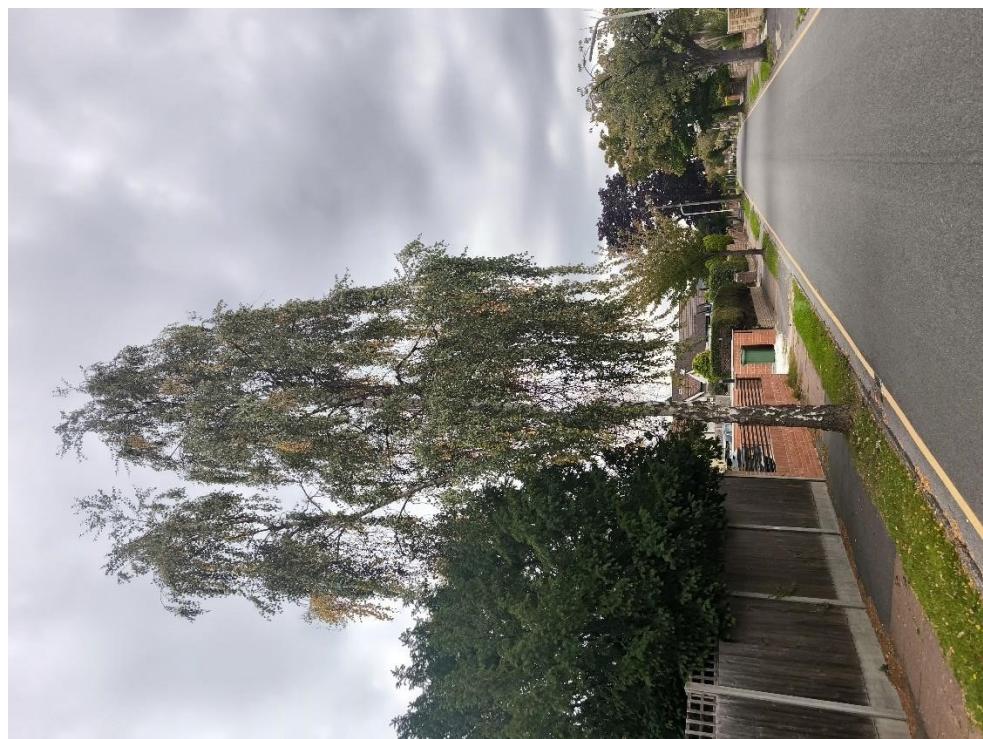
- 6.4 T3 is a Silver Birch, *Betula pendula*, and is growing on the street to the south of the property, along the northside of The Chase.
It is quite tall and narrow for its species, which could mean it is a Fagus variant.
There is a large secondary branch on the south side of the west side of the crown. There is a climbing vine, possibly honeysuckle, growing over from the adjacent property of no.1 The Chase, up to a height of approx. 9m into the crown.
A branch has snapped off or been removed on the south side/road side of the crown, low down on the stem. It is still lightly coloured so has happened recently. The pruning wound is not clean cut which suggests a snap out.
