Full Structural Inspection

Client Fourwalls Property Management Ltd.
Address 60 Summerhouse Lane, West Drayton UB7 0AW
Date of Inspection 12th June 2025
Reference 25165

Structural Engineer Walid Khan BEng
Director of Stabuild Ltd.
79 College Road, Harrow HA1 1BD, UK
info@stabuild.co.uk
020 8935 5840
Company reg. 09979783
VAT reg. 365020917

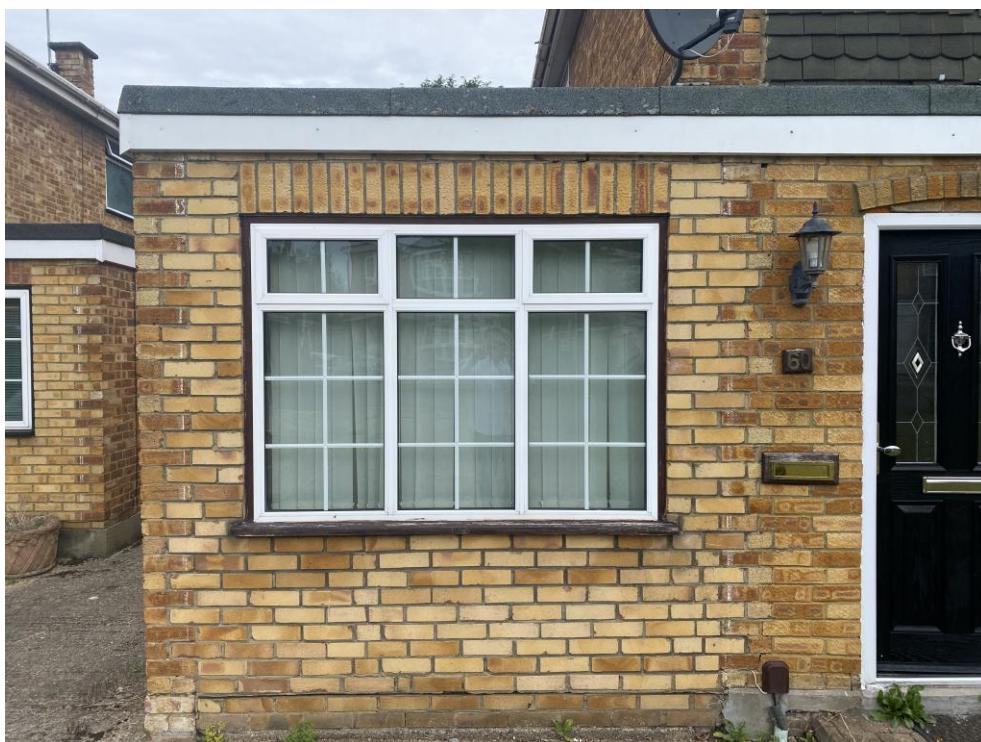
Figure 4

Evidence of new brickwork and repointing is noted around the ground level bay window (refer to **Figure 4**).

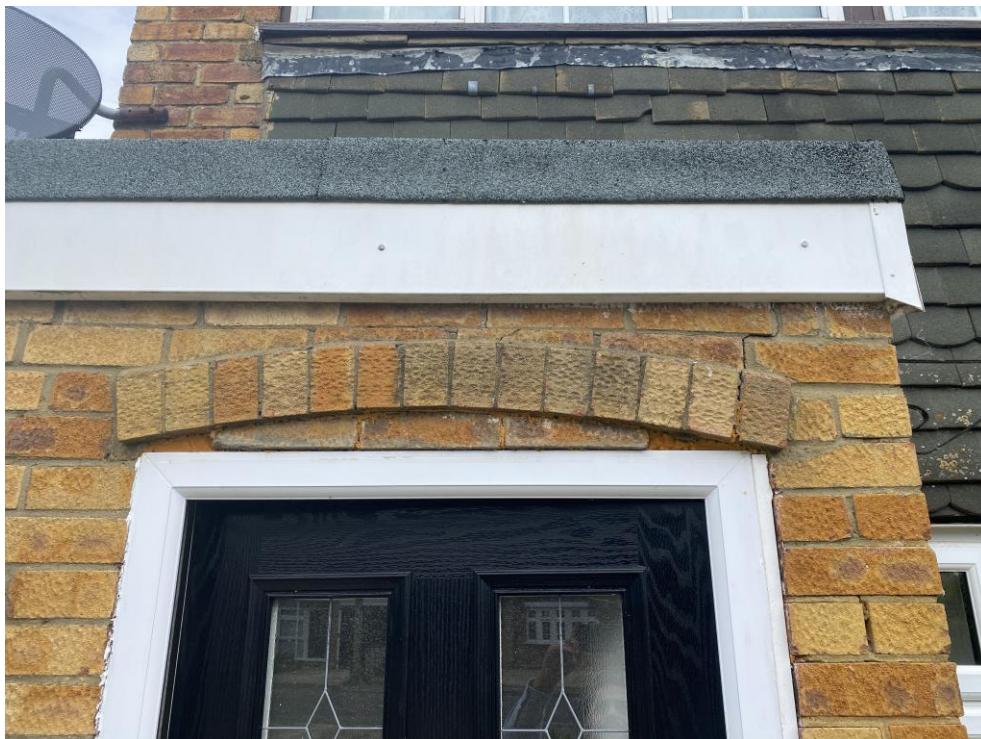
Figure 5

A vertical crack is noted in the top-right corner of the front entrance in the arched lintel (refer to **Figure 5**).

Prior to repairing the cracks in the masonry walls, the lintels above the windows and door in the flank and front facades should be exposed and further assessed. If the lintels are noted to be damaged, they should be replaced with adequate lintels designed by a structural engineer.

Helibars are to be installed over the cracks in the masonry walls at every three courses of brick. The minimum thickness required for the helibars are 8mm and should bear at least 500mm in to the brickwork at each side of the crack. Once the helibars are installed, the brickwork is to be repointed to make good. When repointing any cracking to the mortar the area should be raked out to a depth of at least 20mm to provide a good key for the new mortar. The mortar to be used should match the existing mortar. This should be lime or cement based and should be determined by the building contractor on site.

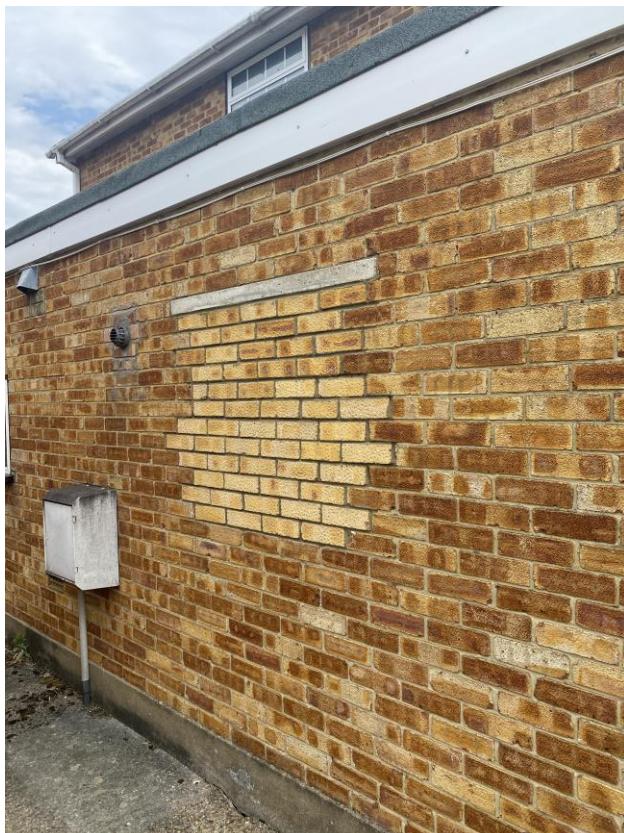
Figure 6

Evidence of new brickwork and repointing is noted at ground level (refer to **Figure 6**).

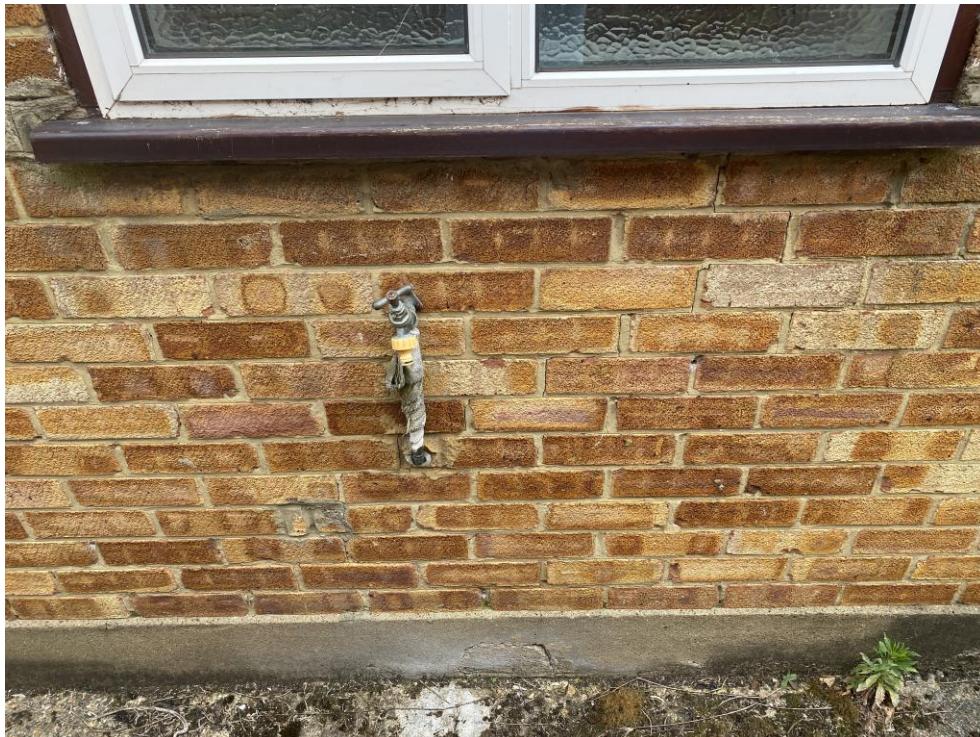
Figure 7

A diagonal stepped crack is noted in the bottom-right corner of the ground level toilet window (refer to **Figure 7**). A diagonal stepped crack is also noted in the top-left corner of this window (refer to **Figure 8**).

The cracks highlighted in this report could be due to mild subsidence, especially the diagonal cracks noted in the flank wall. Therefore, to eliminate further structural movement, the two trees highlighted in this report should be removed by an Arborist.

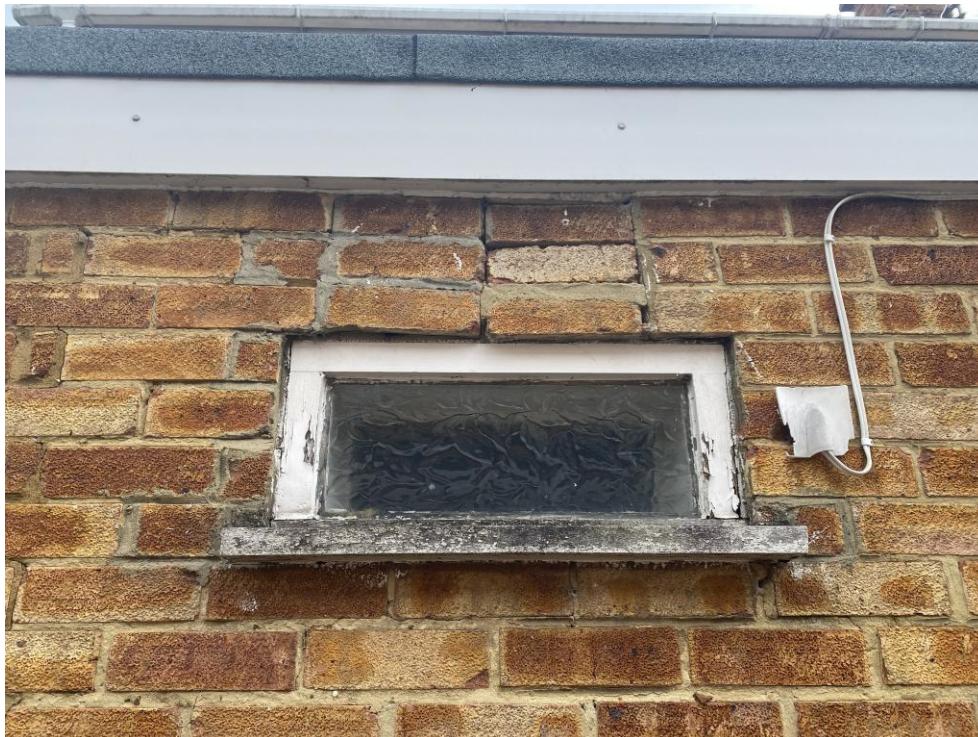
Figure 9

Loose brickwork is noted above the small window at ground level (refer to **Figure 9**).

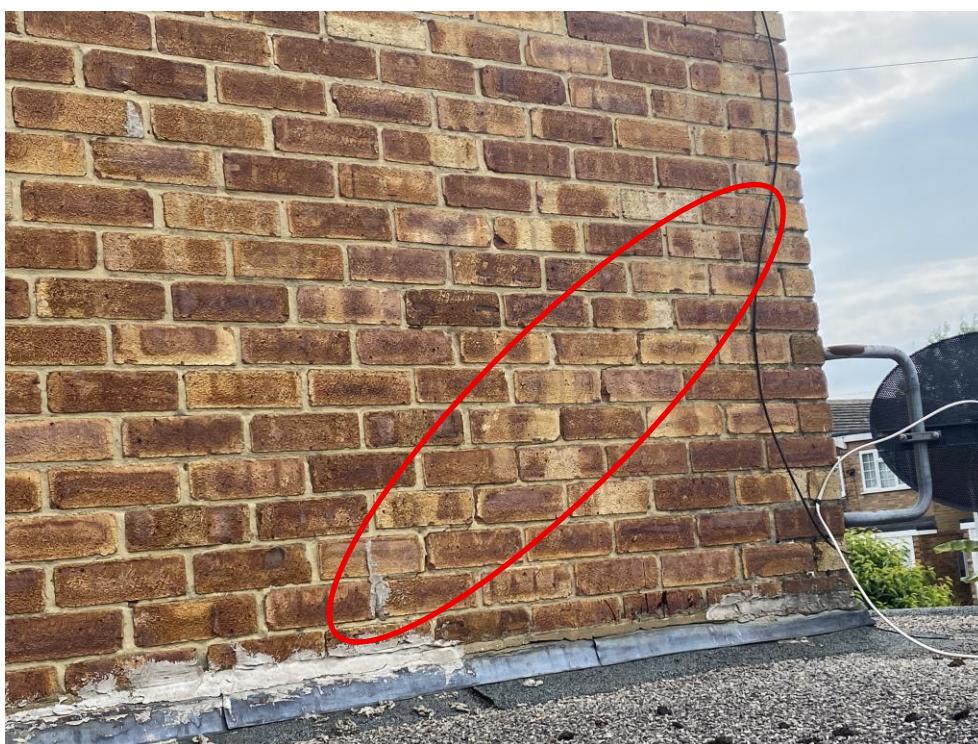
Figure 10

A diagonal stepped crack is noted in the external flank wall towards the front of the house at first floor level (refer to **Figure 10**).

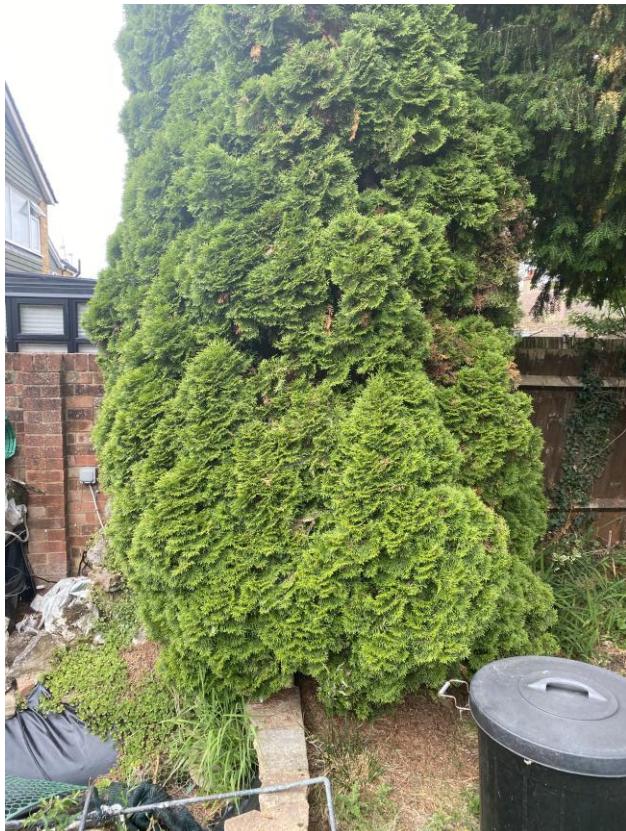
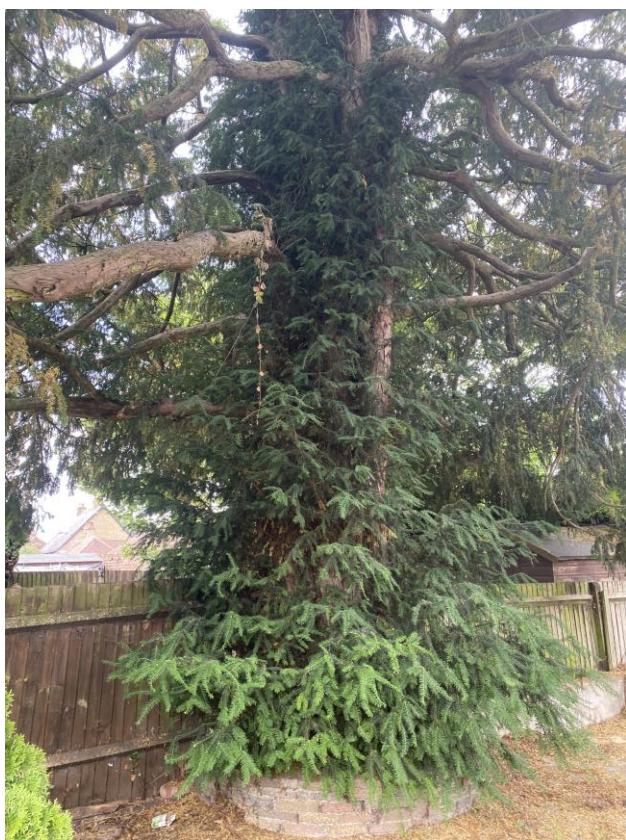
A Leyland Cypress and Yew tree are noted in the rear garden (refer to **Figures 11 and 12**). The trees are approximately 4m and 9m away from the rear façade and approximately 8m and 10m tall, respectively.

According to the NHBC guidelines, the Leyland Cypress and Yew tree is a low water demand tree. Therefore, the recommended minimum foundation depth required at the rear of the property in order to avoid subsidence is 1m. Taking into account the age of the property, it is possible that the foundations at the rear are shallower than 1m therefore, the trees are deemed a threat to the structural integrity of the property.

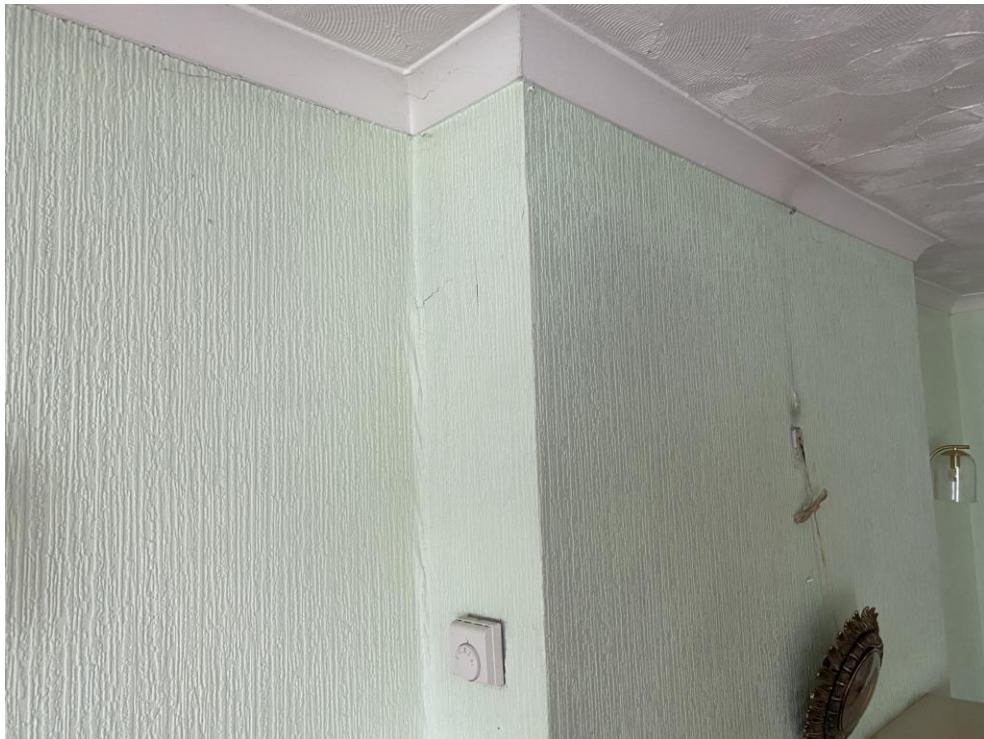
Figure 13

Some warping and cracking is noted in the wallpaper adjacent to the chimney breast (refer to **Figure 13**).

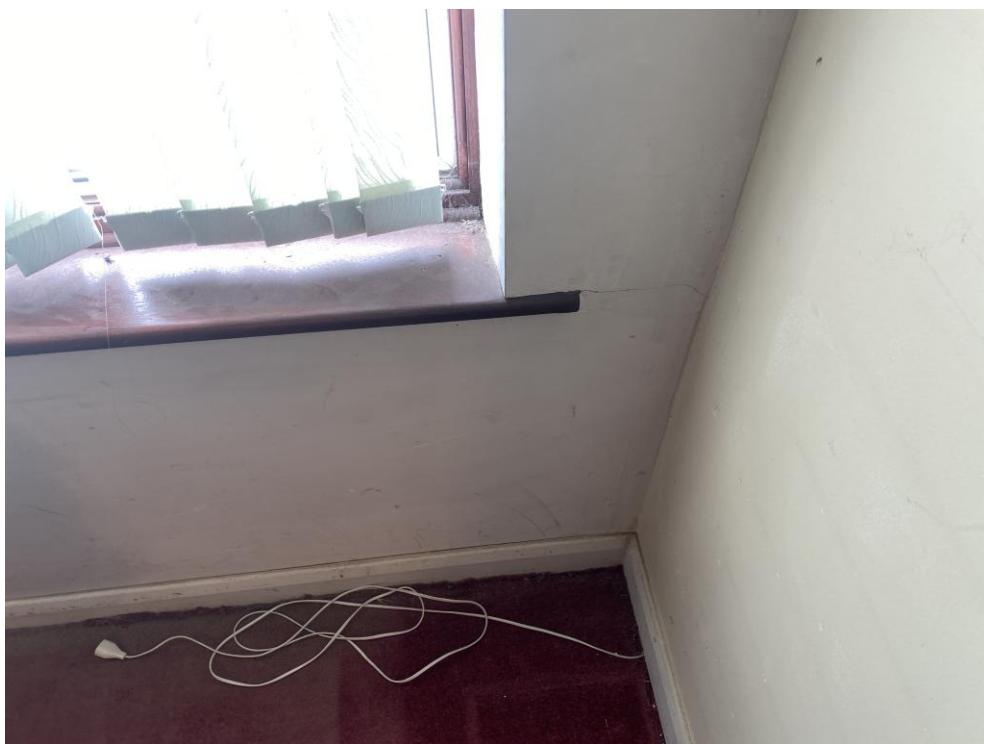
Figure 14

A horizontal crack is noted in the bottom-left corner of the bay window (refer to **Figure 14**). A further horizontal crack is noted in the bottom-right corner of this bay window (refer to **Figure 15**).

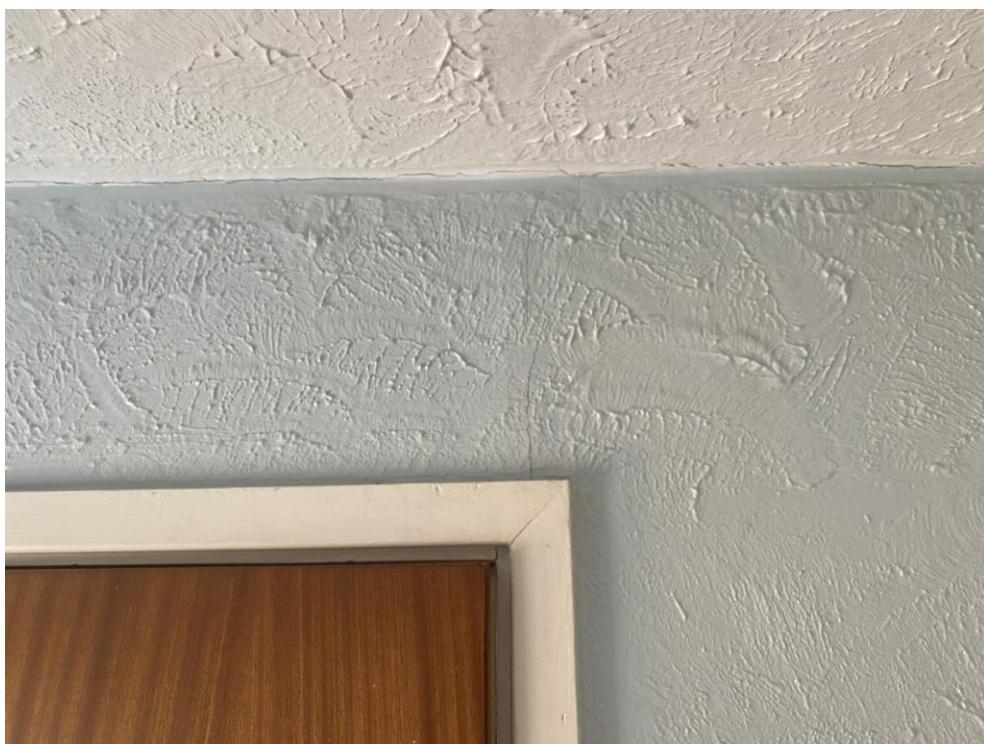
Figure 16

A vertical hairline crack is noted in the top-right corner of the toilet door (refer to **Figure 16**).

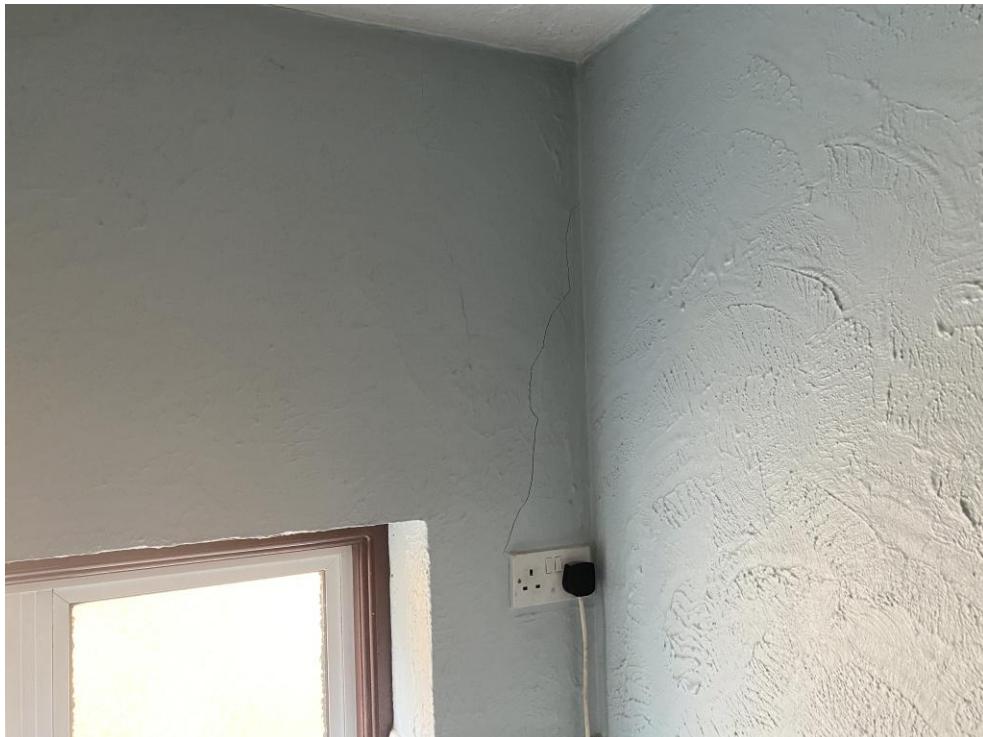
Figure 17

A diagonal crack is noted on the right-hand side of the toilet window (refer to **Figure 17**).

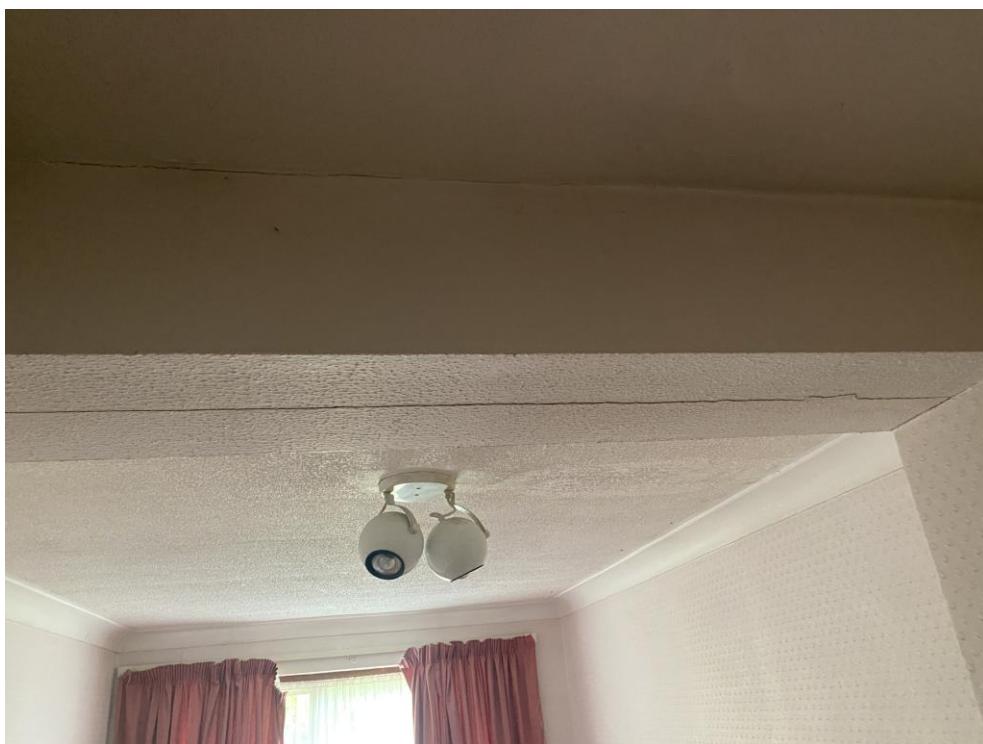
Figure 18

A horizontal crack is noted in the underside of the downstand beam in the rear bedroom (refer to **Figure 18**).

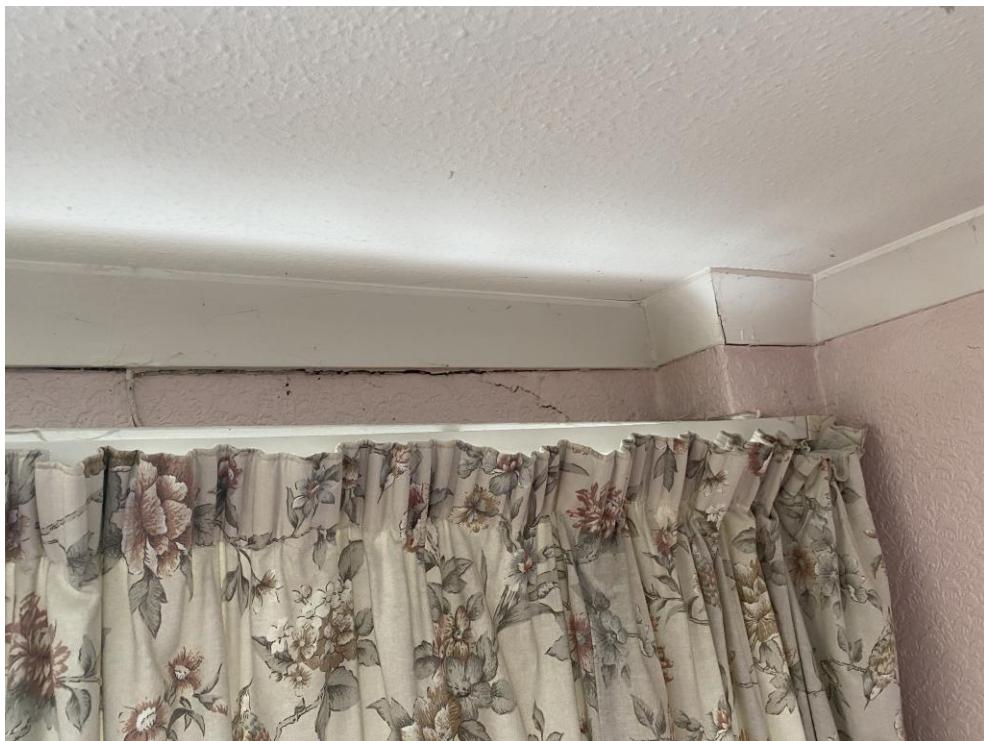
Figure 19

A diagonal crack is noted in the wall paper in the top-left corner of the front bedroom window (refer to **Figure 19**).

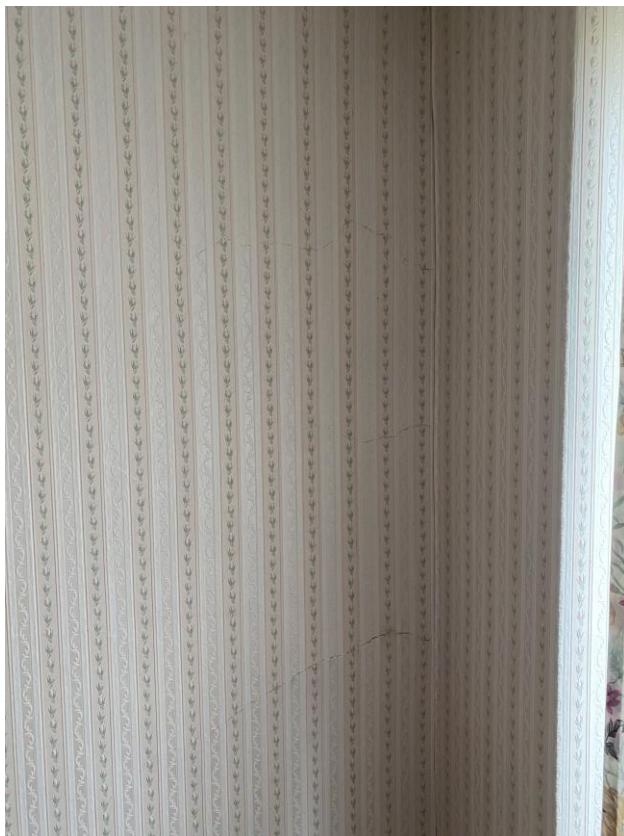
Figure 20

Horizontal cracks are noted in the flank wall of the rear bedroom (refer to **Figure 20**).
