**FORMER BARN HOTEL
WEST END ROAD
RUISLIP**

OUTLINE STRUCTURAL METHODOLOGY REPORT

Ref: AM/23530~srep_rev 1

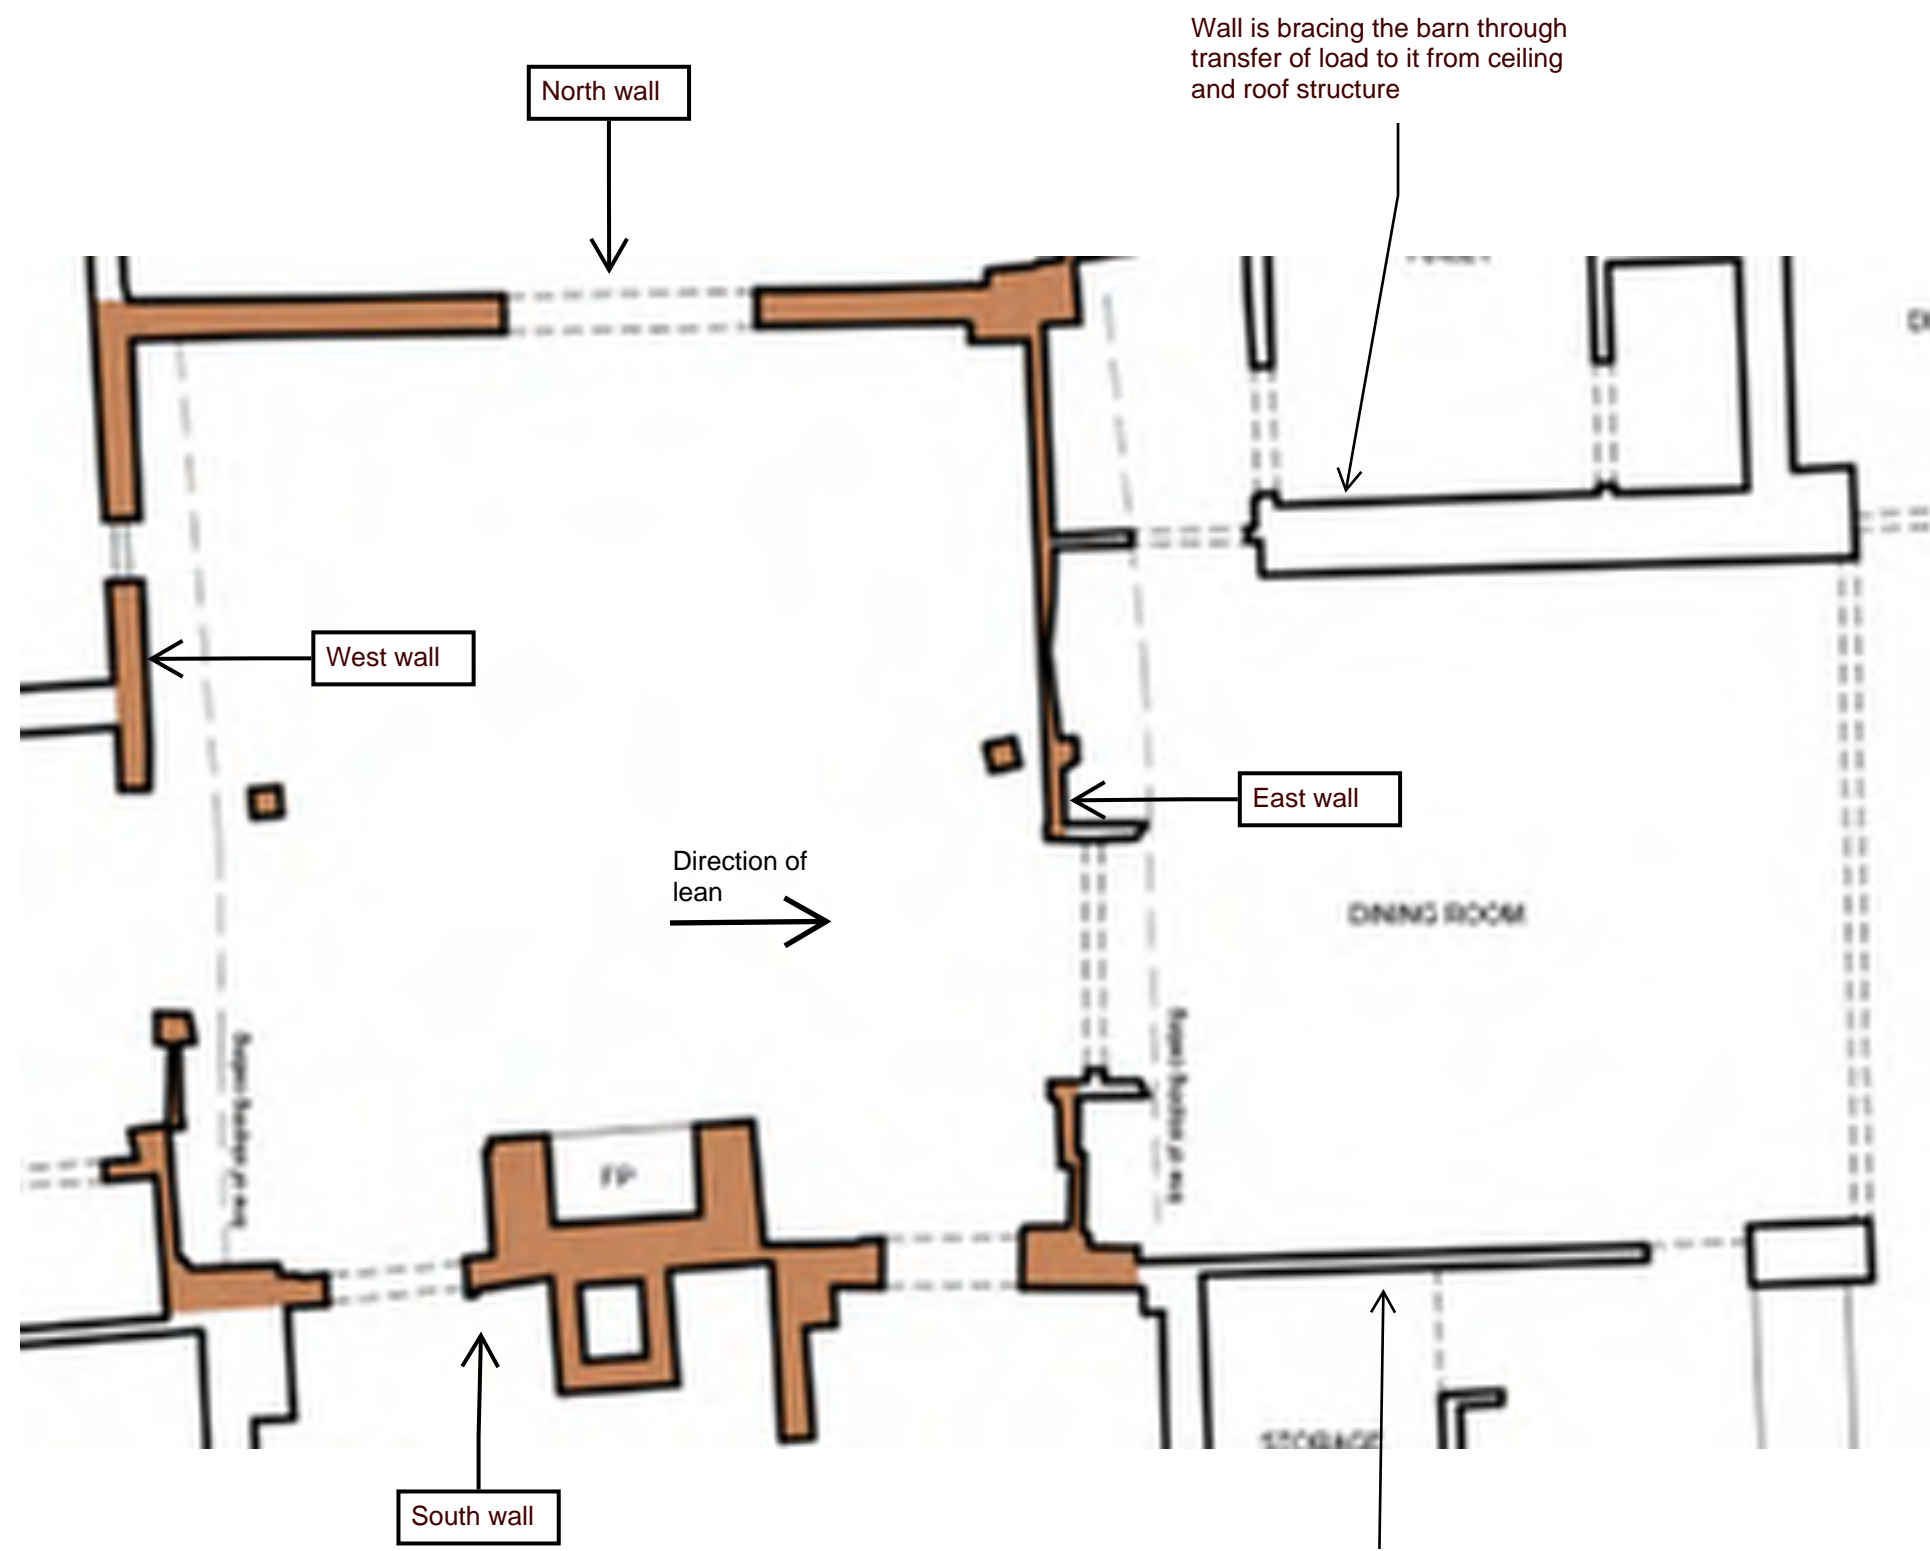
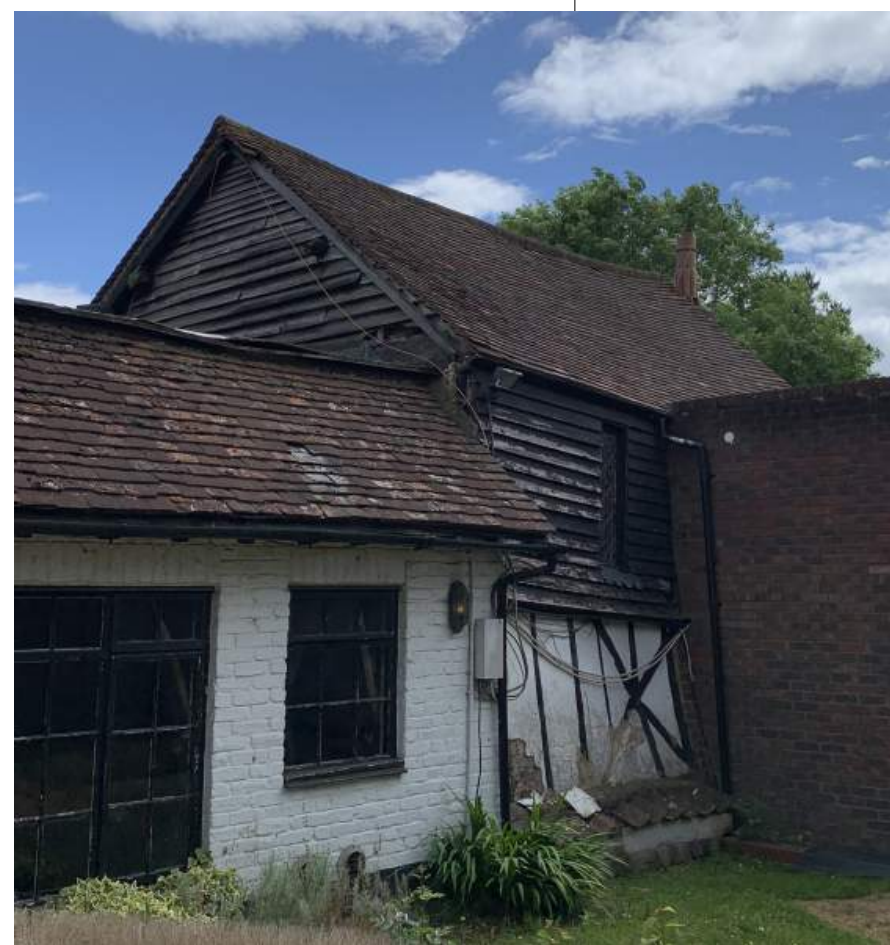
Title
LEANING BARN PLAN

- 2.1 The barn has a dual pitch timber roof with rafters supported at mid span by purlins which span from the end walls to central queen post truss. Above the rafters timber sarking boards are present which are finished with clay plain tiles. The gable walls at the north and south ends also comprise queen post trusses.

- 2.5 Modern timber posts are present beneath each end of the central truss and are inboard of the perimeter walls. These posts are understood to have been installed in the early 21st century

- 2.6 Notches to the internal face of the central posts appear to be mortices which might have received a tennon connection from a central dividing wall within the barn which would have laterally braced the structure however these walls no longer exist

- 2.7 Without this the head plate to the eastern and western side walls is required to span the full distance between the end walls which it is unlikely to have the stiffness to do. As such the removal of these walls is likely to have contributed to the distortion which is seen, however the surrounding structures, particularly to the east currently appear to be providing sufficient compensatory restraint.

- 2.8 The absence of haunches at the heads of the posts within the side walls which support the central truss was also noted, which if present would assist in providing lateral stability to the structure.

- 4.5 Based on the findings of our survey initial repair and strengthening proposals are shown on drawings within the appendix. Once areas of the frame which are currently concealed are exposed at the beginning of the site works we will undertake a further inspection and finalize the schedule and specification of remedial works which are required.

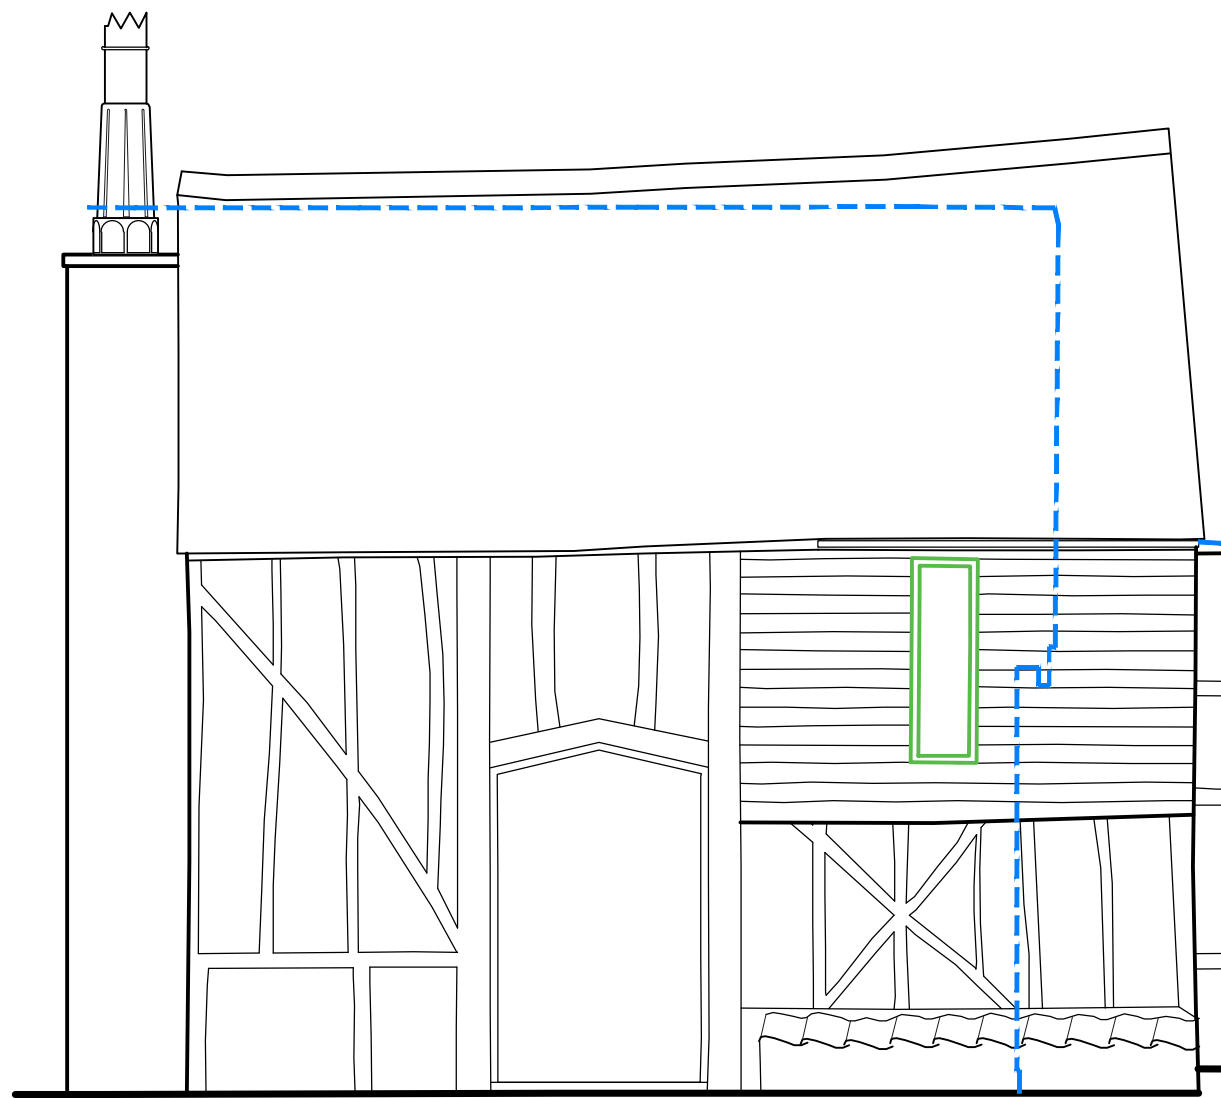
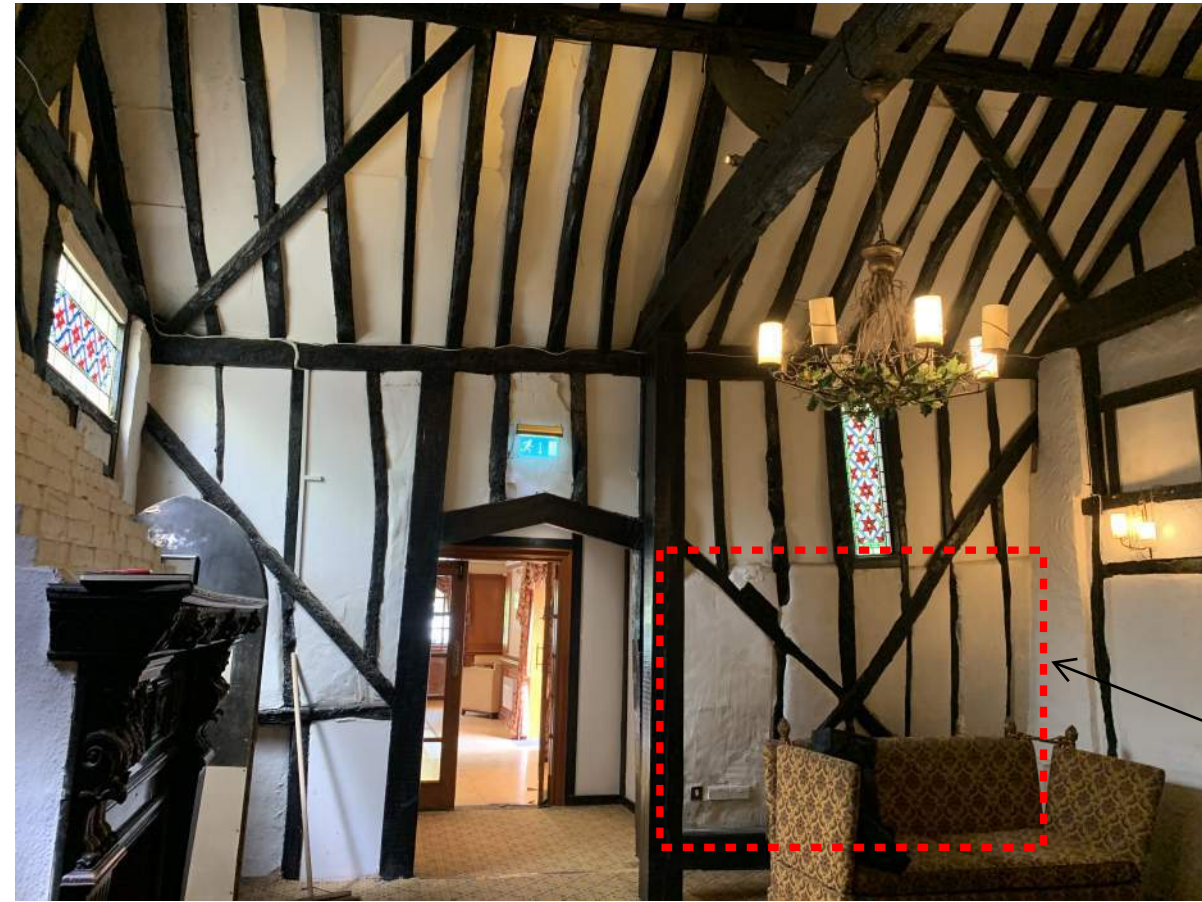
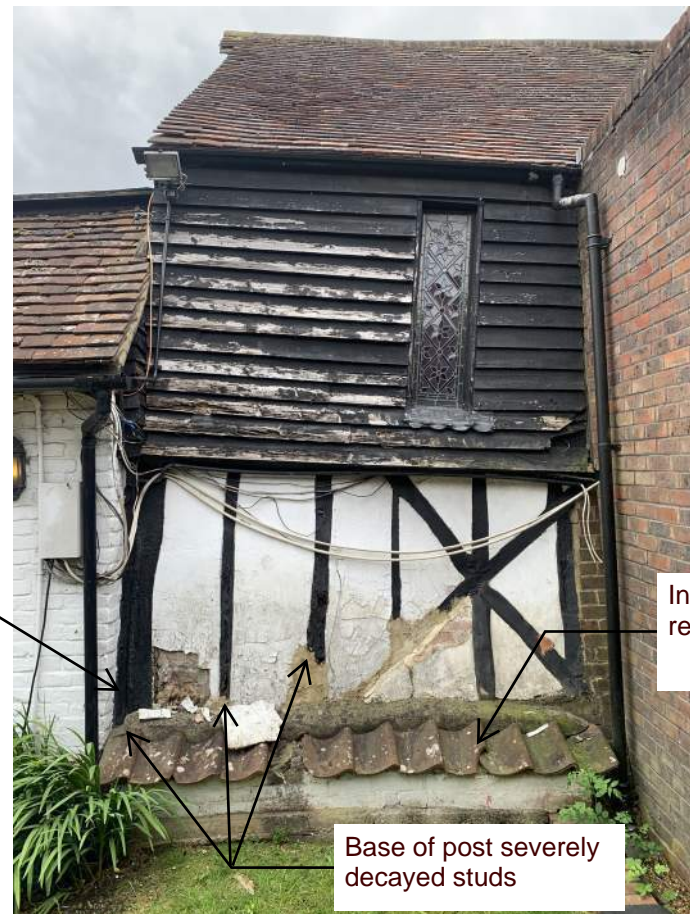
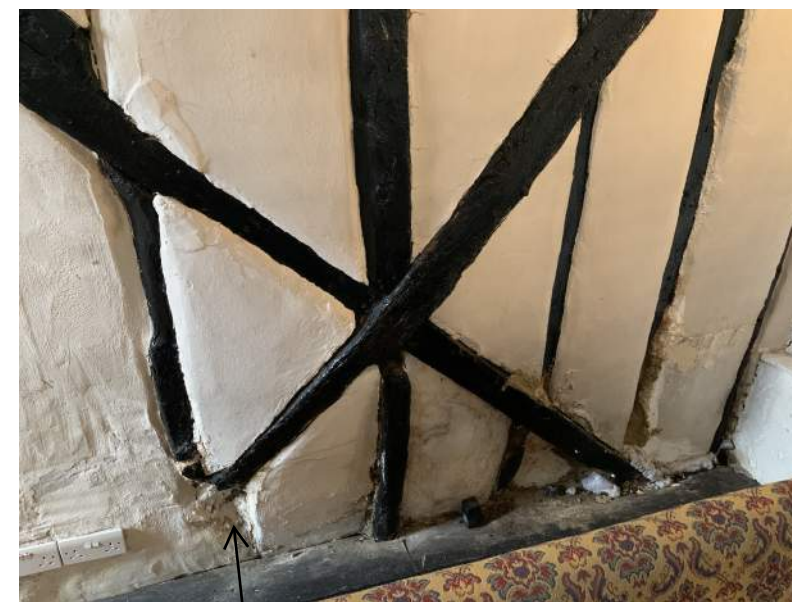
Title
LEANING BARN WEST
ELEVATION

- 2.11 The head of the wall leans by 400mm to the east.
- 2.12 Partial remains of cross bracing to the north of the entrance. The bottom half of the panel has masonry infill between studs, externally this is rendered with some sections found to be delaminating. Beneath this hard cement pointing to mortar joints between brickwork is evident. Above this the panel is clad with horizontal timber boarding.

- 2.13 At the base of the panel a tiled plinth can be found, its not known what this contains and as such opening up work is required to investigate.
- 2.14 A number of stud ends and one end of a bracing section are discontinuous which have been replaced with masonry infill. This has affected the robustness of the panel which has bowed to an extent that it will need to be dismantled and re-built. There is significant decay to at least two other studs which warrants replacement.

Significant distortion to panel, see external photograph below. Lower half will largely require replacement, roof structure to be propped during

Decay to base of post recorded internally

Investigation work required below plinth

Base of post severely decayed studs

End of stud and bracing appears to have been lost

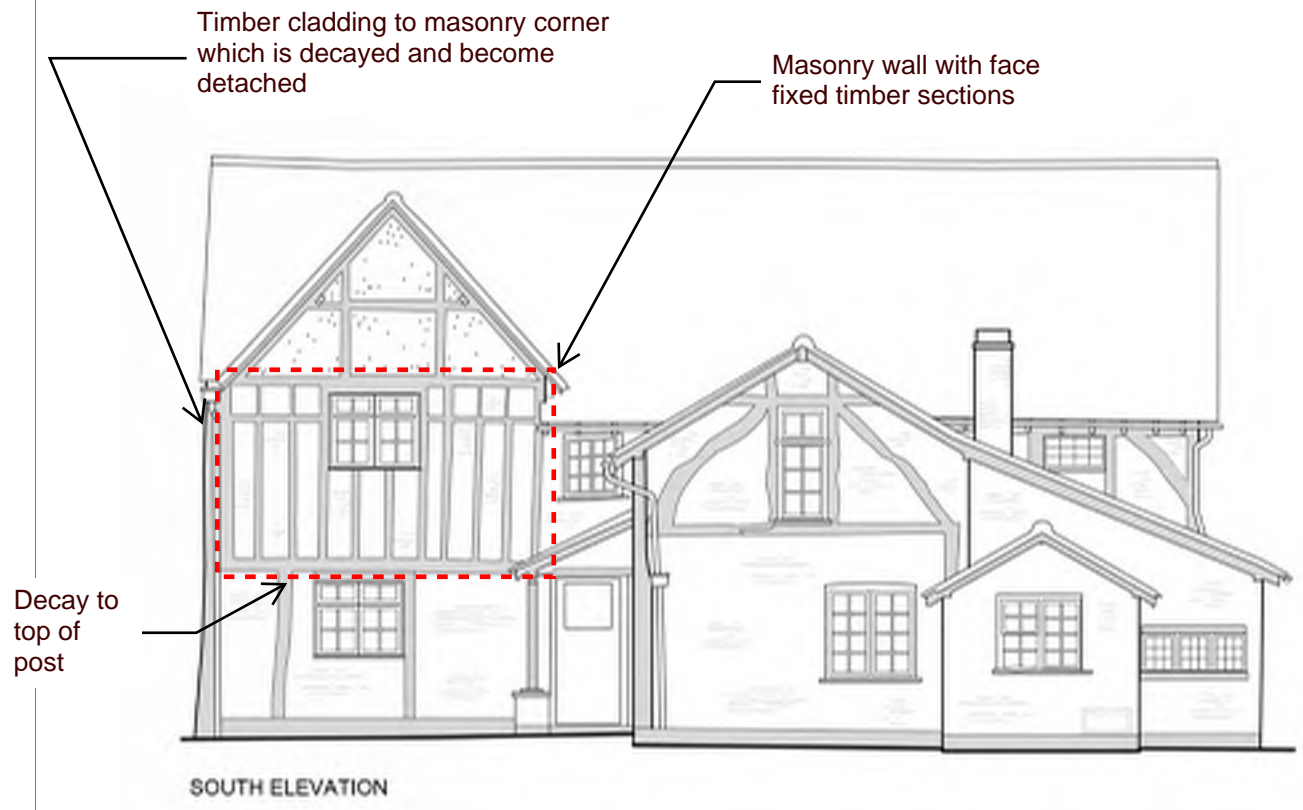
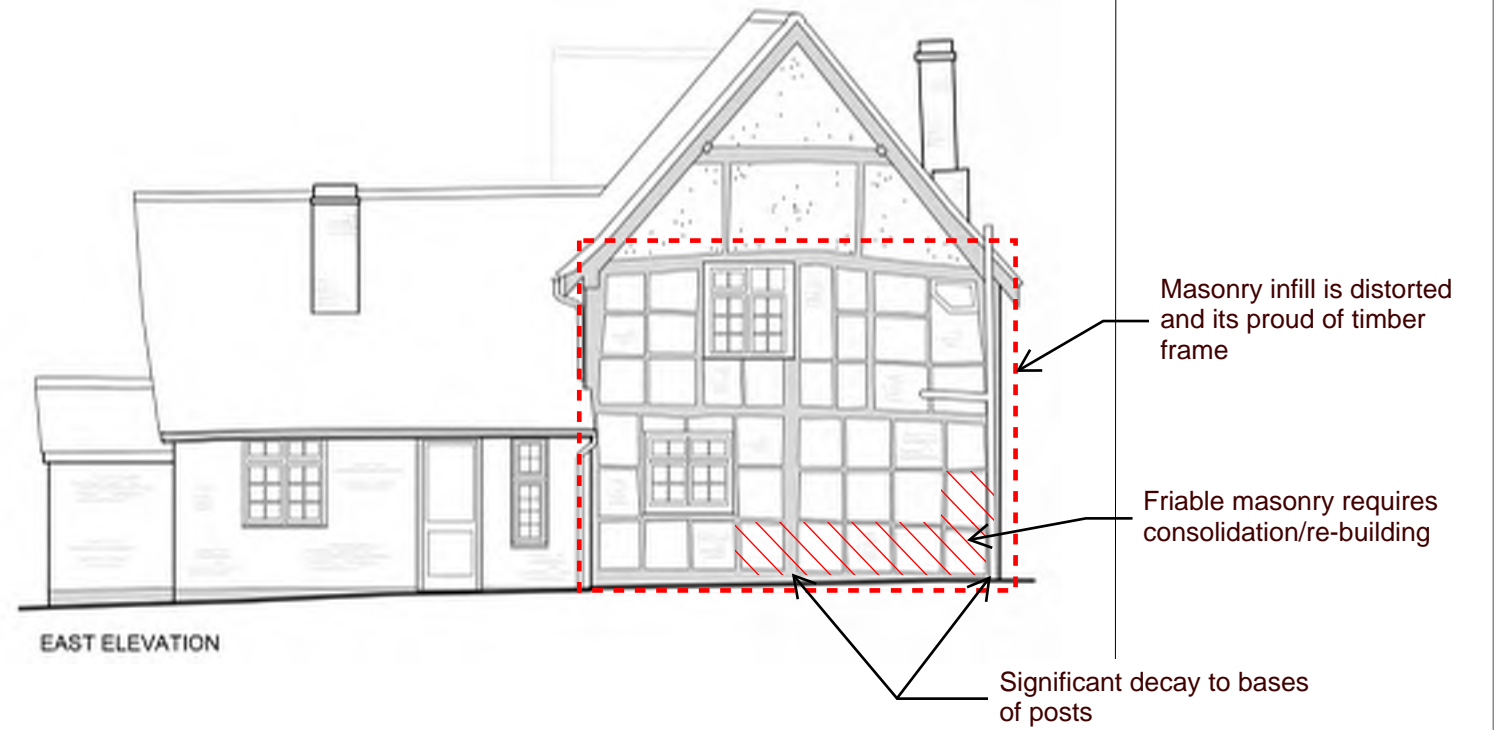
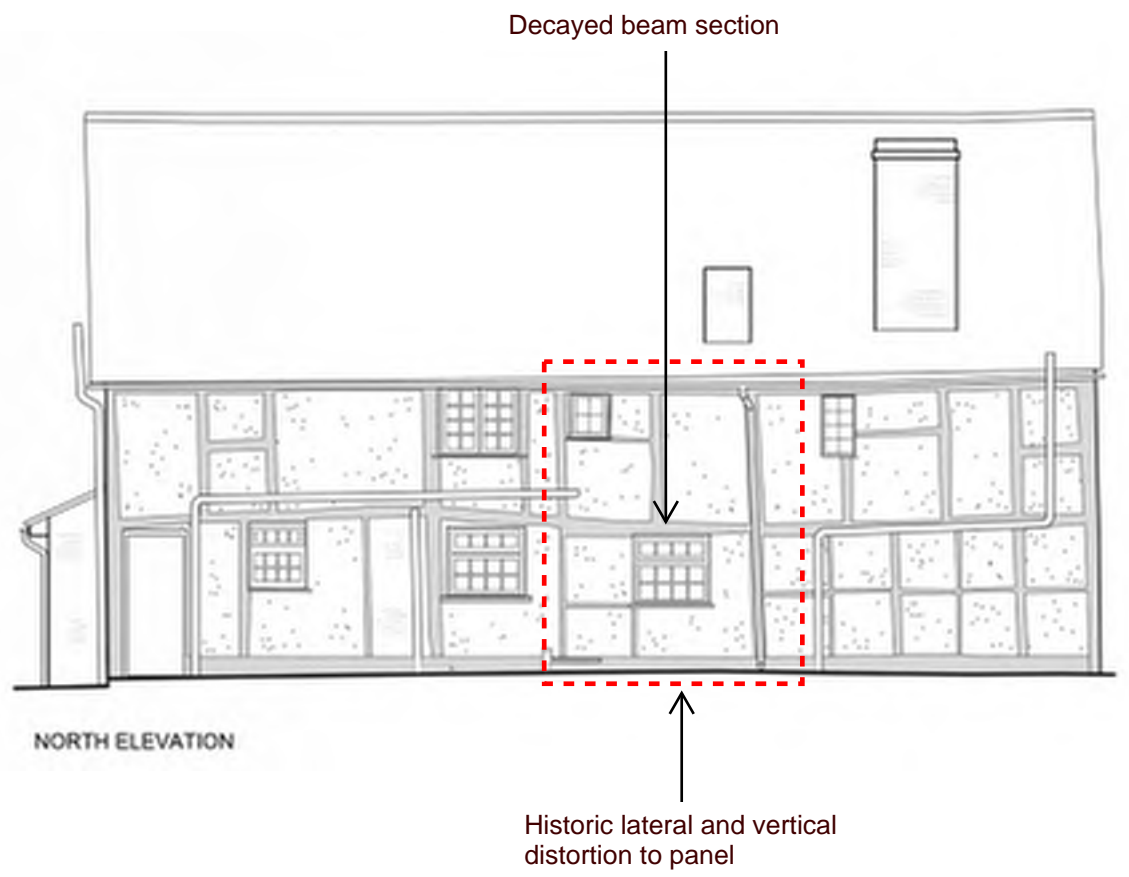
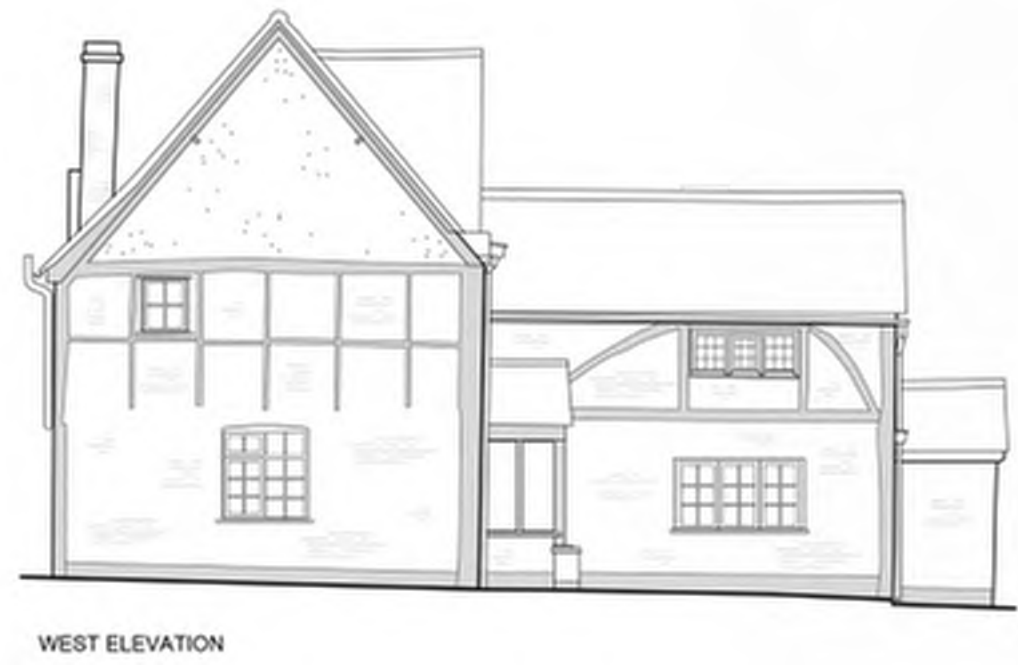
Title
SHERLEYS FARM HOUSE
ELEVATIONS
PRELIMINARY REPAIR
REQUIREMENTS

- 2.36 The eastern elevation to the original building is comprised of timber framing with white painted masonry infill between, beneath lime mortar joints are present. Most of these panels have undergone some degree of movement which has resulted in them sitting slightly proud of the timber frame work, bulge's are also present.

- 2.39 Towards the bottom of the elevation some sections of brickwork are friable, particularly in the north east corner and the base of the timber post was found to be decayed to a depth of at least 50mm, this warrants replacement. A soil vent pipe is also present on this corner which leads us to us to believe that defective drainage is likely to be causing the decay to the structure. Ponding was also found to be evident on the path that runs along the northern elevation.

- 2.40 Sufficient decay to the require the replacement of the base of central post was also identified and the first floor level window frame.
- 2.41 Generally both masonry and timber framing to the northern elevation was found to be in a better condition. There is significant lateral and vertical distortion to the center of the elevation however this is historic. It also coincides with where the first floor landing has dropped, decay to the beam above the window was also recorded.

- 2.42 The western elevation has undergone significant historic alterations, timber framing is evident at first floor but not at ground level where lime mortar joints were found to the masonry. The south west corner is also formed in masonry with timber cladding but which is heavily decayed. At eaves level the cladding and hopper have detached from the building.

- 2.43 The southern elevation to the original building has also undergone extensive past alterations. At first floor the wall is formed entirely from masonry with face fixed timber sections in an attempt to resemble studs however some have detached. At ground floor level some timber framing is present but decayed.

- 2.38 This will likely require the dismantling and reconstruction of the affected panels including the introduction of concealed ties. Decayed timber sections will also need to be replaced and any lost timber to timber connections reinstated.

- 4.9 Generally the structural framing to this building was also observed to be in a reasonably good condition.
- 4.10 Decayed elements identified during the survey as requiring strengthening or replacements works are included within the appendix to this report. As other elements of the frame are uncovered during the works additional conservation works may also be found to be necessary.

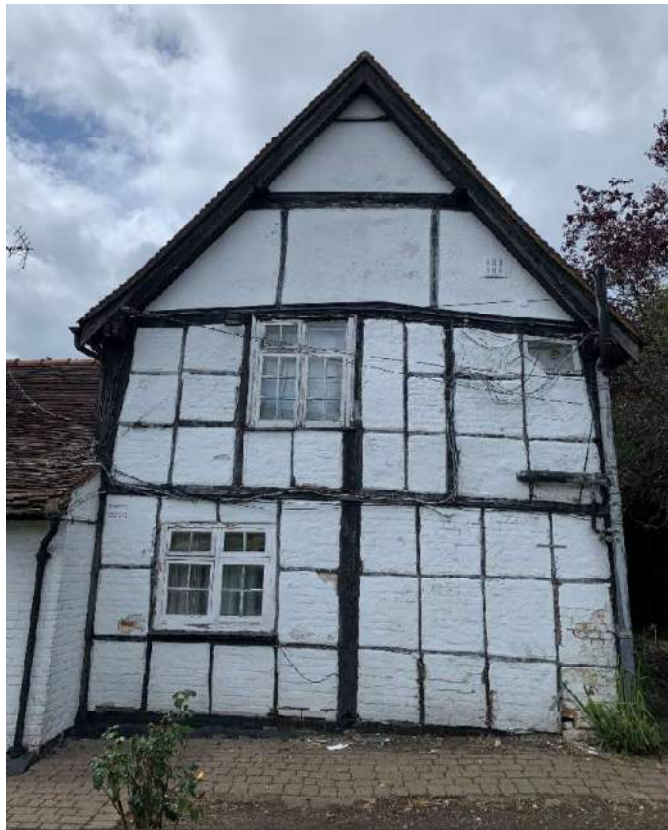
Photograph 1 – East elevation

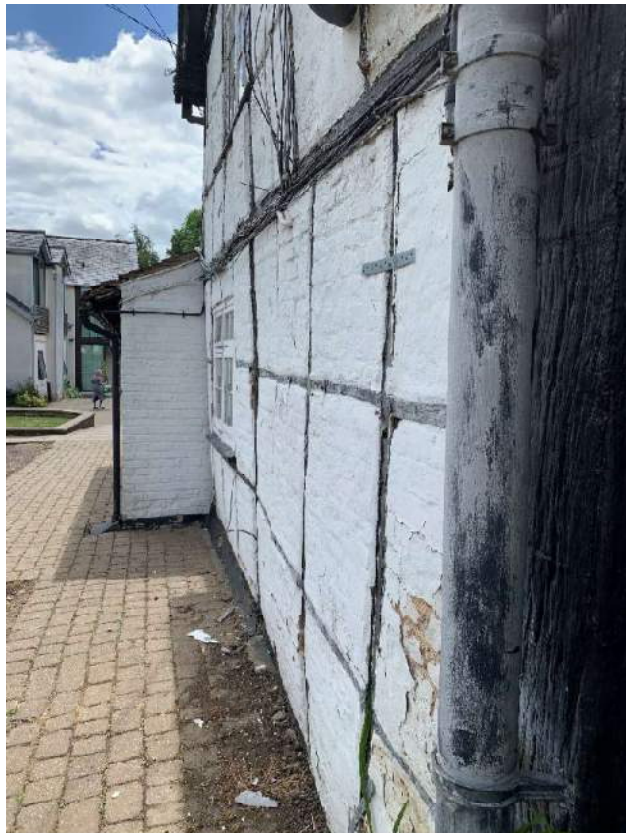
Photograph 2 – Showing distortion to lower panels

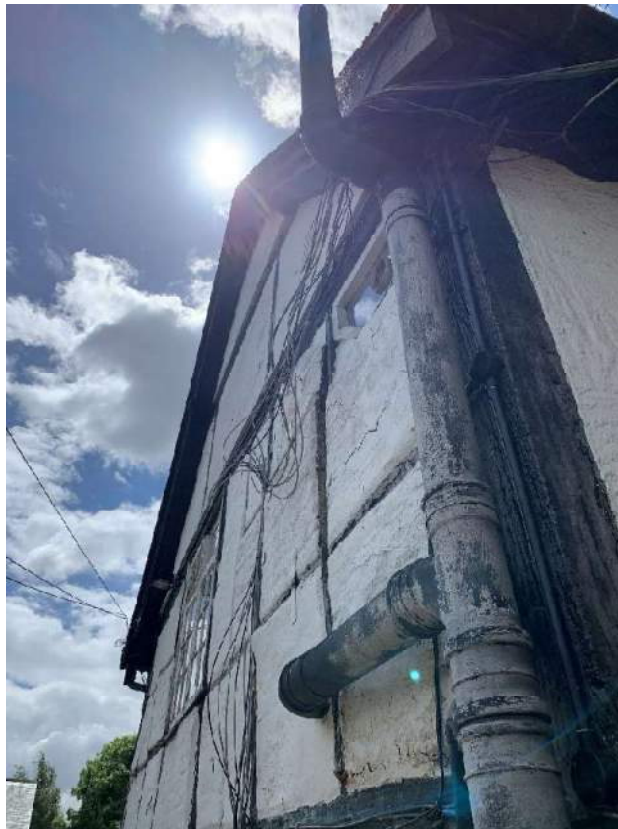
Photograph 3 – Showing distortion to upper panels

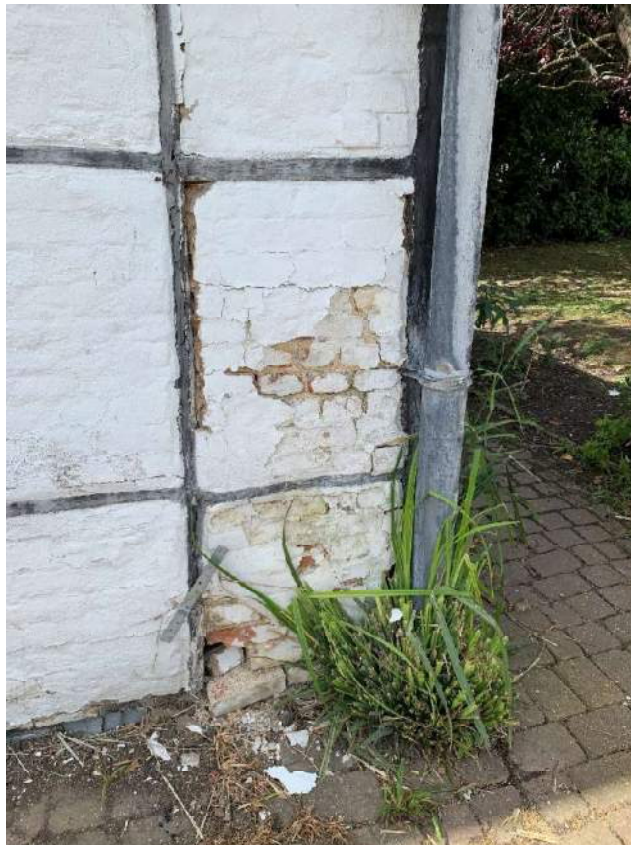
Photograph 4 – Friable masonry to north eastern corner

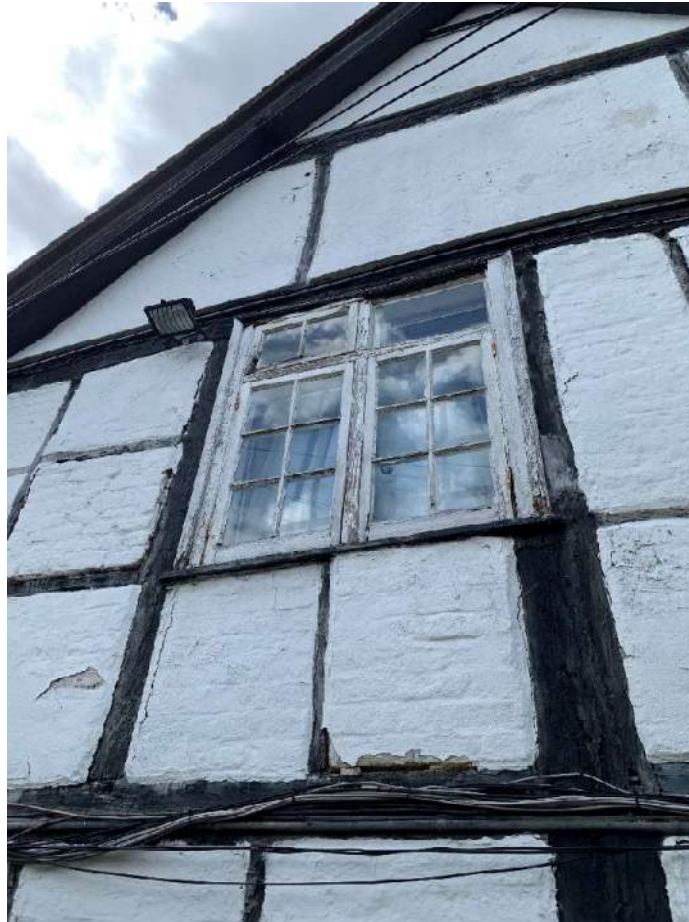
Photograph 5 – decayed window frame

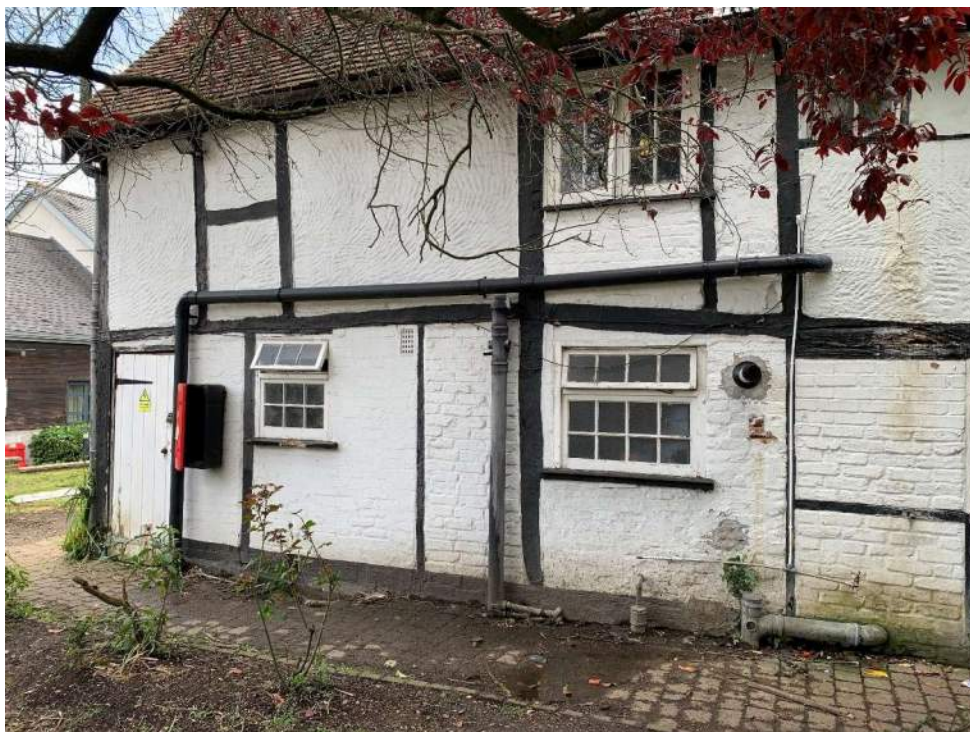
Photograph 6 – North elevation eastern end

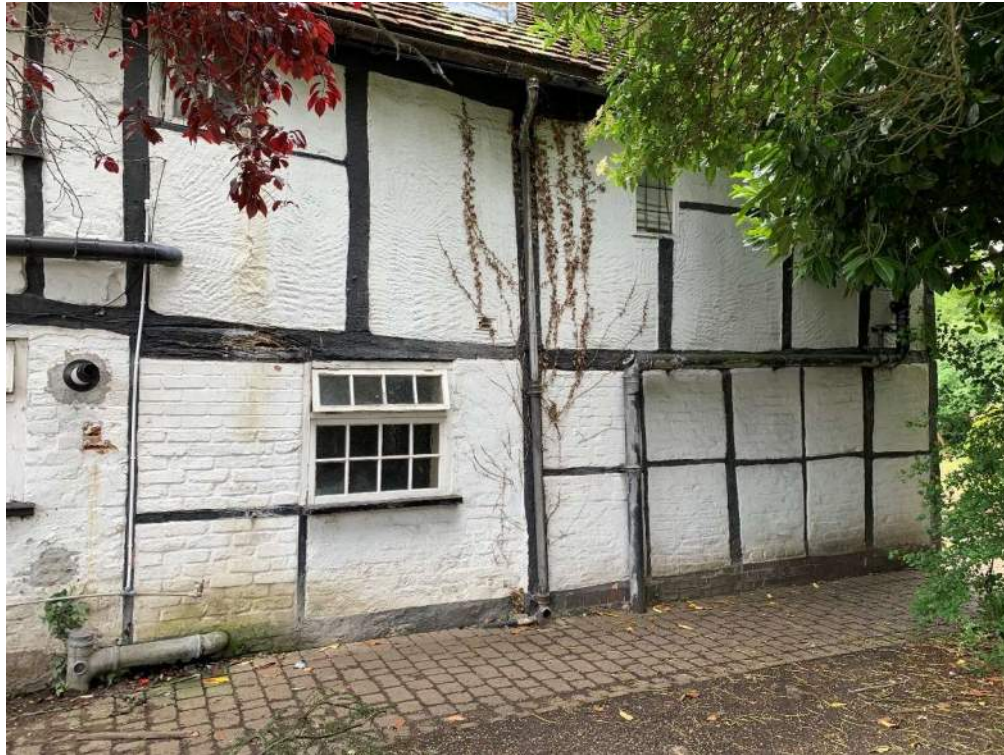
Photograph 7 – North elevation western end

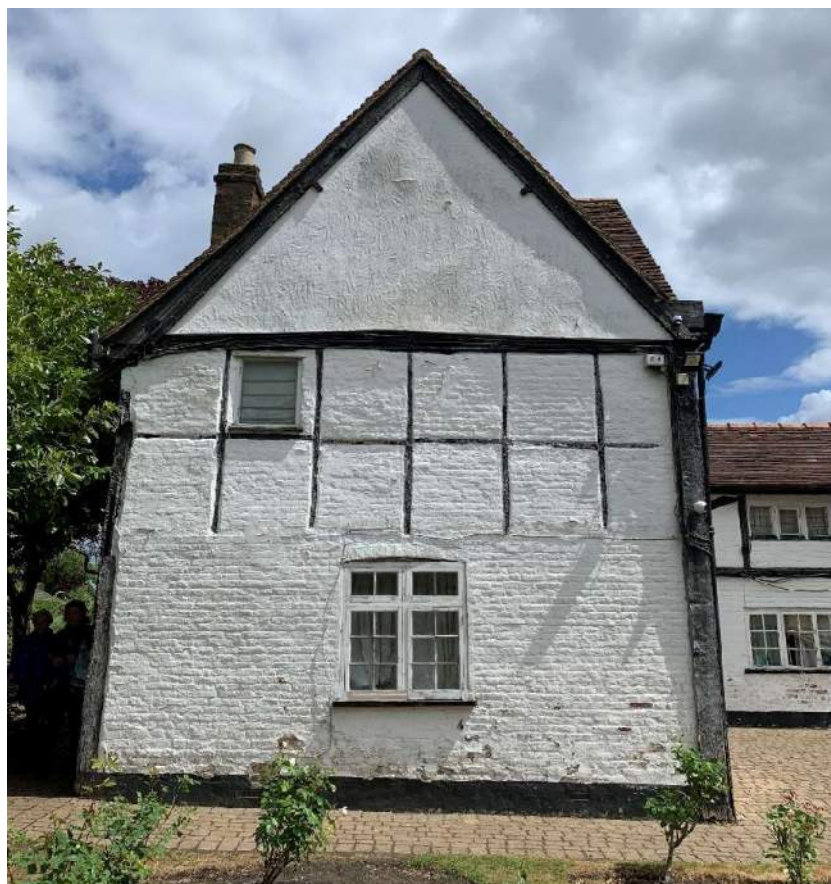
Photograph 8 – Western elevation

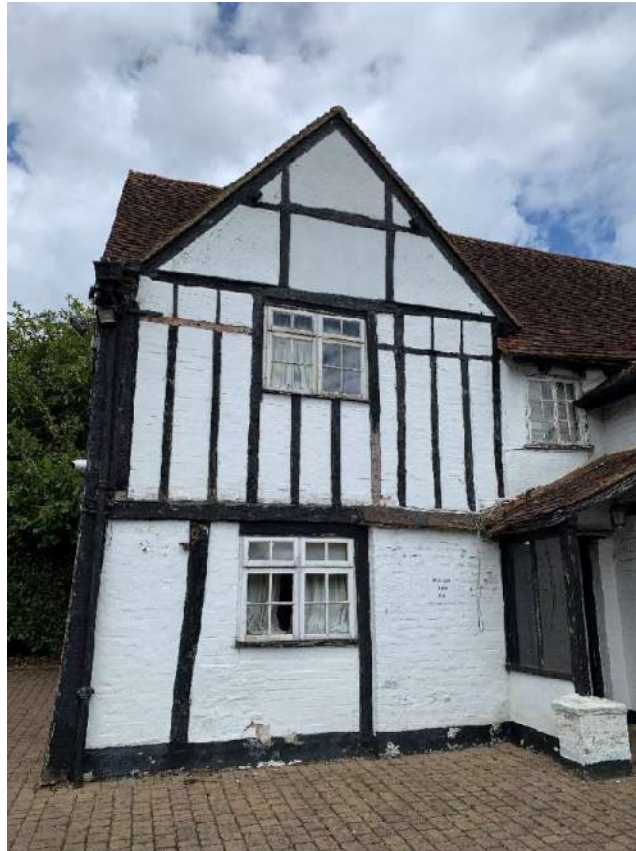
Photograph 9 – Southern elevation

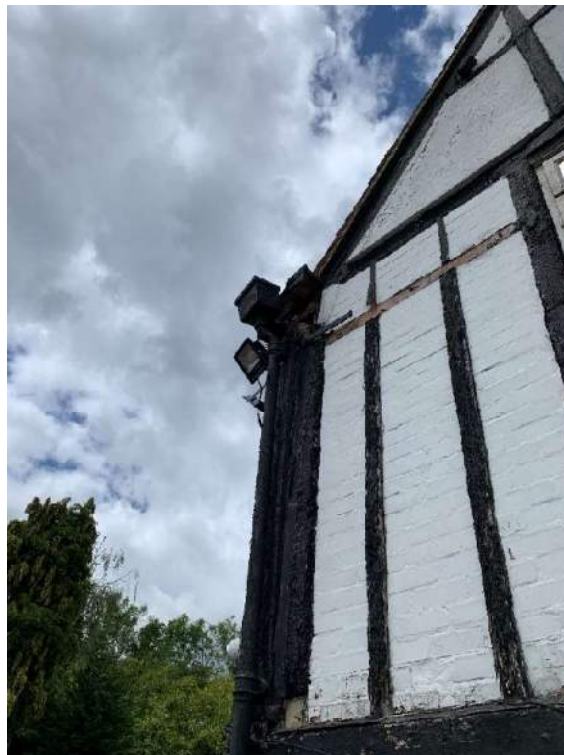
Photograph 10 – Dislodged cladding and hopper

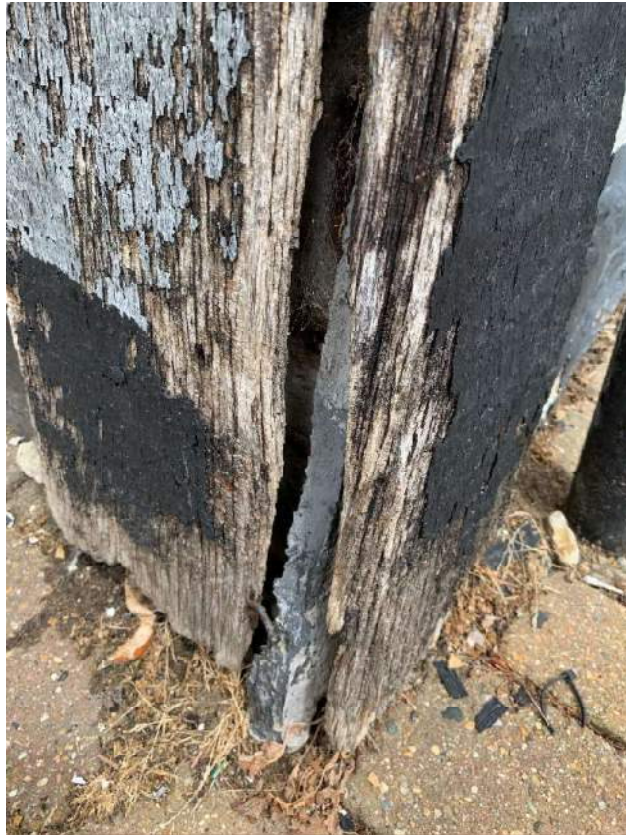
Photograph 11 – Decayed base to corner cladding
