Our Ref: IFS-PRE-SUB-25-0125956

Subsidence Damage Identified At : 24 St. Lawrence Drive, Pinner, HA5 2RU

## Arboricultural Consultancy for Prestige

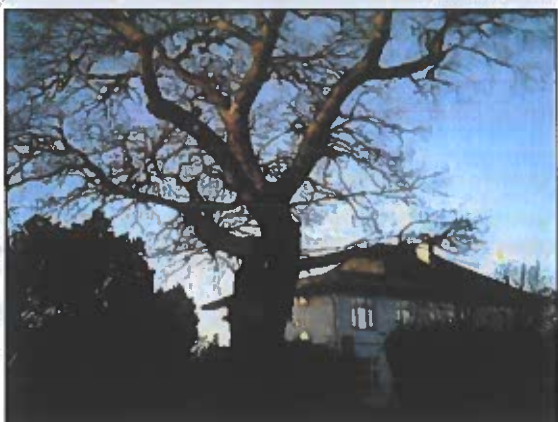
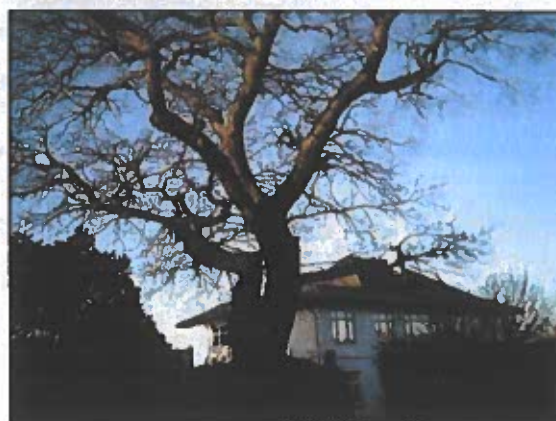
T1 - Oak

| Tree No. | Species | Age Cat | Approx. Height (m) | Distance to Building (m) * | Ownership | Action | Requirement |
|---|---|---|---|---|---|---|---|
| T1 | Oak | 3 | 23.8 | 18.1 | B - Local Authority | Action to avoid future risk | Undertake a scheme of appropriate vegetation management so as to effectively mitigate future subsidence risk. Any pruning undertaken should be in accordance with BRE IP7/06 and repeated on a 3-year (max) basis to be deemed as effective. |

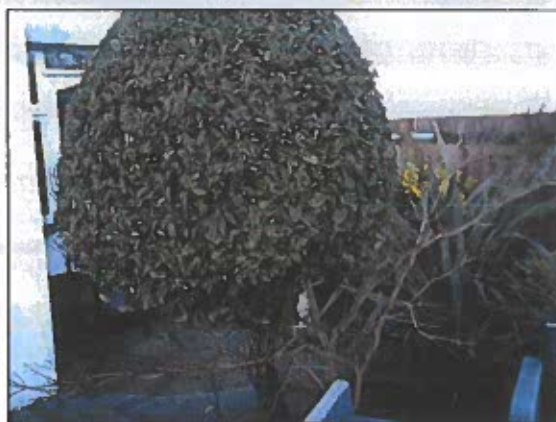
T4 - Laurel (Bay)

| Tree No. | Species | Age Cat | Approx. Height (m) | Distance to Building (m) * | Ownership | Action | Requirement |
|---|---|---|---|---|---|---|---|
| T4 | Laurel (Bay) | 1 | 2.3 | 1.5 | C - Insured | Action to avoid future risk | Maintain at, or below current dimensions by way of regular pruning. |

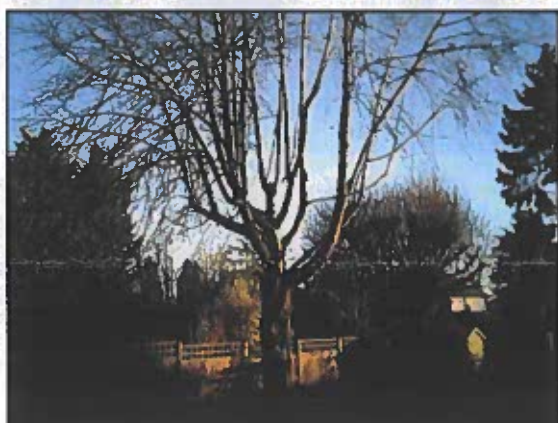
T5 - Cherry

With due regards to species profile, size and proximity, C1 (Wisteria) and T5 (Cherry) are considered the dominant features proximate to the focal areaS of movement and accordingly, where vegetation is confirmed as being causal, we have identified them as the primary cause of the current subsidence damage.

| Tree No. | Species | Age Cat | Approx. Height (m) | Distance to Building (m) * | Ownership | Action | Requirement |
|---|---|---|---|---|---|---|---|
| T5 | Cherry | 1 | 14.8 | 13.4 | C - Insured | Remove | Remove close to ground level and treat stump to inhibit regrowth. |

Consequently, we have advocated the complete removal of C1 (Wisteria) and T5 (Cherry) as it will offer the most certain arboricultural solution likely to restore long-term stability.

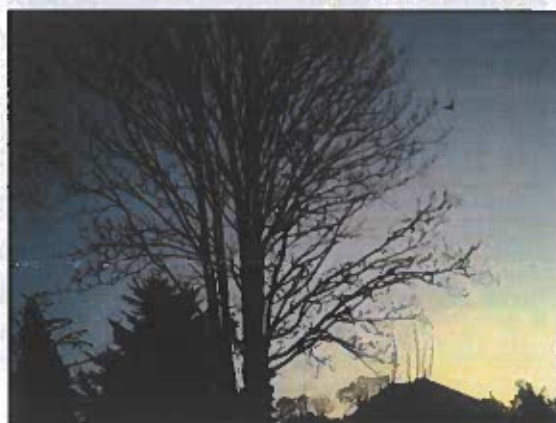
T6 - Sycamore

| Tree No. | Species | Age Cat | Approx. Height (m) | Distance to Building (m) * | Ownership | Action | Requirement |
|---|---|---|---|---|---|---|---|
| T6 | Sycamore | 1 | 17.6 | 13.7 | C - Insured | Action to avoid future risk | Maintain at, or below current dimensions by way of regular pruning. |

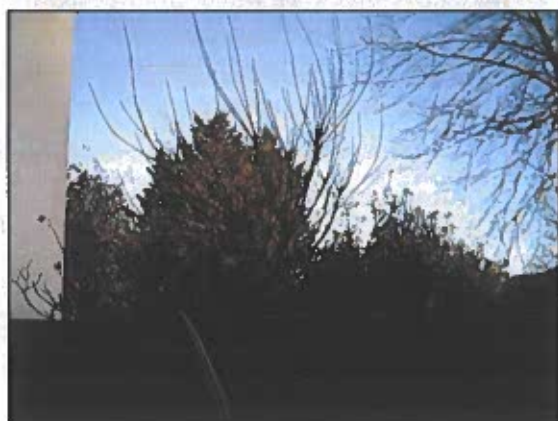
T7 - Other

| Tree No. | Species | Age Cat | Approx. Height (m) | Distance to Building (m) * | Ownership | Action | Requirement |
|---|---|---|---|---|---|---|---|
| T7 | Cotinus | 1 | 3.3 | 5 | A - Third Party | No action | No works required |

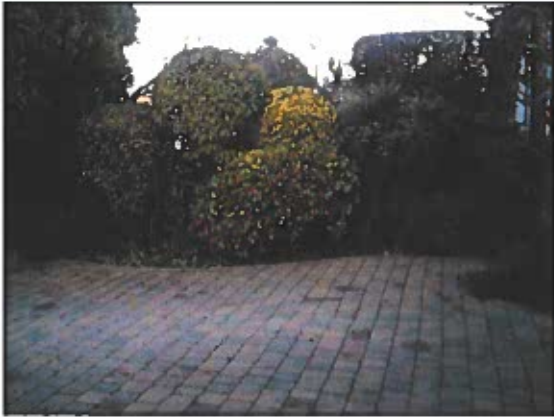
SG1 - Mixed species shrubs

| Tree No. | Species | Age Cat | Approx. Height (m) | Distance to Building (m) * | Ownership | Action | Requirement |
|---|---|---|---|---|---|---|---|
| SG1 | Mixed species shrubs: Skimmia, Euonymus, Mahonia, Privet, Viburnum, Photinia and Elaeagnus. | 1 | 2.3 | 0.8 | C - Insured | Action to avoid future risk | Maintain at broadly current dimensions by way of regular pruning. |

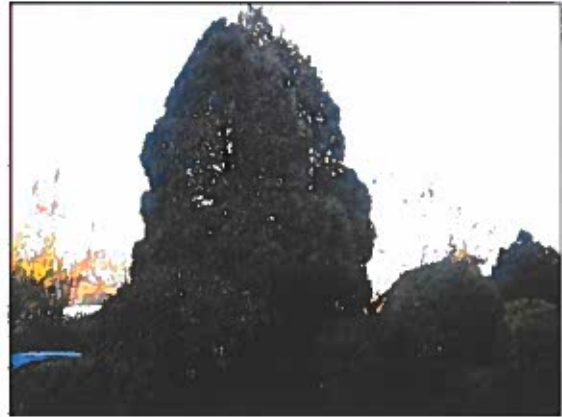
T2 - Cypress

| Tree No. | Species | Age Cat | Approx. Height (m) | Distance to Building (m) * | Ownership | Action | Requirement |
|---|---|---|---|---|---|---|---|
| T2 | Cypress | 1 | 7.2 | 7.7 | C - Insured | Action to avoid future risk | Maintain at broadly current dimensions by way of regular pruning. |

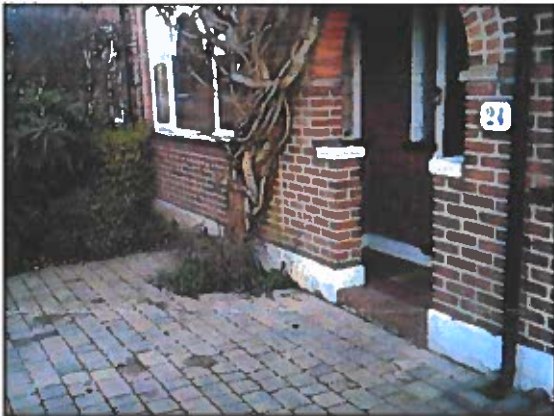
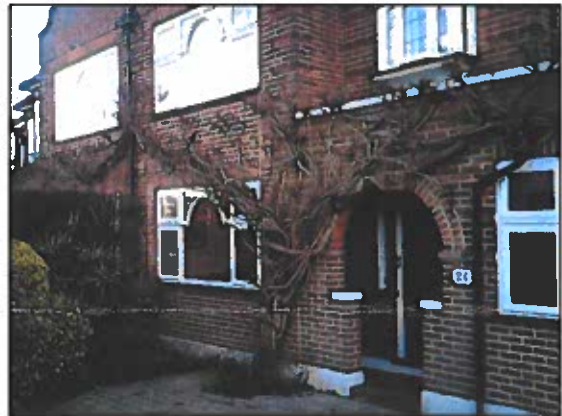
C1 - Wisteria

| Tree No. | Species | Age Cat | Approx. Height (m) | Distance to Building (m) * | Ownership | Action | Requirement |
|---|---|---|---|---|---|---|---|
| C1 | Wisteria | 1 | 4.4 | 0.1 | C - Insured | Remove | Remove close to ground level and treat stump to inhibit regrowth. |

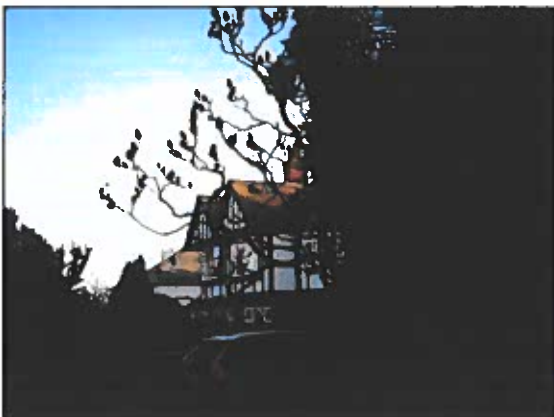
T3 - Rhus

| Tree No. | Species | Age Cat | Approx. Height (m) | Distance to Building (m) * | Ownership | Action | Requirement |
|---|---|---|---|---|---|---|---|
| T3 | Rhus | 1 | 4.2 | 8 | A - Third Party | No action | No works required. |

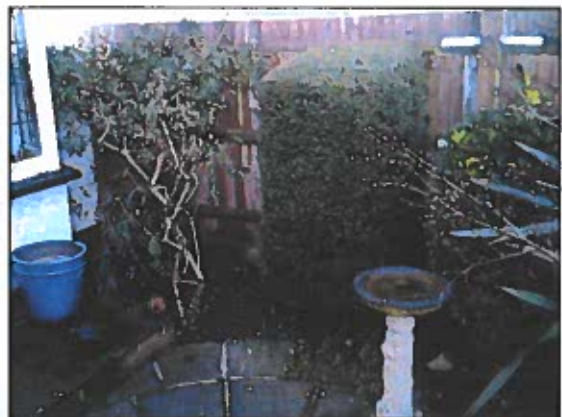
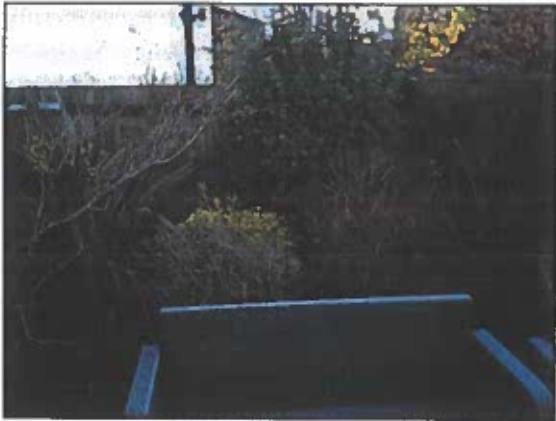
SG2 - Mixed species shrubs

| Tree No. | Species | Age Cat | Approx. Height (m) | Distance to Building (m) * | Ownership | Action | Requirement |
|---|---|---|---|---|---|---|---|
| SG2 | Mixed species shrubs: Yew, Rose, Euonymus, Ornamental Acer, Pittosporum and Cornus. | 1 | 1.7 | 1 | C - Insured | Action to avoid future risk | Maintain at broadly current dimensions by way of regular pruning. |
