STRUCTURAL INSPECTION  
REPORT  
BARRA HALL, HAYES

December 2024

## BARRA HALL, HAYES

Ridge and Partners LLP  
3 Valentine Place  
London  
SE1 8QH

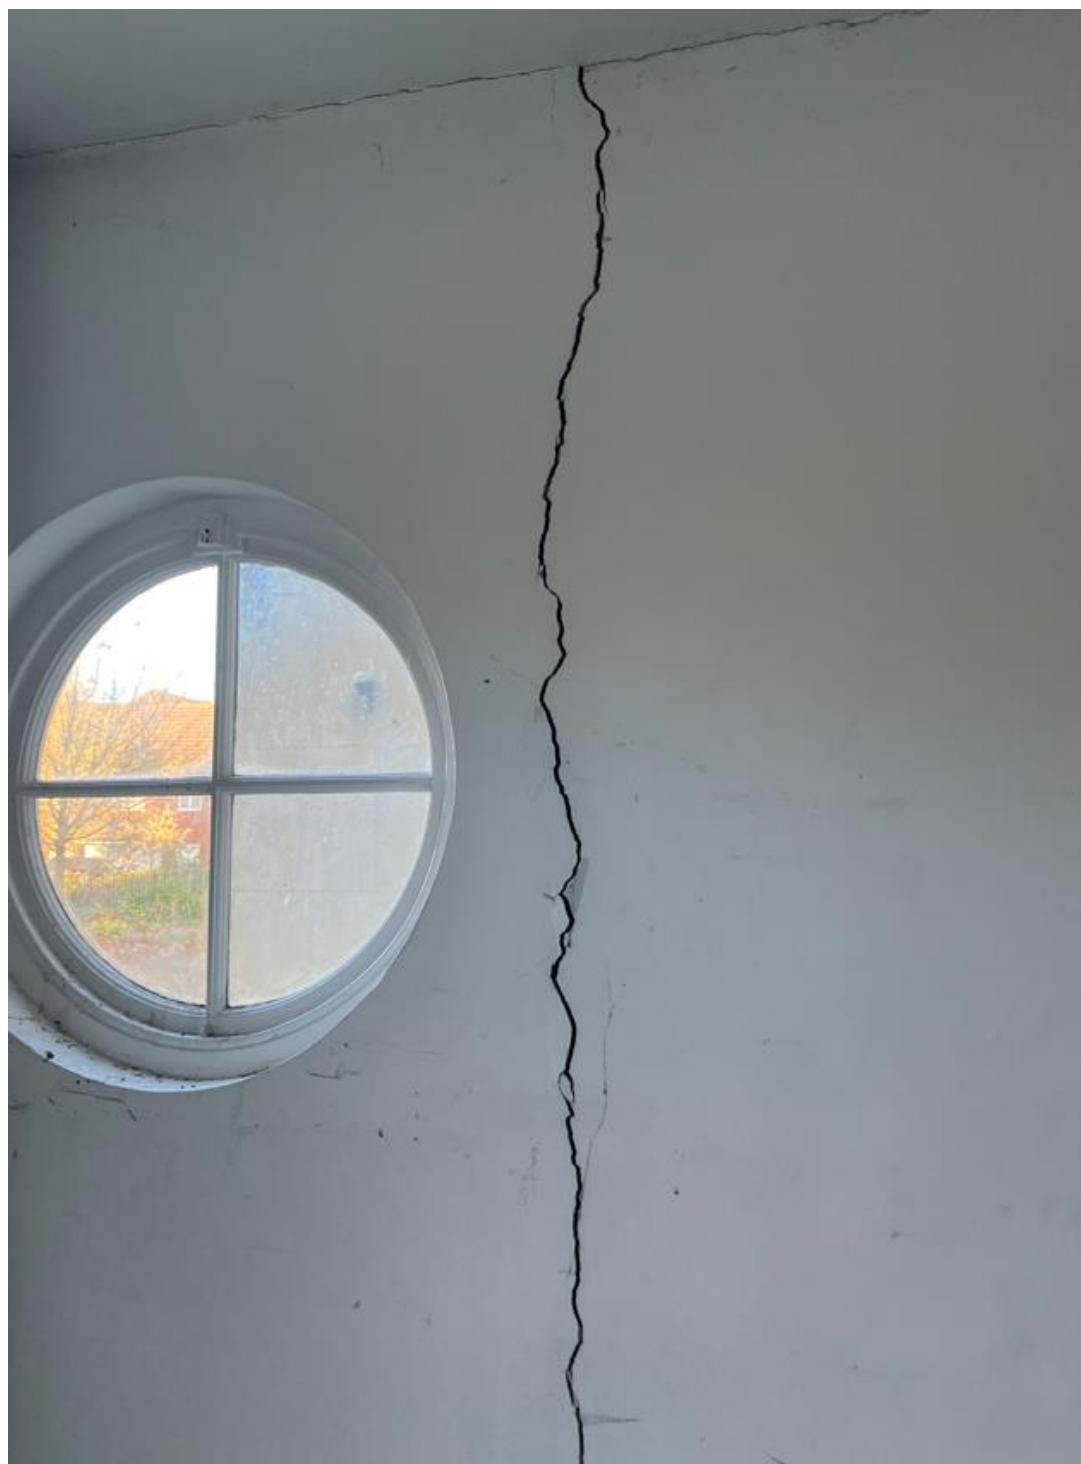
- At ground floor on the west side of the building adjacent to the round window. This crack appears to be caused by restraint from a perpendicular wall. See Figure 1 below.

Figure 1 – Crack in wall by round window

- The crack locations marked in red on the observation drawings are to be repaired in accordance with BRE253 and using a recognised masonry repair system such as Helifix.
- The masonry over the window at the front elevation (Figure 4) should be exposed to investigate whether the crack is structural or just within the render.

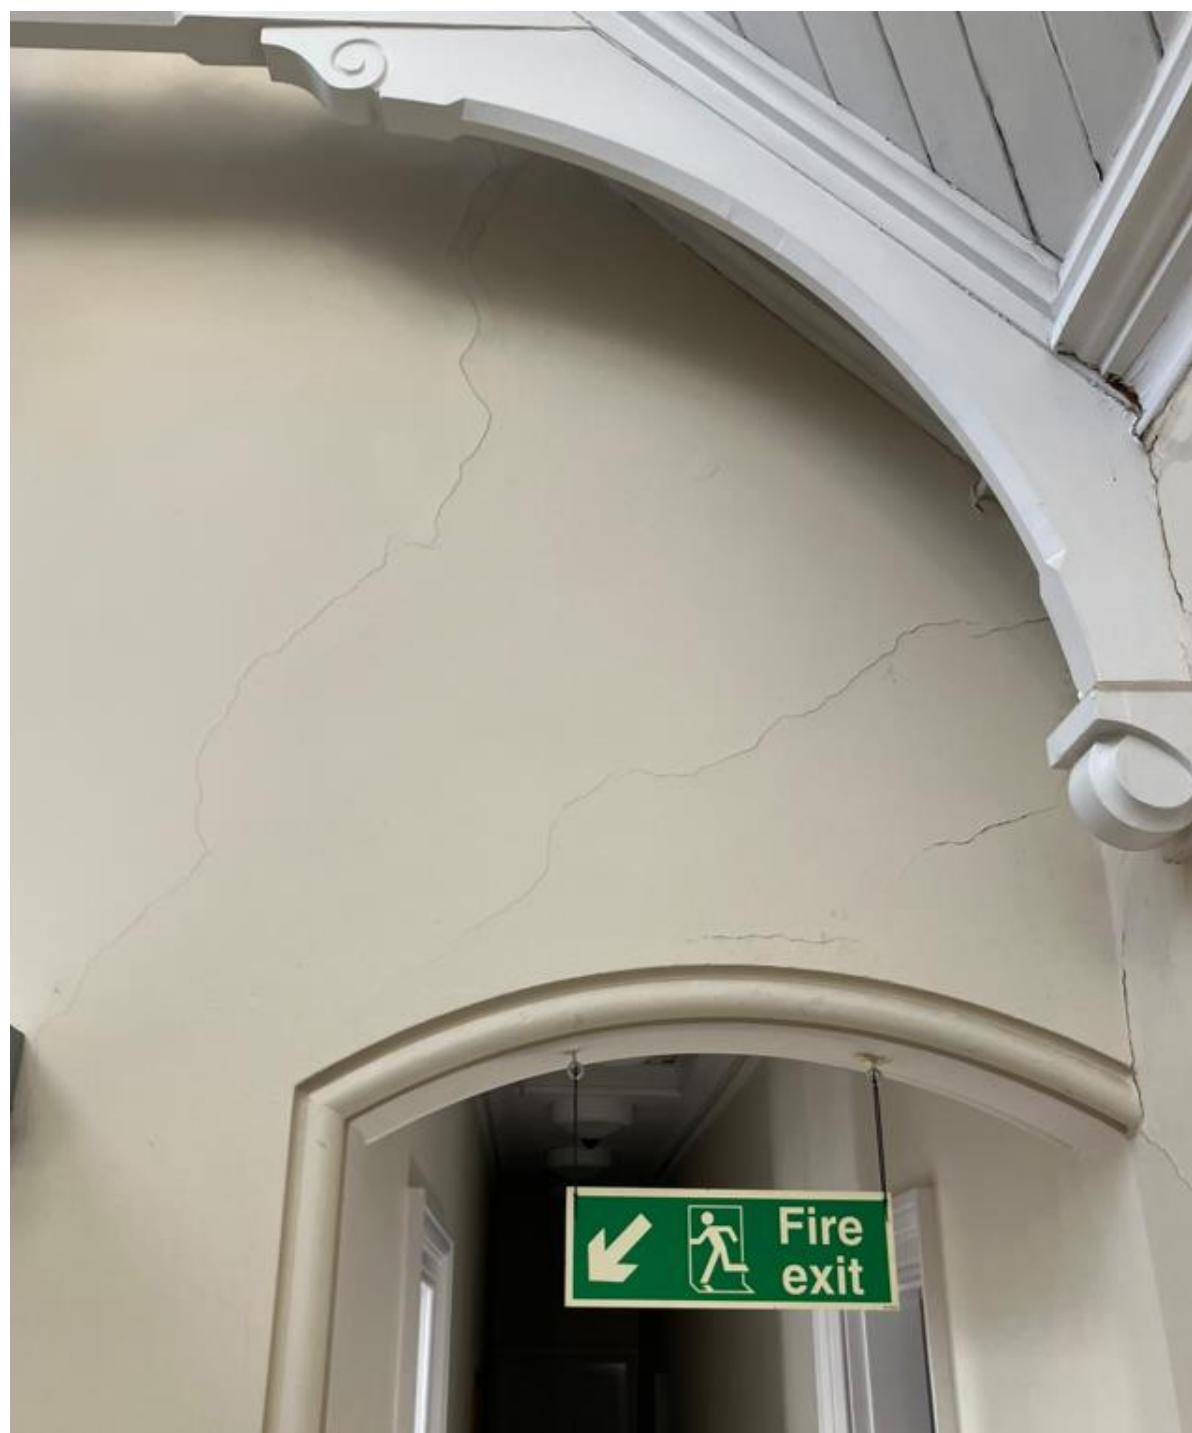
- Over the doorway on the first-floor landing in the main hallway – see Figure 2 below.
  - In the rear walls of the storeroom at ground floor.
  - Over the rear door of the kitchen. See Figure 3 below.

Figure 2 – Crack to wall over landing in hallway

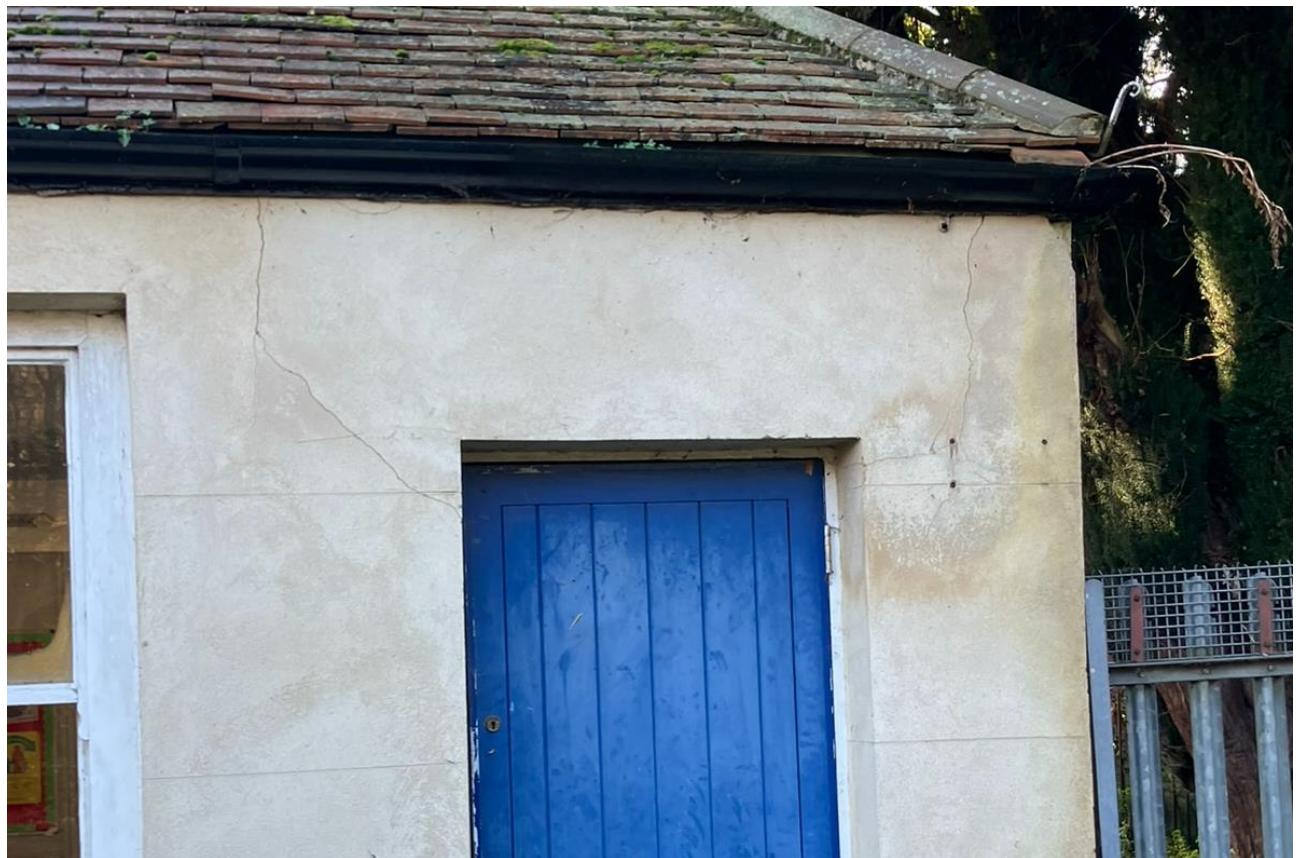
Figure 3 – Cracks to wall over doorway of kitchen

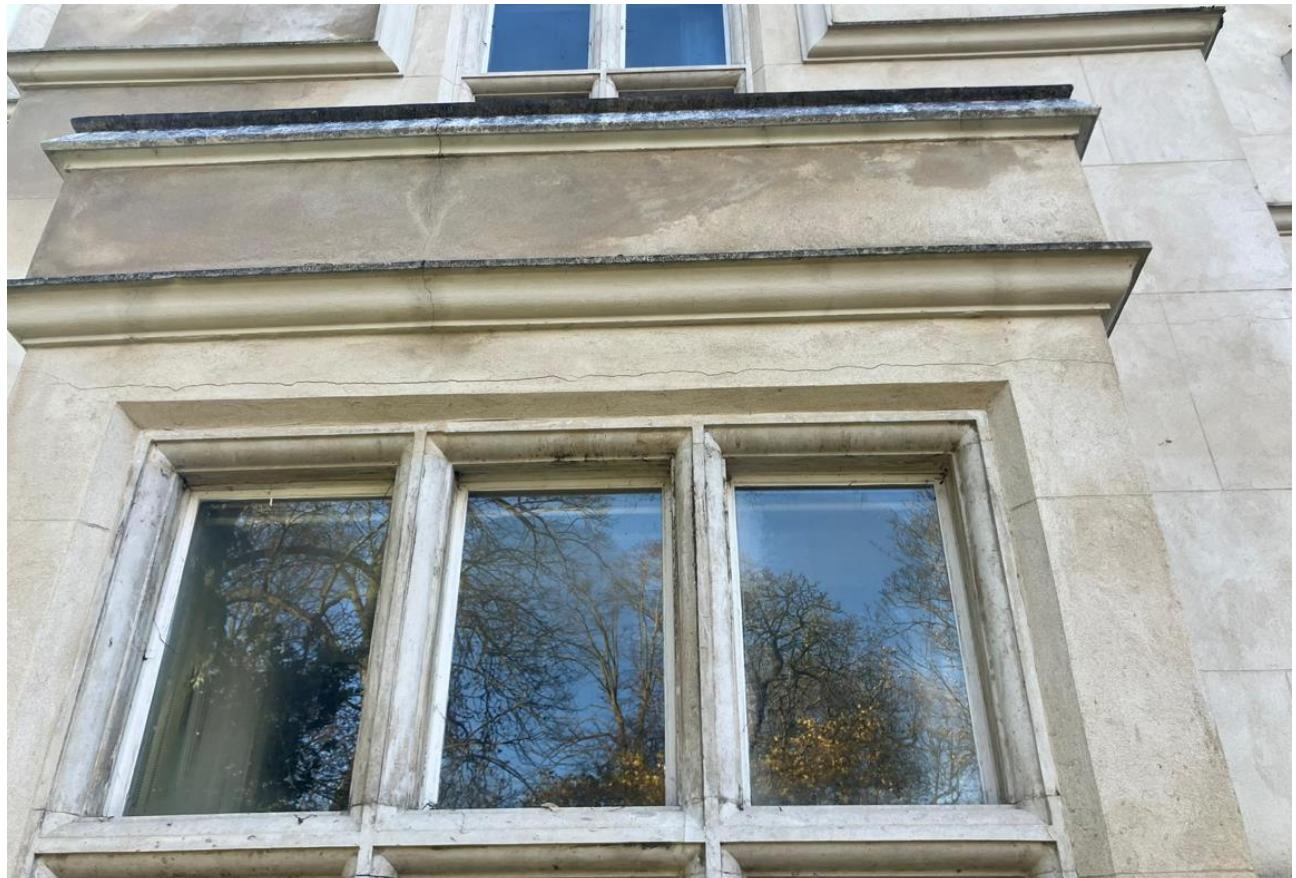
Figure 4 – Horizontal crack to wall over window in bay of Toy Library room

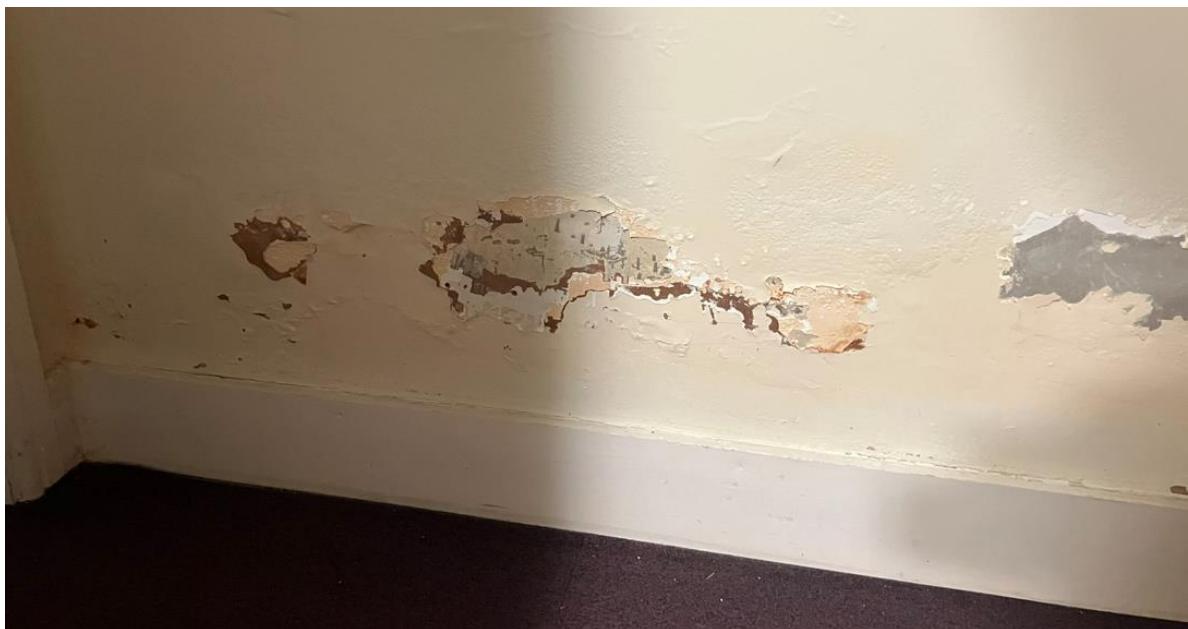
- Above the therapy room. See Figure 10.
3. **Cracking to cornicing at the perimeter of ceilings.** See Figure 11.
4. **Water damage to wall and roof areas.** See Figures 5 and 6.

Figure 5 – Water damage to ground floor wall in corridor

- A specialist should be consulted to determine whether measures need to be taken to repair the structural elements and prevent future water ingress/rising damp

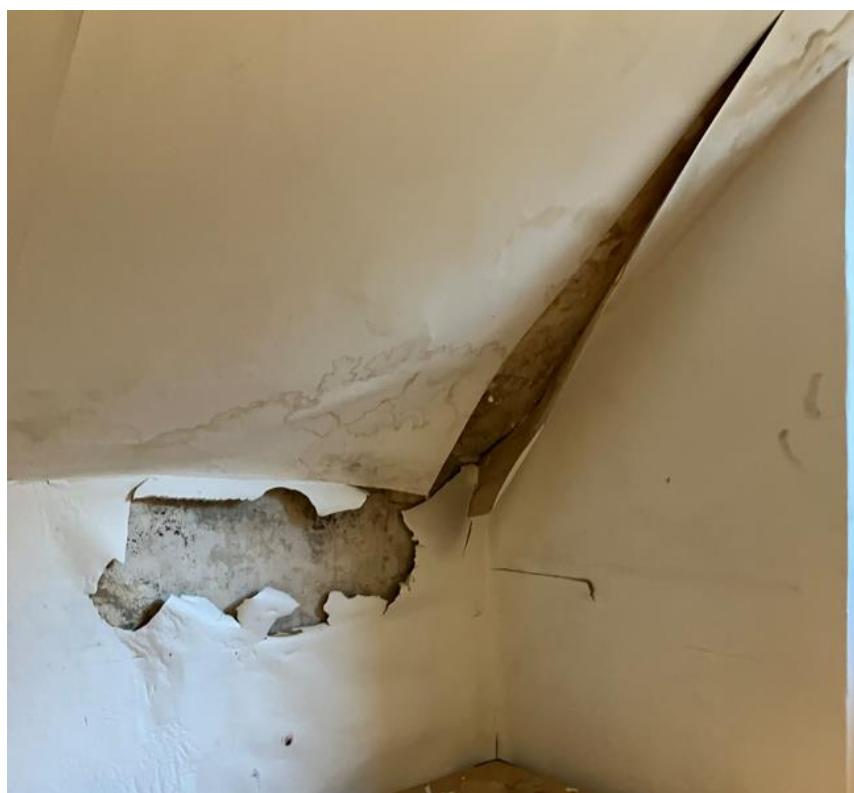
Figure 6 – Water damage to roof structure in first floor meeting room

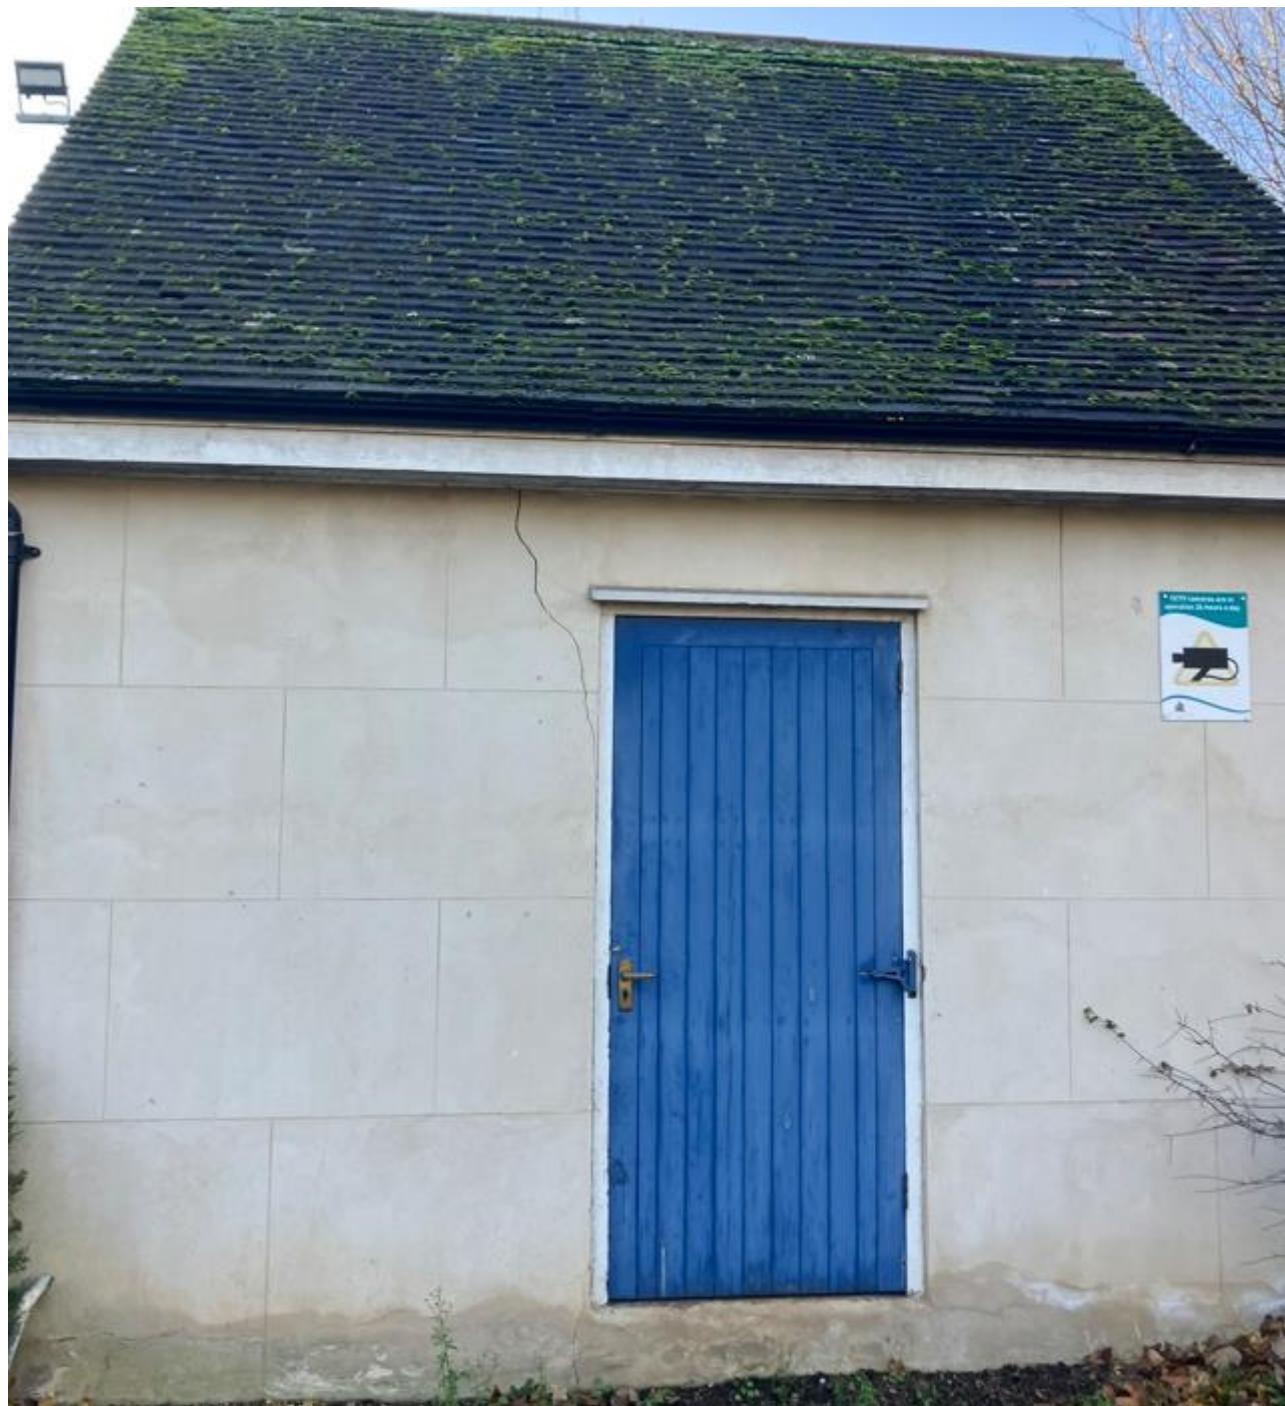
- By the door of the boiler house. See Figure 7 below.
  - In the Sensory room at ground floor in the corner by the bay window – see Figure 8 below
2. **Cracking in ceilings.** This is generally minor and has probably appeared over a long duration with the floors subject to repetitive footfall movement and long-term creep of timber joists. It may also be caused by storage loads in loft areas. There are significant ceiling cracks in the following locations:

Figure 7 – Crack to wall over doorway in Boiler House

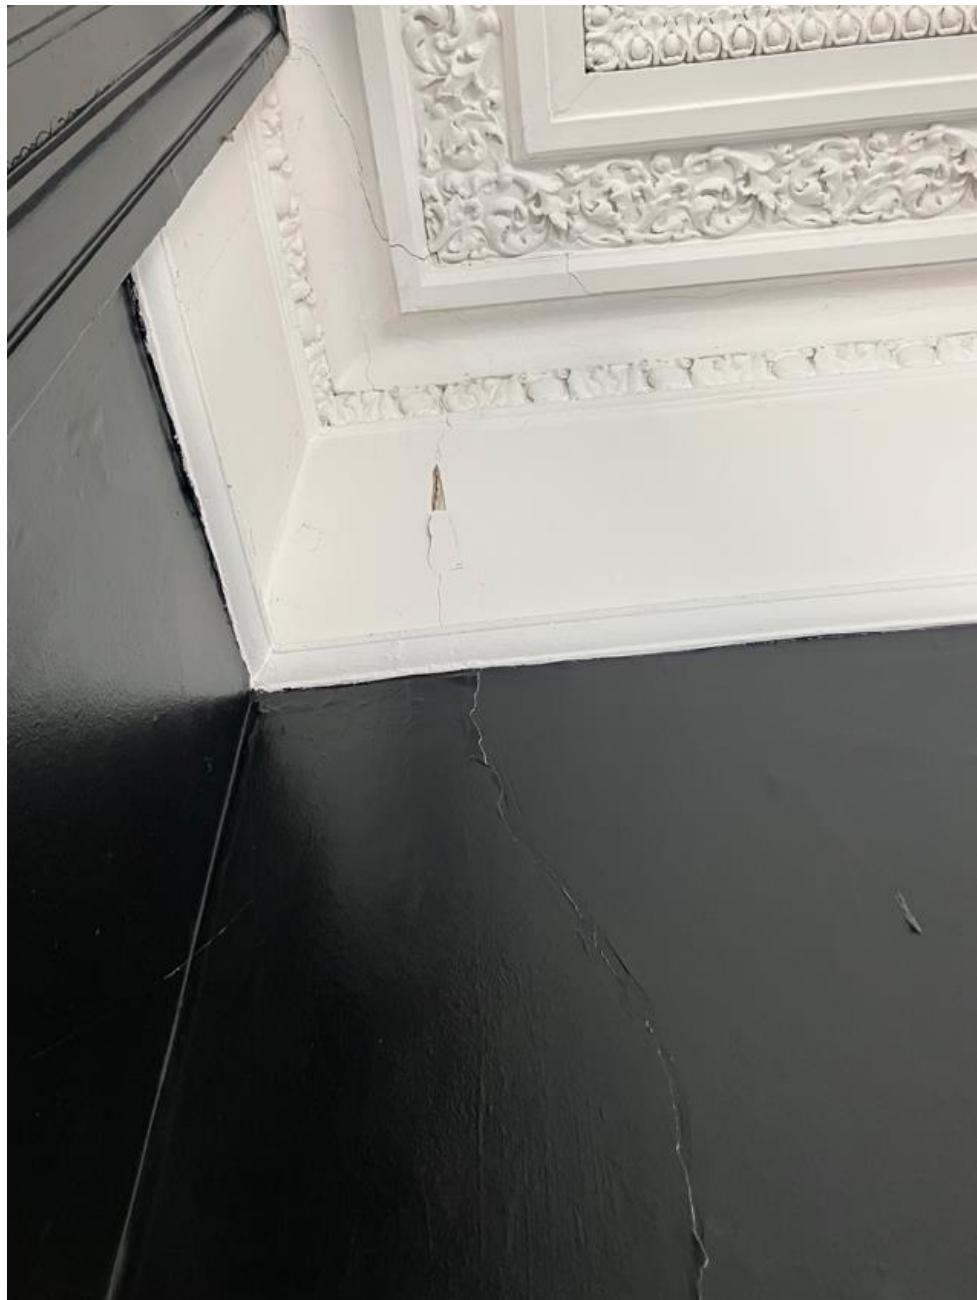
Figure 8 – Vertical wall crack in the Sensory Room

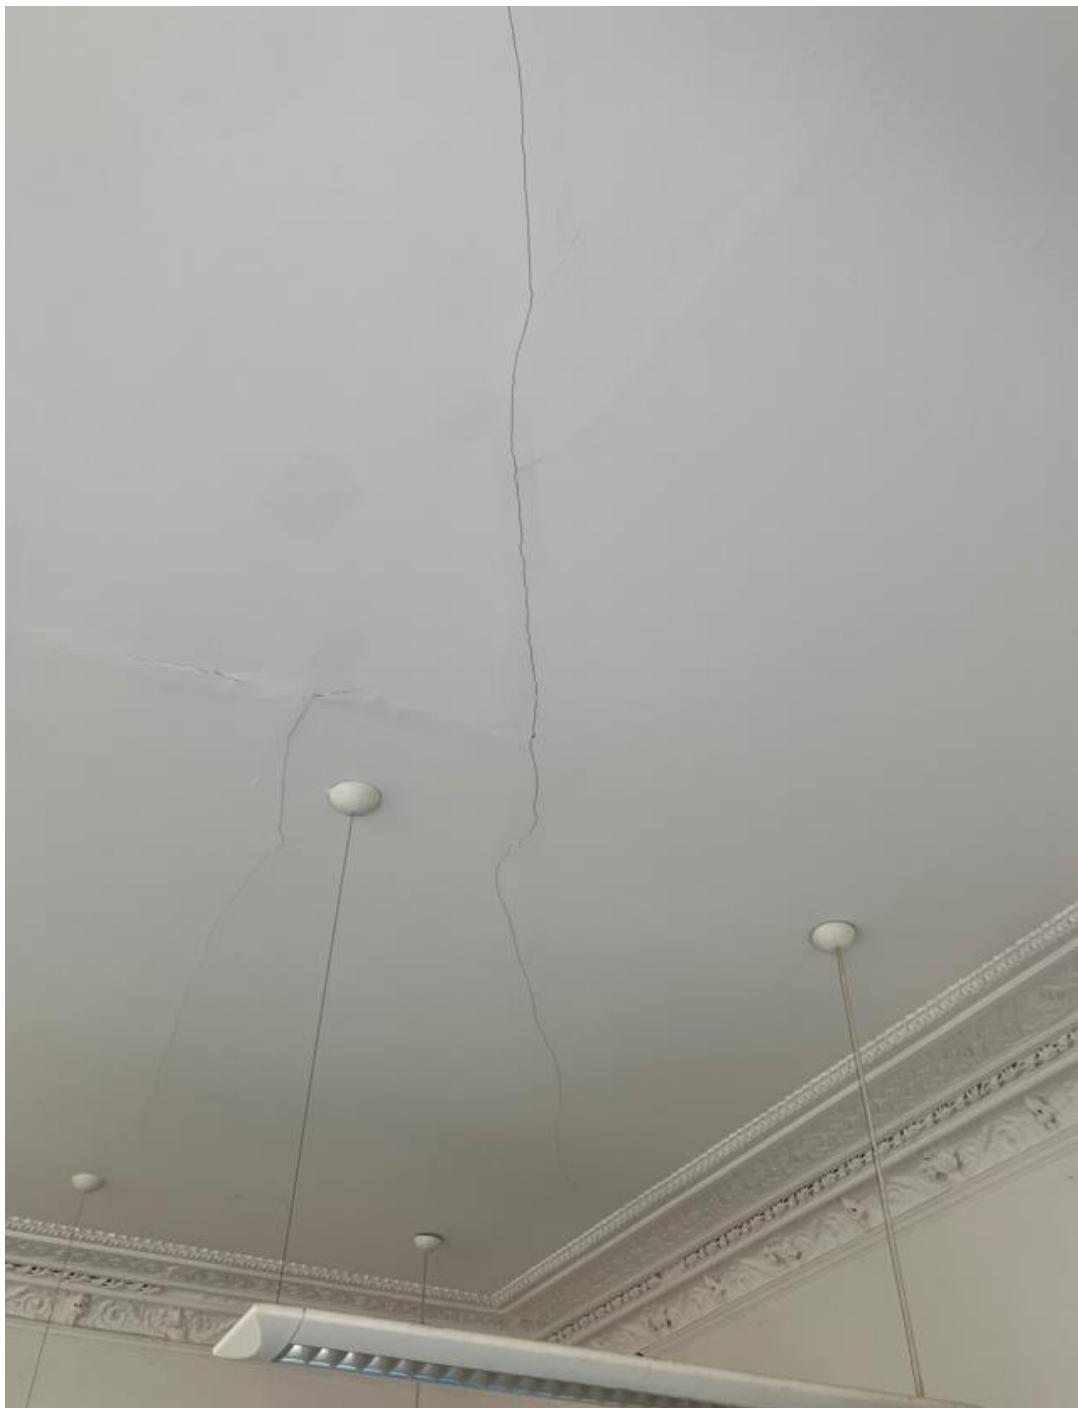
- Above the Creche room which appear to have been caused by excessive deformation of the floor structure as this could be observed from the room above. See Figure 9.

Figure 9 – Ceiling crack over Creche

- It is recommended that the joists above the ceiling in the creche and therapy rooms are exposed for further inspection by an Engineer.
- Other cracked ceilings should be filled or replaced with new plasterboard prior to decoration.
- Lofts areas should not be used for storage without strengthening to the ceiling joists.

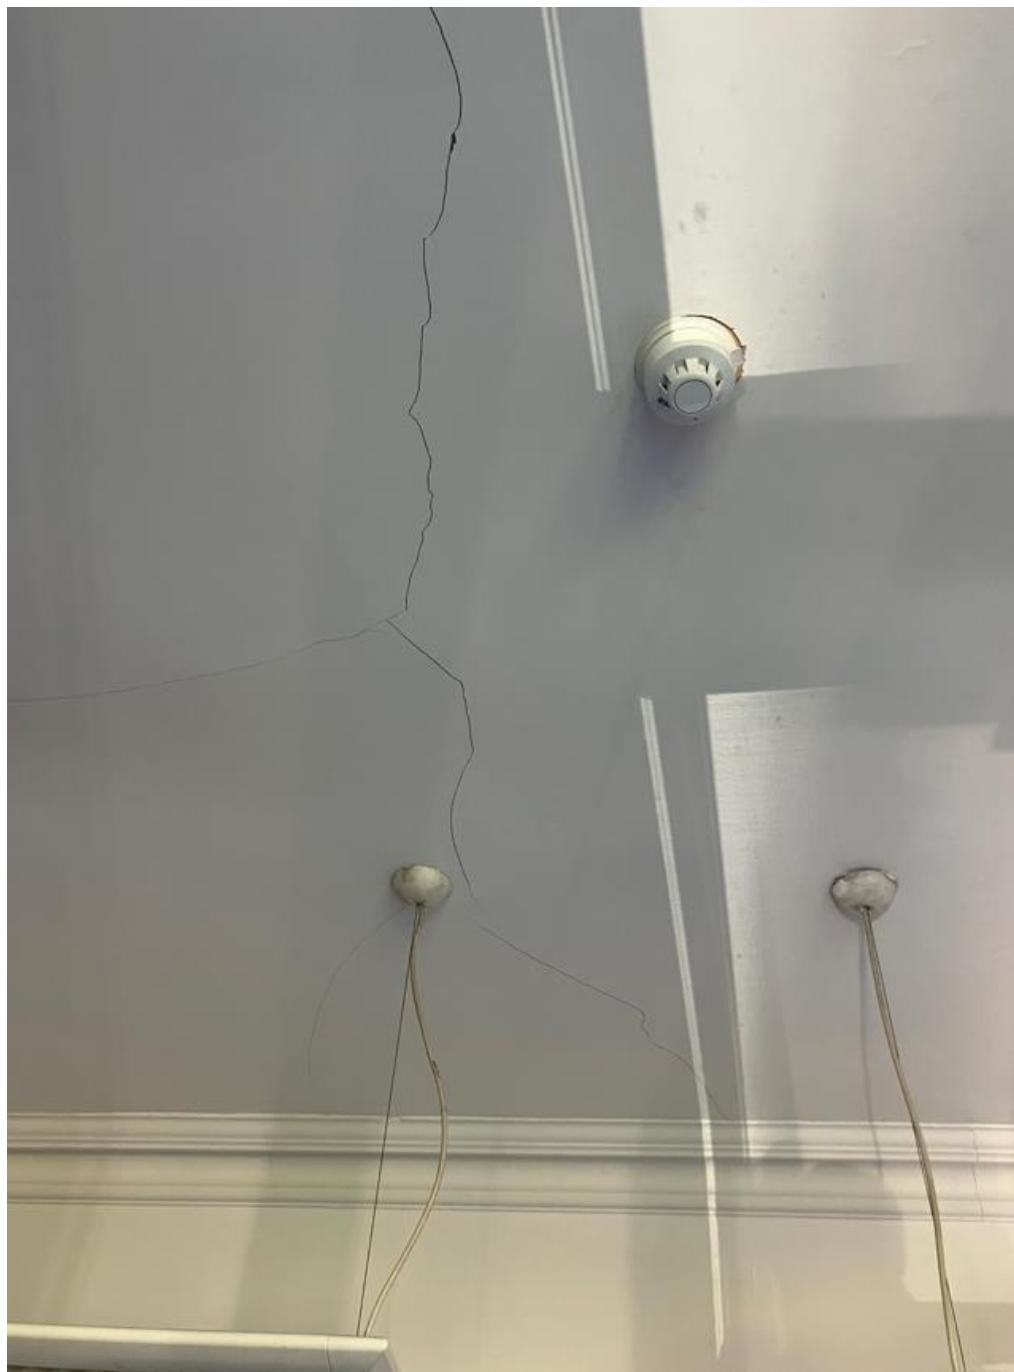
Figure 10 – Ceiling crack over first floor Therapy Room

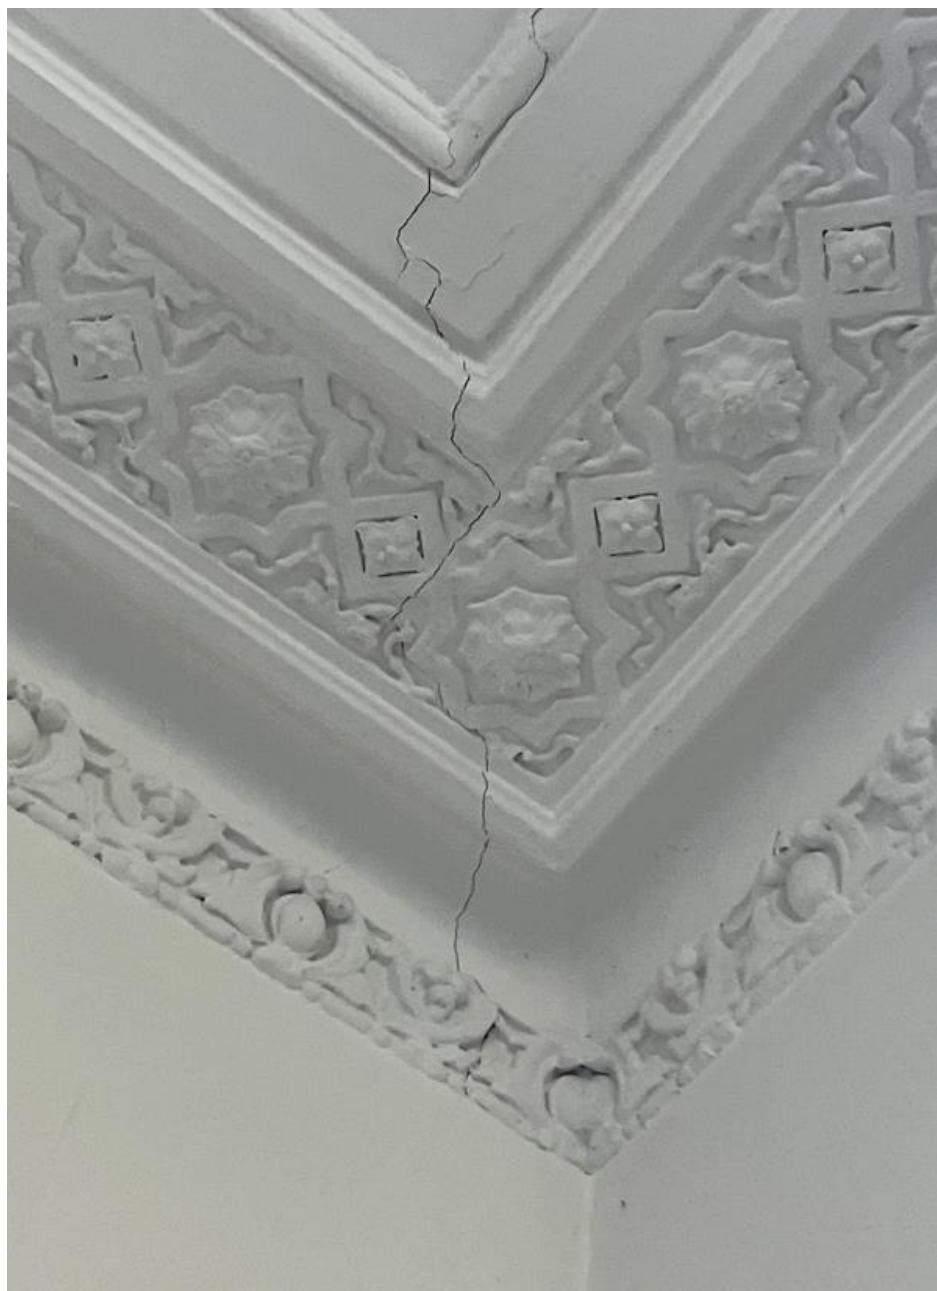
Figure 11 – Typical Cornice damage
