ARBORICULTURAL ASSESSMENT REPORT

22 Wieland Road, Northwood HA6 3QU

PRI Ref: 293558

Survey Date: 30-04-2024

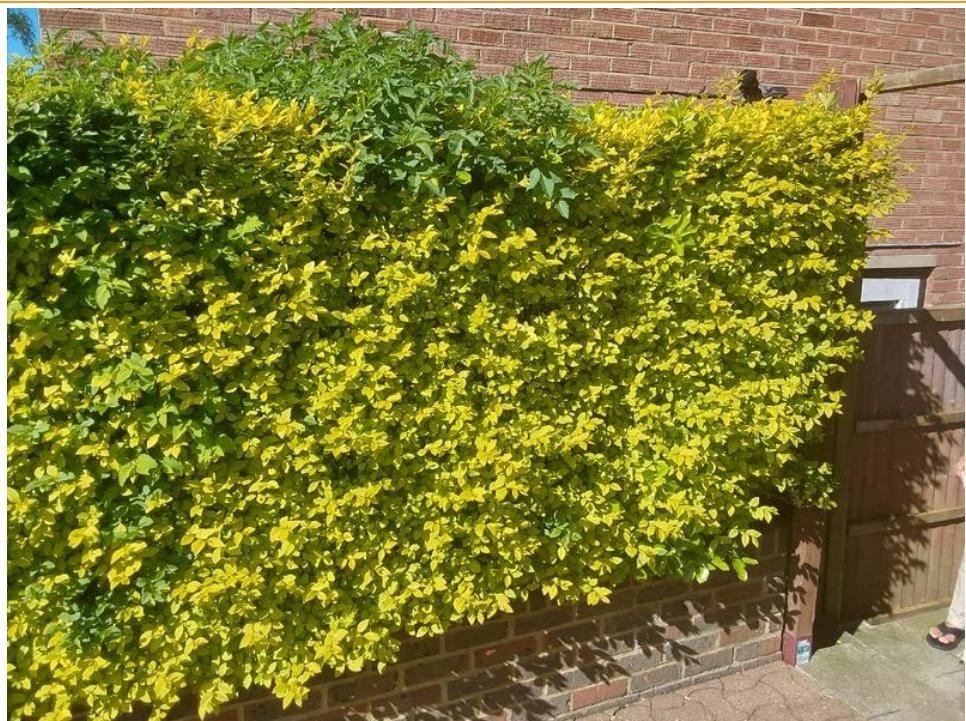
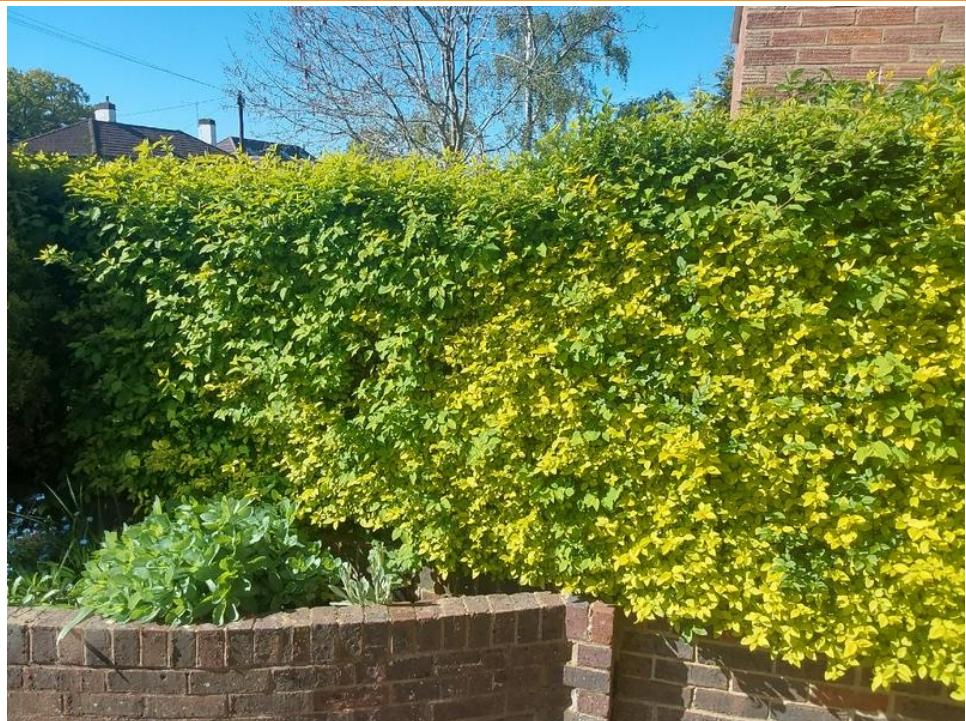
Tree No:	Common Name	Age Class	Condition	Height (m)	Crown Spread (m)	Stem diam. (mm)	No. of Stems	Dist to bldg. (m)	Roots Implicated	Pruning History	Recommendation	Tree Work Constraints	Notes	Owner address	Owner
HG1	Spindle	Early Mature	Good	2.00	1.00	50	20	1.00	No	Managed by regular pruning.	No work required.	There are restrictions to the site or to the tree - contractor should quote.	Approximate DBH range of 10mm – 50mm.	24 Wieland Road, Northwood HA6 3QU	P3P
HG2	Mixed species group	Mature	Good	4.00	2.00	50	20	1.50	No	Subject to historic crown reduction management.	No work required.	The third party may be responsible for works.	Group consists of Forsythia, Hawthorn and Bramble with an approximate DBH range of 10mm – 50mm within group. Although not implicated for current claim, greater management going forwards is advised.	24 Wieland Road, Northwood HA6 3QU	P3P
HG3	Privet	Mature	Good	4.00	2.00	25	20	0.50	No	Managed by regular pruning.	No work required.	The third party may be responsible for works.	Approximate DBH range of 10mm – 30mm.	20 Wieland Road, Northwood HA6 3QU	P3P

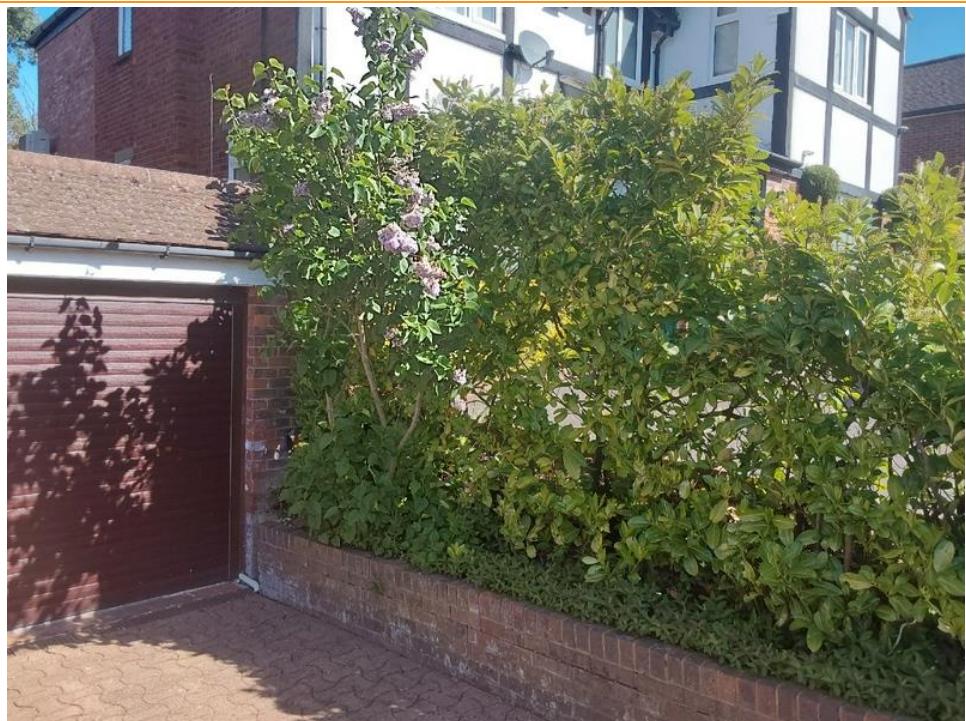
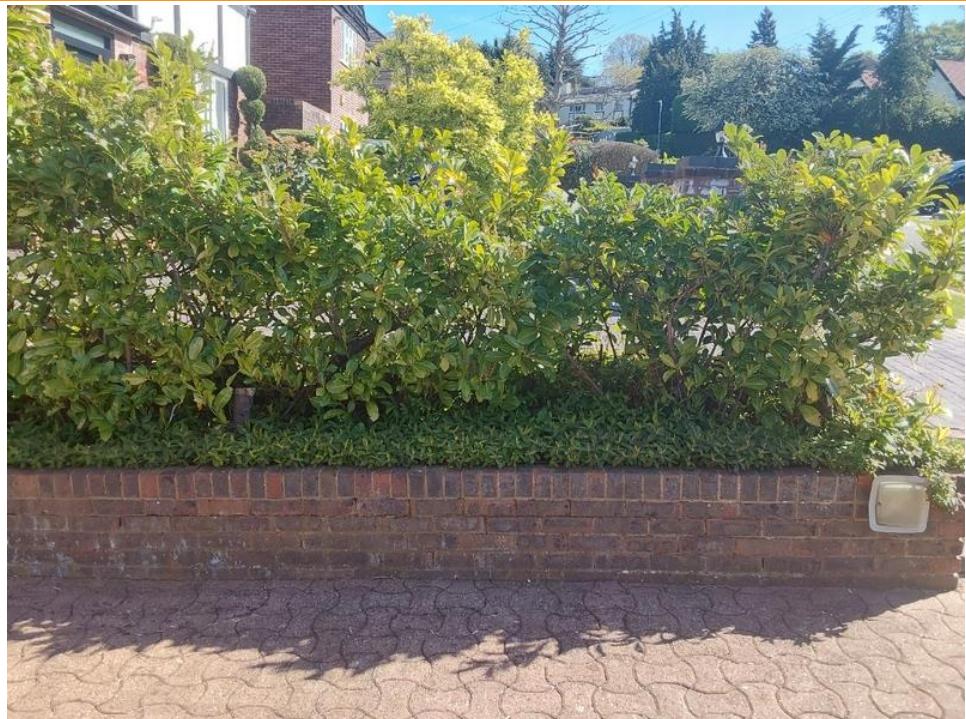
Tree No:	Common Name	Age Class	Condition	Height (m)	Crown Spread (m)	Stem diam. (mm)	No. of Stems	Dist to bldg. (m)	Roots Implicated	Pruning History	Recommendation	Tree Work Constraints	Notes	Owner address	Owner
HG4	Laurel (Cherry)	Semi-Mature	Good	3.00	1.00	50	18	0.20	No	Managed by regular pruning.	No work required.	The third party may be responsible for works.	Noted includes single stem of lilac. Approximate DBH range of 10mm – 50mm. Although not implicated in current claim removal to allow 2m clearance from property is advised.	Joint ownership – 22 & 20 Wieland Road, Northwood HA6 3QU	UKN
T1	Willow (Weeping)	Mature	Good	13.00	10.00	825	1	13.50	Yes	Subject to recent crown reduction within the last 12 months.	Fell and treat stump with eco plugs (broadleaved).	There are restrictions to the site or to the tree - contractor should quote.	TPO tree managed as a pollard.	20 Wieland Road, Northwood HA6 3QU	PH

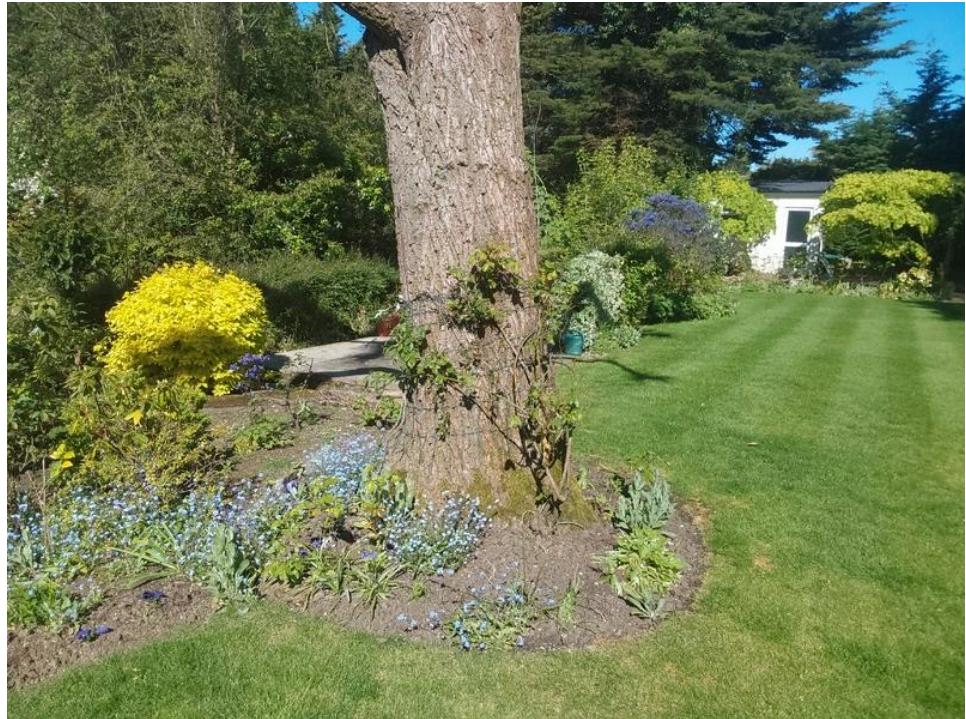
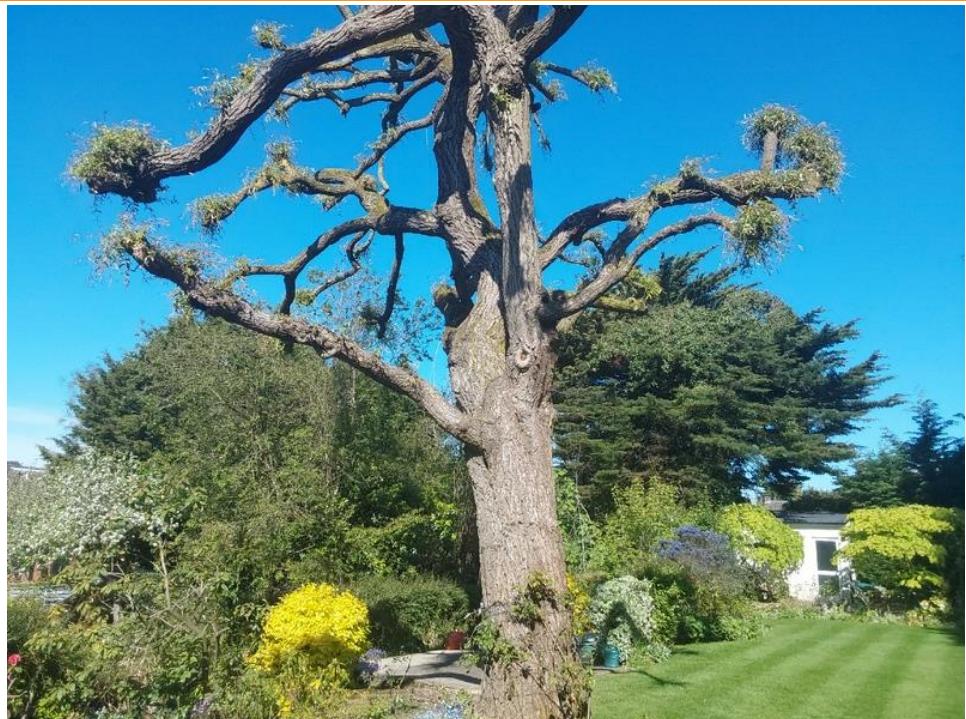
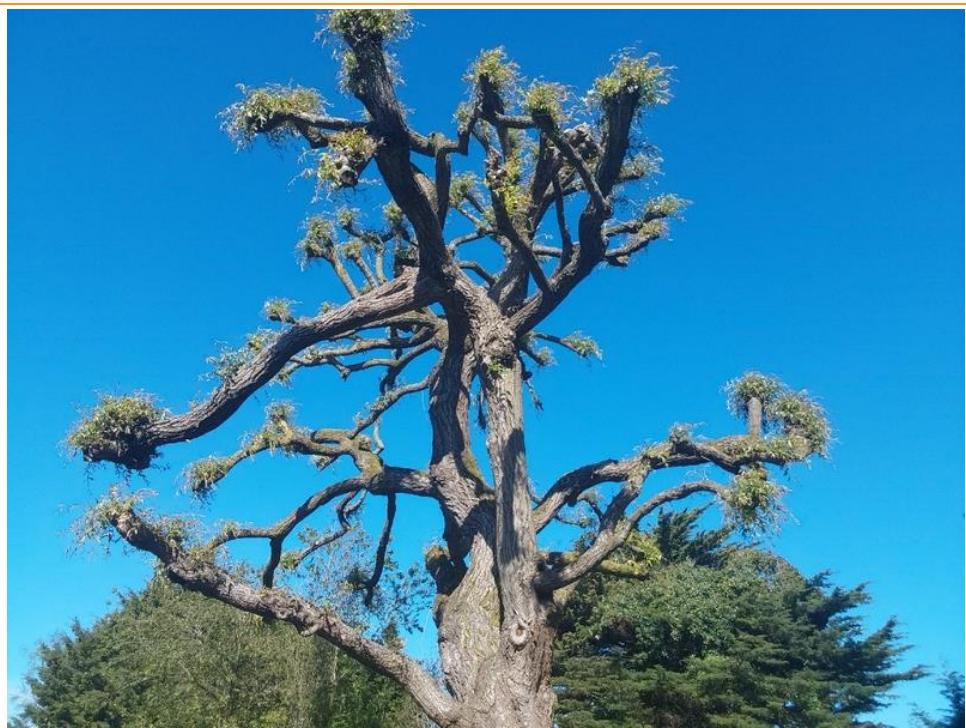
Hillingdon Council (London Borough) has confirmed that T1 (Willow (Weeping)) is subject to a Tree Preservation Order. However, there are no Conservation Area controls.

Tree No:	Species	Works Required	CA	TPO	Ownership
T1	Willow (Weeping)	Fell and treat stump with eco plugs (broadleaved).	No	Yes	PH

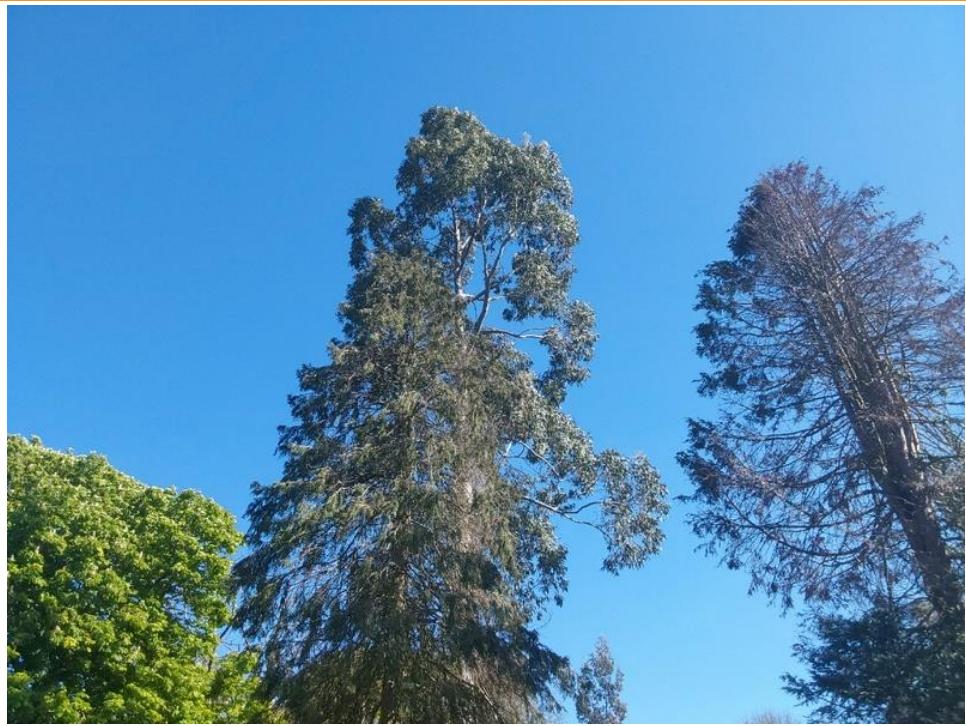
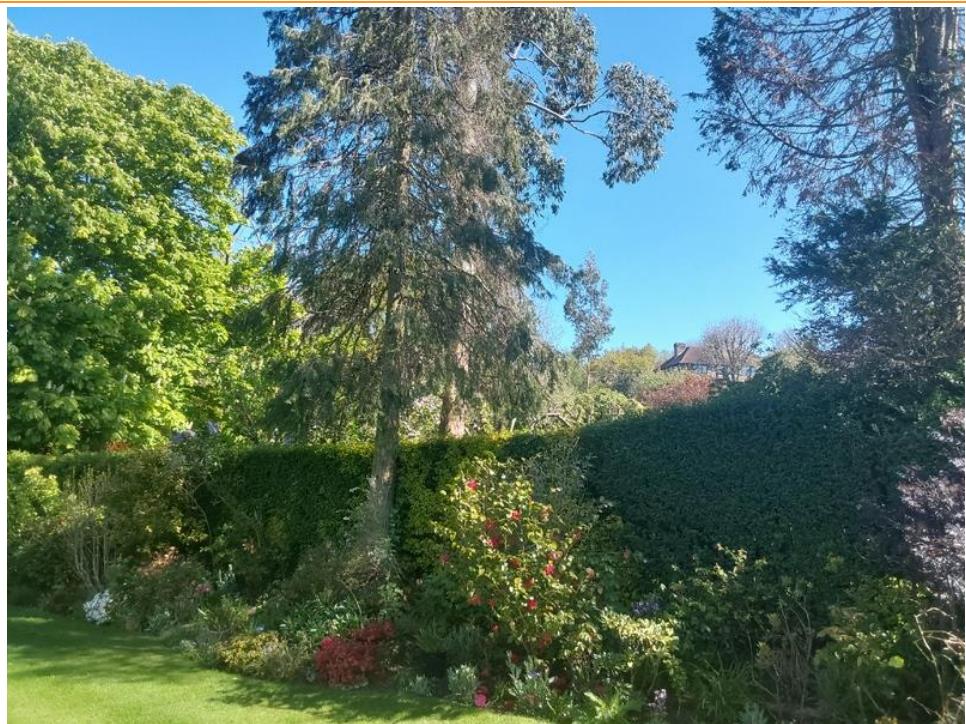
T2	Eucalyptus	Early Mature	Good	16.00	9.00	250	1	15.00	No	No significant past works.	No work required.	The third party may be responsible for works.	Although not implicated for current claim, greater management going forwards is advised.	20 Wieland Road, Northwood HA6 3QU	P3P

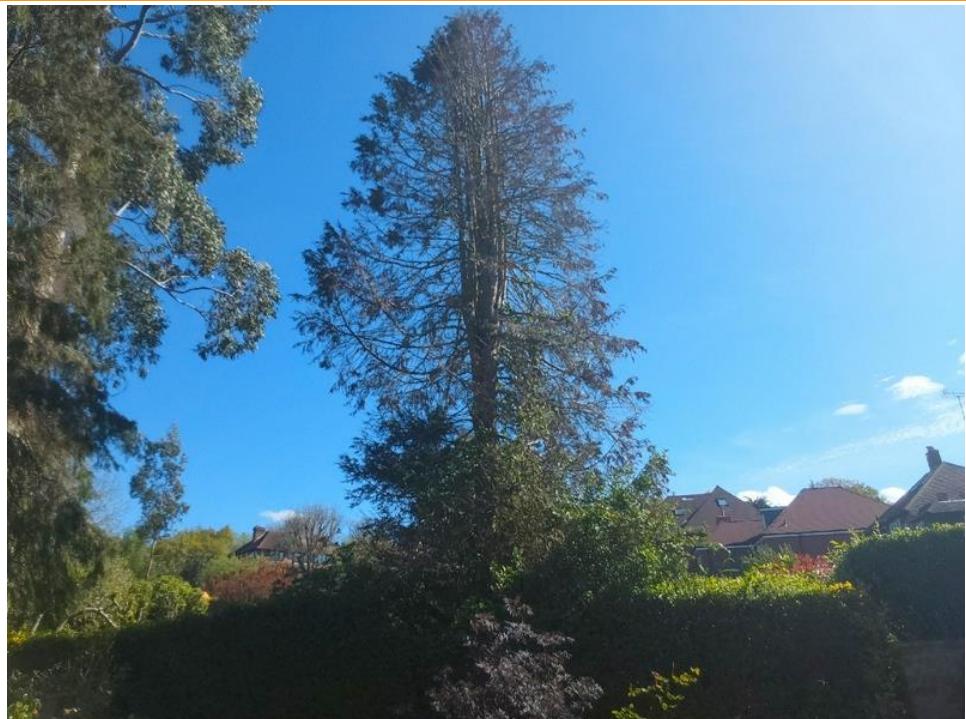
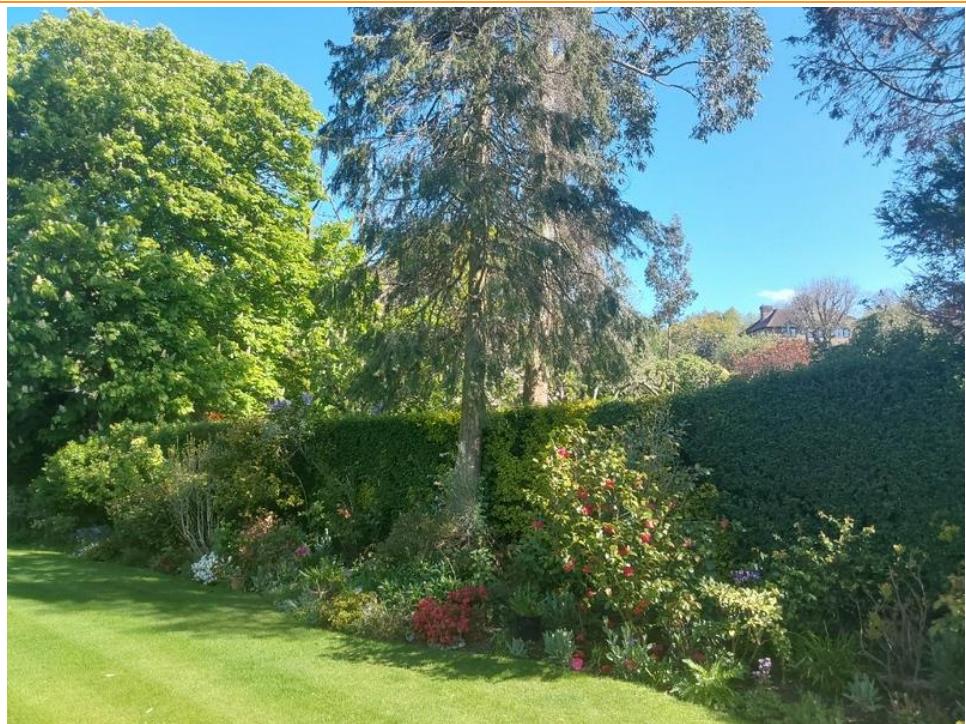
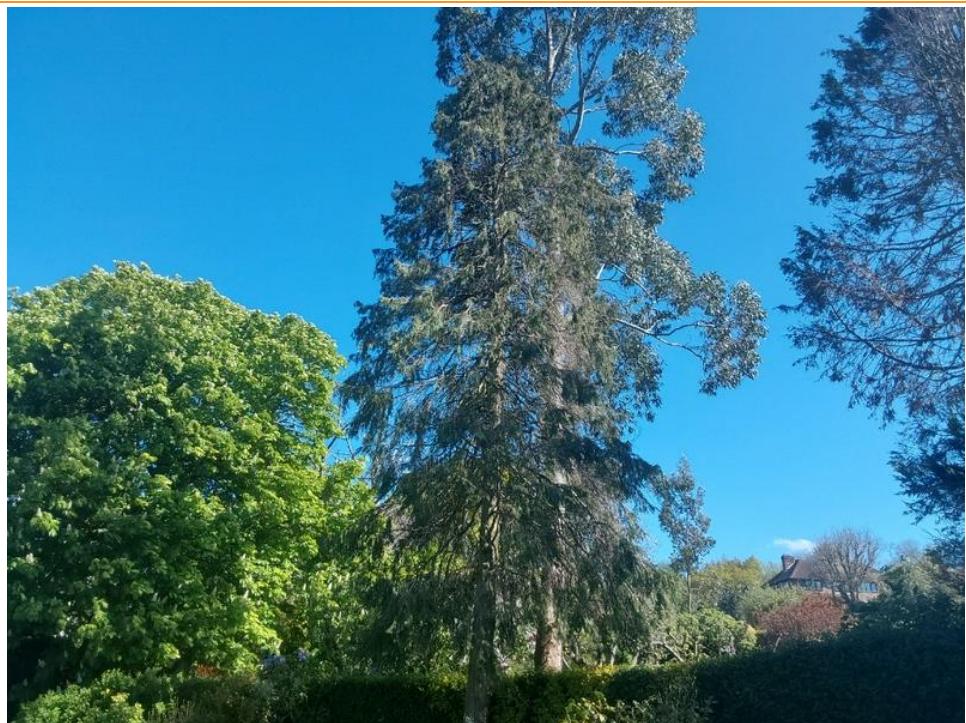
Noted 2x Cypress 1st & closest is declining and 2nd is outside AOI

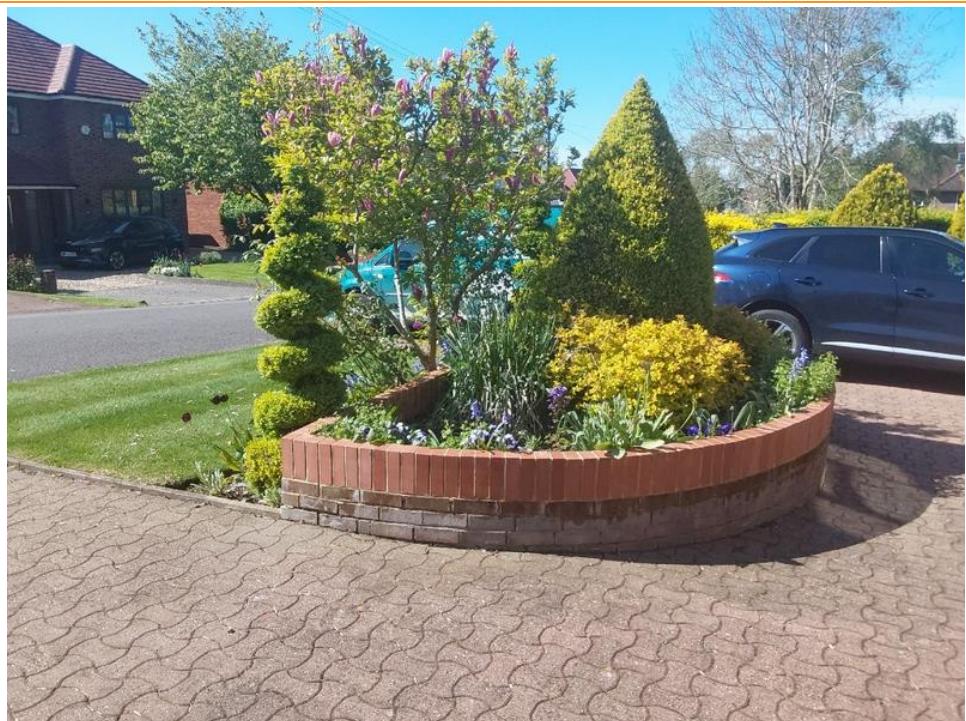
Noted 3x Cypress keep ornamental size and 1 X Magnolia outside AOI
