# Appraisal of Common Hawthorn Tree Located in The Front Garden of No. 3 Moor Park Road

**No. 3 Moor Park Road, Northwood, Middx HA6 2DL**

Arboricultural Impact Appraisal in respect of potential insurance issues and safety liabilities at :  
No. 3 Moor Park Road, Northwood, Middx HA6 2DL  
S.A. Lanigan – Chartered Arboriculturist - MICFor, Dip.Arb.(RFS),M.ArborA, RCarborA – ISA - BCMA, CUEW,  
ASCA Registered Consulting Arborist #588  
Date: 30<sup>TH</sup> July 2020 - Our Ref: SAL/KMA/10178b

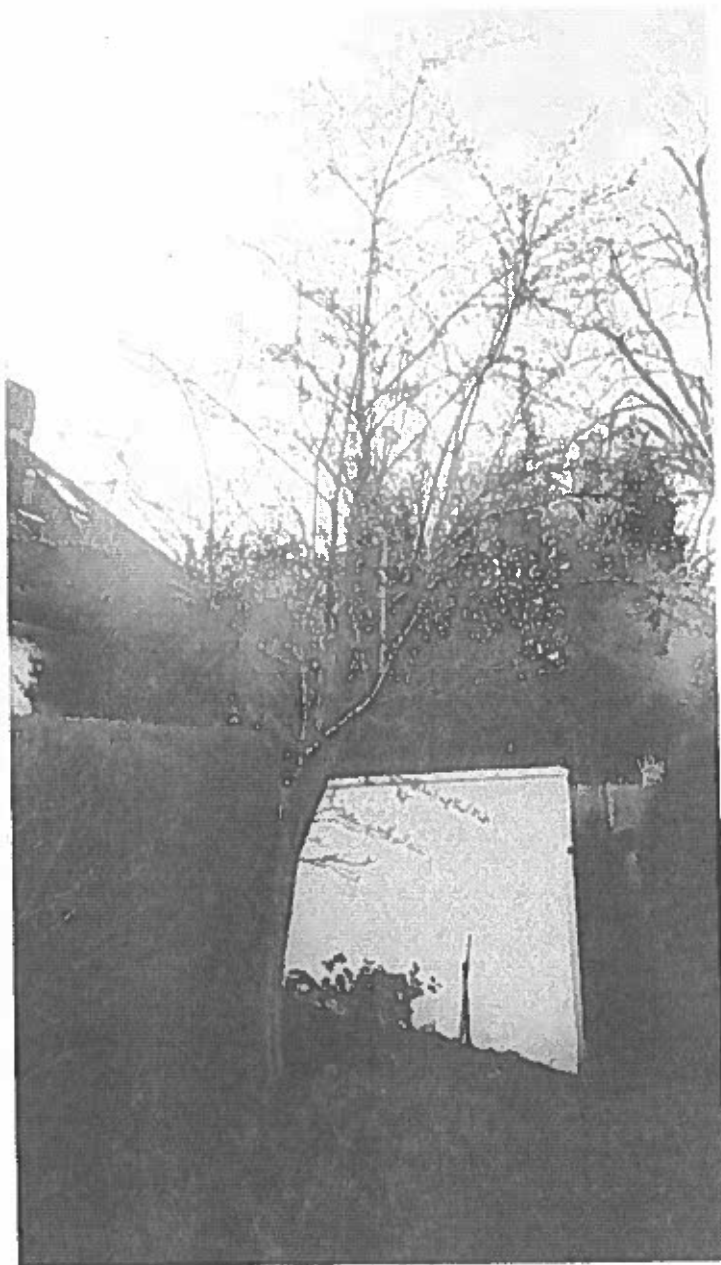
- 3.5 I saw that the tree has produced large, spreading surface orientated roots (see photographs 1 & 6, Appendix 1). This feature is not uncommon in hawthorn trees. One root in particular which grows to the north has grown under a light concrete path which it has broken and displaced (see photograph 6, Appendix 1). There is a foul water inspection chamber immediately adjacent to the damaged area. No damage or displacement is apparent and upon lifting the cover I was able to see that the interior too was intact.

**Photograph 1 - Hawthorn (T1) viewed from the northwest**

5.1 Fell tree and grind out stump to eliminate roots and potential re-growth.

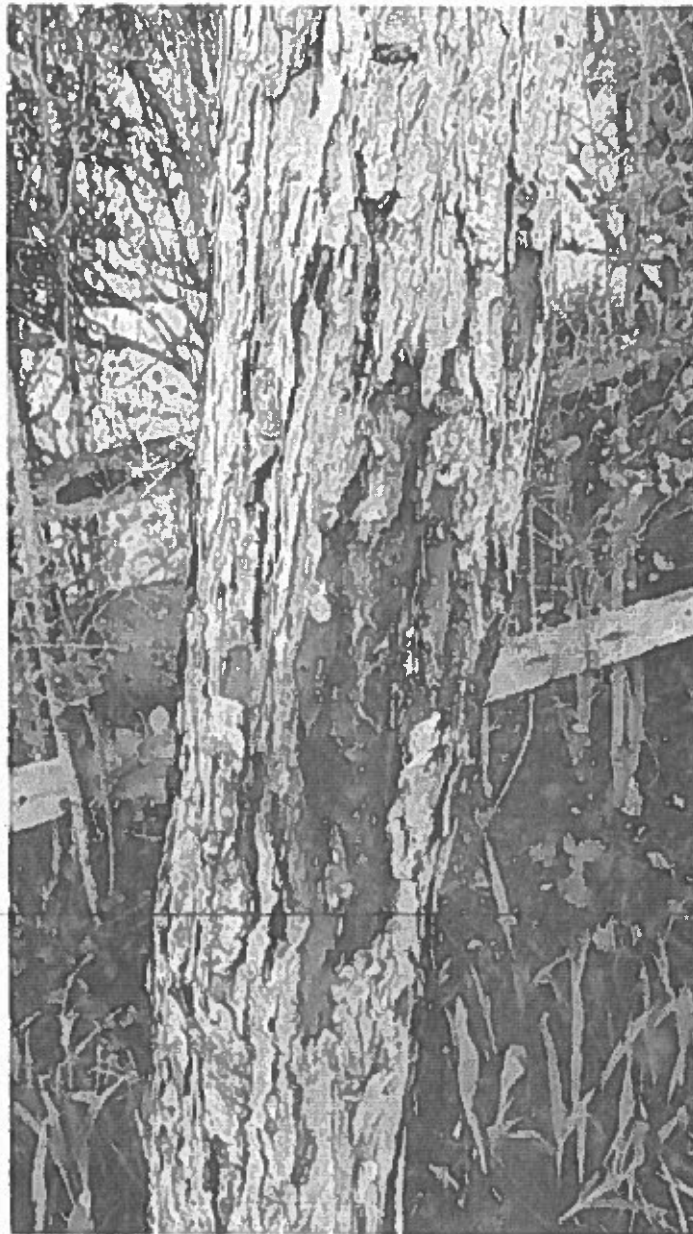
- 3.4 After viewing the crown area and overall form of the tree I looked closely at the trunk. There are signs of superficial mechanical damage on all sides of the trunk from near ground level to around 2m above (see photographs 2, 3, 4 & 5 Appendix 1). The damage seems to end around the crown breakout point which leads me to conclude that the most likely causal agents of the damage are birds. I surmise that the shallow bark damage may be caused by insectivorous birds hunting insect eggs, larvae and the insects themselves in the relatively thick bark tissues around the trunk.

**Photograph 2 - Area of significant bark damage on western side**

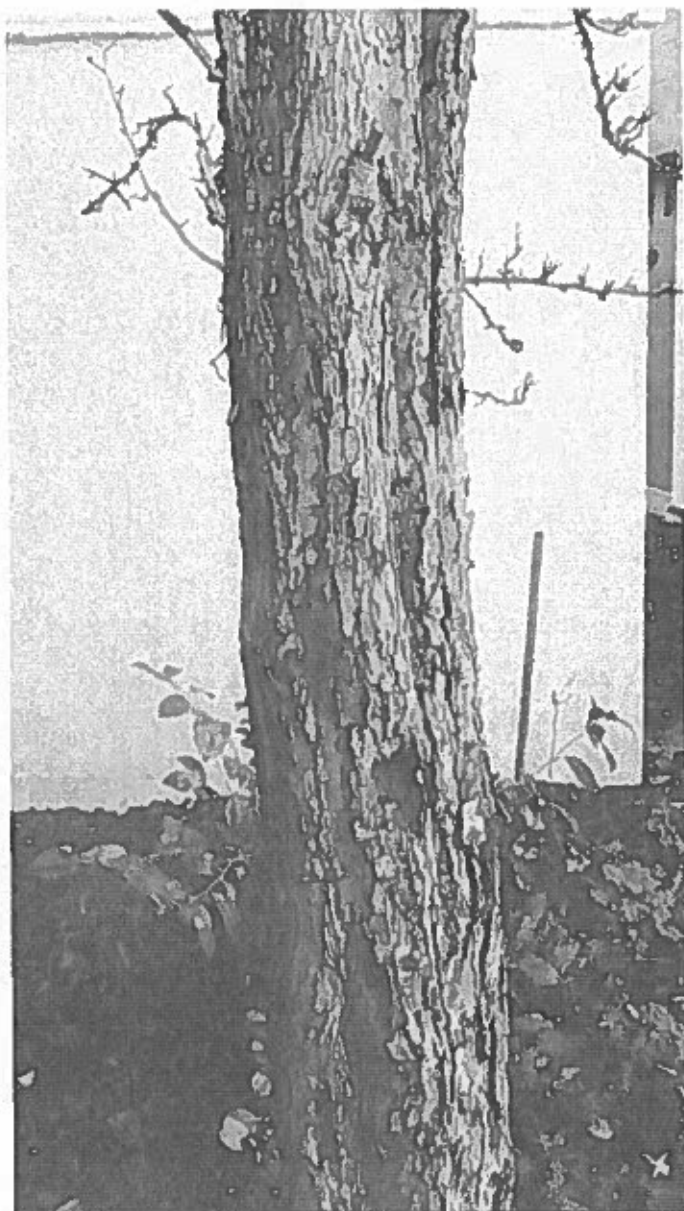
**Photograph No 3 - Discrete areas of bark damage**

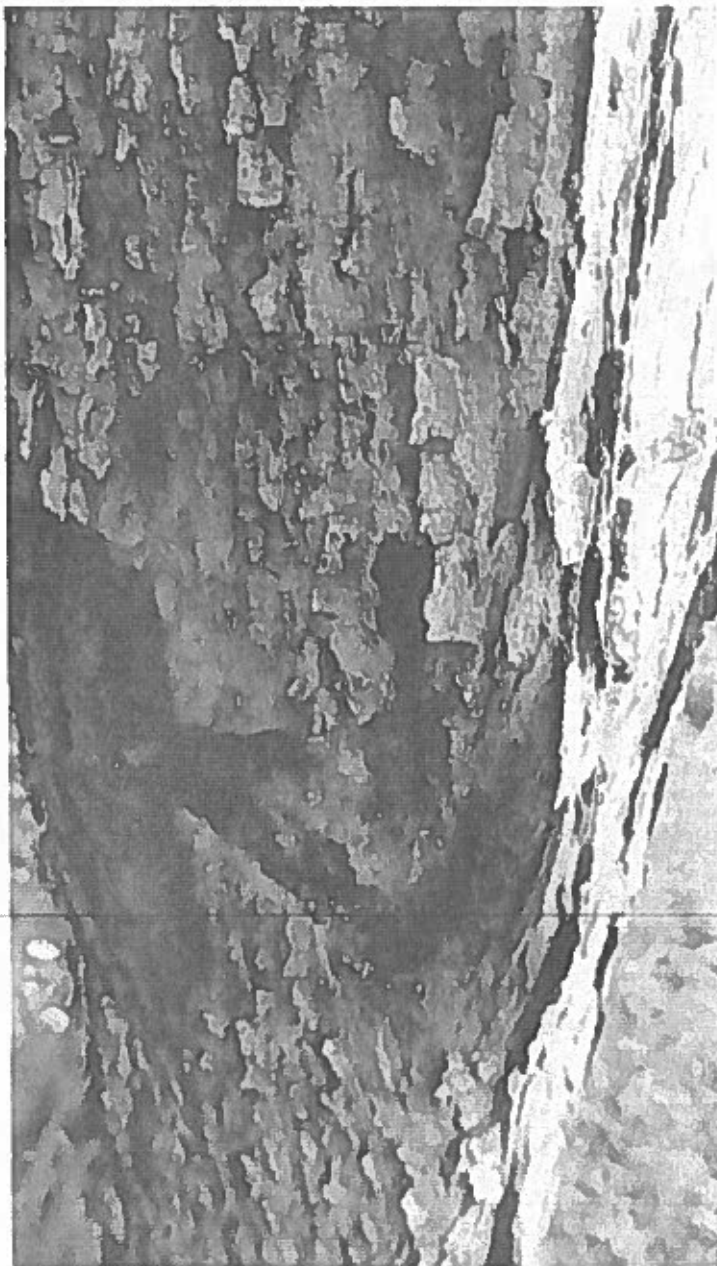
**Photograph No 4 - Bark damage on eastern side**

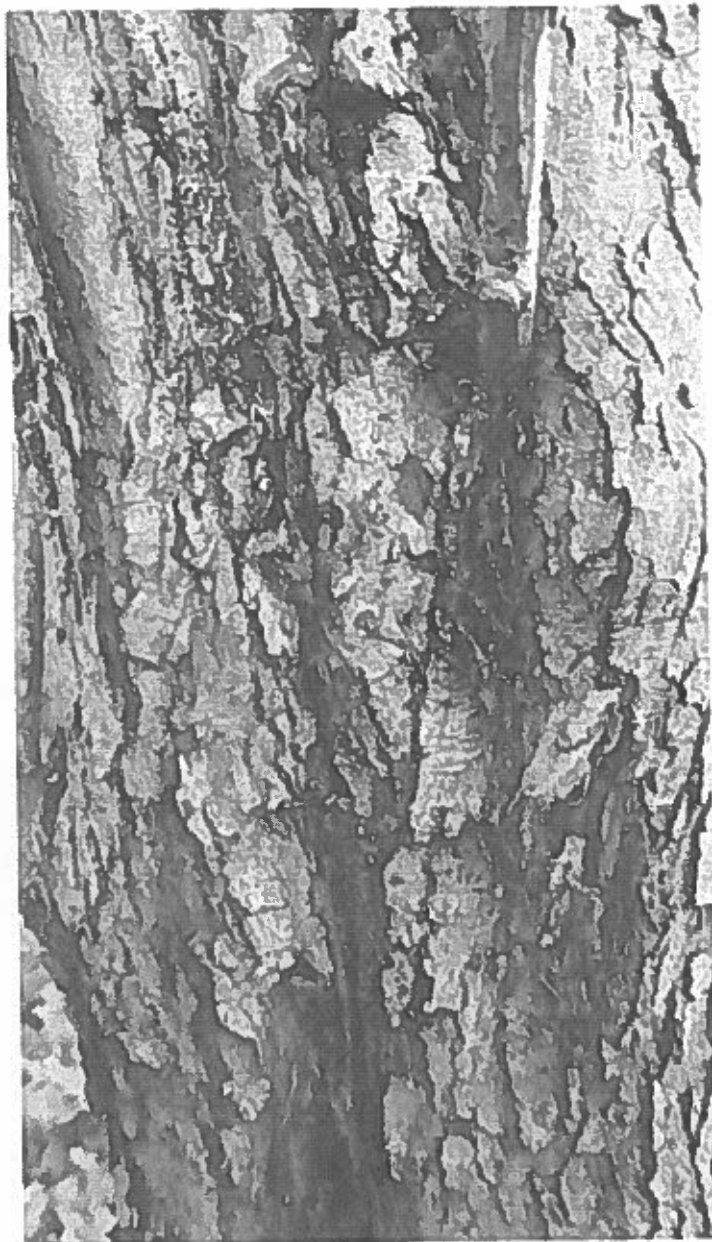
**Photograph No 5 - Bark damage showing that the bark seems to have been pulled up and physically torn away**

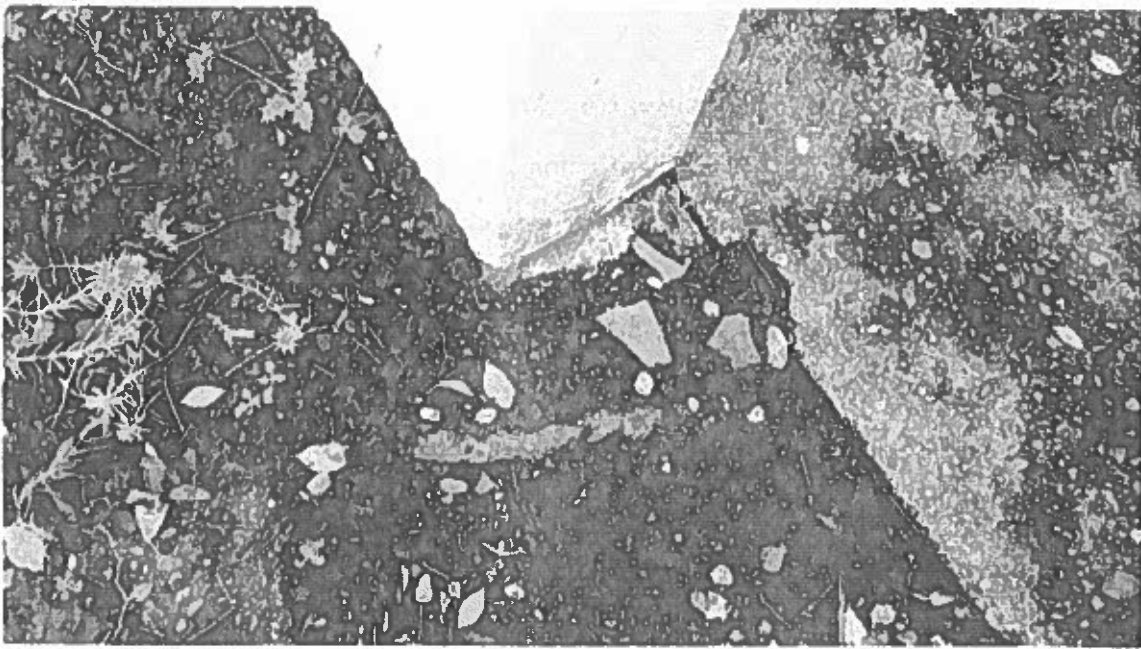
**Photograph No 6 - Surface root that displaced the concrete surfacing**
