**Tree Survey, Arboricultural Impact Assessment
Preliminary Arboricultural Method Statement & Tree Protection Plan
In Accordance with BS 5837:2012**

Proj. No 9763	The Old Stables - Extension, 77 Park Lane, Harefield, UB9 6BL		
Client:		LPS Architecture	
Date of Report:	14/10/2022	Revision:	Original

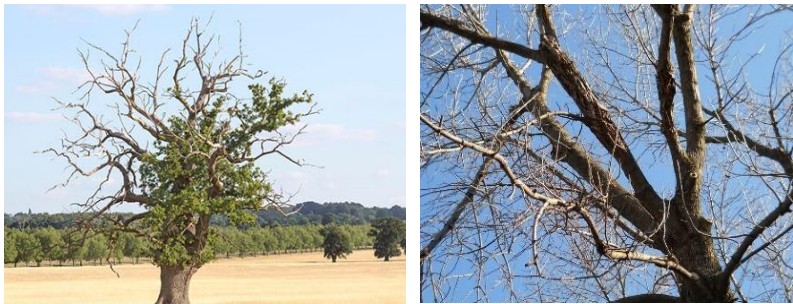
Name: Deadwood	
Symptoms/damage type and cause:	This relates to dead branches in the crown of the tree. In the majority of cases, this is caused by the natural ageing process of the tree or shading due to its close proximity to neighbouring trees. However, in some situations, it may be related to fungal, bacterial or viral infection.
Consequence:	Depending upon the location and mass of dead wood removal of the affected tissue may be necessary to prevent harm to persons or property as the wood will become unstable as it decays and in some circumstances is likely to fall from the tree with little or no warning.
Control:	Detailed monitoring should be undertaken on those trees showing signs of excessive deadwood production to identify the underlying cause.
Species affected:	Most tree species.
Images:

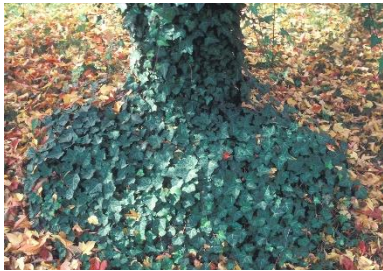
Name: <i>Hedera helix</i> (Ivy)	
Symptoms/damage type and cause:	Ivy may grow to varying degrees on all areas of a tree from the base to the upper crown. It is possible that in doing so it will out-compete the host tree for available light thereby suppressing the host.
Consequence:	This is generally only harmful to the tree on already unhealthy specimens which may be constricted by large ivy stems around the trunk or may have their top growth suppressed by a mass of flowering shoots in the crown. Ivy can also mask potentially dangerous faults on a tree.
Control:	Ivy should only be removed if absolutely necessary because it provides abundant cover to wildlife and then by severing twice close to the ground and removing a length of stem thereby causing the gradual dying away of the aerial parts of the plant providing extended benefit to wildlife whilst relieving the pressure on the tree.
Species affected:	Most trees can be affected.
