Tree Safety Survey & Report

St Raphael's Convent
Court Drive
Hillingdon
UB10 0BW

Client:	MCO Group Ltd
Job Ref.:	24 23491 St Raphaels Convent
Survey Date:	05/10/2024
Report Date:	08/10/2024
Rev. No.:	-
Checked By:	AA

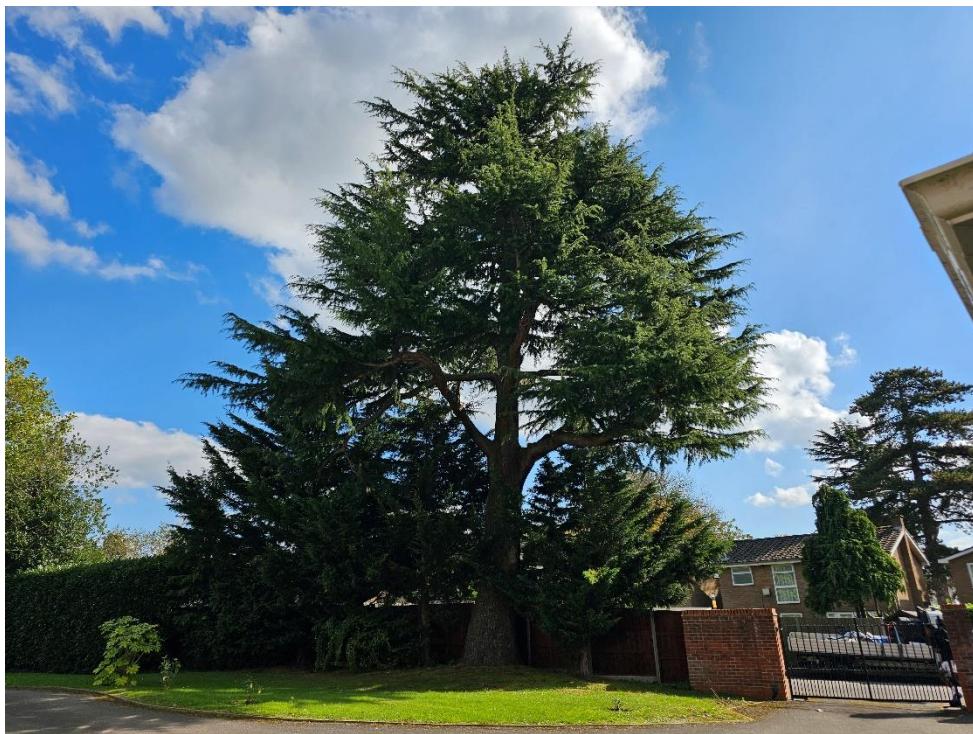
Photograph 1: T1, viewed from the northwest

DATE	TREE NO.	TYPE	SPECIES	HEIGHT RANGE (m)	DBH RANGE (mm)	AGE	CROWN SPREAD AVERAGE (m)	OBSERVATIONS	WORKS SPECIFICATION	REASONS FOR WORKS	RISK	WORKS PRIORITY
05/10/2024	1	T	Deodar Cedar	15-20	1250-1500	Mature	8	No significant recent management, past storm damage, numerous tear wounds, multiple 'dogs-leg' boughs, branch end cavities with decay, old pruning wounds to primary scaffolds and stem, large 'flush-cut' to lower stem, lower stem appears swollen	Undertake detailed safety inspection with the use of mechanical apparatus	To reduce risk of structural failure	High	3-Months
05/10/2024	2	G	Leyland Cypress	10-15	200-300	Early Mature	4	No significant recent management			Low	
05/10/2024	3	T	Holly	5-10	200-300	Mature	3	No significant recent management, slightly sparse crown, growing within hedge, full VTA not possible due to dense ground vegetation	Clear 1m of vegetation around stem base	To enable next annual inspection	Medium	3-Months

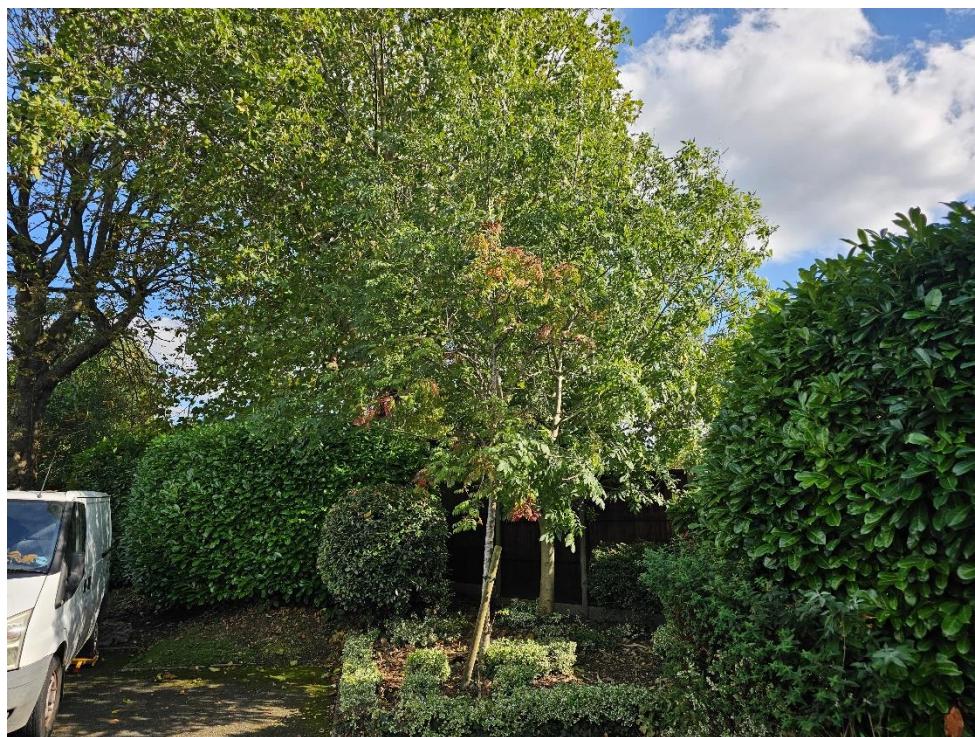
Photograph 4: T4 and T5, viewed from the west

05/10/2024	4	T	Ash	5-10	100-200	Early Mature	3	No significant recent management, exposed surface roots			Low	
05/10/2024	5	T	Rowan	0-5	75-100	Semi-Mature	1	No significant recent management, tree tie and stake	Remove tree tie and stake	Routine maintenance	Low	1-Year

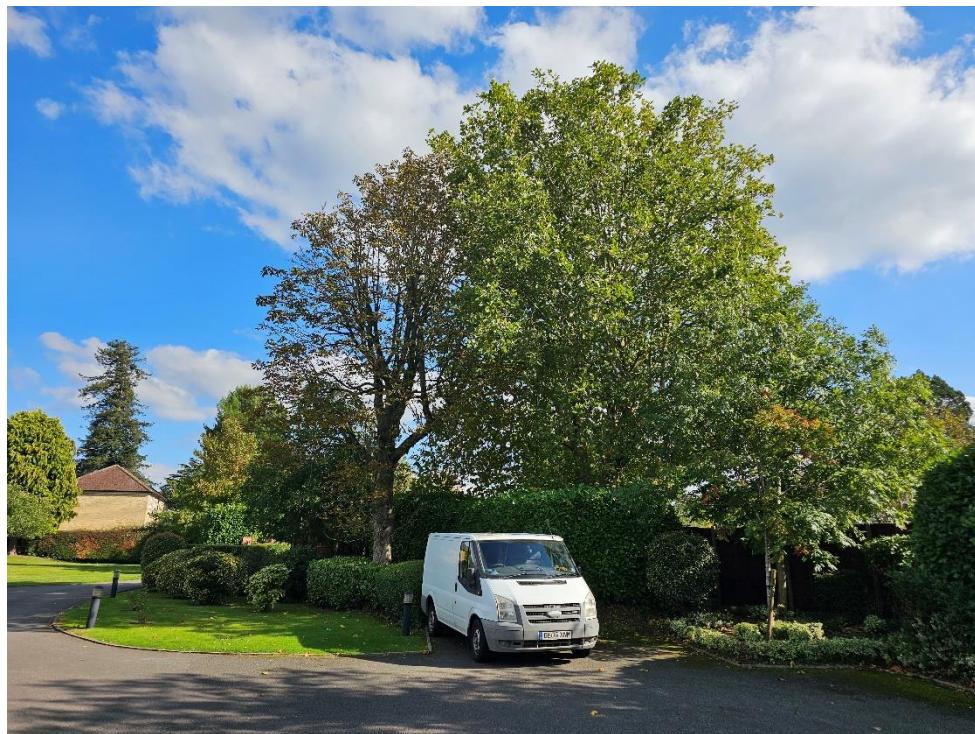
Photograph 5: T6 and T7, viewed from the northwest

DATE	TREE NO.	TYPE	SPECIES	HEIGHT RANGE (m)	DBH RANGE (mm)	AGE	CROWN SPREAD AVERAGE (m)	OBSERVATIONS	WORKS SPECIFICATION	REASONS FOR WORKS	RISK	WORKS PRIORITY
05/10/2024	6	T	London Plane	10-15	700-800	Mature	8	No significant recent management, historical pollard, old pruning wounds to primary scaffolds and stem, burring to primary scaffolds and stem, lower stem appears swollen, potential fungus on lower stem thought to be <i>Kretzschmaria deusta</i>	Undertake detailed safety inspection with the use of mechanical apparatus	To reduce risk of structural failure	High	3-Months
05/10/2024	7	T	Horse Chestnut	10-15	500-600	Mature	4	No significant recent management, evidence of lightening past strike, sparse crown short shoots, old pruning wounds to primary scaffolds and stem, burring to primary scaffolds and stem, epicormic growth, growing within hedge, full VTA not possible due to dense ground vegetation	Clear 1m of vegetation around stem base	To enable next annual inspection	Medium	3-Months

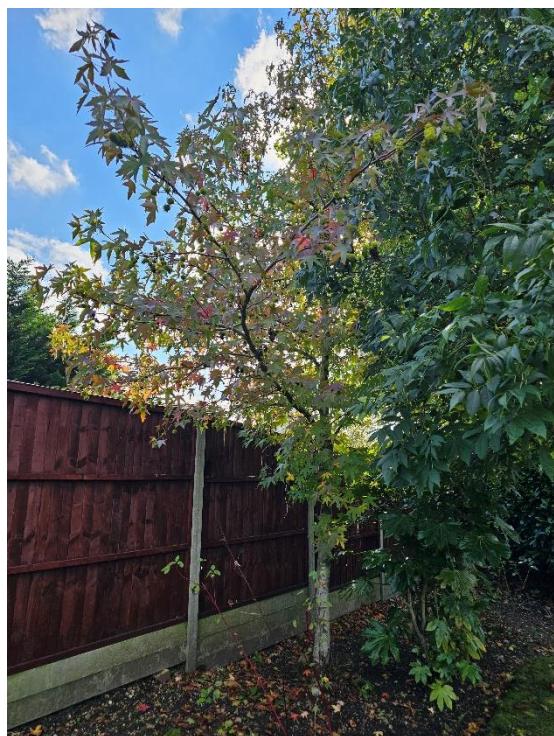
Photograph 6: T8, viewed from the northeast

05/10/2024	8	T	Liquidambar	5-10	75-100	Early Mature	3	No significant recent management, suppressed			Low	
05/10/2024	9	T	Ash	5-10	100-200	Early Mature	3	No significant recent management			Low	
05/10/2024	10	G	Liquidambar	5-10	100-200	Early Mature	4	No significant recent management, tree to western end of group has bifurcated stem with split	Fell tree at western end of group to ground level	To minimise risk to persons and property	Medium	3-Months

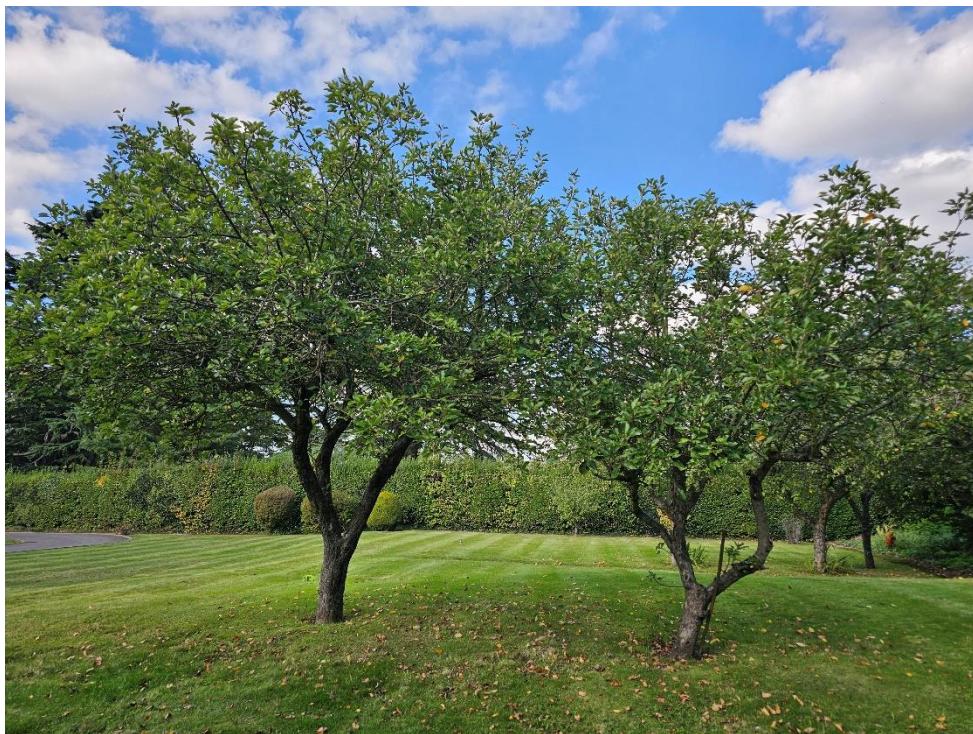
Photograph 9: G11, viewed from the south

DATE	TREE NO.	TYPE	SPECIES	HEIGHT RANGE (m)	DBH RANGE (mm)	AGE	CROWN SPREAD AVERAGE (m)	OBSERVATIONS	WORKS SPECIFICATION	REASONS FOR WORKS	RISK	WORKS PRIORITY
05/10/2024	11	G	Apple	0-5	100-200	Mature	3	No significant recent management, old pruning wounds to primary scaffolds and stems, trifurcated and bifurcated stems			Low	
05/10/2024	12	T	Lawson Cypress	5-10	400-500	Mature	4	No significant recent management			Low	
05/10/2024	13	T	Apple	0-5	400-500	Mature	4	No significant recent management, old pruning wounds to primary scaffolds and stems, hollow stem to ground level	Reduce tree significantly leaving 0.5-1m growth above crown break	To minimise risk of structural failure	Low	1-Year
05/10/2024	14	G	Apple	0-5	200-300	Mature	4	No significant recent management, sparse crowns, old pruning wounds to primary scaffolds and stems, bifurcated stems, degraded bracket fungus on tree central to group			Low

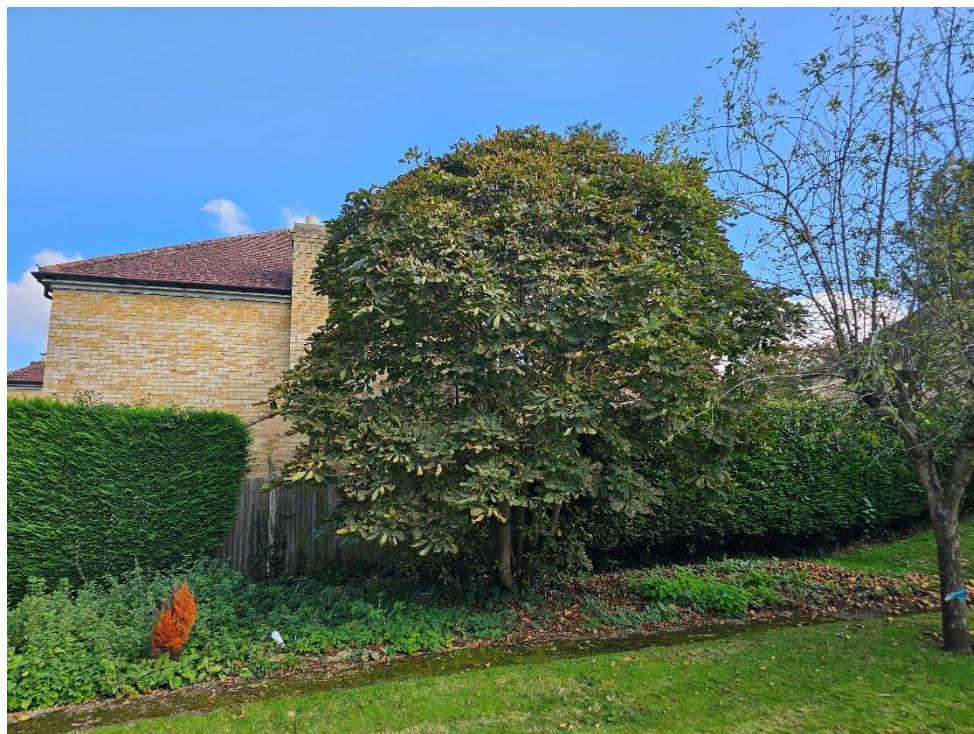
Photograph 13: T15, viewed from the west

05/10/2024	15	T	Horse Chestnut	0-5	100-200	Early Mature	4	No significant recent management, multi-stemmed			Low	
05/10/2024	16	T	Holly	5-10	100-200	Mature	2	No significant recent management, sparse crown short shoots, trifurcated stem, growing within hedge, full VTA not possible due to dense ground vegetation	Clear 1m of vegetation around stem base	To enable next annual inspection	Medium	3-Months

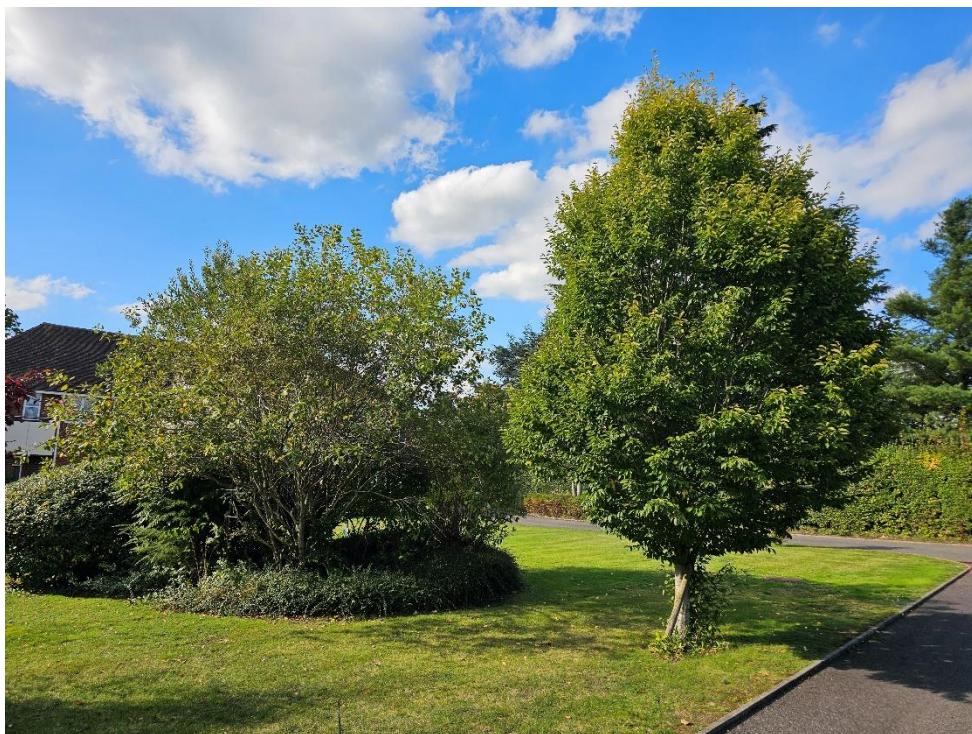
Photograph 15: T17 and T18, viewed from the southeast

DATE	TREE NO.	TYPE	SPECIES	HEIGHT RANGE (m)	DBH RANGE (mm)	AGE	CROWN SPREAD AVERAGE (m)	OBSERVATIONS	WORKS SPECIFICATION	REASONS FOR WORKS	RISK	WORKS PRIORITY
05/10/2024	17	T	Hornbeam	5-10	100-200	Early Mature	2	No significant recent management, epicormic and basal growth, tree tie and stake	Remove epicormic and basal growth, remove tree tie and stake	Routine maintenance	Low	1-Year
05/10/2024	18	T	Goat Willow	0-5	75-100	Early Mature	4	No significant recent management, multi-stemmed			Low	
05/10/2024	19	T	Larch	0-5	75-100	Semi-Mature	1	No significant recent management, low branches	Lift crown to 1.5m	Routine maintenance	Low	1-Year
05/10/2024	20	G	Yucca	0-5	100-200	Mature	1	No significant recent management, minor stem wound to one tree, single and multi-stemmed trees			Low	
05/10/2024	21	T	Yew	5-10	200-300	Mature	2	Subject to regular management, full VTA not possible due to dense lower growth			Low

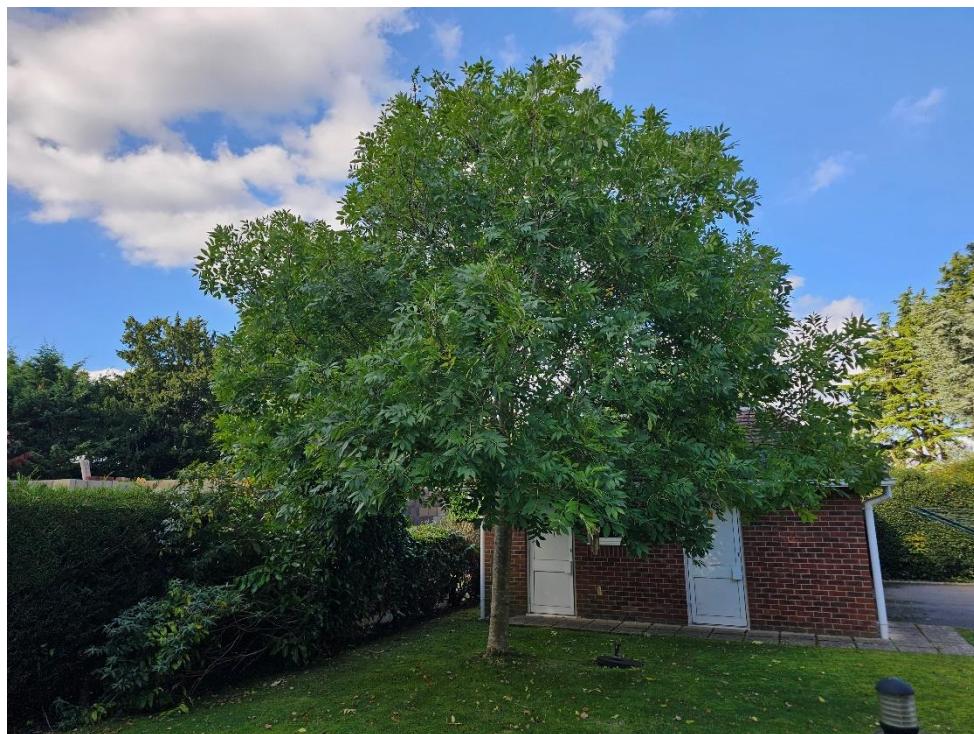
Photograph 19: T22, viewed from the south

05/10/2024	22	T	Ash	0-5	100-200	Early Mature	4	No significant recent management, branches close to structure, low branches	Cut back to achieve 2m clearance from structure, lift crown to 2.5m	Routine maintenance	Low	1-Year
05/10/2024	23	G	Crab Apple	0-5	75-100	Early Mature	3	No significant recent management, low branches	Lift crown to 2.5m	Routine maintenance	Low	1-Year

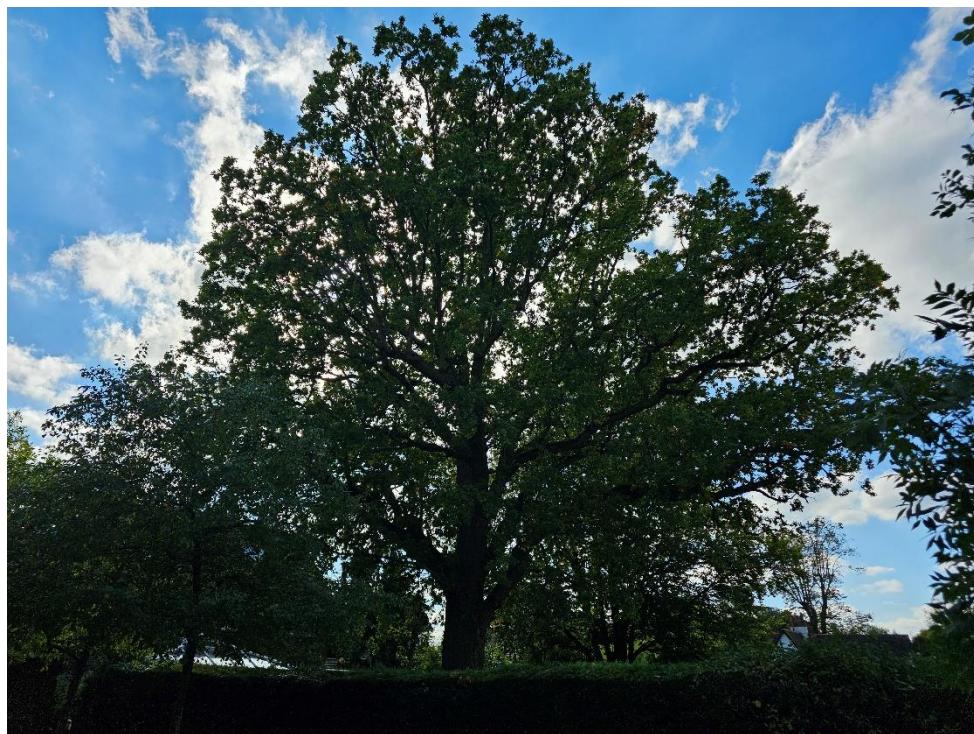
Photograph 21: T24, viewed from the northeast

DATE	TREE NO.	TYPE	SPECIES	HEIGHT RANGE (m)	DBH RANGE (mm)	AGE	CROWN SPREAD AVERAGE (m)	OBSERVATIONS	WORKS SPECIFICATION	REASONS FOR WORKS	RISK	WORKS PRIORITY
05/10/2024	24	T	Oak	15-20	800-900	Mature	10	No significant recent management, moderate deadwood, woodpecker holes, old pruning wounds to primary scaffolds and stem some with decay, full VTA not possible due to limited access	Remove deadwood/climbing inspection to assess woodpecker holes, major scaffolds and pruning wounds with decay	Routine maintenance/To minimise risk of structural failure	Medium	3-Months
05/10/2024	25	T	Ash	0-5	100-200	Early Mature	3	No significant recent management, branches close to structure	Cut back to achieve 2m clearance from structure, lift crown to 2.5m	Routine maintenance	Low	1-Year
05/10/2024	26	T	Leyland Cypress	0-5	75-100	Semi-Mature	1	No significant recent management			Low	
05/10/2024	27	T	Cherry	5-10	75-100	Semi-Mature	2	No significant recent management, branches close to structure, bifurcated stem	Cut back to achieve 2m clearance from structure	Routine maintenance	Low	1-Year

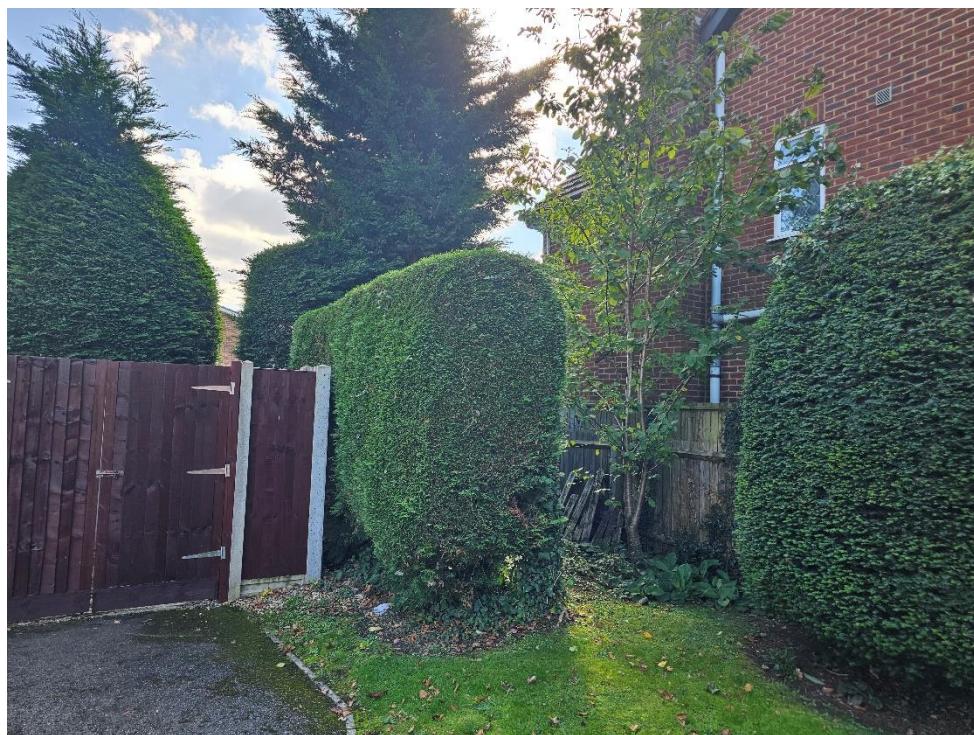
Photograph 24: T27 and G28, viewed from the northeast

05/10/2024	28	G	Leyland Cypress	0-5	100-200	Early Mature	1	Subject to regular management, managed as low-level hedge				
05/10/2024	29	G	Leyland Cypress	5-10	100-200	Early Mature	3	No significant recent management, branches close to structure	Cut back to achieve 2m clearance from structure	Routine maintenance	Low	1-Year
05/10/2024	30	T	Leyland Cypress	5-10	200-300	Mature	2	Subject to regular management			Low
