**Arboricultural survey to British  
Standard B.S. 5837: 2012 'Trees in  
relation to design, demolition and  
construction - Recommendations'  
at  
42 Dene Road  
Northwood**

**Prepared by**  
Simon Hawkins N.D Arbor M. Arbor. A.

25/05/2017

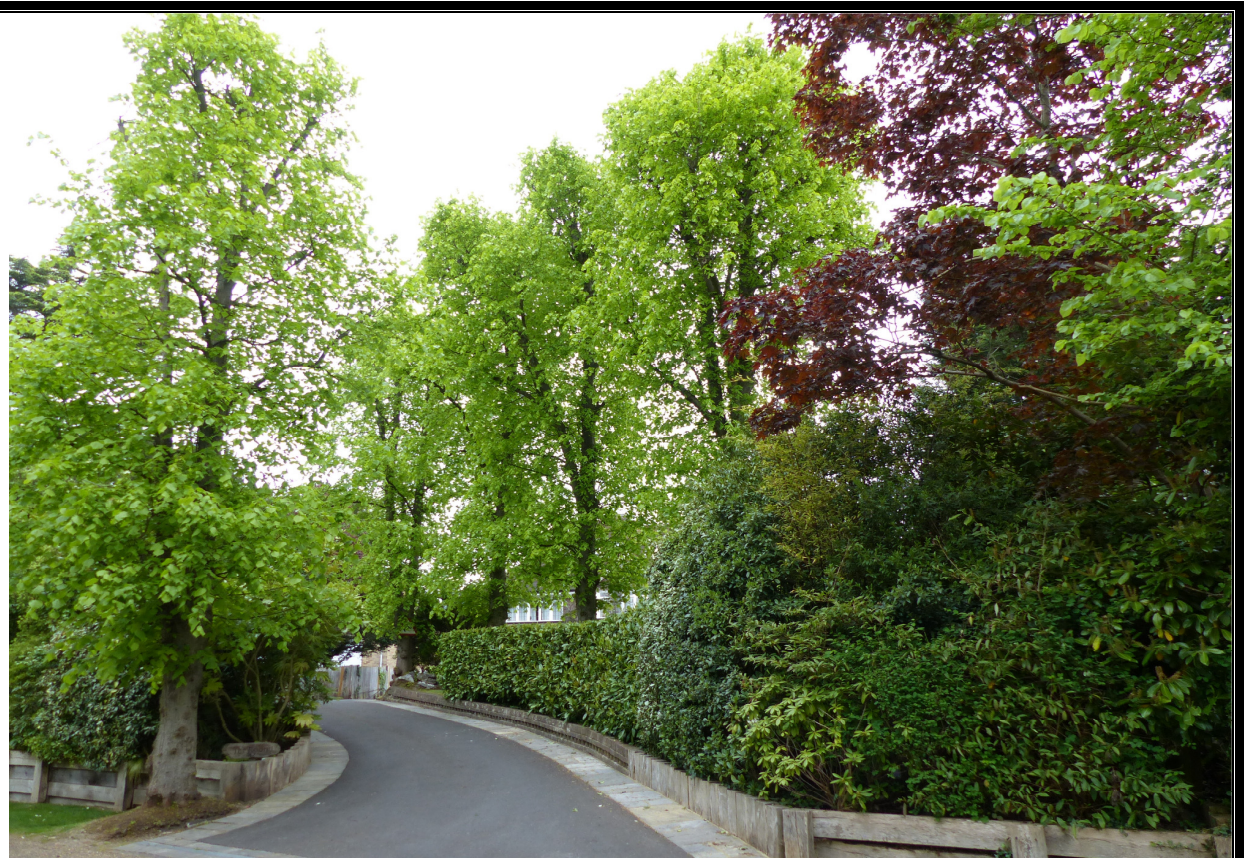
- 4.1 The site is stocked with a number of mature trees. The trees on and around the site are important features of the local landscape, contributing positively to the visual amenity of the area.
- 4.2 At the front of the site and lining the edge of the driveway are a number of mature lime trees that have been kept pruned (fig 1).

**Fig: 1 The lime trees at the front of the property and lining the driveway have been kept in shape by pruning**
