# FORMER NESTLE FACTORY, HAYES

ARBORICULTURAL IMPACT ASSESSMENTS

MAY 2017

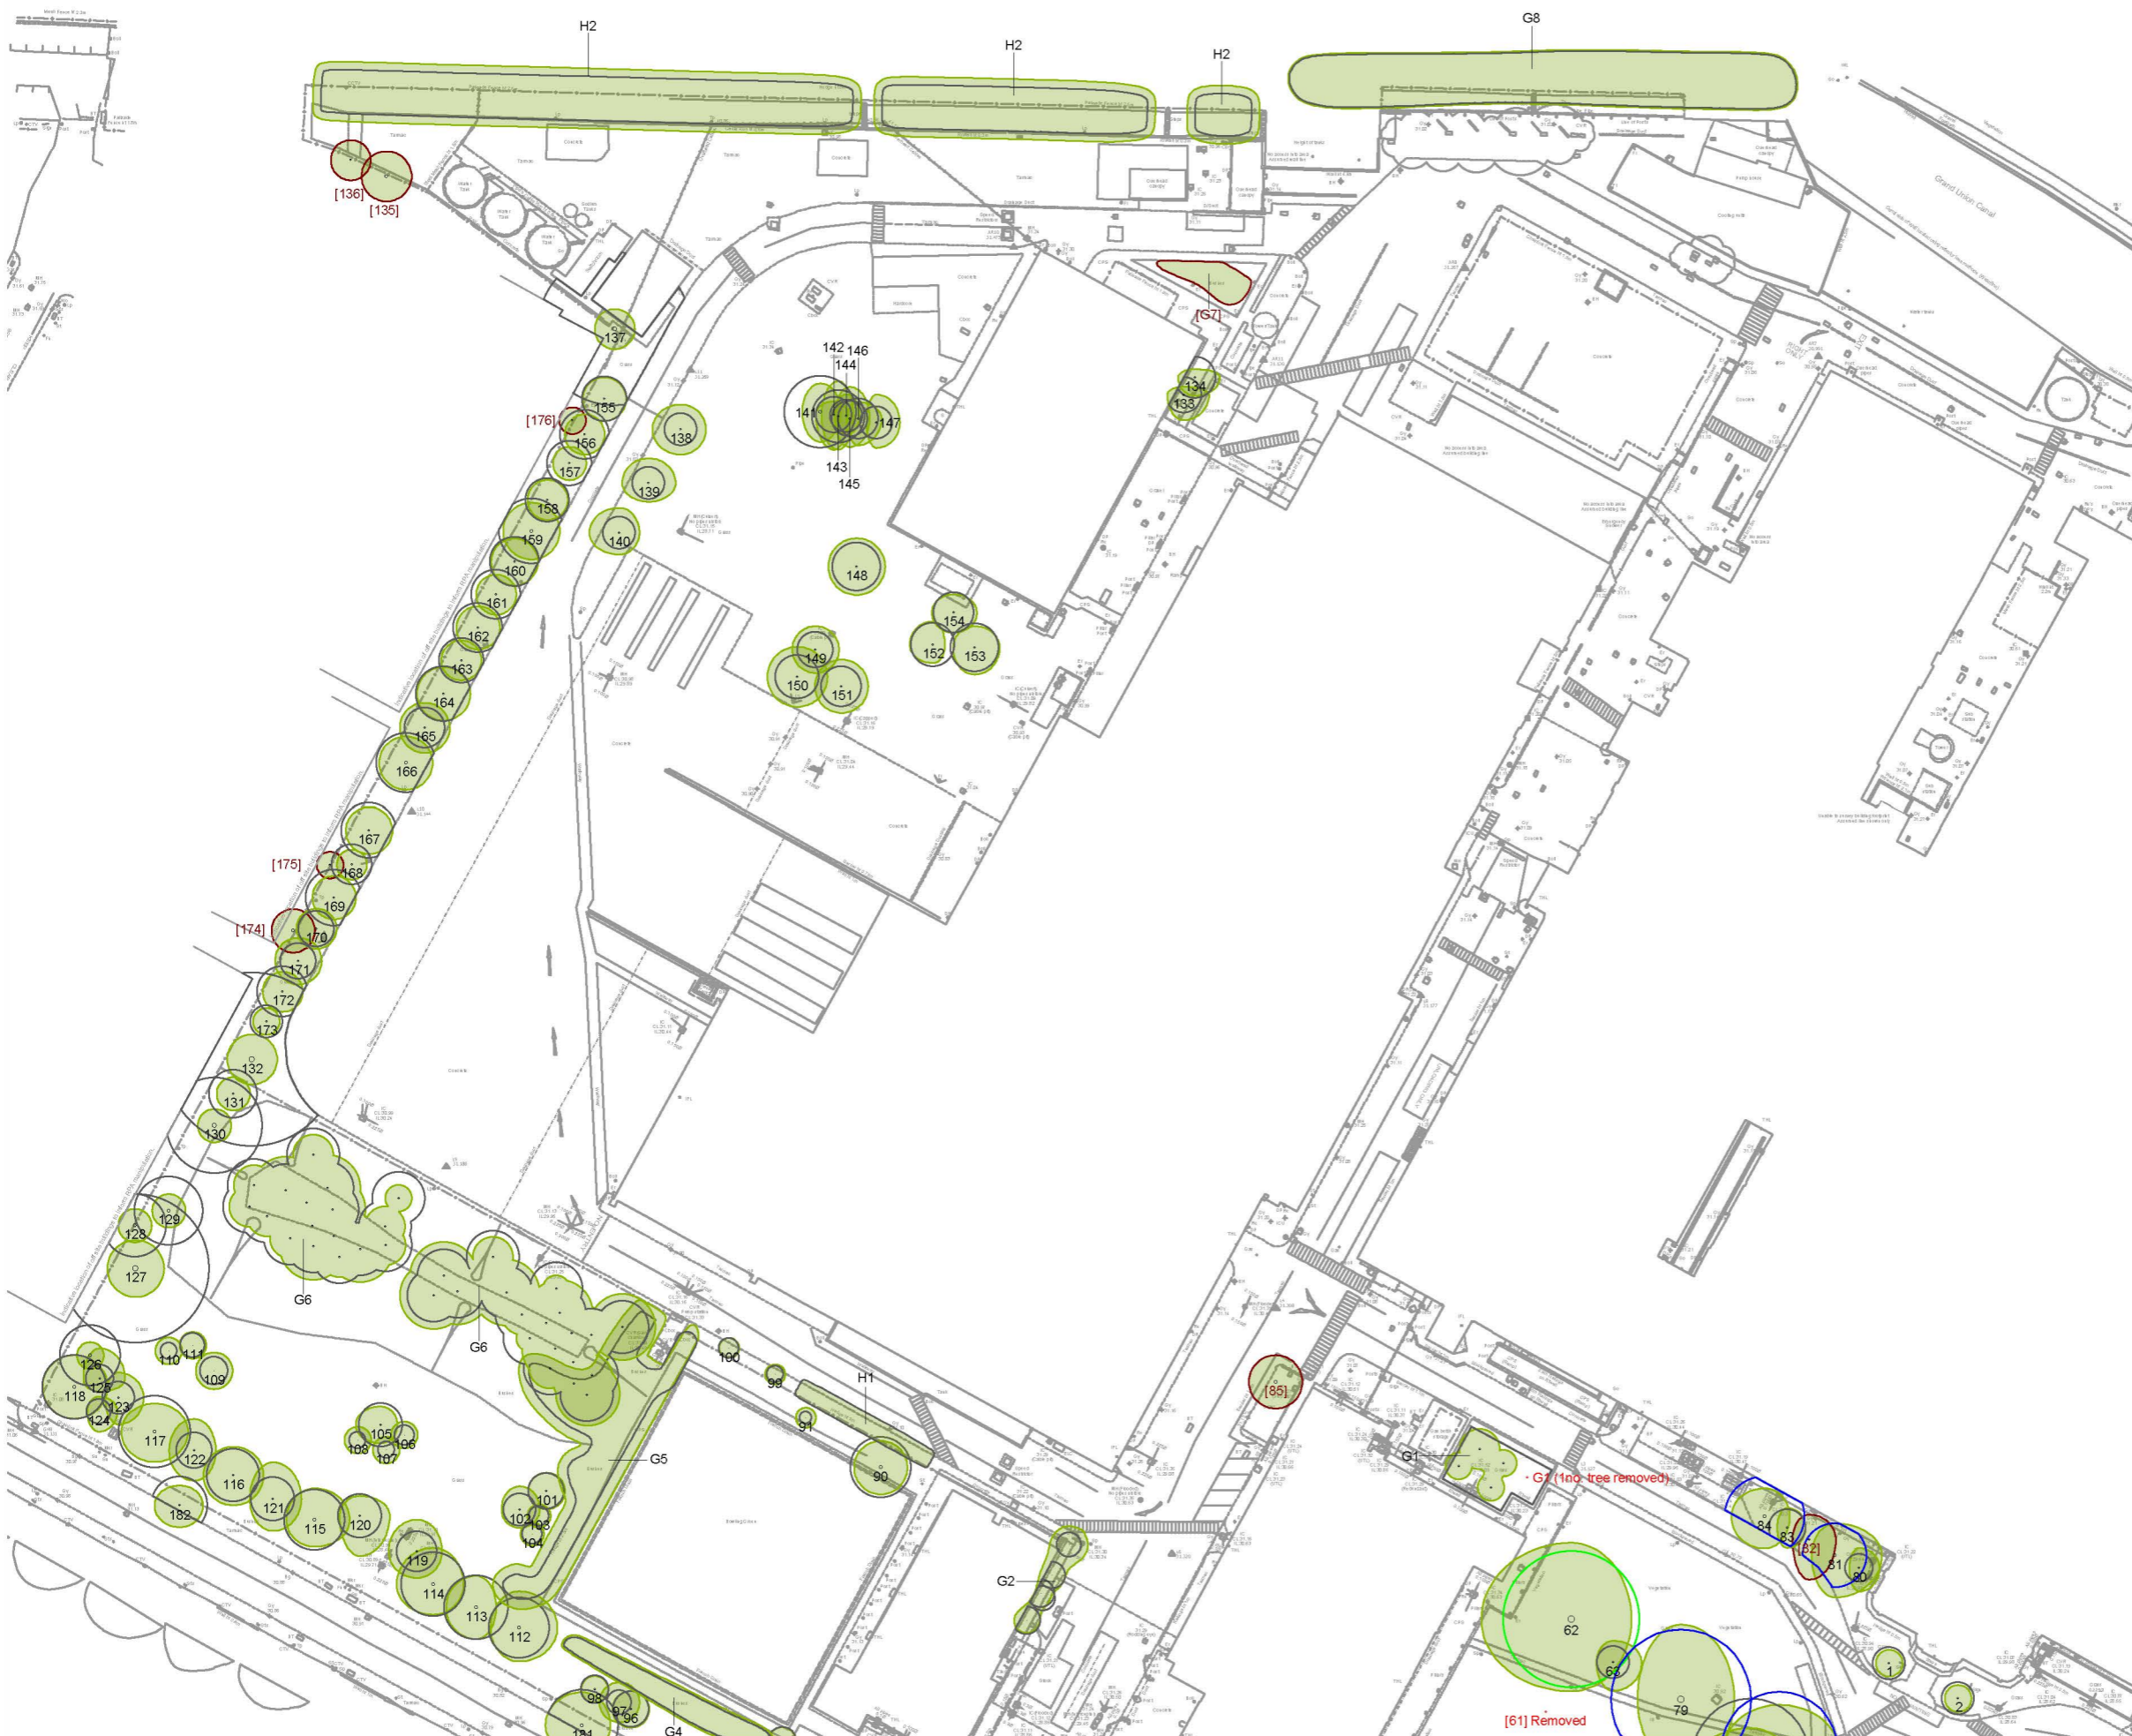
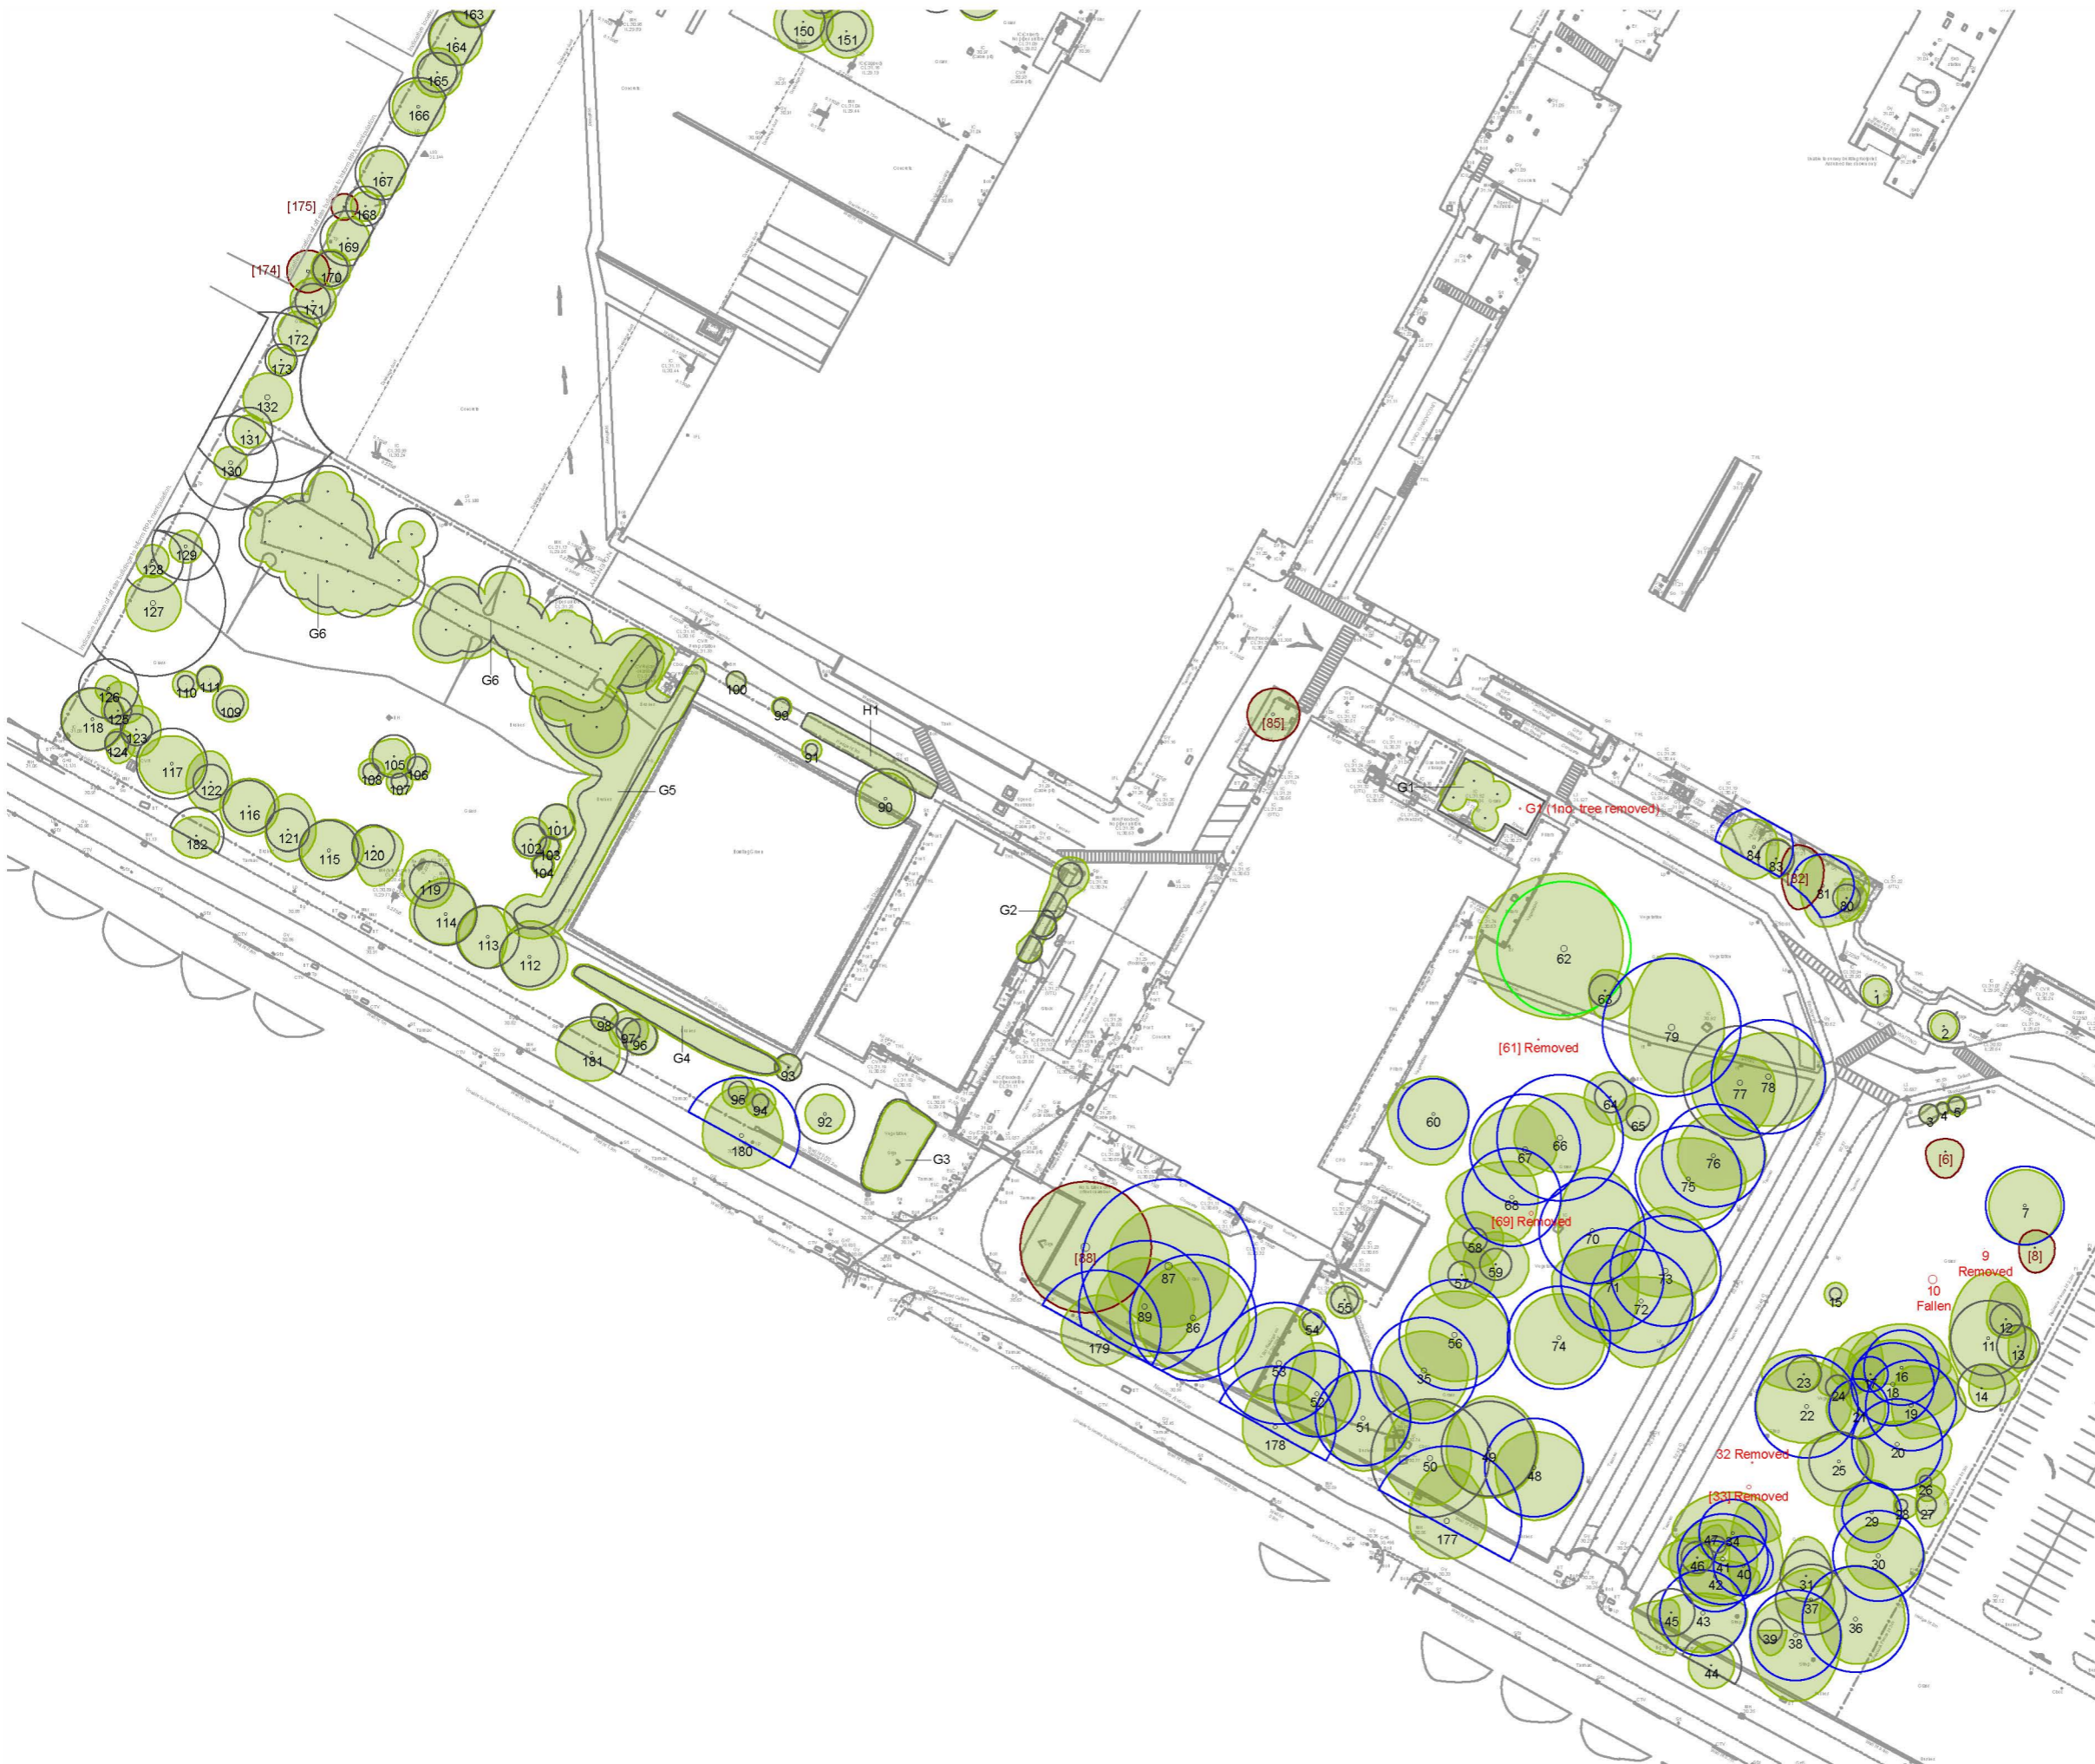
TREE CONSTRAINTS PLAN (9236 TCP 01 Rev A)

- 5.8 **Category U Tree Cover**<sup>4</sup>
- 5.8.1 **T6** Silver Birch: Exhibiting a decay cavity at its base to the west, T6's poor structural condition is anticipated to result in its early loss.

- 5.8.2 **T8** Silver Birch, **T80** Cherry, **T85** False Acacia, **T88** Beech & **G7** Rowan: All are considered to be in a below average physiological condition, such that they are in a state of terminal decline.
